# **Final Thomas Creek Restoration Project Year 4 Monitoring Report**

Wake County, North Carolina

DMS Project ID Number – 96074, DEQ Contract No. 5549

Report Prepared and Submitted by Michael Baker Engineering, Inc.

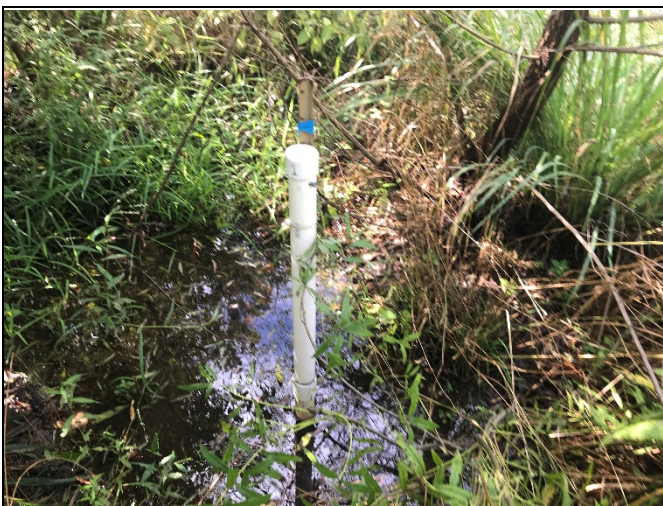
PP-17: Reach 2, Flow Gauge #1 at Station 20+75

To monitor flow on restored reaches, two flow gauges were installed on site; TMCK-FL1 on Reach 2 (Station 20+75), and TMCK-FL2 on Reach 5 (Station 33+90). The Year 4 flow monitoring data demonstrated that both flow gauges met the stated success criteria of 30 days or more of consecutive flow. The gauges also demonstrated similar patterns relative to rainfall events and can corroborate reported overbank flow events from the crest gauge, as shown in the flow gauge graphs found in Appendix E.

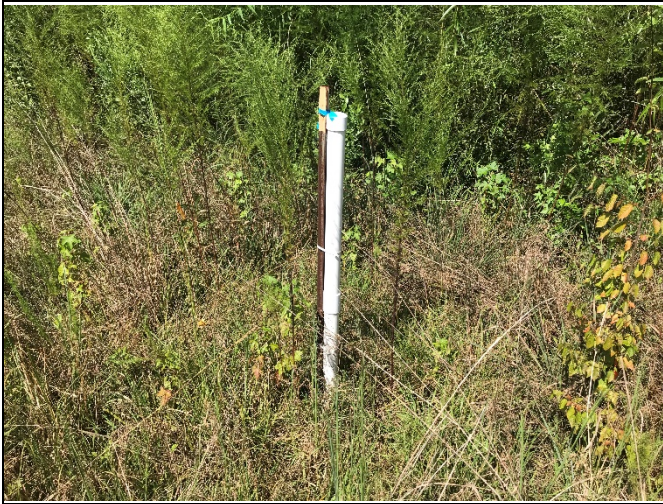
PP-31: Reach 2, Crest Gauge at Station 38+90

To monitor on-site bankfull events, one crest gauge (crest gauge #1) was installed along the downstream portion of Reach R2 at bankfull elevation along the left top of bank at approximately Station 38+90. During Year 4 monitoring, one above-bankfull event was documented in April 2019. Further details of the crest gauge readings are presented in Table 12 in Appendix E, and photographs can be found in Appendix B.

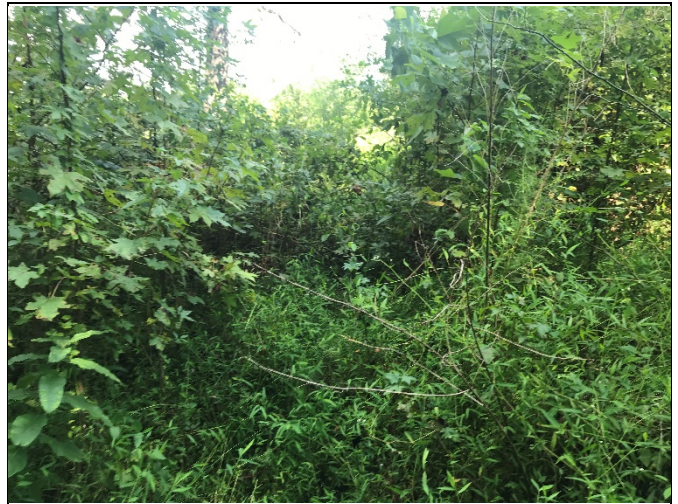
PP-36: Reach 1, view of drainage on left bank at Station 44+00

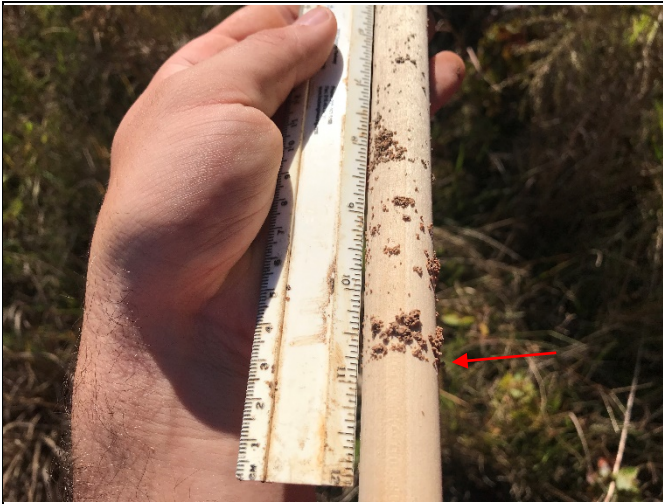
Overbank event of 0.89 ft on 4/19/19

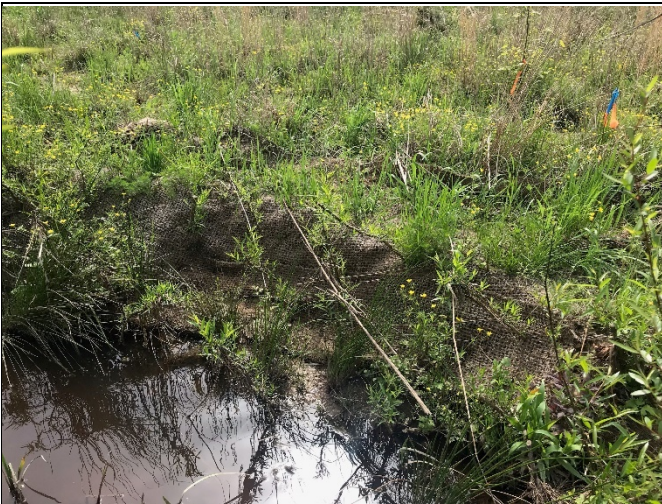
R2 Station 34+75: Bank stabilizing in April 2019
