# **Thomas Creek Restoration Project Year 5 Monitoring Report - FINAL**

Wake County, North Carolina

DMS Project ID Number – 96074, DEQ Contract No. 5549

Report Prepared and Submitted by Michael Baker Engineering, Inc.

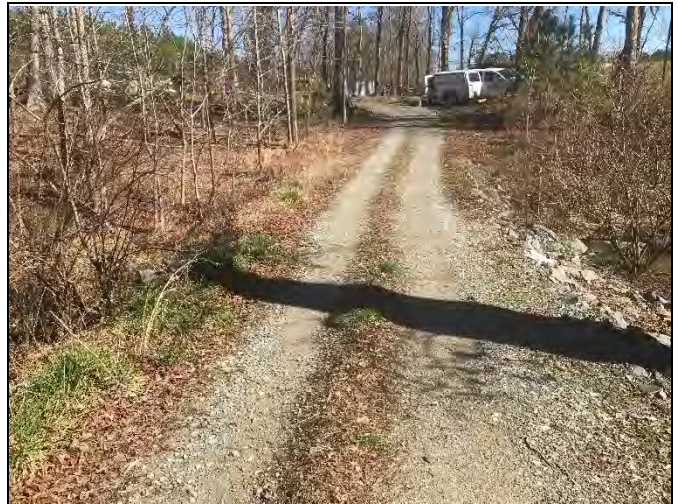
PP-6: Reach 3, stream crossing, Station 18+80

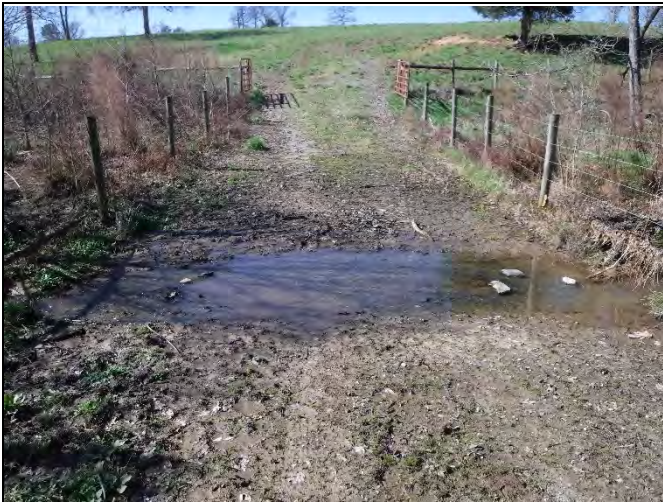
PP-23: Reach 2, view of crossing at Station 27+75

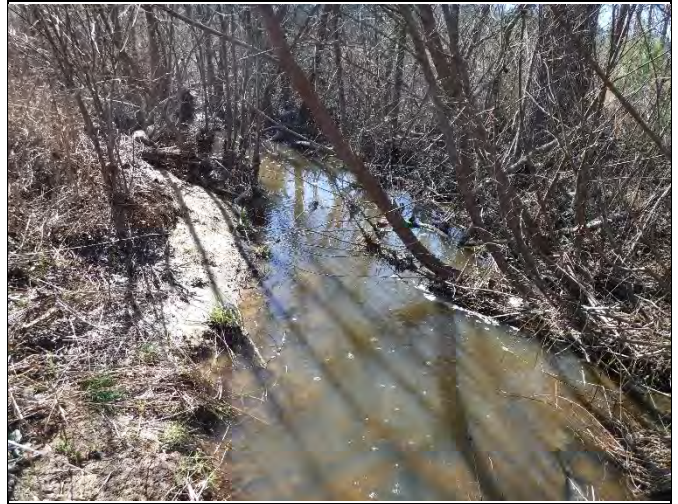
PP-32: Reach 2, view downstream at Station 39+40

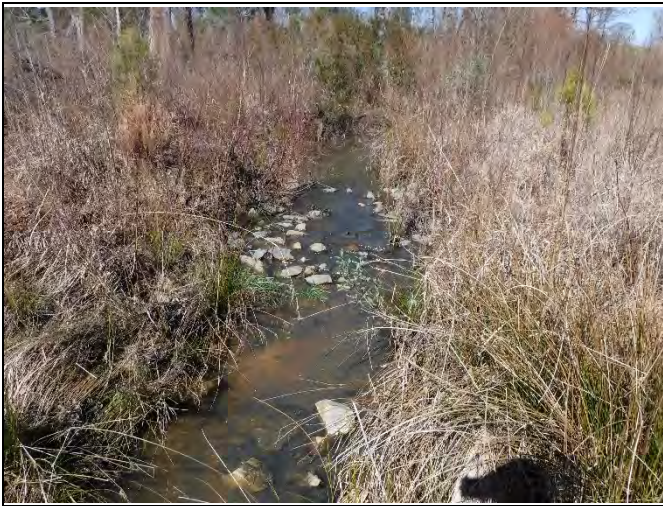
PP-33: Reach 2, view upstream at Station 41+50

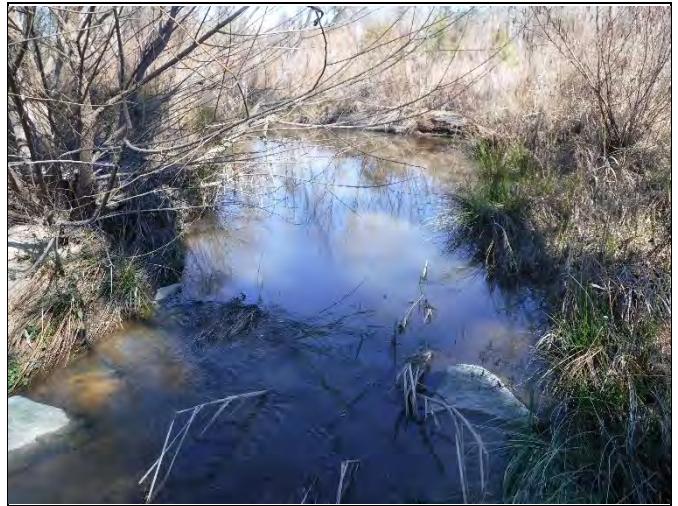
PP-34: Reach 1, view upstream at Station 42+75

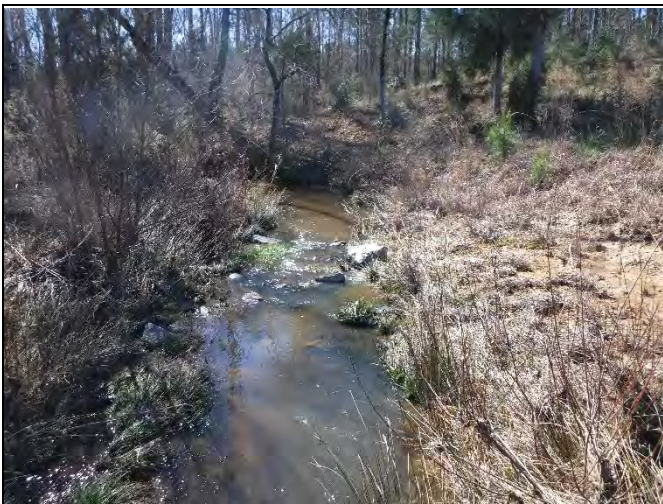
PP-35: Reach 1, view downstream at Station 43+25

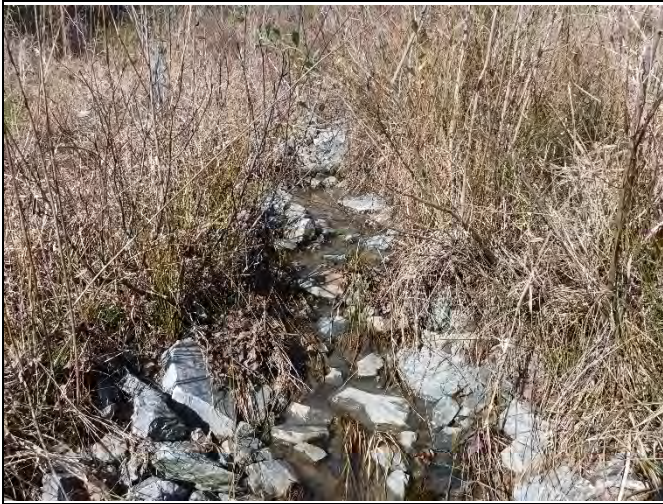
PP-37: Reach 6, view upstream at Station 10+75

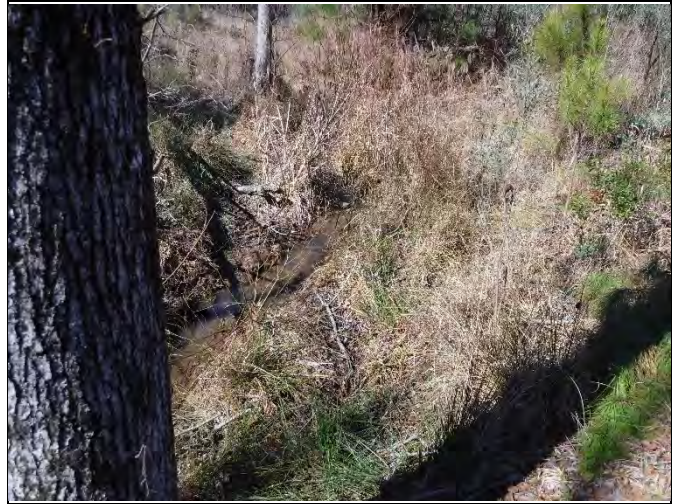
PP-38: Reach 6, view upstream at Station 11+50

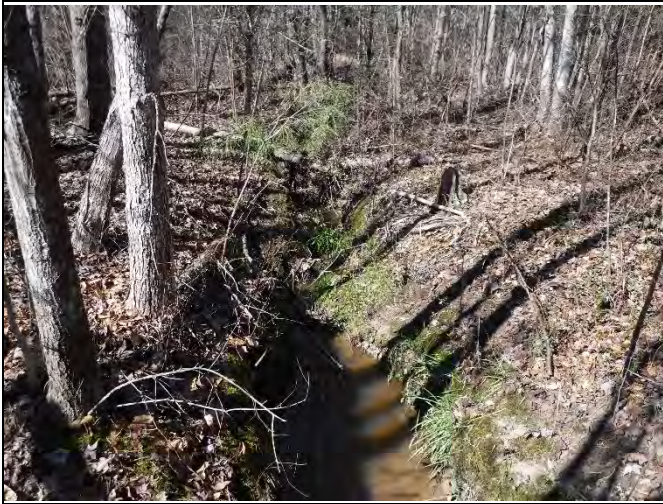
PP-39: Reach 6, view upstream at Station 15+25

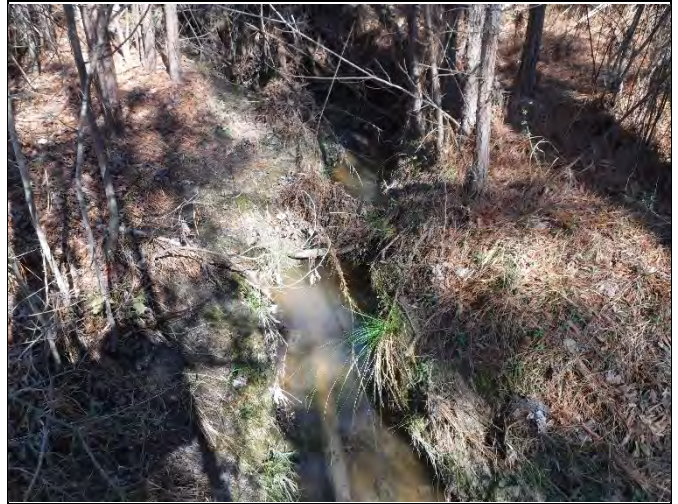
PP-40: Reach 6, view upstream at Station 18+90

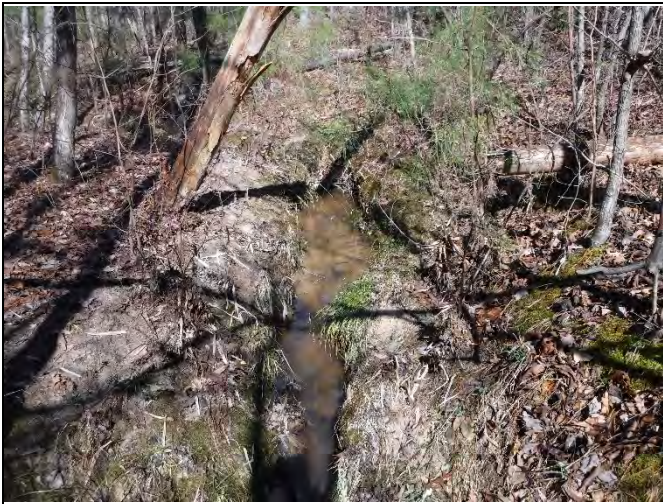
PP-41: Reach 6, view upstream at Station 25+50

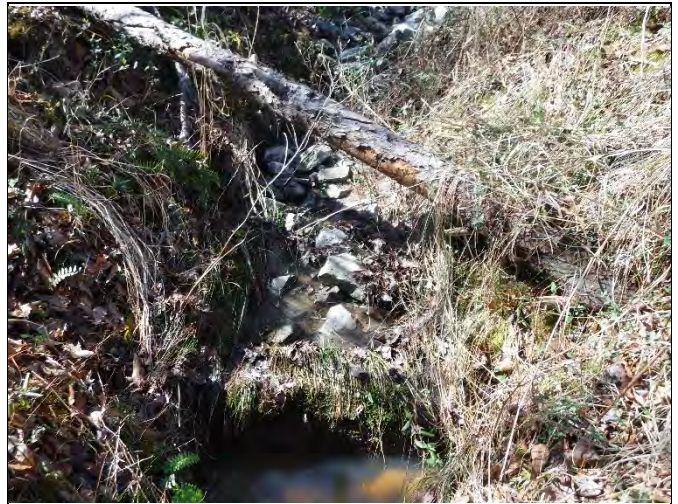
PP-42: Reach 7, view upstream at Station 10+40

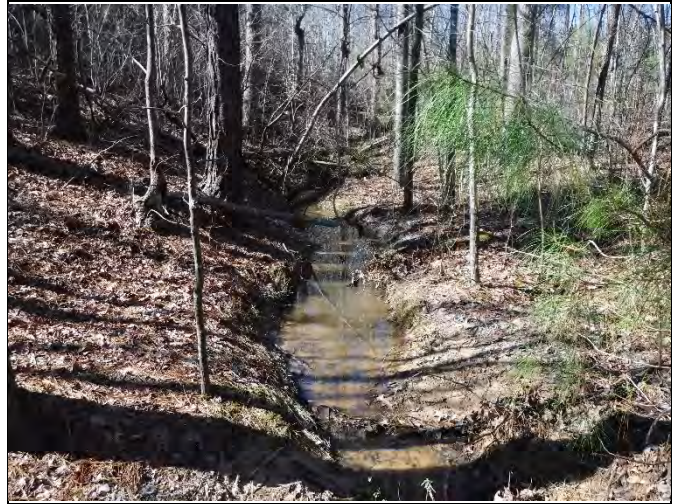
PP-44: Reach 7, view upstream at Station 15+00

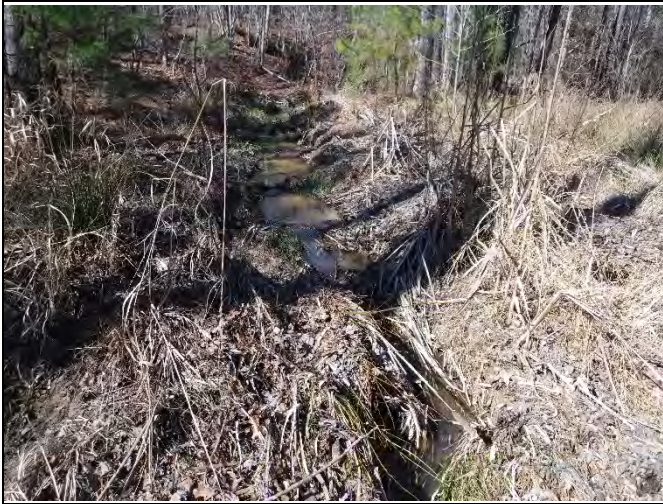
PP-45: Reach 5, view upstream at Station 30+25

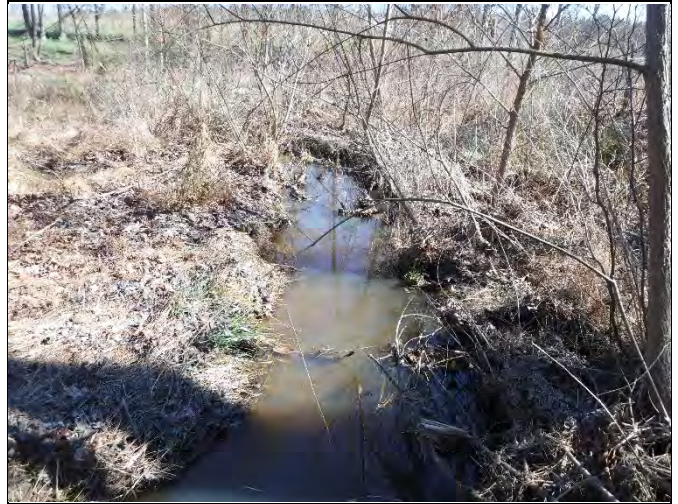
PP-46: Reach 5, view downstream at Station 30+75

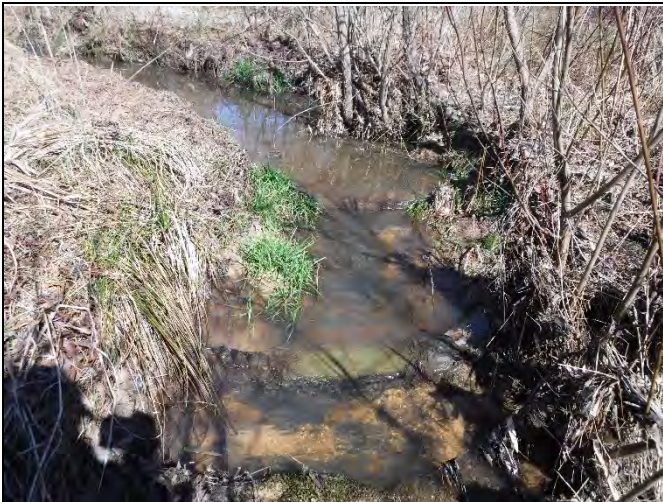
PP-47: Reach 5, view downstream at Station 31+40

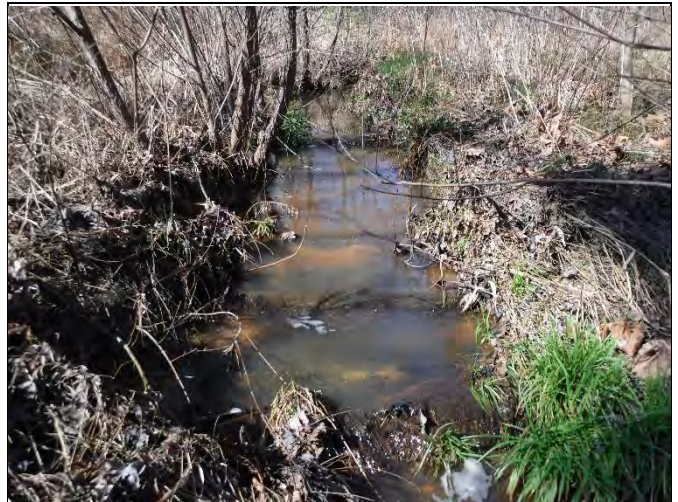
PP-48: Reach 5, view downstream at Station 32+50

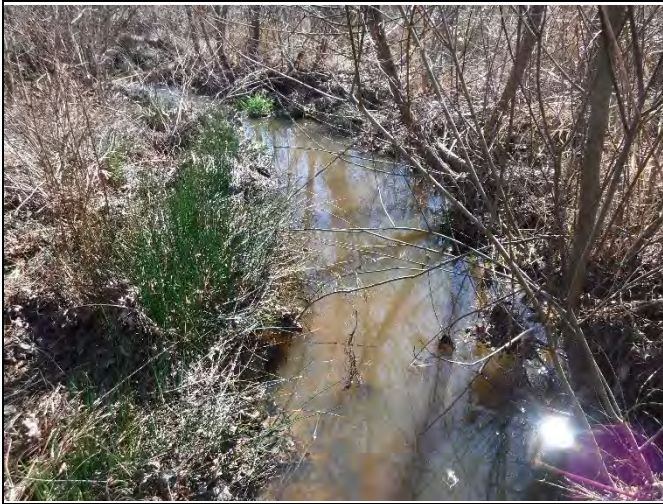
PP-49: Reach 5, view upstream at Station 33+10

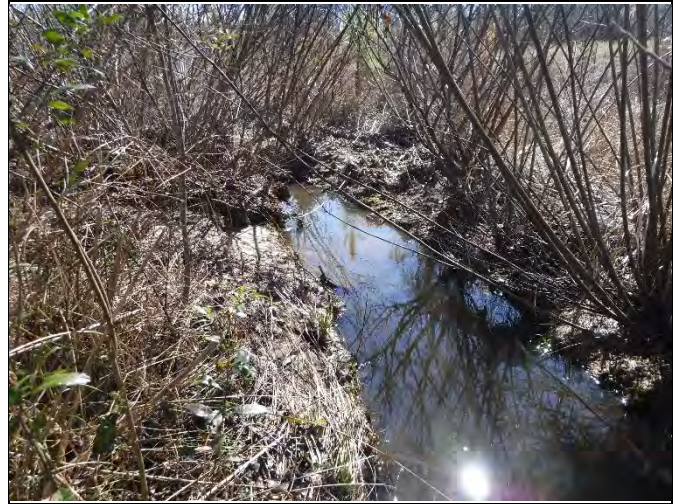
PP-50: Reach 5, view downstream at Station 33+75

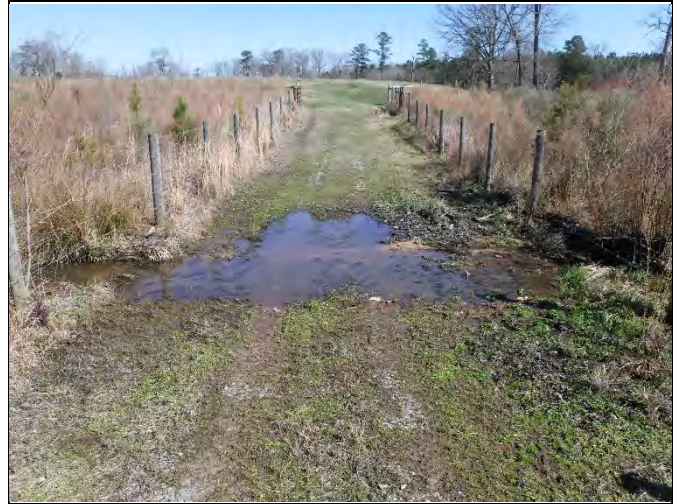
PP-52: Reach 5, view of crossing at Station 35+00

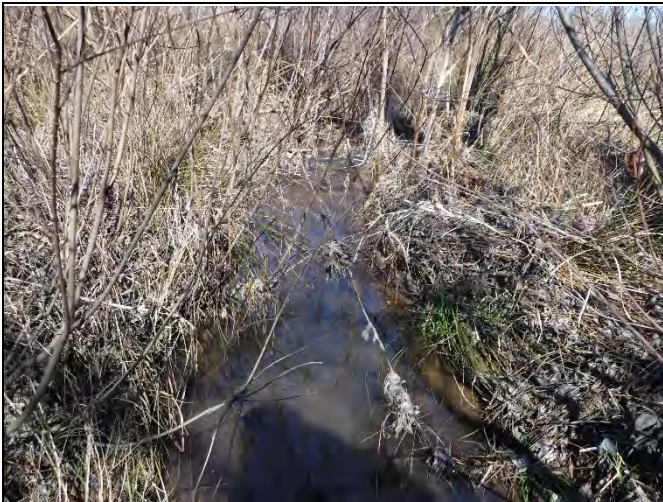
PP-53: Reach 5, view upstream at Station 36+40

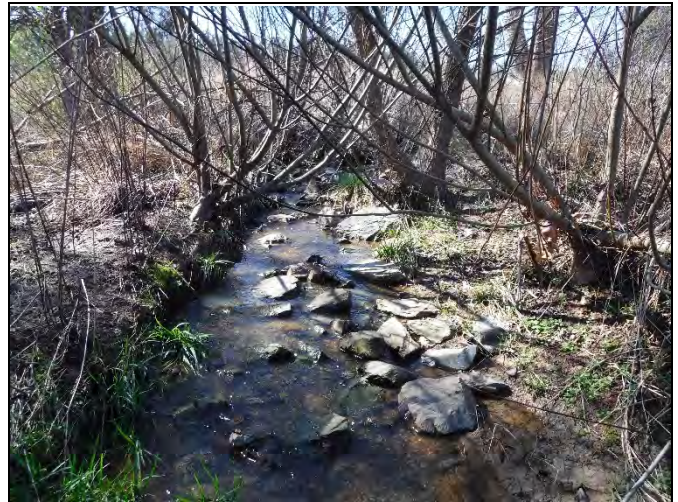
PP-54: Reach 5, view upstream at Station 36+75

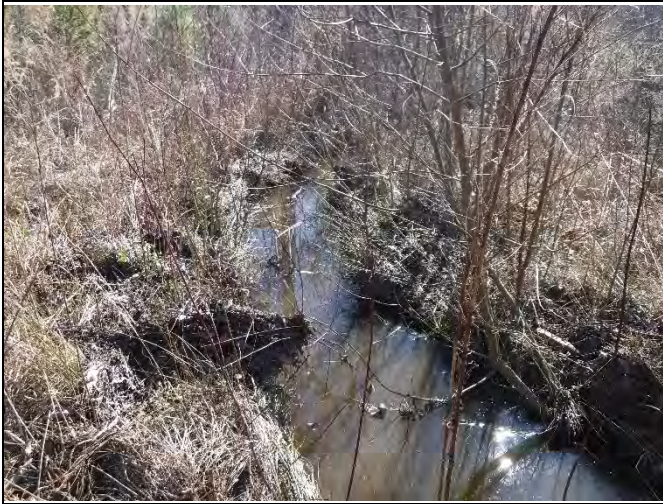
PP-55: Reach 5, view downstream at Station 37+30

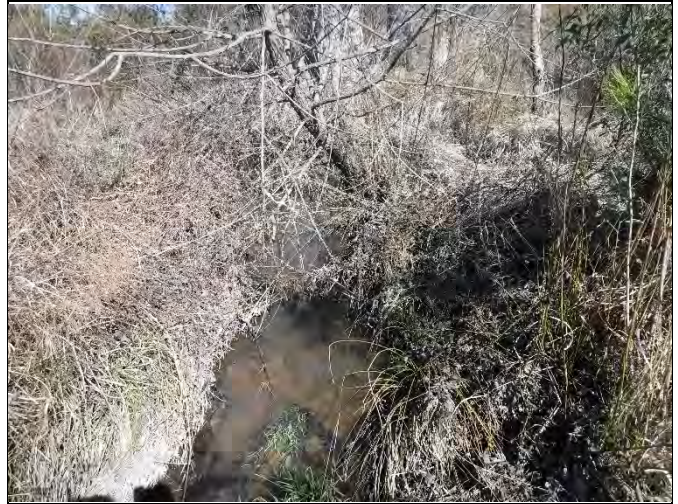
PP-56: Reach 5, view upstream at Station 38+50

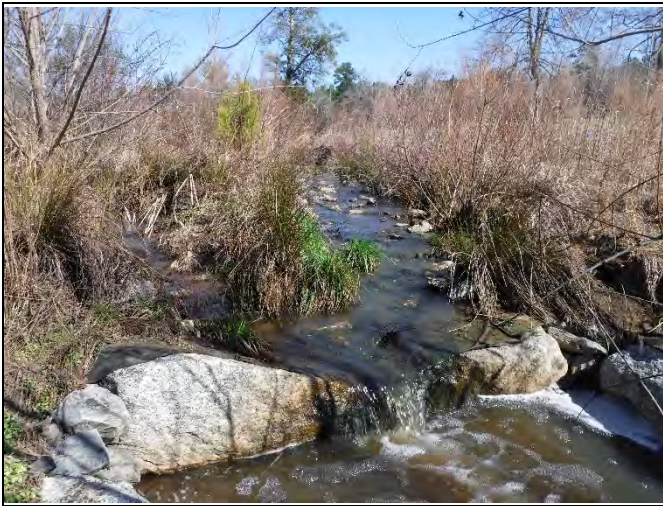
PP-57: Reach 5, view upstream at Station 39+90  
(the confluence of R5 and R2)

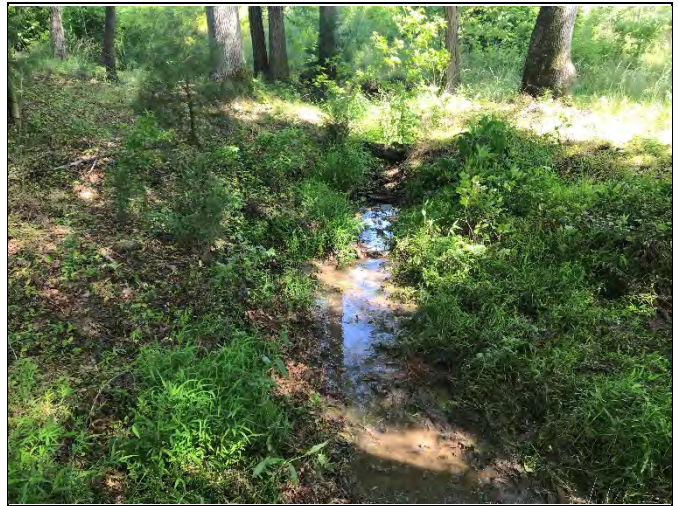
PP-58: Reach T2, view upstream at Station 10+80  
(photo from 6/2/20)

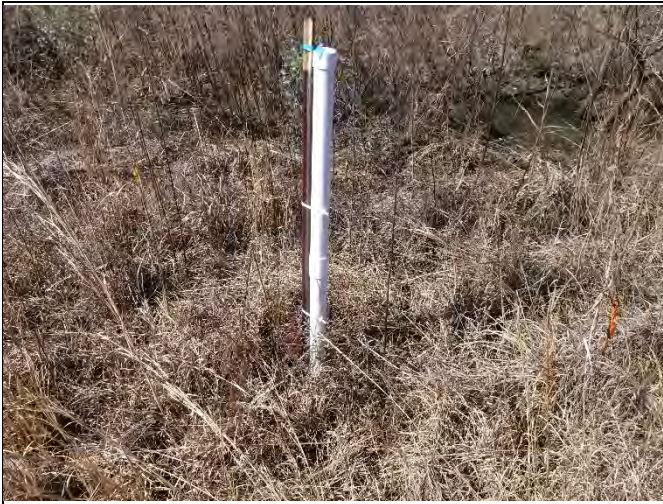
Crest Gauge on Reach R2 at Station 38+90  
(photo from 2/14/20)

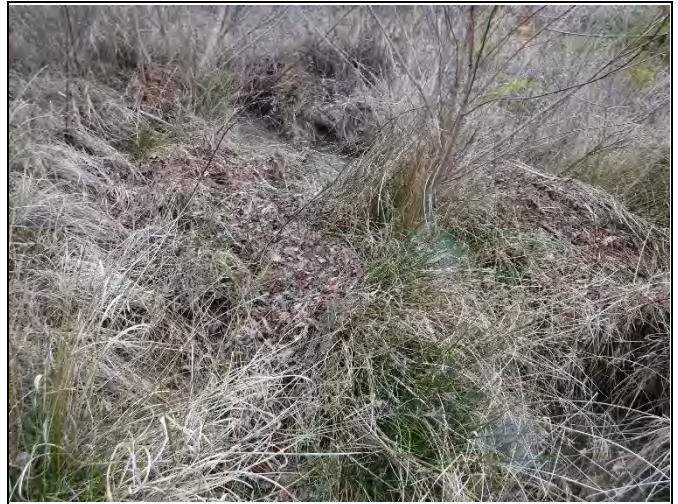
Debris piles in floodplain along Reach R2  
(photo from 2/20/20)

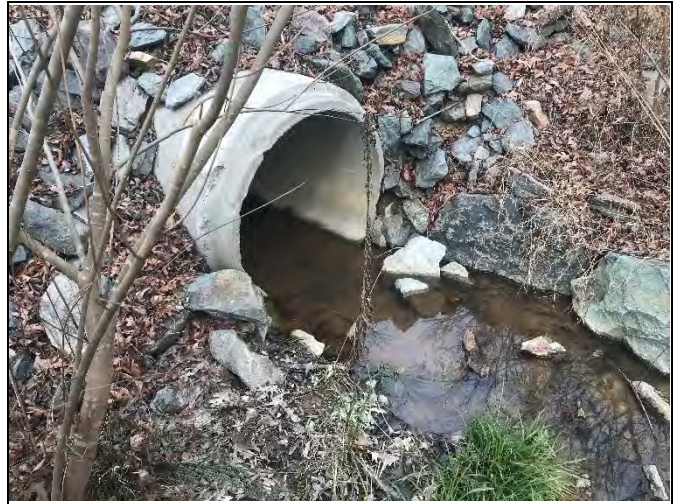
Pipe culvert on R3 (photo: 1/23/20)

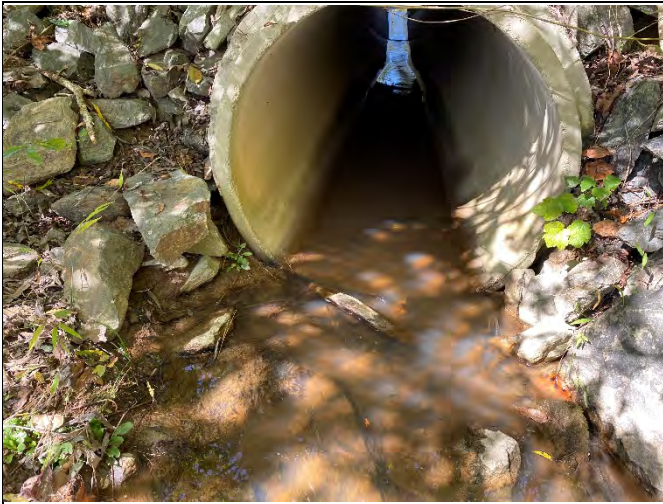
Pipe culvert on R3 (photo: 10/22/20)

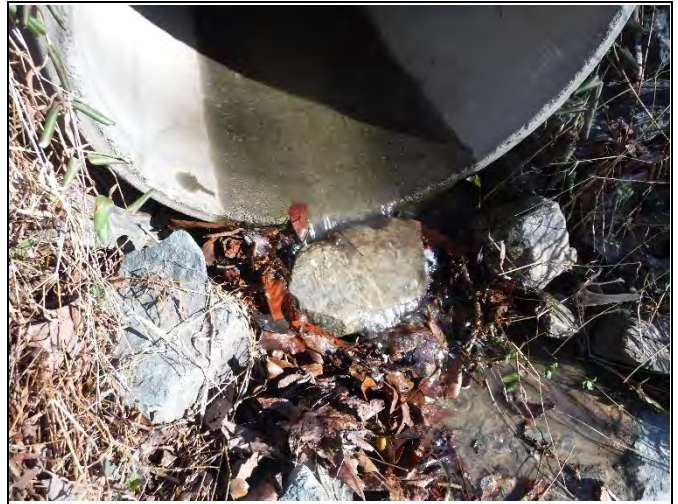
Pipe culvert on R4 (photo: 2/14/20)

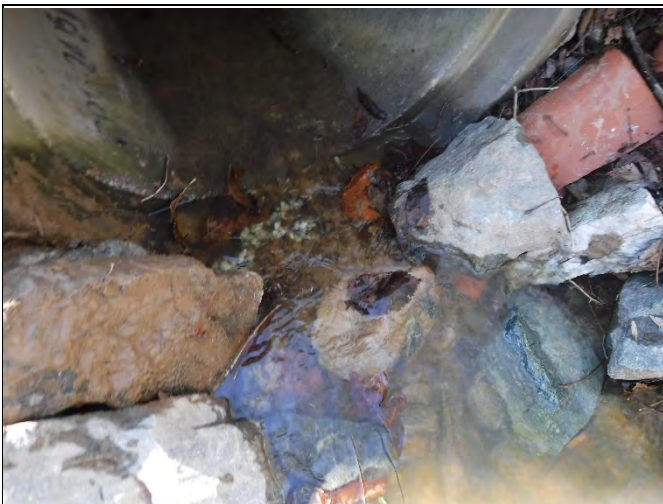
Pipe culvert on R4 (photo: 2/20/20)
