Thomas Creek Restoration Project Year 6 Monitoring Report - FINAL

Wake County, North Carolina

DMS Project ID Number – 96074, DEQ Contract No. 5549

Report Prepared and Submitted by Michael Baker Engineering, Inc.

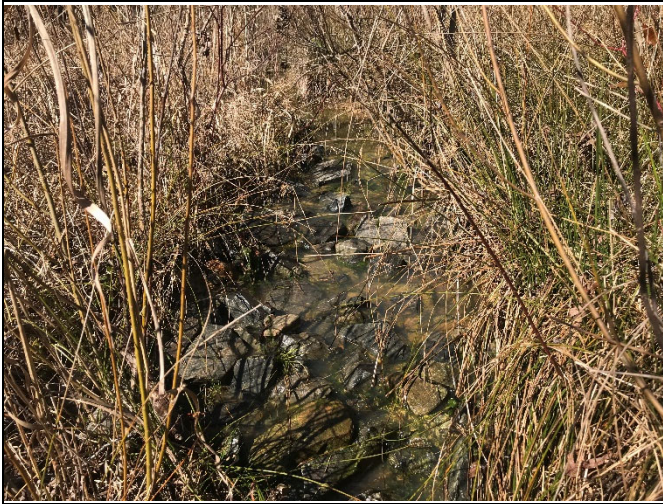
PP-36: Reach 1, view of drainage on left bank at Station 44+00

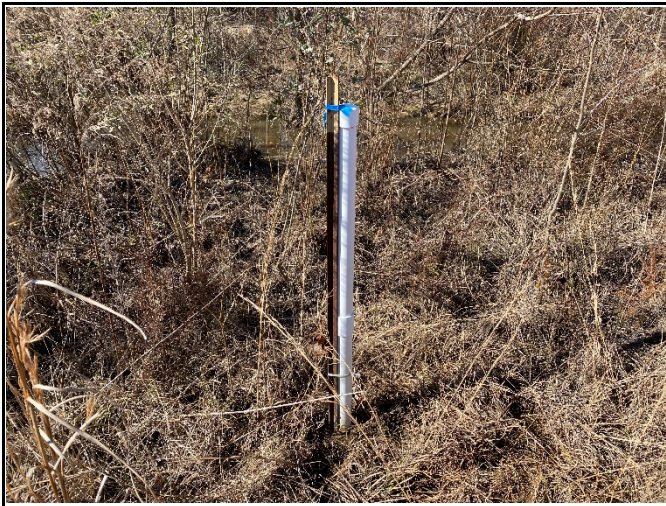
Crest Gauge on Reach R2 at Station 38+90
(photo from 2/18/21)

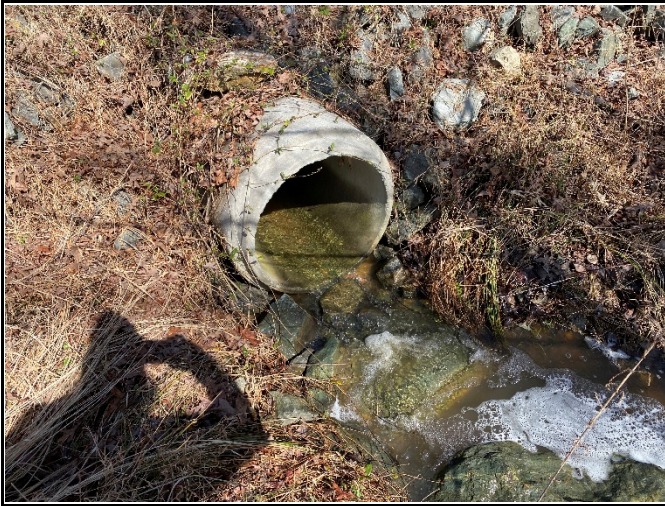
Flow in pipe culvert on R4 (photo: 2/16/21)

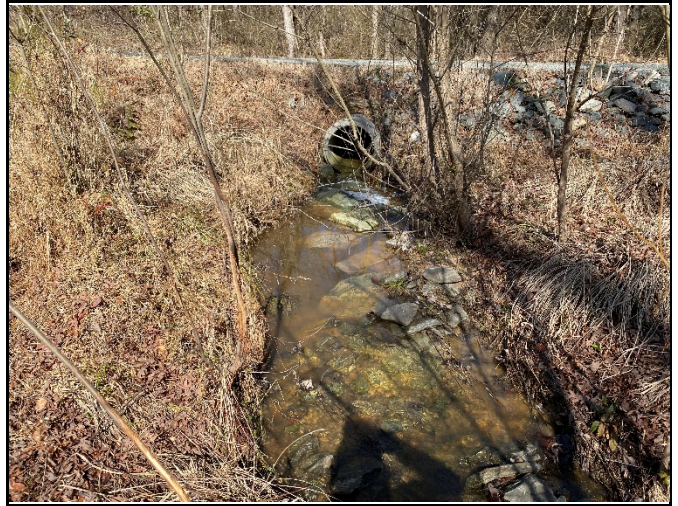
Flow in pipe culvert on R4 (photo: 2/16/21)

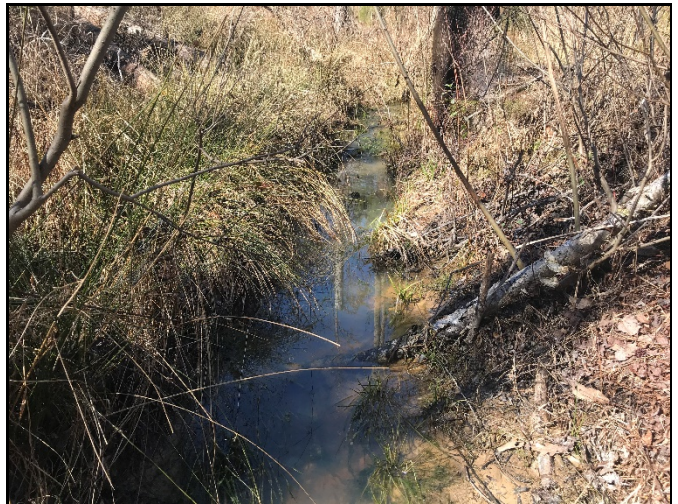
Flow on upper R6, upstream (photo: 2/16/21)

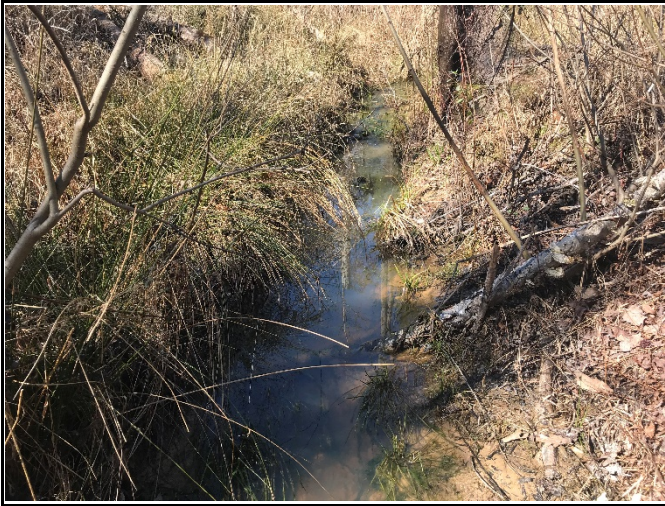
Flow on upper R6, upstream (photo: 2/16/21)

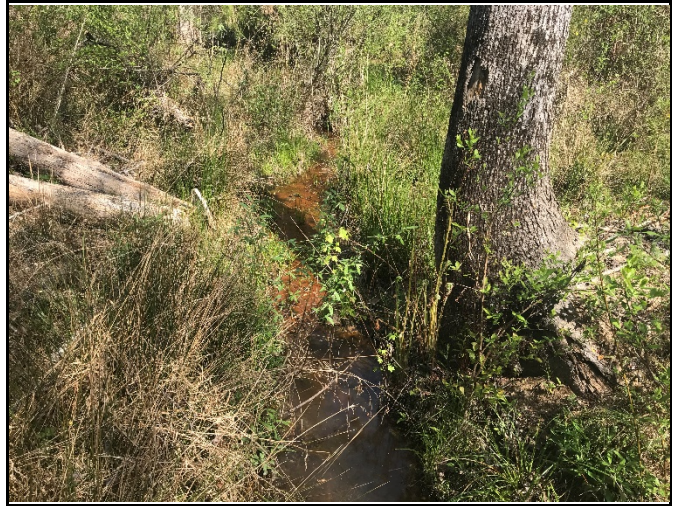
Flow on upper R6, upstream (photo: 4/13/21)

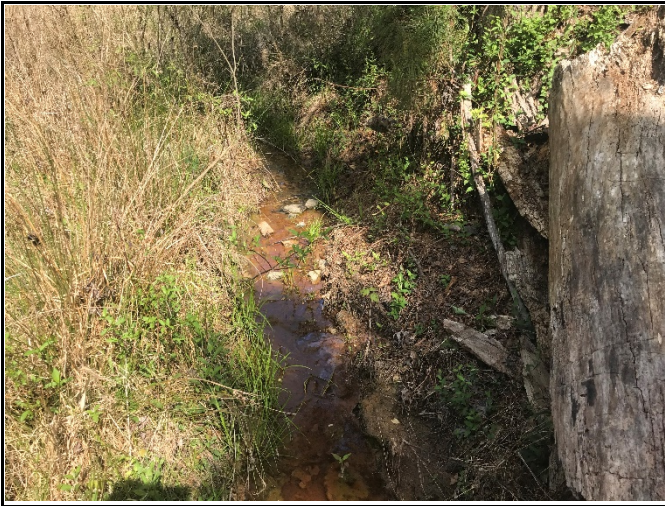
Flow on upper R6, upstream (photo: 4/13/21)

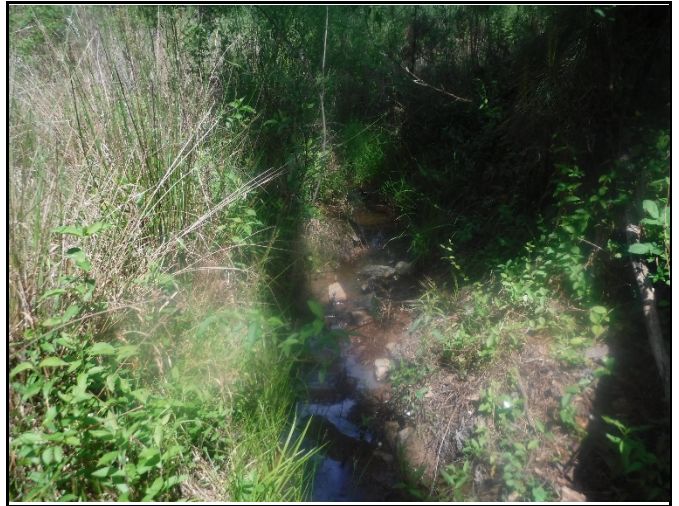
Flow on upper R6, upstream (photo: 5/5/21)

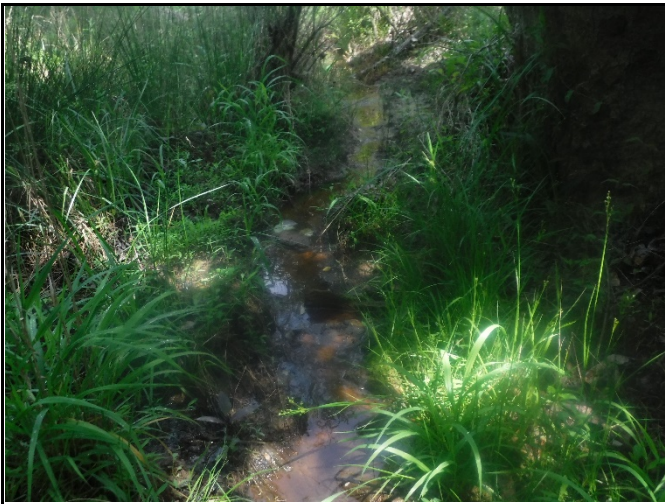
Flow on upper R6, upstream (photo: 5/5/21)

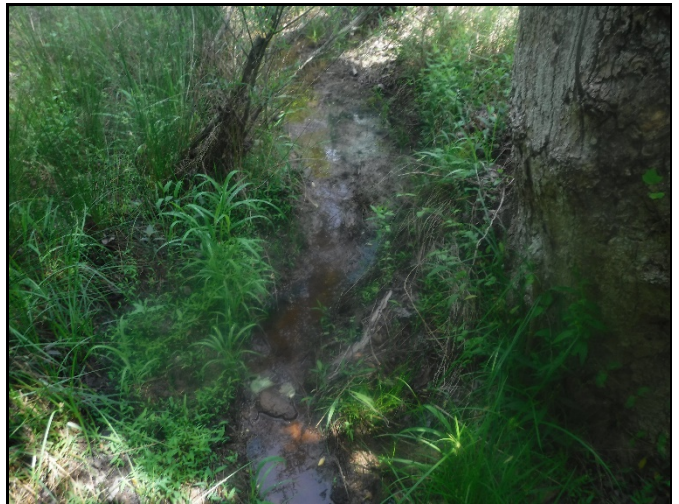
Flow on upper R6, upstream (photo: 5/5/21)
