# MONITORING YEAR 5 ANNUAL REPORT

## VILE CREEK MITIGATION SITE

Alleghany County, NC  
DEQ Contract No. 5999  
DMS Project No. 96582

Data Collection Period: April – October 2021  
Submission Date: January 19, 2022

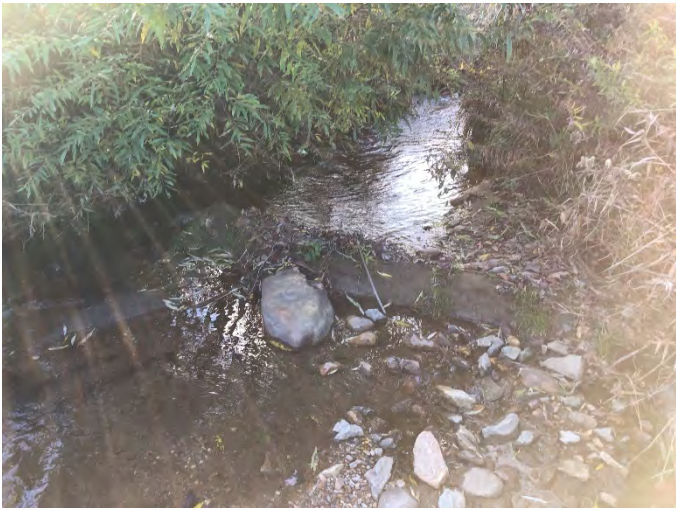
**Photo 1** – Vile Creek R1: Station 103+90 – Right bank piping and scour around log sill. 10-26-2021

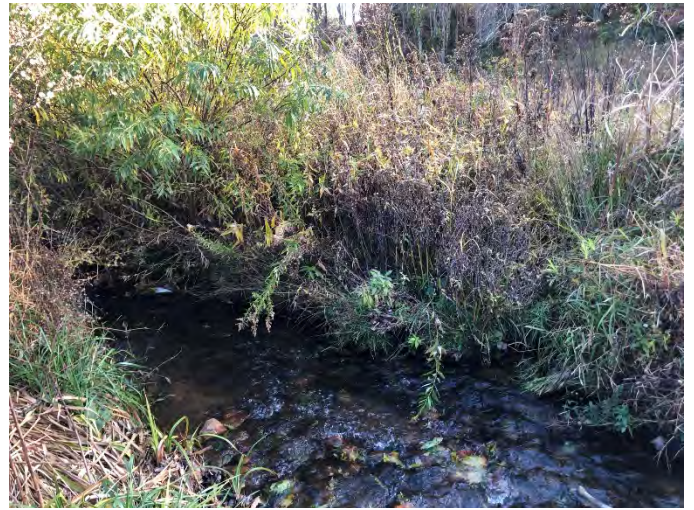
**Photo 2** – Vile Creek R1: Station 103+90-104+20 – Right bank scour. 10-26-2021

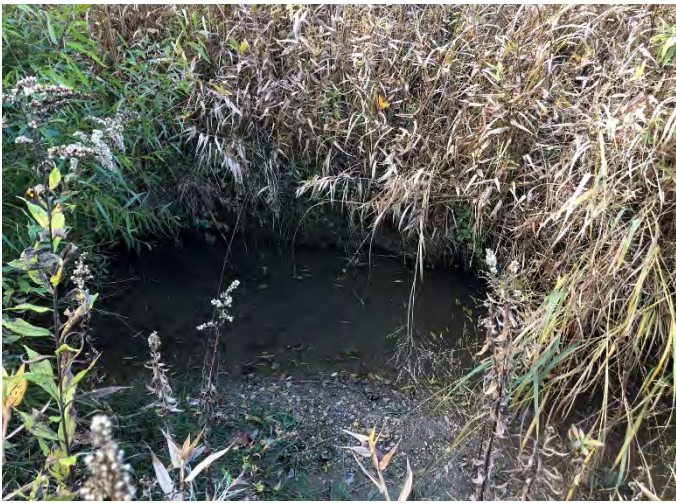
**Photo 3** – UT1 R1: Station 202+90-203+15 – Left Bank Scour. 10-26-2021

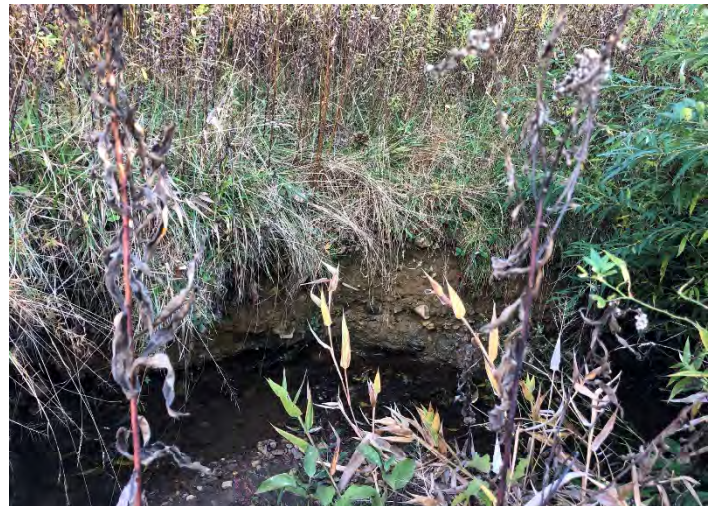
**Photo 6** – UT1 R1: Station 206+40 – 206+60 – Bank Scour 10-26-2021

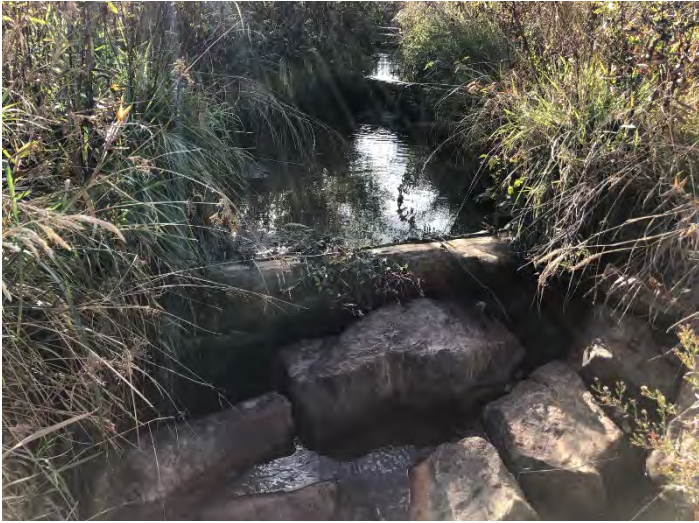
**Photo 7** – UT1 R1: Station 212+50 – Structure piping. 10-26-2021

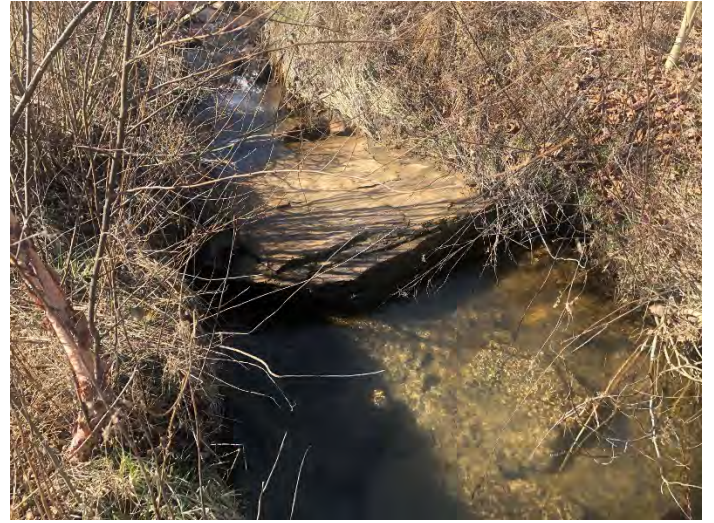
**Photo 8**– UT1 R2: Station 220+98 – Piping around structure 3-17-2021

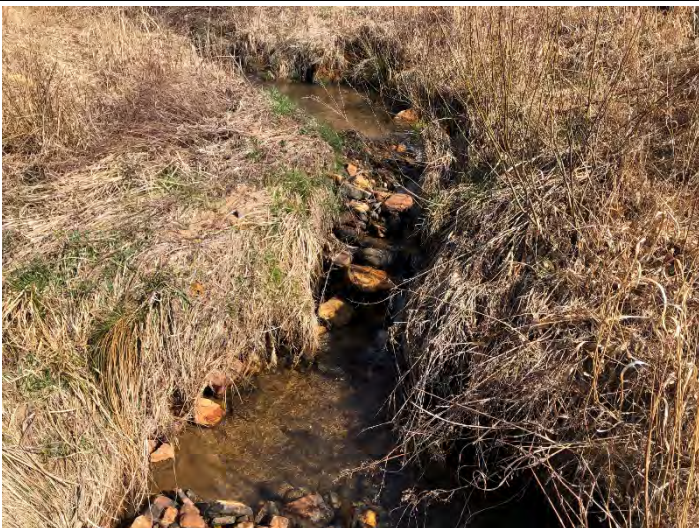
**Photo 9** – UT2: Station 304+90– Headcut 3-17-2021

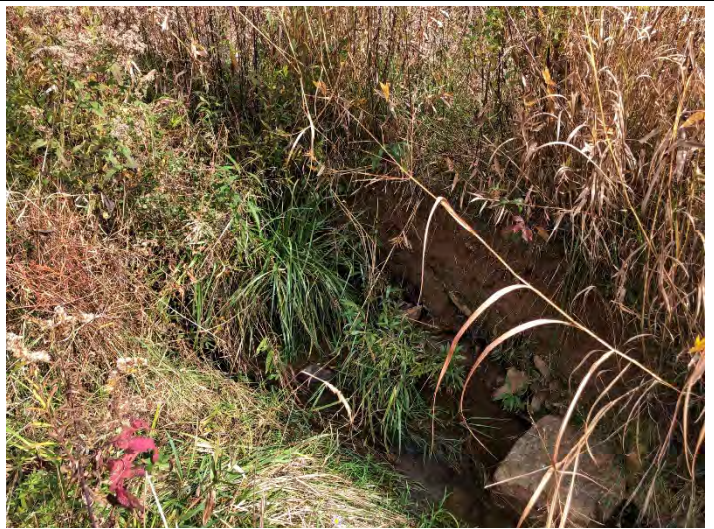
**Photo 10** – UT2: Station 305+00 – 305+50 – Bank scour. 10-26-2021

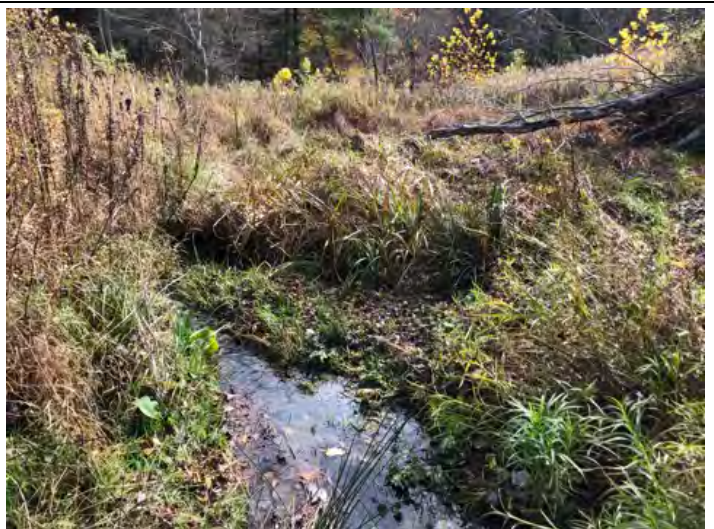
**Photo 12** – UT2 Station 309+70: Stream aggradation. 10-26-2021

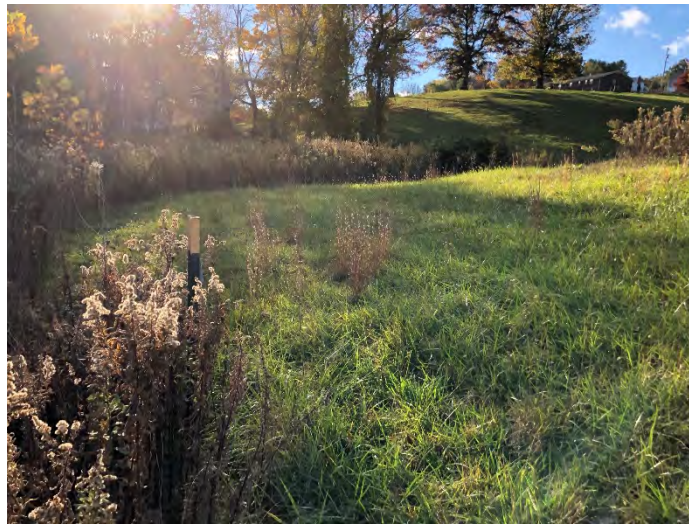
**Photo 15** - UT1 R1: Easement encroachment. 10-27-2021

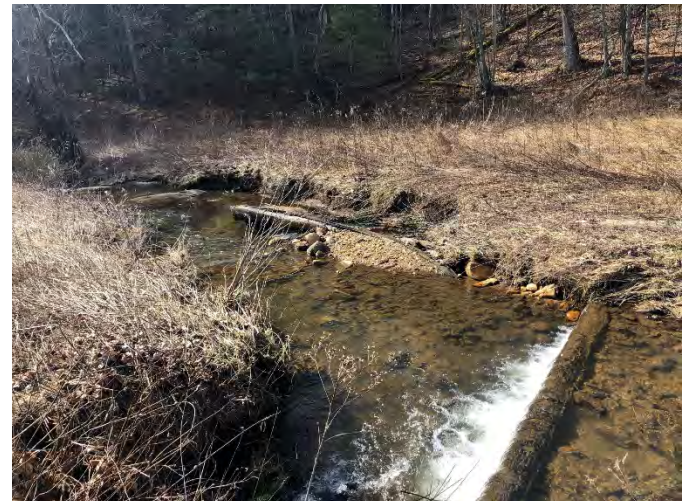
Vile Creek R2: STA 122+20 - 123+00 – Right Bank Erosion 3-17-2021

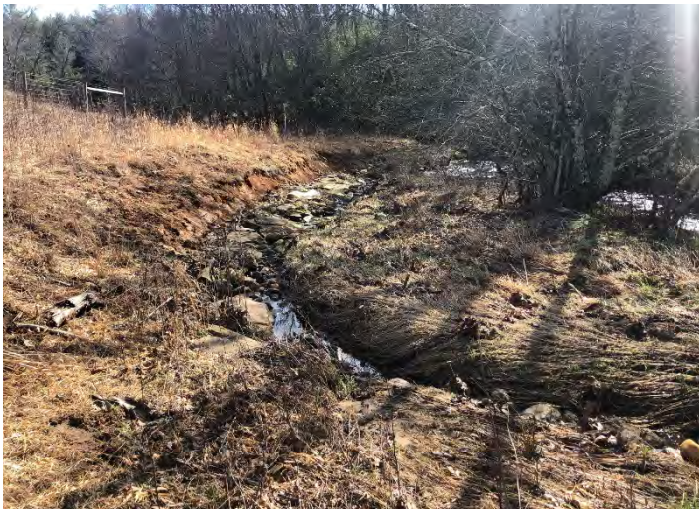
Vile Creek R3: STA 125+00 - 125+60 - Secondary Channel Erosion  
3-17-2021

Smooth out slope with excavator. Use Coir fiber matting and seed to stabilize slope. Planting will be completed in the next dormant season.
