MONITORING YEAR 2 ANNUAL REPORT

ALEXANDER FARM MITIGATION SITE

Alexander County, NC
DEQ Contract No. 7416
DMS Project No. 100048
USACE Action ID No. SAW-2018-00451
NCDEQ DWR Certification No. 18-0665
RFP #: 16-007277

Data Collection Period: January 2021 – November 2021
Final Submission Date: February 1, 2022

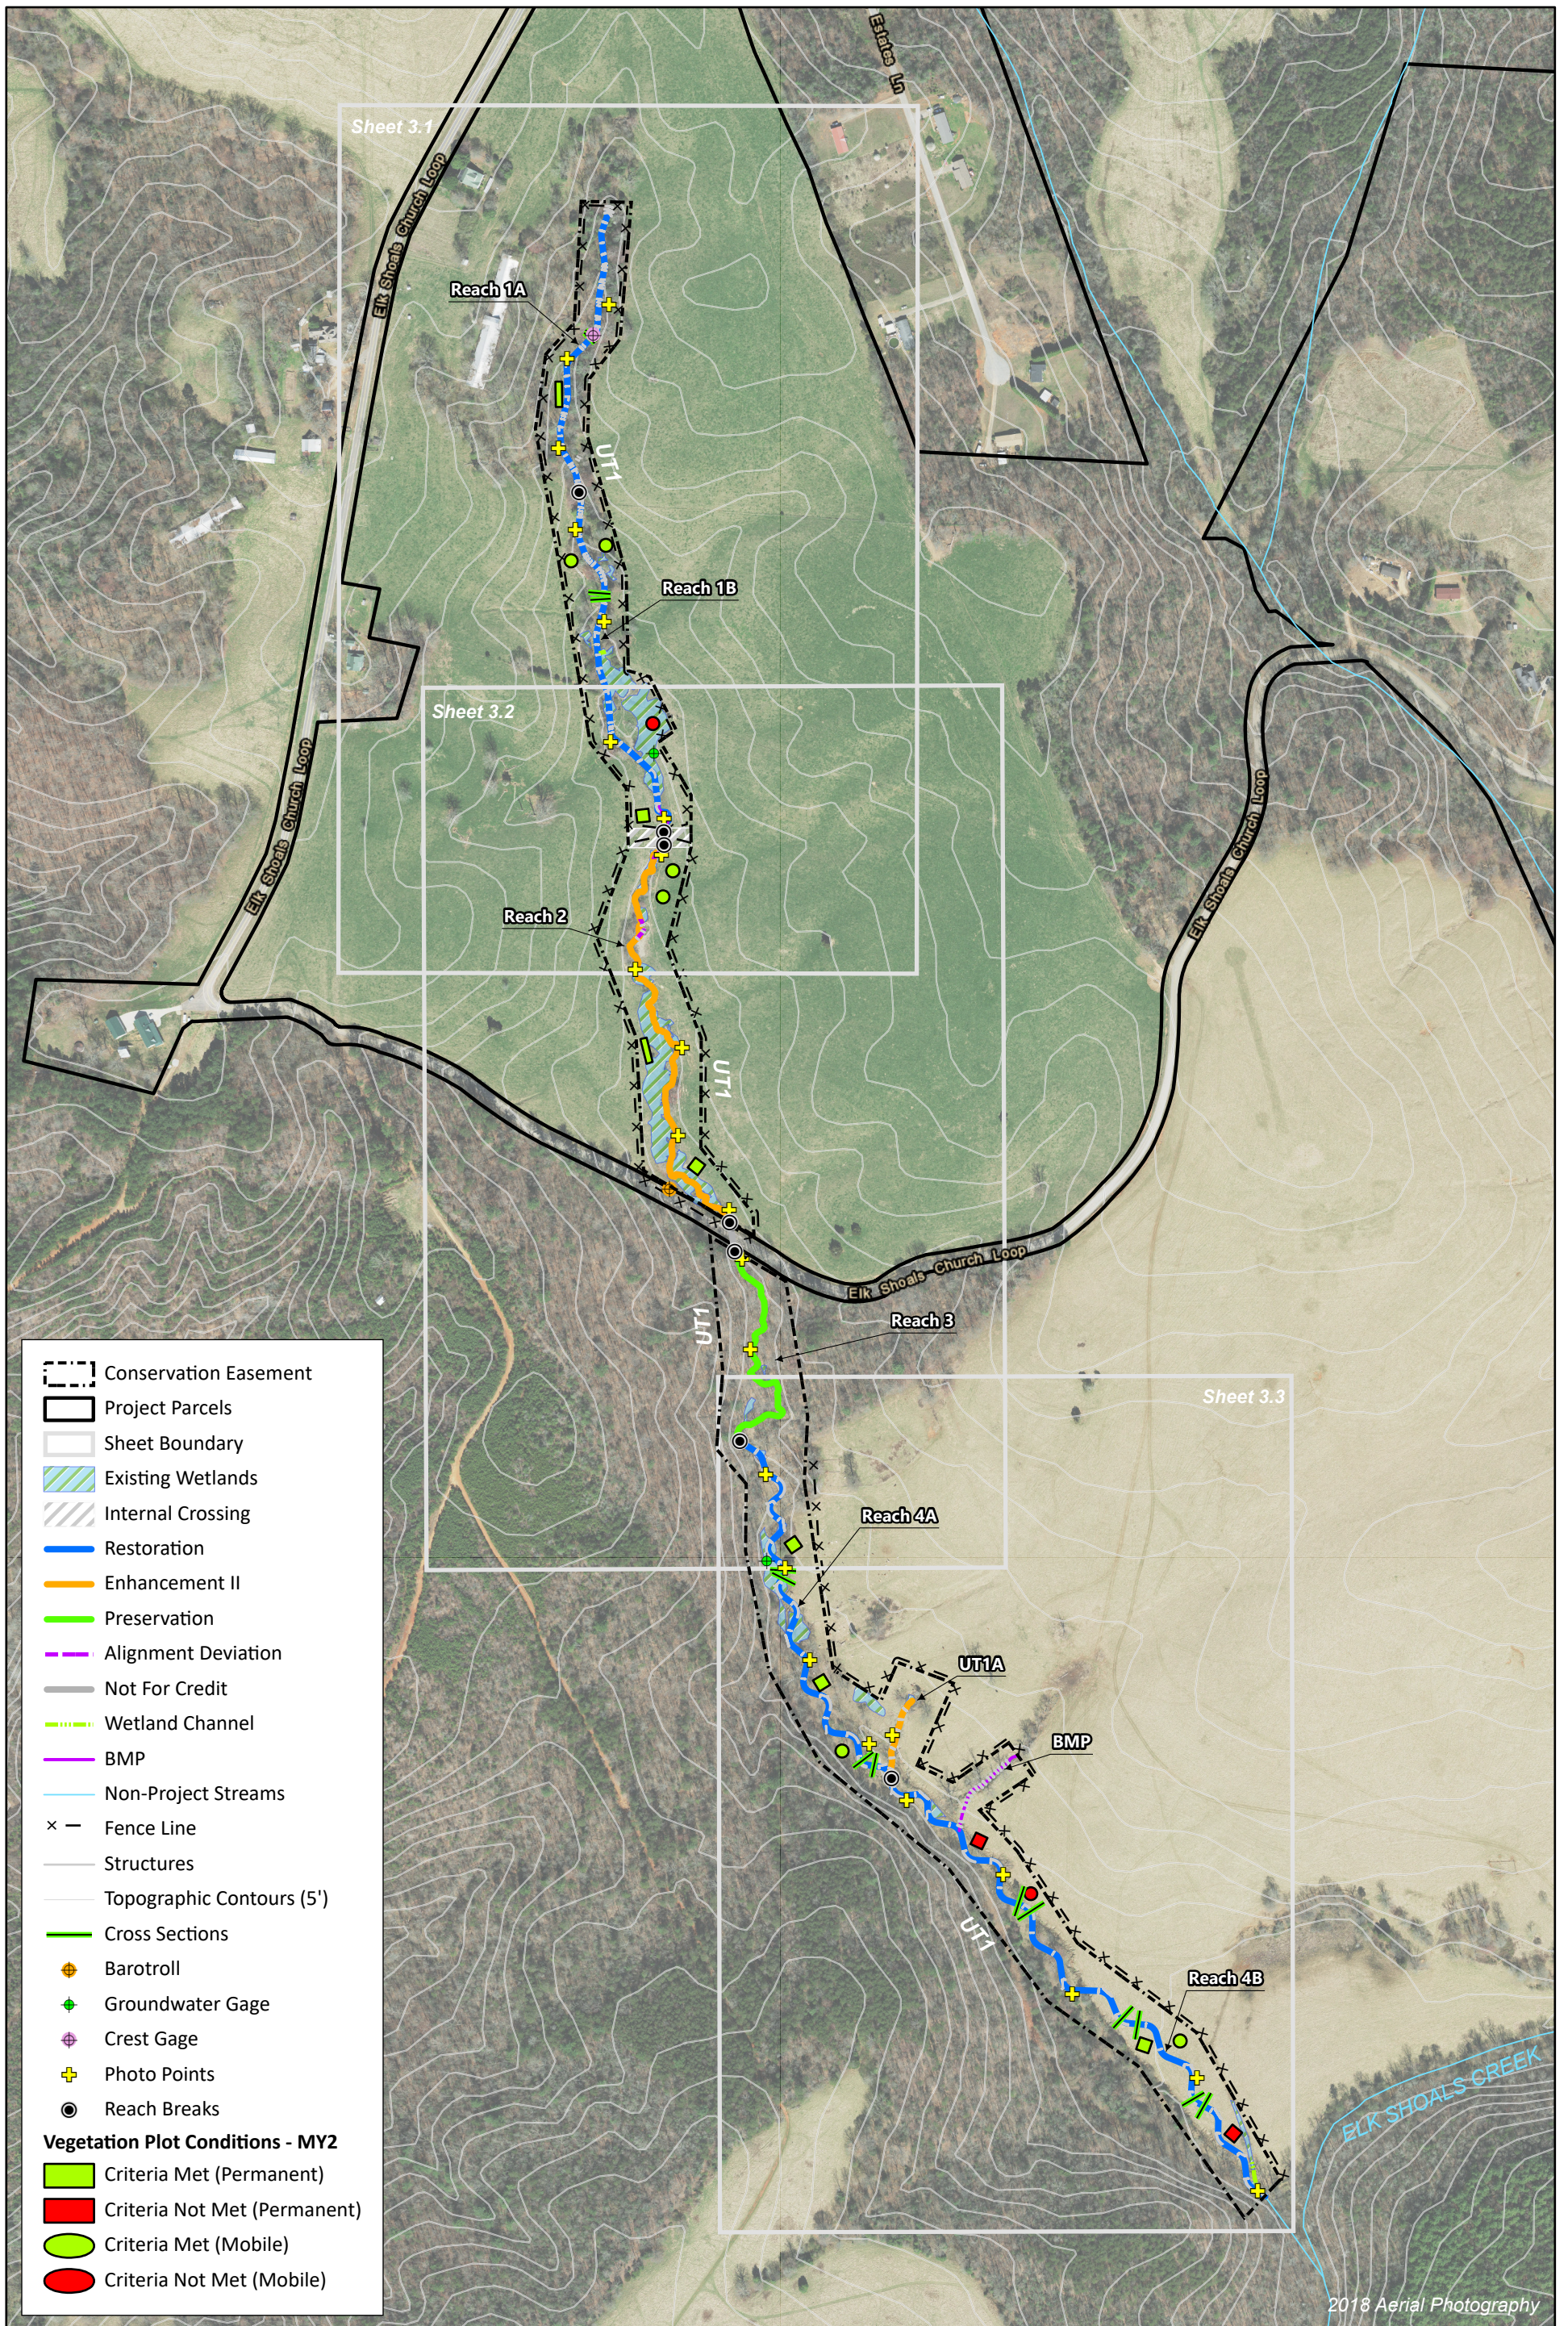
Figure 3.0 Current Condition Plan View (Key)
 Alexander Farm Mitigation Site
 DMS Project No. 100048
 Monitoring Year 2 - 2021
 Alexander County, NC

All streams on the Site are remaining stable. The three areas of concern that were recorded in MY1 have stabilized with streambank vegetation and are no longer an issue. During the MY2 visual stream assessment a couple minor areas of concern were noted along UT1 Reach 1A and UT1 Reach 4A. On UT1 Reach 1A, station 140+00, there are a couple small areas of piping under the angled log sills within the riffle. On UT1 Reach 4A there is approximately 110 LF of aggradation from station 138+75 to 139+85. It is anticipated that the channel will continue to move the sediment through the system, and it will no longer be an issue. Wildlands will continue to monitor these areas and remedial actions will be implemented if areas of concern begin to threaten the stability of the project. Please refer to Appendix 2 for stream stability tables, area of concern photos, and CCPV Figures 3.0 – 3.3.

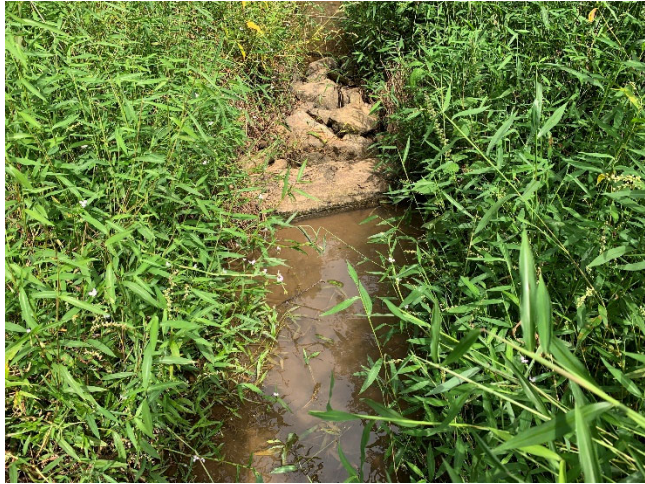
UT1 R1A Structure Piping (STA 104+00) – view Upstream
(09/15/2021)

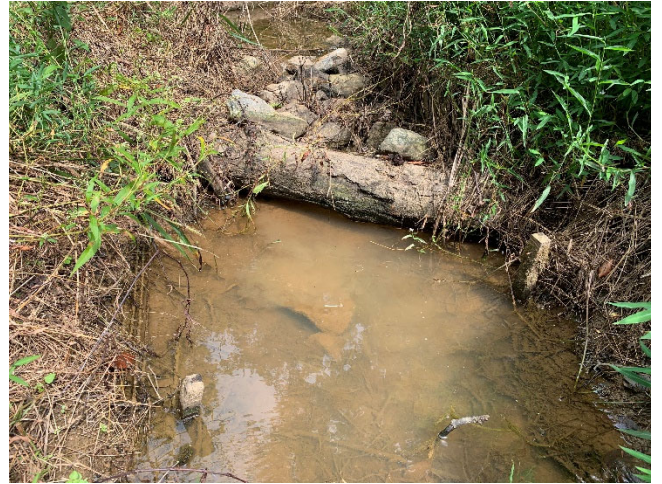
UT1 R1A Structure Piping (STA 104+00) – view Upstream
(09/15/2021)

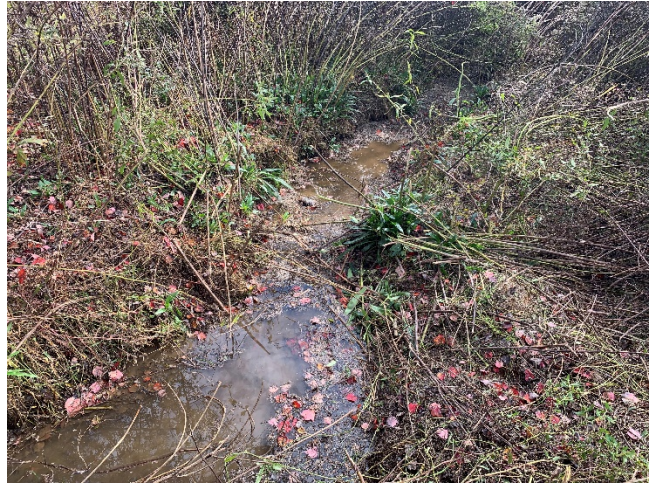
UT1 R2 Right Bank Stabilized (STA 120+00-120+20) – view downstream (11/3/2021)

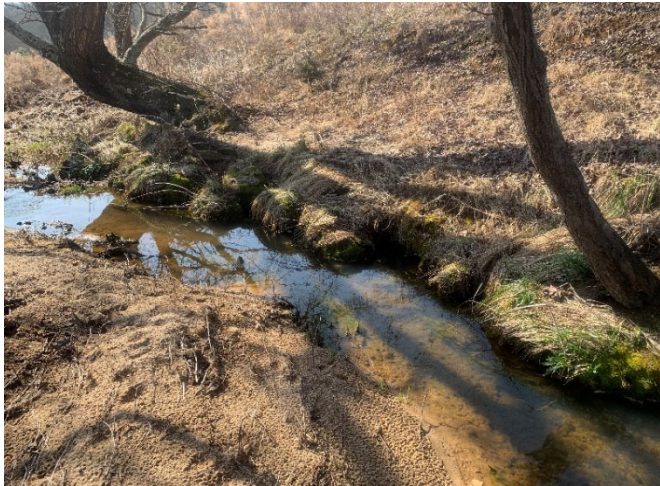
UT1 R2 Right Bank Erosion (STA 121+00-121+15) – view downstream (2/9/2021)

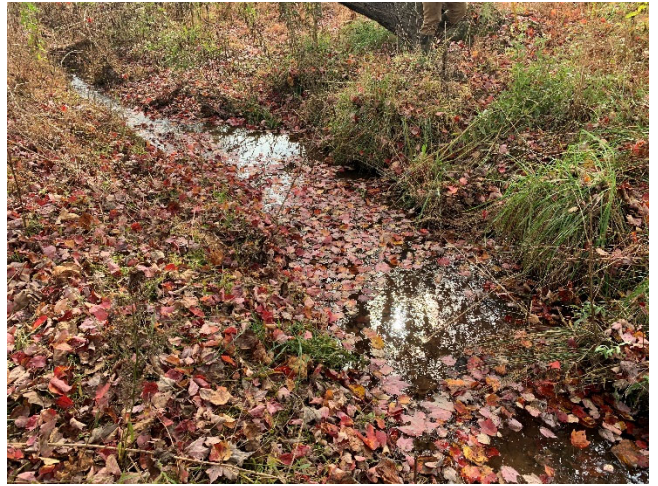
UT1 R2 Right Bank Stabilized (STA 121+00-121+15) – view downstream (11/3/2021)

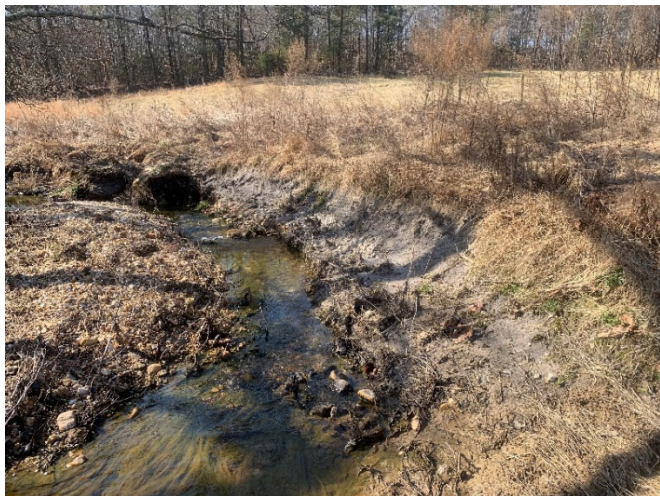
UT1 R2 Right Bank Erosion (STA 126+00-126+20) – view downstream (2/9/2021)

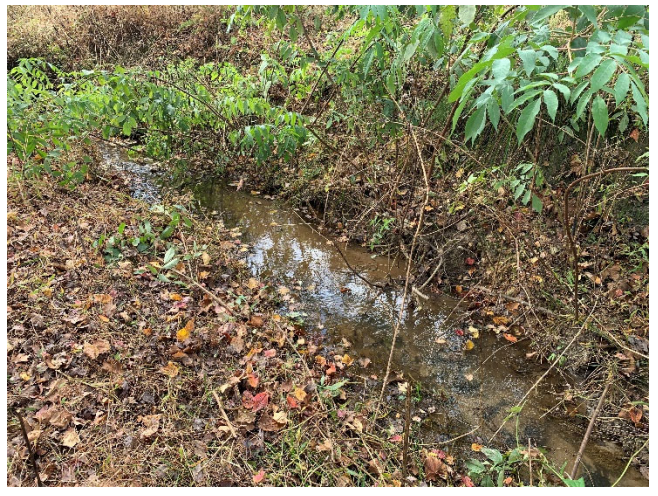
UT1 R2 Right Bank Stabilized (STA 126+00-126+20) – view downstream (11/3/2021)

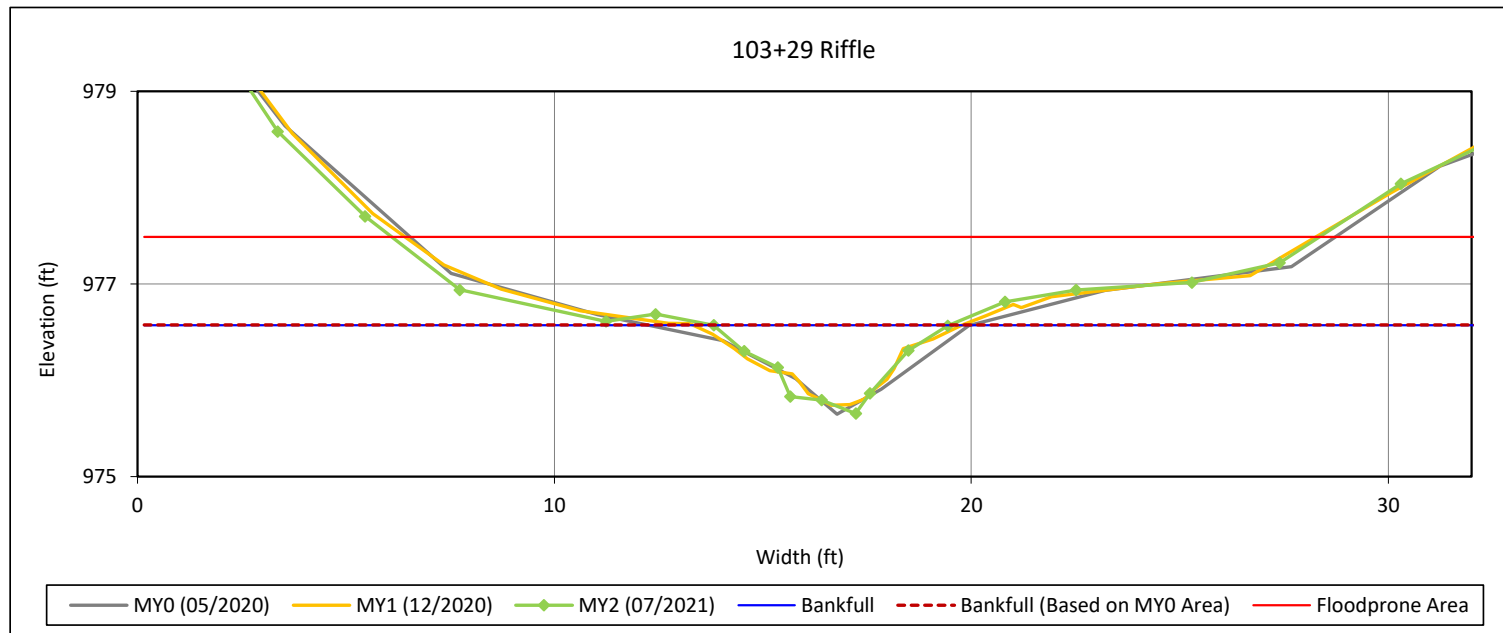
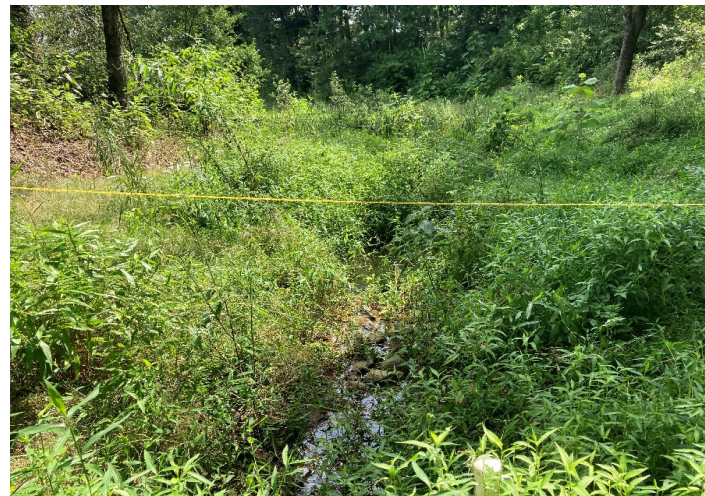
Cross-Section 1-UT1 Reach 1A

2.7	x-section area (ft.sq.)
5.6	width (ft)
0.5	mean depth (ft)
0.9	max depth (ft)
6.0	wetted perimeter (ft)
0.4	hydraulic radius (ft)
11.9	width-depth ratio
22.2	W flood prone area (ft)
3.9	entrenchment ratio
1.0	low bank height ratio

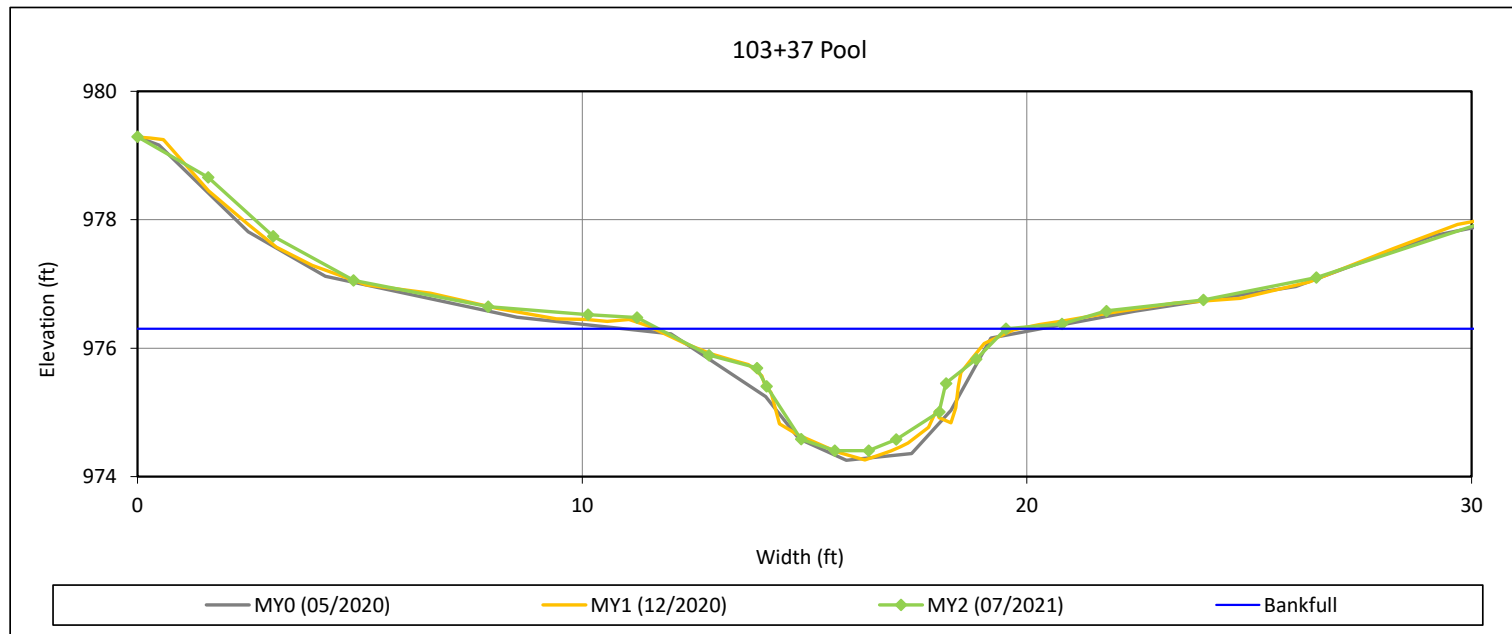
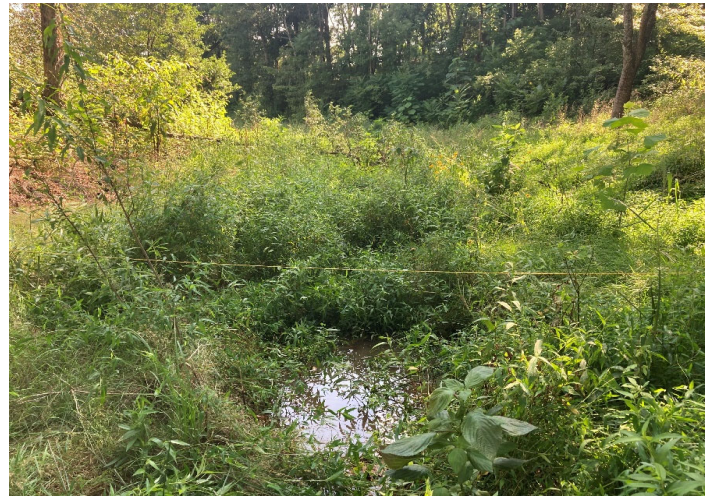
Cross-Section 2-UT1 Reach 1A

8.1	x-section area (ft.sq.)
7.8	width (ft)
1.0	mean depth (ft)
1.9	max depth (ft)
9.1	wetted perimeter (ft)
0.9	hydraulic radius (ft)
7.5	width-depth ratio

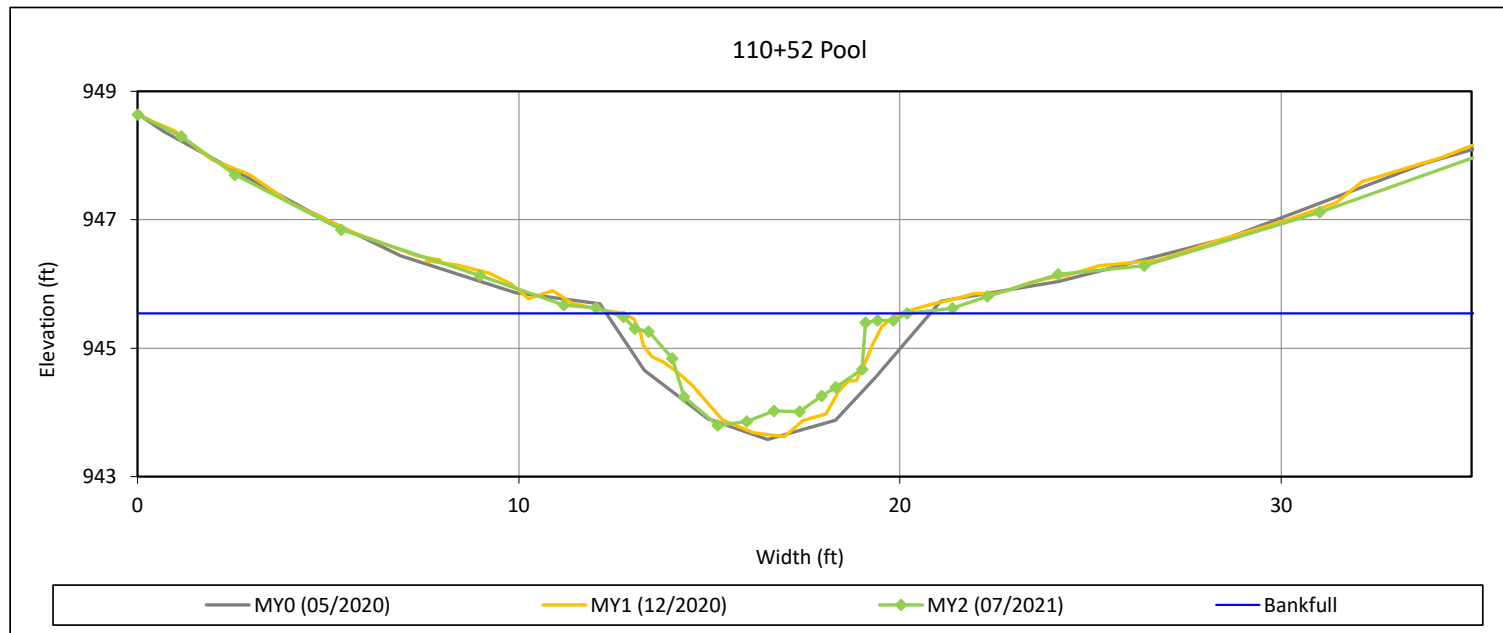
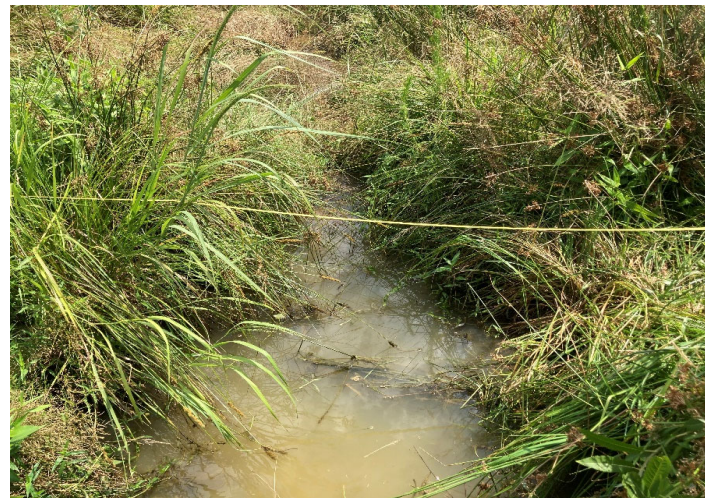
Cross-Section 3-UT1 Reach 1B

7.7	x-section area (ft.sq.)
7.7	width (ft)
1.0	mean depth (ft)
1.7	max depth (ft)
9.2	wetted perimeter (ft)
0.8	hydraulic radius (ft)
7.7	width-depth ratio

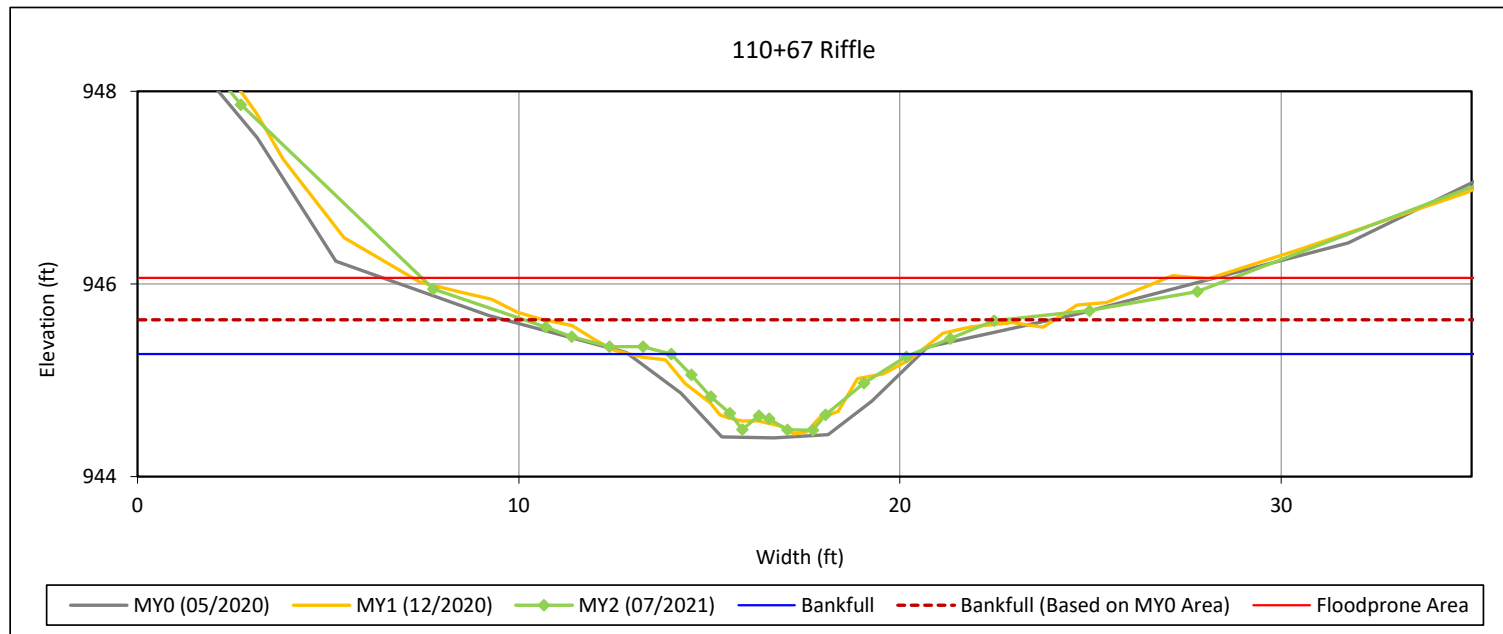
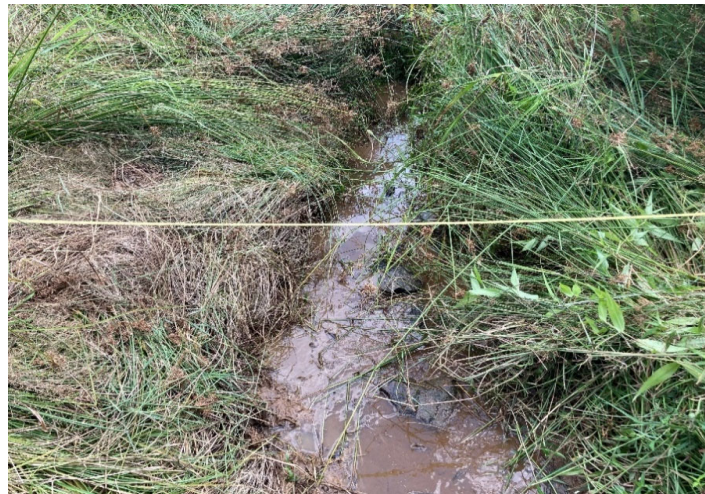
Cross-Section 4-UT1 Reach 1B

3.0	x-section area (ft.sq.)
6.3	width (ft)
0.5	mean depth (ft)
0.8	max depth (ft)
6.7	wetted perimeter (ft)
0.4	hydraulic radius (ft)
13.5	width-depth ratio
21.3	W flood prone area (ft)
3.4	entrenchment ratio
0.7	low bank height ratio

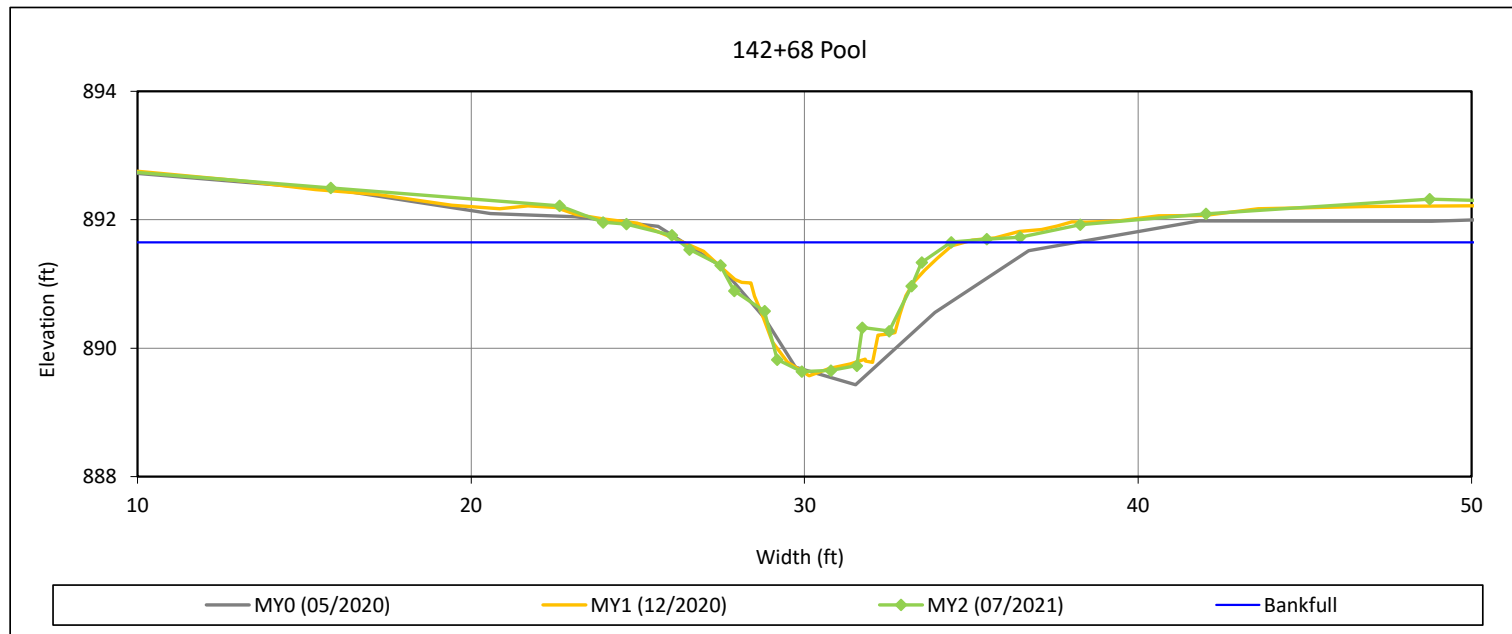
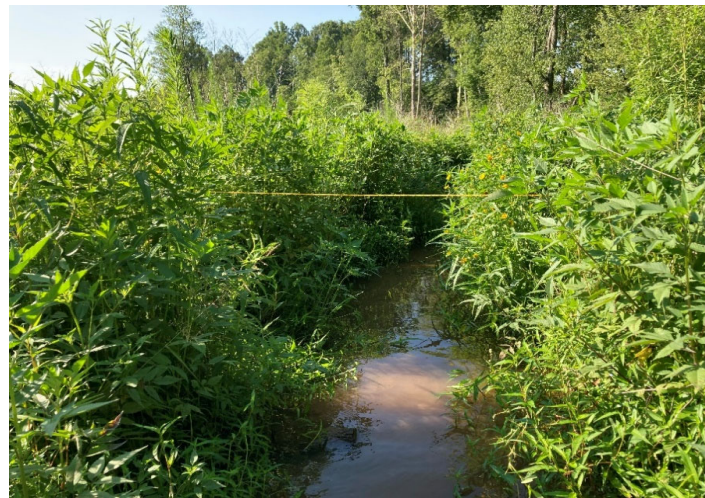
Cross-Section 5-UT1 Reach 4A

8.9	x-section area (ft.sq.)
8.1	width (ft)
1.1	mean depth (ft)
2.0	max depth (ft)
9.9	wetted perimeter (ft)
0.9	hydraulic radius (ft)
7.4	width-depth ratio

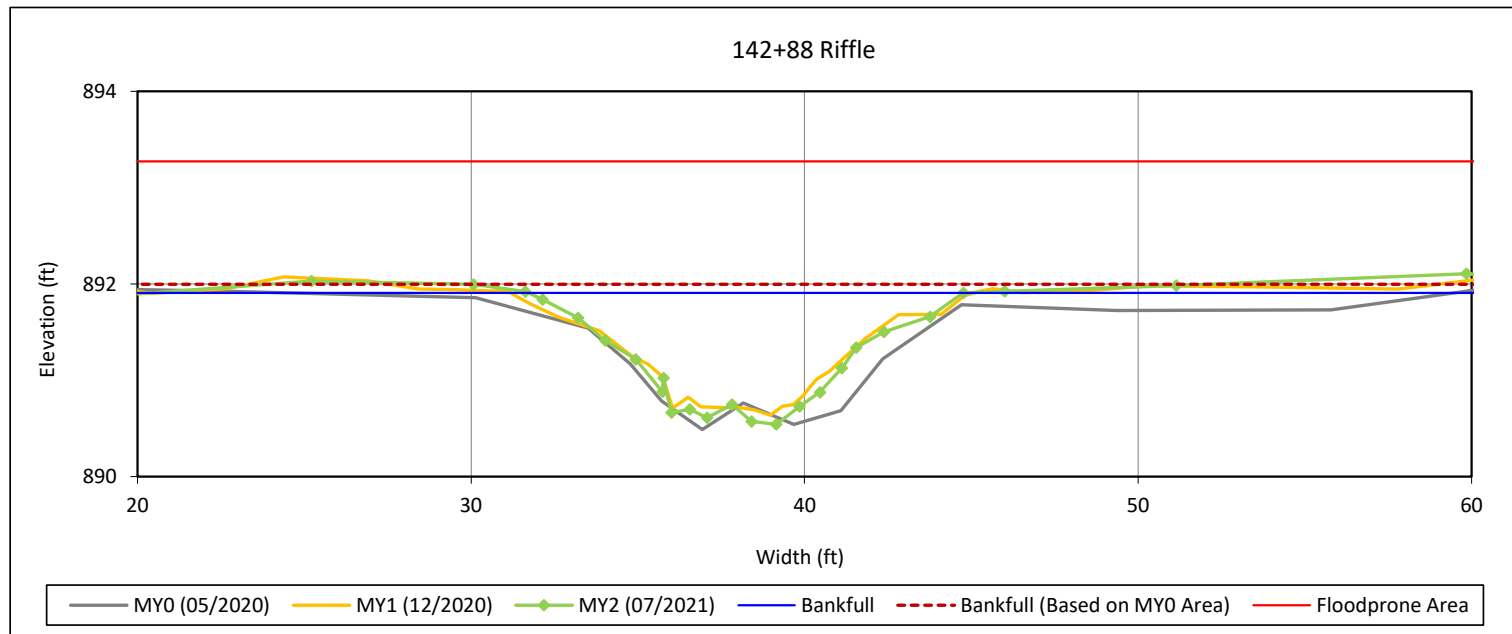
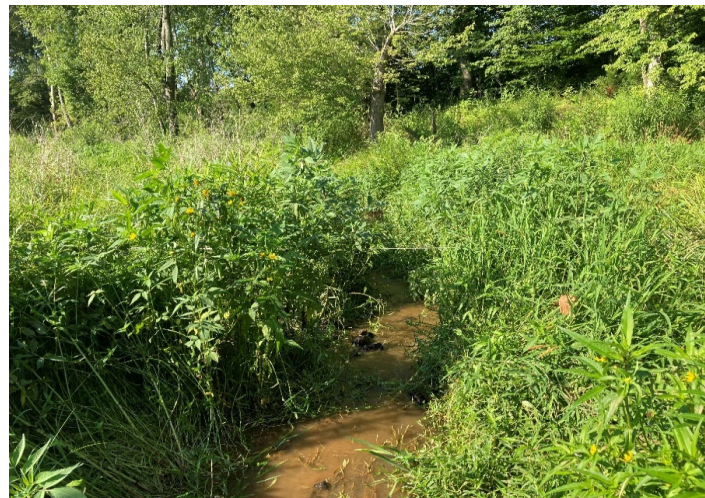
Cross-Section 6-UT1 Reach 4A

9.4	x-section area (ft.sq.)
13.0	width (ft)
0.7	mean depth (ft)
1.4	max depth (ft)
13.7	wetted perimeter (ft)
0.7	hydraulic radius (ft)
18.1	width-depth ratio
66.3	W flood prone area (ft)
5.1	entrenchment ratio
0.9	low bank height ratio

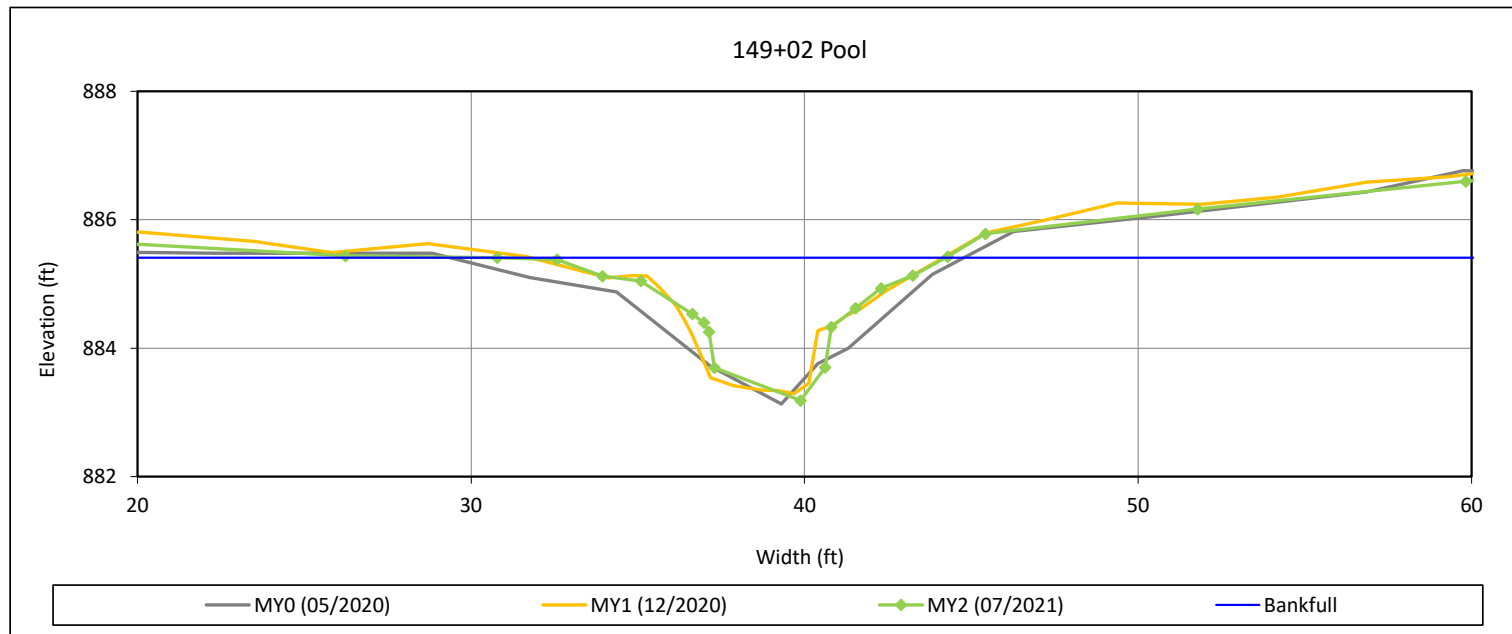
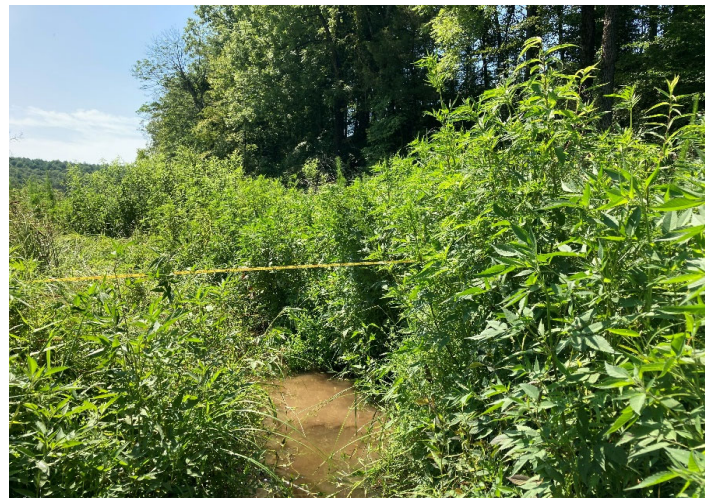
Cross-Section 7-UT1 Reach 4A

10.8	x-section area (ft.sq.)
13.5	width (ft)
0.8	mean depth (ft)
2.2	max depth (ft)
14.9	wetted perimeter (ft)
0.7	hydraulic radius (ft)
16.8	width-depth ratio

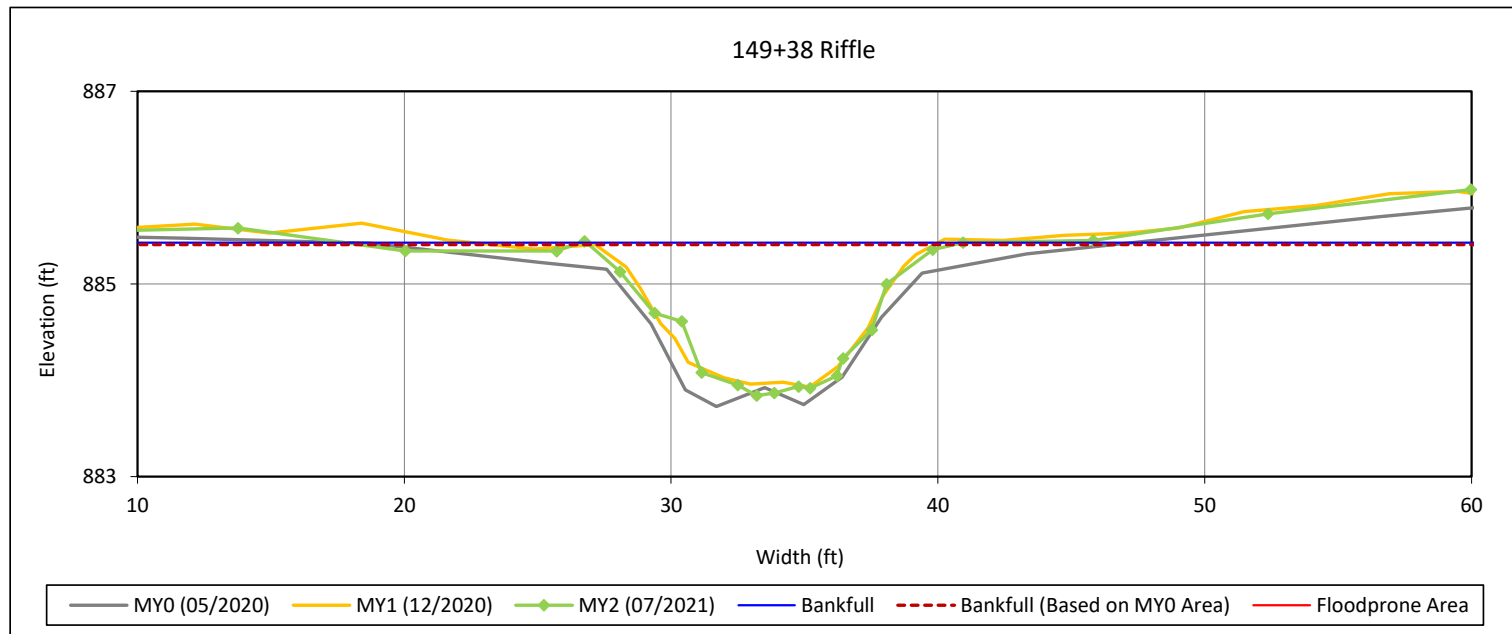
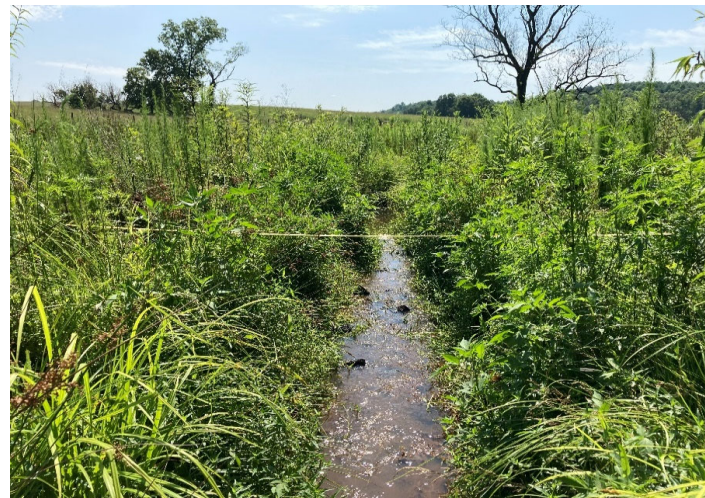
Cross-Section 8-UT1 Reach 4A

12.3	x-section area (ft.sq.)
14.1	width (ft)
0.9	mean depth (ft)
1.6	max depth (ft)
14.7	wetted perimeter (ft)
0.8	hydraulic radius (ft)
16.3	width-depth ratio
62.6	W flood prone area (ft)
4.4	entrenchment ratio
1.0	low bank height ratio

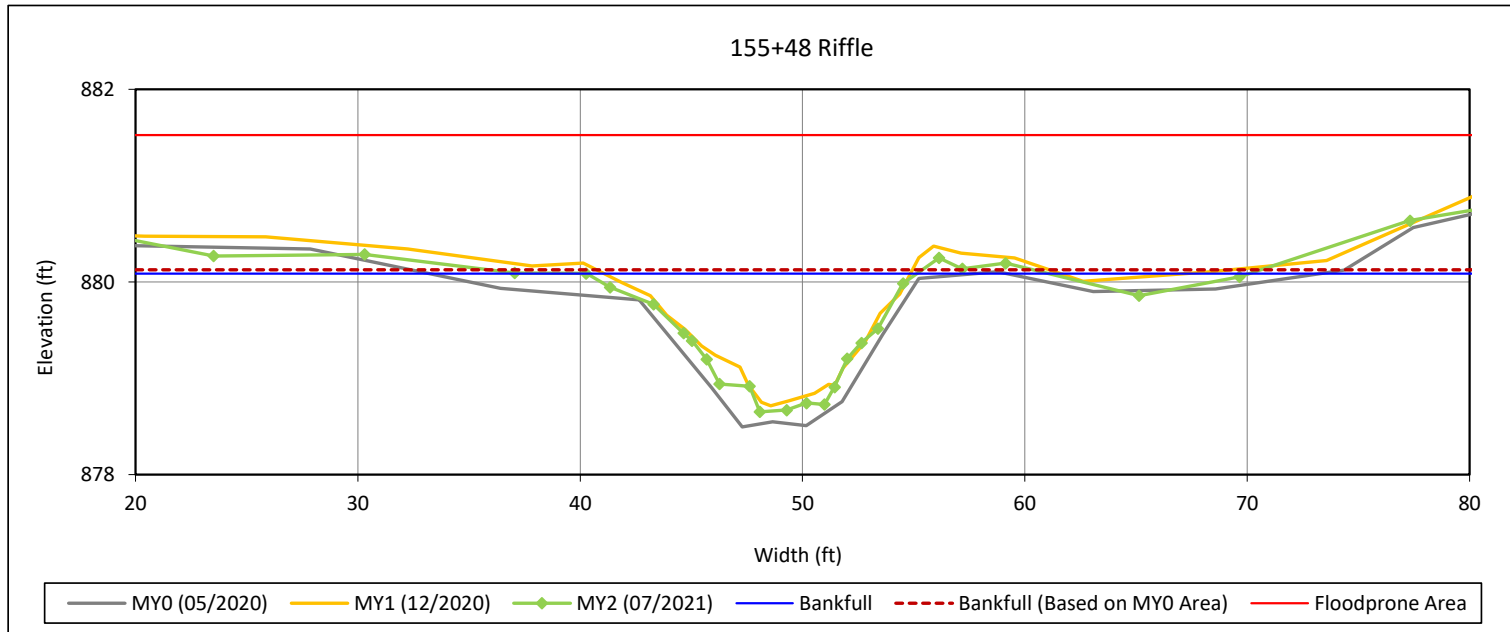
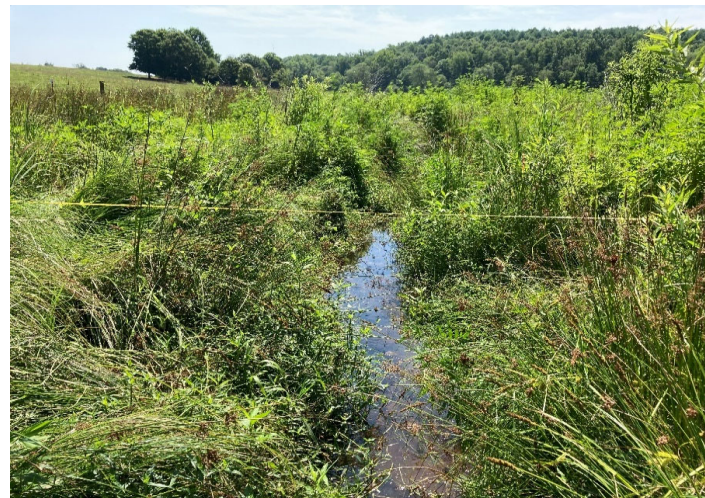
Cross-Section 9-UT1 Reach 4B

11.3	x-section area (ft.sq.)
14.9	width (ft)
0.8	mean depth (ft)
1.4	max depth (ft)
15.3	wetted perimeter (ft)
0.7	hydraulic radius (ft)
19.6	width-depth ratio
80.8	W flood prone area (ft)
5.4	entrenchment ratio
1.0	low bank height ratio

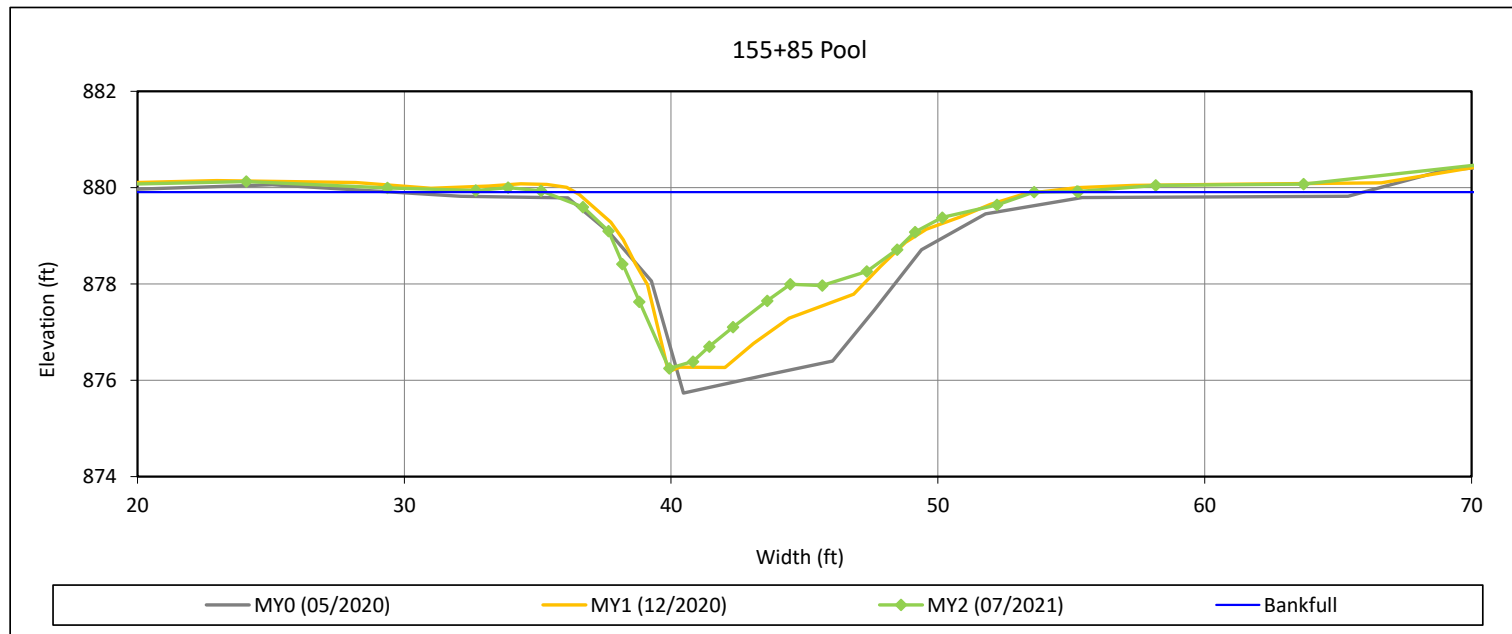
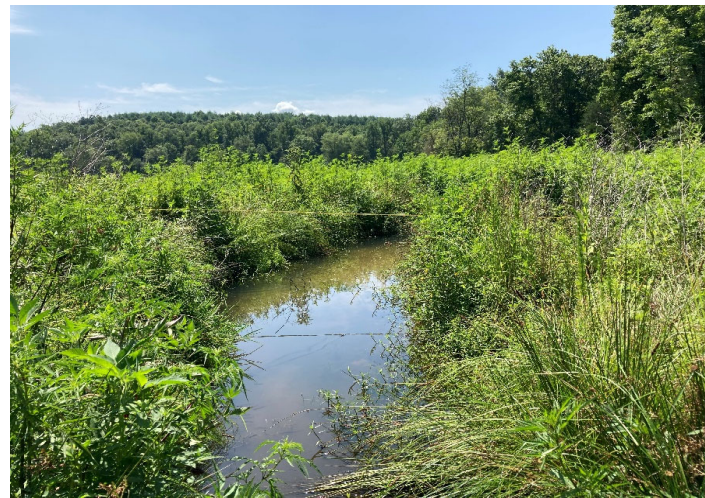
Cross-Section 10-UT1 Reach 4B

28.1	x-section area (ft.sq.)
18.3	width (ft)
1.5	mean depth (ft)
3.7	max depth (ft)
20.5	wetted perimeter (ft)
1.4	hydraulic radius (ft)
12.0	width-depth ratio

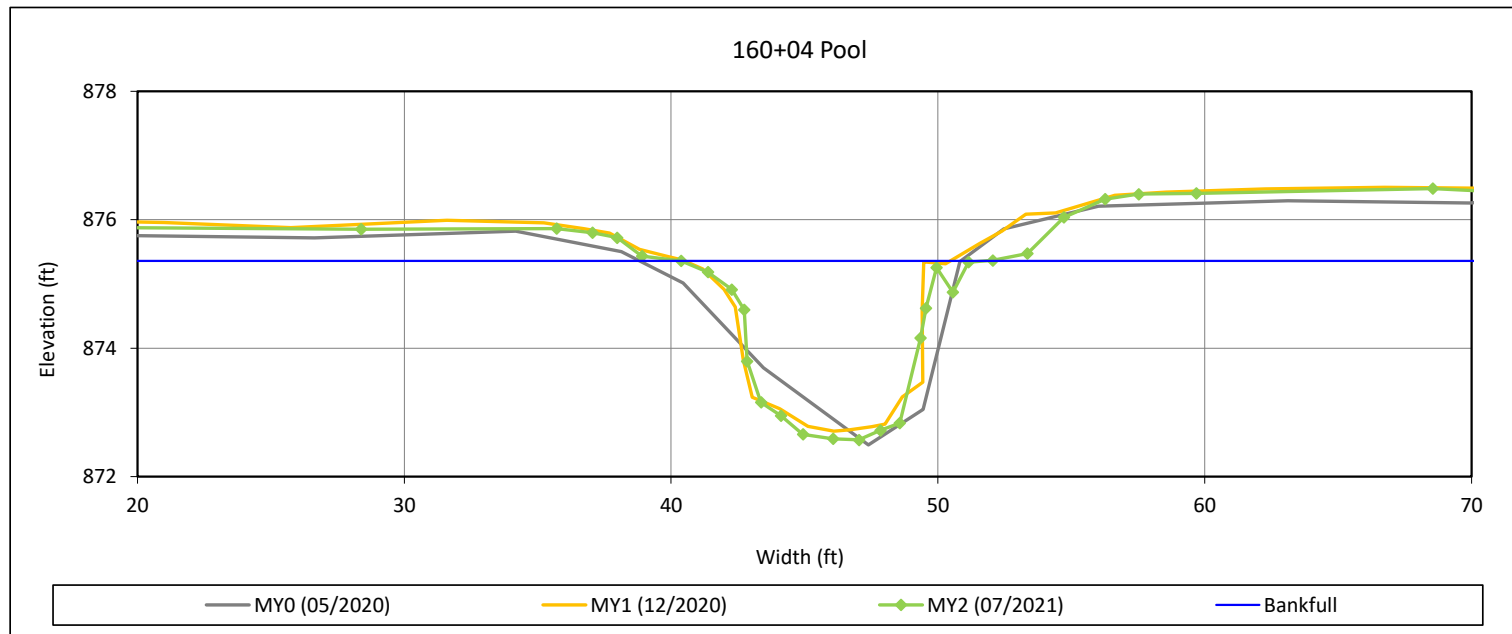
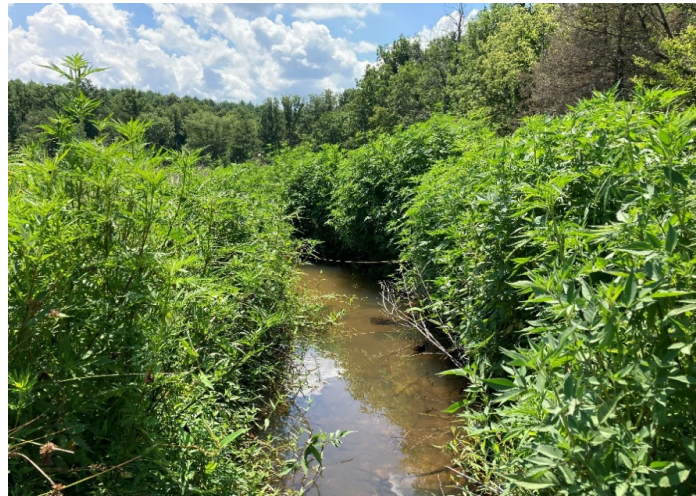
Cross-Section 11-UT1 Reach 4B

17.6	x-section area (ft.sq.)
11.4	width (ft)
1.5	mean depth (ft)
2.8	max depth (ft)
14.4	wetted perimeter (ft)
1.2	hydraulic radius (ft)
7.4	width-depth ratio

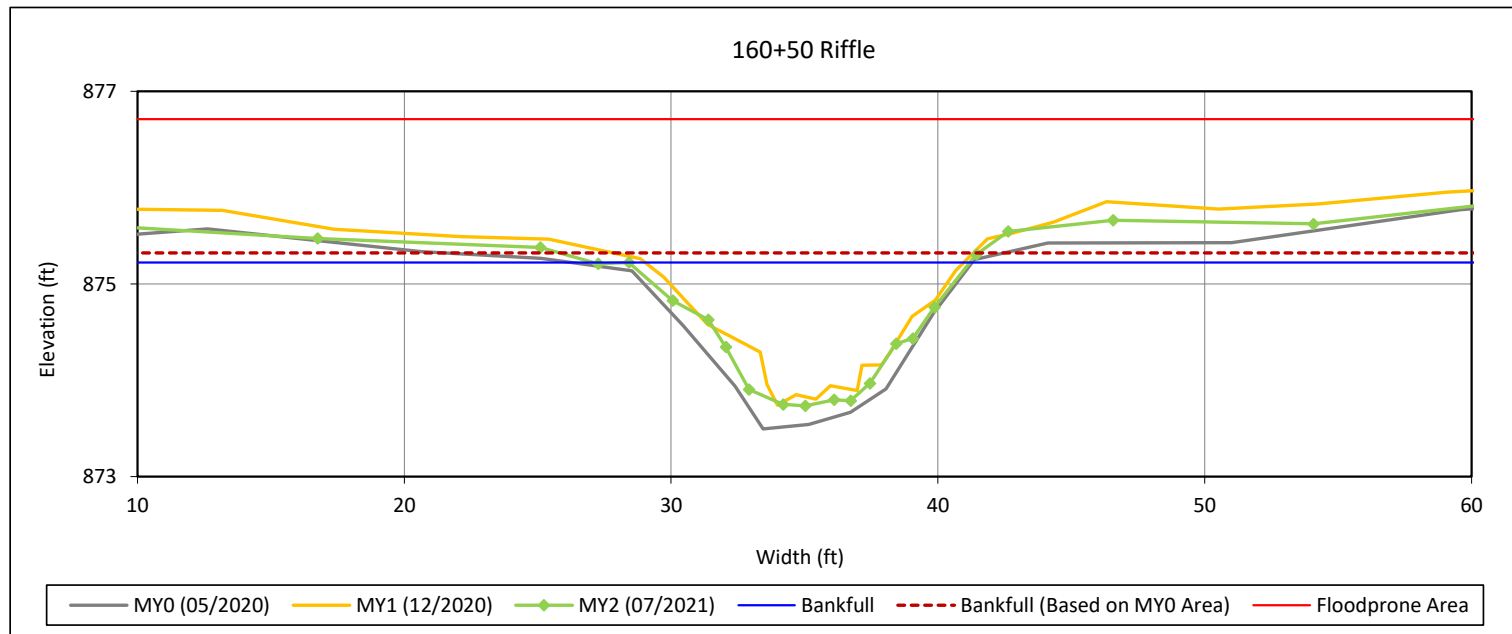
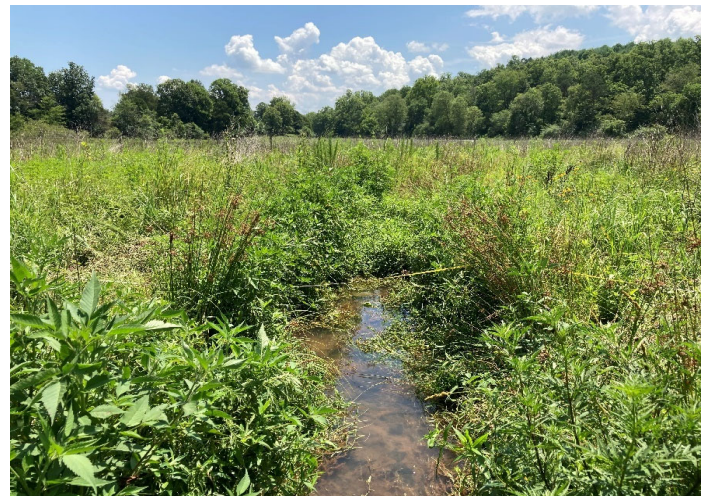
Cross-Section 12-UT1 Reach 4B

11.2	x-section area (ft.sq.)
12.8	width (ft)
0.9	mean depth (ft)
1.5	max depth (ft)
13.3	wetted perimeter (ft)
0.8	hydraulic radius (ft)
14.6	width-depth ratio
74.5	W flood prone area (ft)
5.8	entrenchment ratio
0.9	low bank height ratio
