MONITORING YEAR 2 ANNUAL REPORT

ALEXANDER FARM MITIGATION SITE

Alexander County, NC
DEQ Contract No. 7416
DMS Project No. 100048
USACE Action ID No. SAW-2018-00451
NCDEQ DWR Certification No. 18-0665
RFP #: 16-007277

Data Collection Period: January 2021 – November 2021
Final Submission Date: February 1, 2022

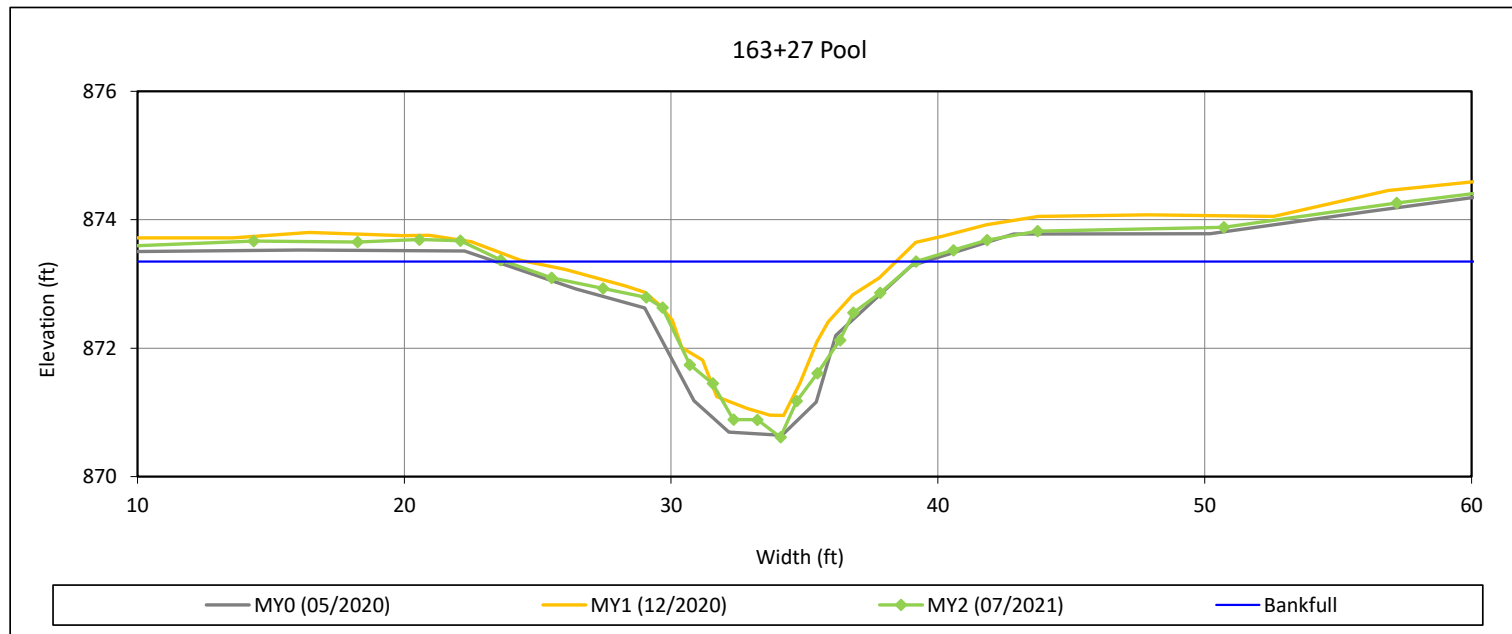
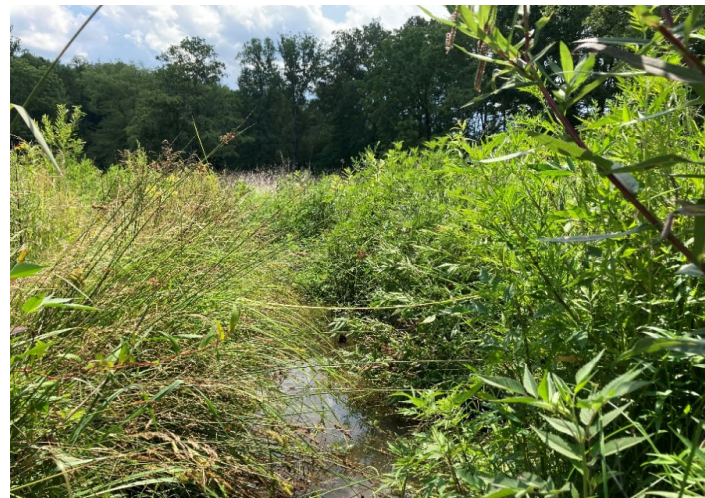
Cross-Section 13-UT1 Reach 4B

16.6	x-section area (ft.sq.)
15.4	width (ft)
1.1	mean depth (ft)
2.7	max depth (ft)
16.8	wetted perimeter (ft)
1.0	hydraulic radius (ft)
14.3	width-depth ratio

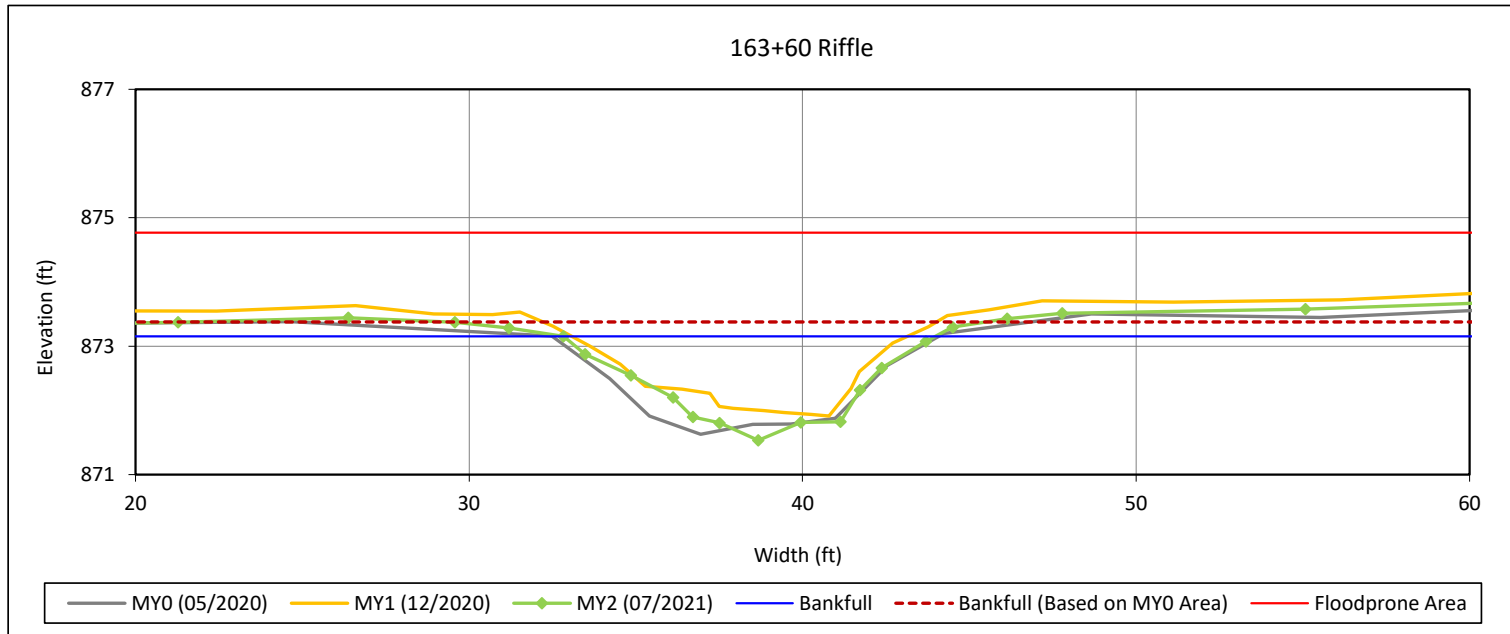
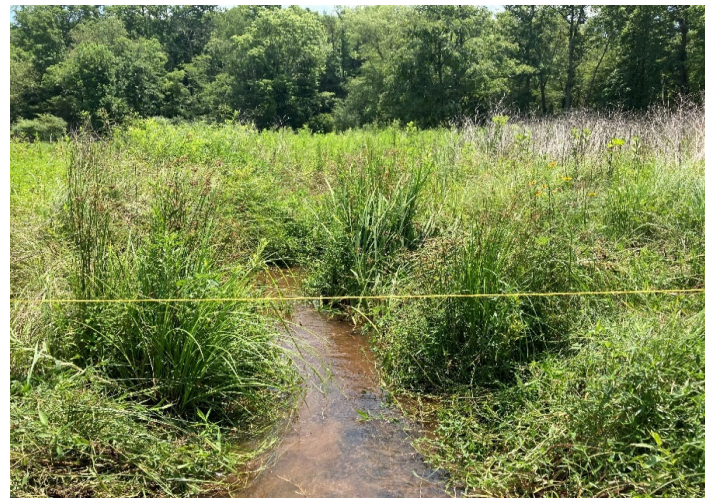
Cross-Section 14-UT1 Reach 4B

10.0	x-section area (ft.sq.)
11.2	width (ft)
0.9	mean depth (ft)
1.6	max depth (ft)
11.8	wetted perimeter (ft)
0.9	hydraulic radius (ft)
12.4	width-depth ratio
73.7	W flood prone area (ft)
6.6	entrenchment ratio
0.9	low bank height ratio

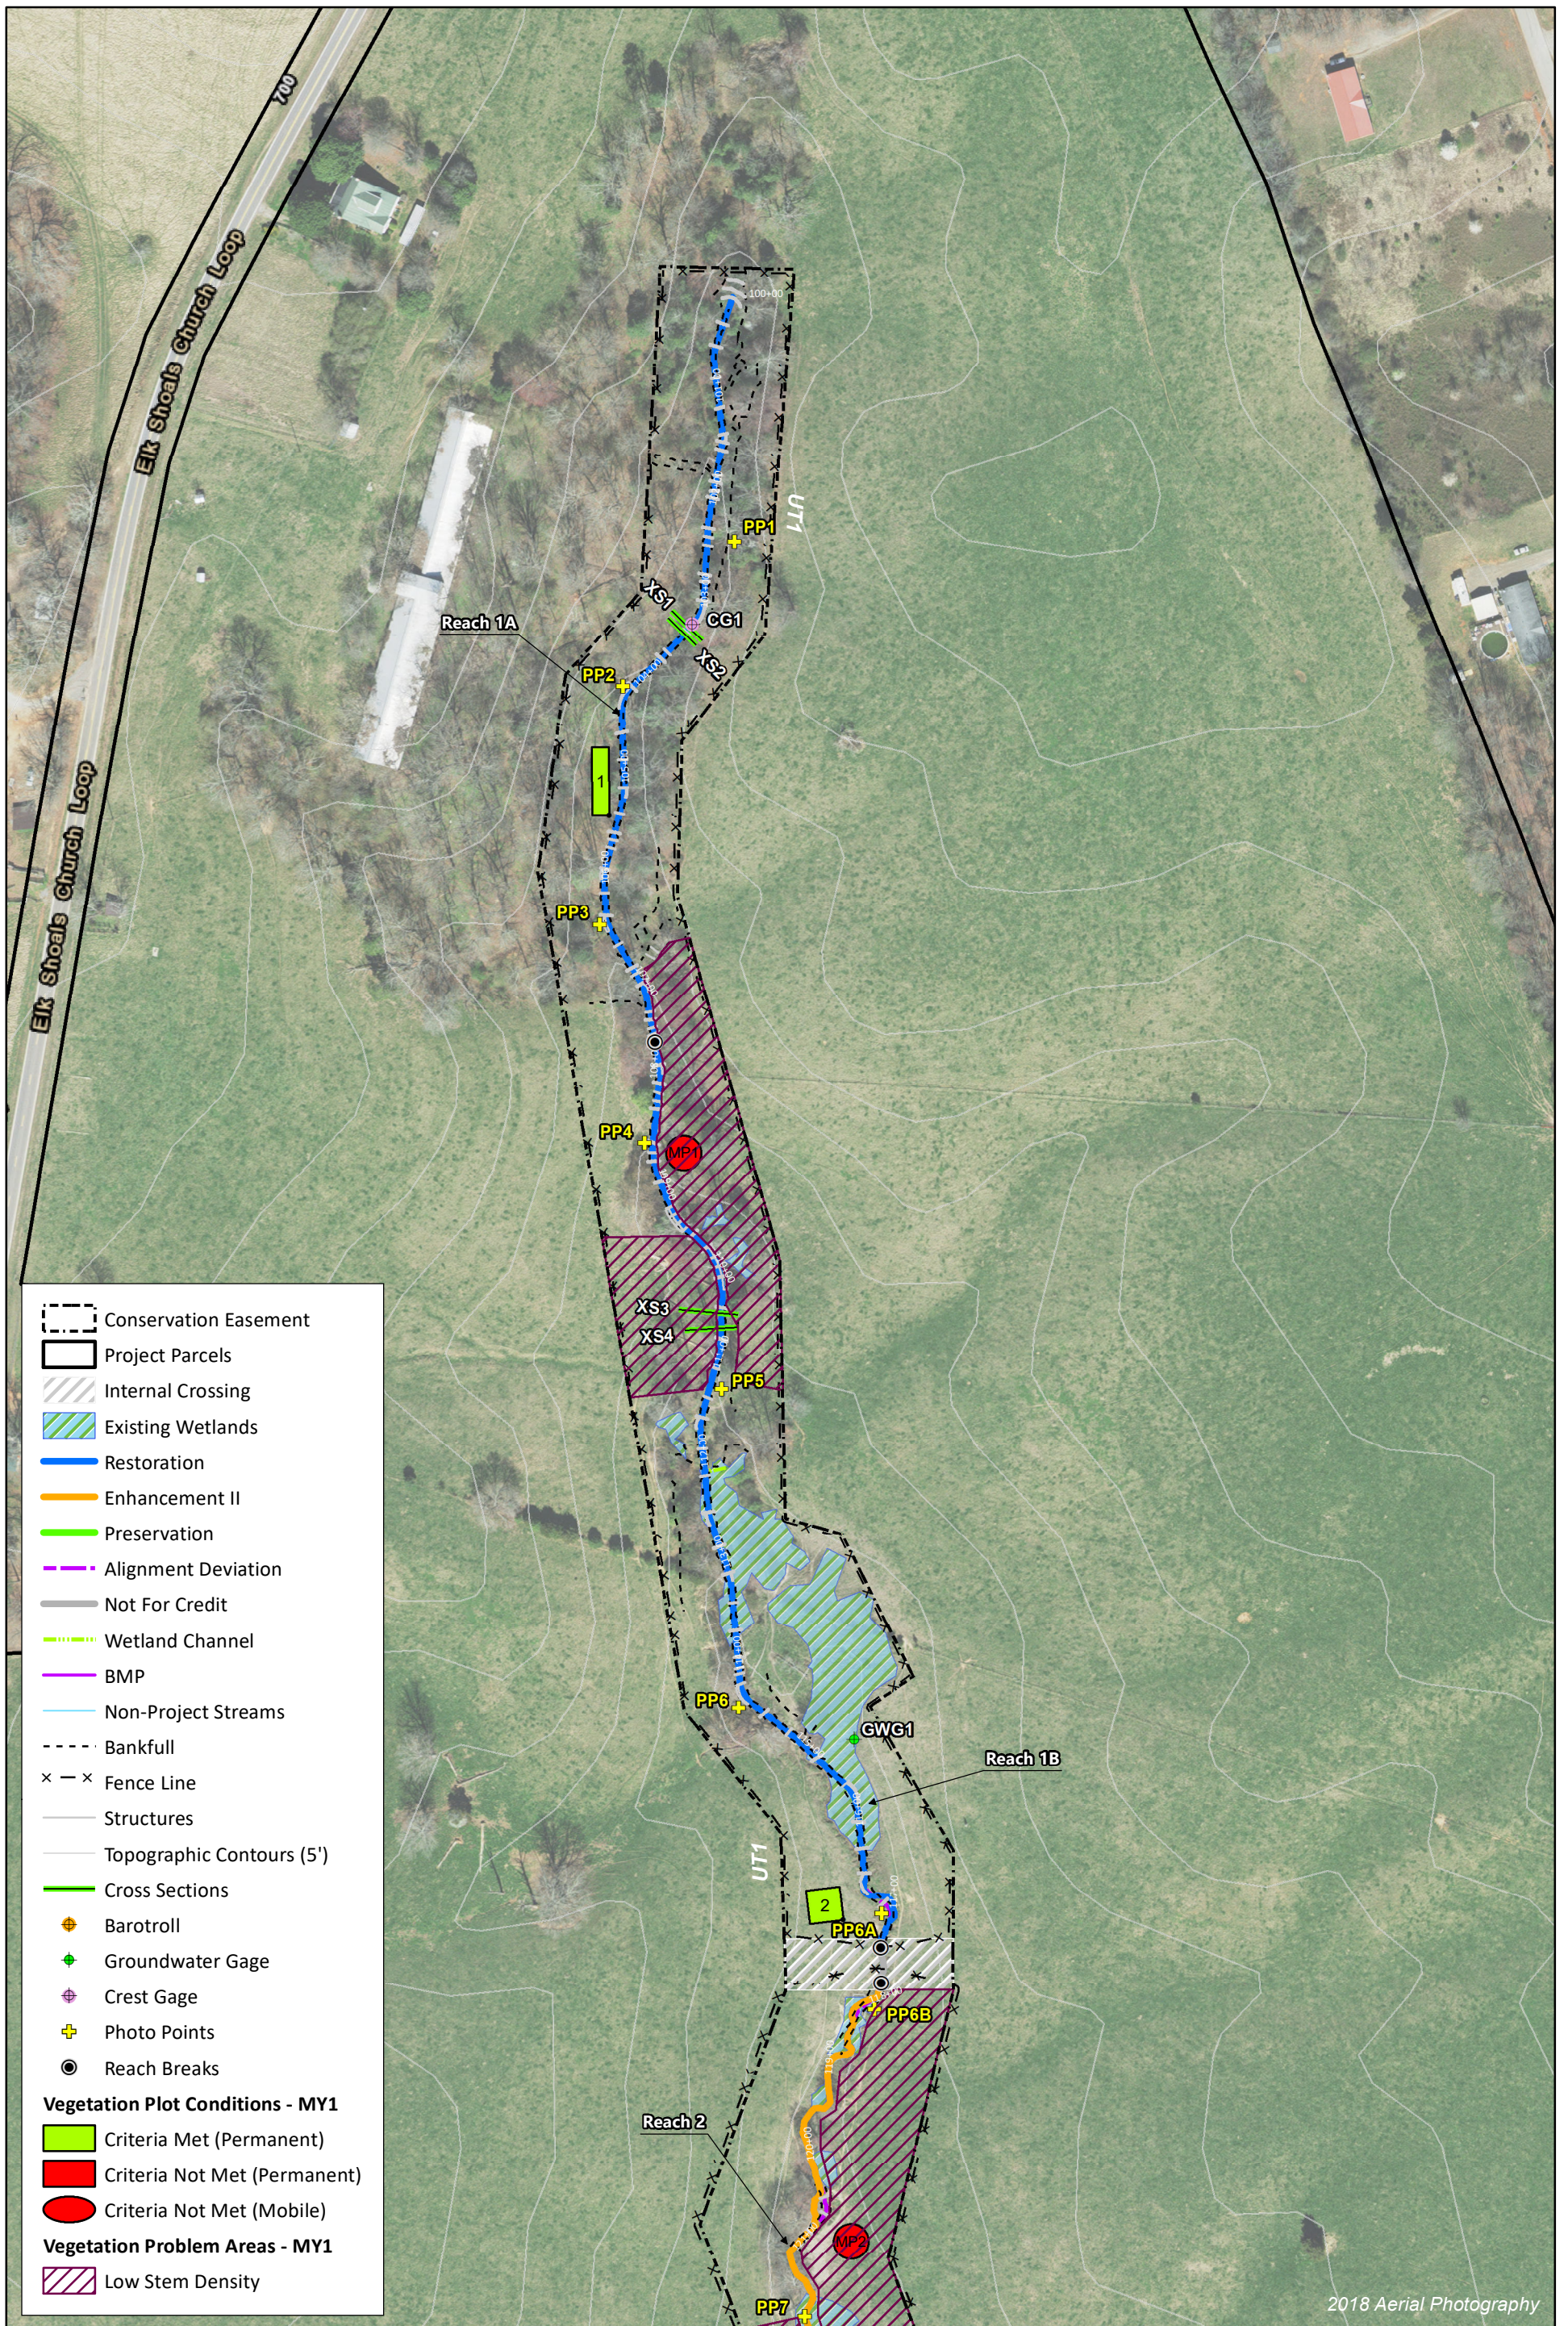
Figure 1.1 Supplemental Planting Map
 Alexander Farm Mitigation Site
 DMS Project No. 100048
 Adaptive Management Plan
 Alexander County, NC

The MY1 vegetation survey that was completed in October 2020 identified six of twelve vegetation plots (Permanent and Mobile) that are not on track to meet MY3 interim success criteria of 320 planted stems per acre. Of those six plots, three are not on track to meet the final success criteria of 210 planted stems per acre. Additionally, low stem density areas across the site total approximately 10.0 acres. These areas of low stem density were noted along UT1 Reach 1A, Reach 1B, Reach 2, Reach 4A, Reach 4B, and UT1A.

Across the Site, all areas slated for replanting, which total 10.0 acres along UT1 Reach 1A, Reach 1B, Reach 2, Reach 4A, Reach 4B, and UT1A (Figures 1.1, 1.2, and 1.3) will be further treated with soil amendments. Grading during construction exposed poor-quality subsoils with low organic matter content and limited biology. Planned soil amendment additions include humic acid, biochar, dried molasses, slow-release fertilizer (2-4-3), rock phosphate, and azomite (a trace mineral supplement). Beyond boosting macro- and micronutrients in the soil, the addition of these amendments will improve other soil properties including cation exchange capacity, pH, and microbial communities. Expected improvements include higher moisture-holding capacity, organic matter, and nutrient availability for plants. The amendments will be applied to the base of each stem rather than broadcasted across the entire 10.0-acre area.

Throughout the 10.0 acres, a mixture of nine species will be planted at a density of 500 stems per acre (Figures 1.1, 1.2, and 1.3). This is 57.6% of the original planted area. Planted trees will all be bare root stock. Species and quantities of trees to be planted are shown in Table 3. Five of the species were not included in the Final Mitigation Plan for the Alexander Farm Site (Wildlands, 2019). They are northern red oak (*Quercus rubra*), white oak (*Quercus alba*), winged elm (*Ulmus alata*), sassafras (*Sassafras albidum*), and eastern cottonwood (*Populus deltoides*). Two of the five species, northern red oak and white oak were previously approved by the IRT for addition to the planting list as part of the As-built Baseline Monitoring Report for the Site (Wildlands, 2020). Though the remaining three species (Winged elm, sassafras, and cottonwood) were not included as part of the project's previously approved planting plans, we believe that they will do well at the site as early successional species and have been added to the planting plan. Winged elm (*Ulmus alata*), sassafras (*Sassafras albidum*), and eastern cottonwood (*Populus deltoides*) are good early successional and hardy trees that should establish well in the growing conditions found on-site (poor soils with variability in moisture regimes). Also, since eastern cottonwoods grow quickly, they can create more favorable growing conditions for the later successional plant species by acting as nurse trees. Supplementally planted trees added to a vegetation plot will be flagged with a color different from what was used to flag the originally planted trees. The additional trees will not be counted towards success criteria until two growing seasons have passed.
