MONITORING YEAR 4 ANNUAL REPORT

BIG HARRIS CREEK MITIGATION SITE

Cleveland County, NC
DMS Project No. 739
DEQ Contract 006256
DWR 401 Project No. 10-0811
USACE Action ID No. SAW-2009-0475
Broad River Basin
HUC 03050105

Data Collection Period: May – November 2021

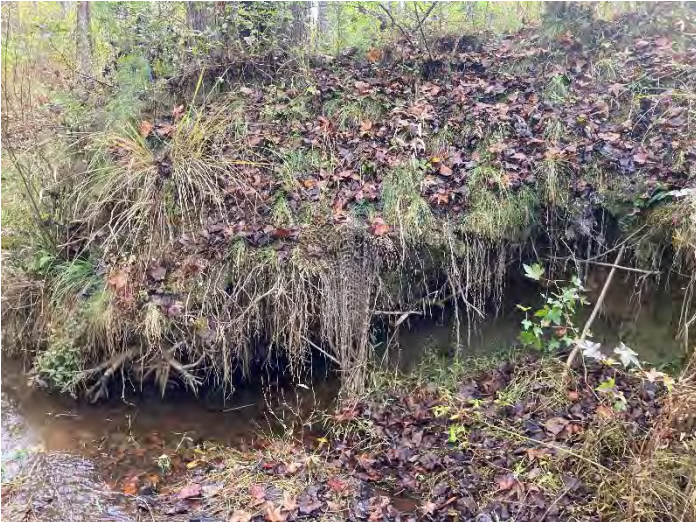
Elliott Creek Bank Scour (STA 141+30) – view downstream
(11/5/2021)

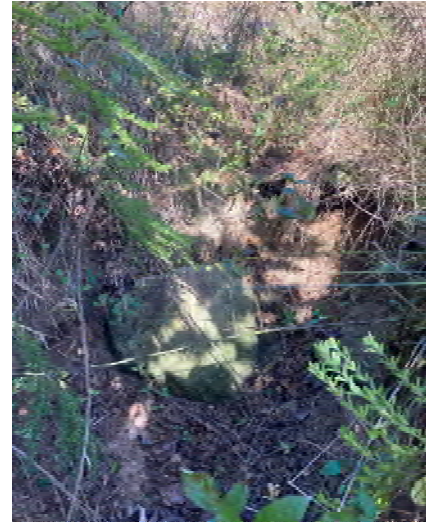
Scott Creek Channel Incision (STA 1211+25 – 1211+36) – view upstream
(10/27/2021)
