# **Brown Creek Tributaries Restoration Project FINAL Year 7 Monitoring Report/Closeout Report**

Anson County, North Carolina

DMS Project ID No. 95351  
DEQ Contract No. 004641  
USACE Action ID: SAW-2012-01108  
DWR Project #14-0345  
RFP #16-004108 (Issued 6/20/2011)  
Yadkin River Basin: 03040104-061030

Project Info:           Monitoring Year: 7 of 7  
                              Year of Data Collection: 2021  
                              Year of Completed Construction: 2015  
                              Submission Date: February 2022

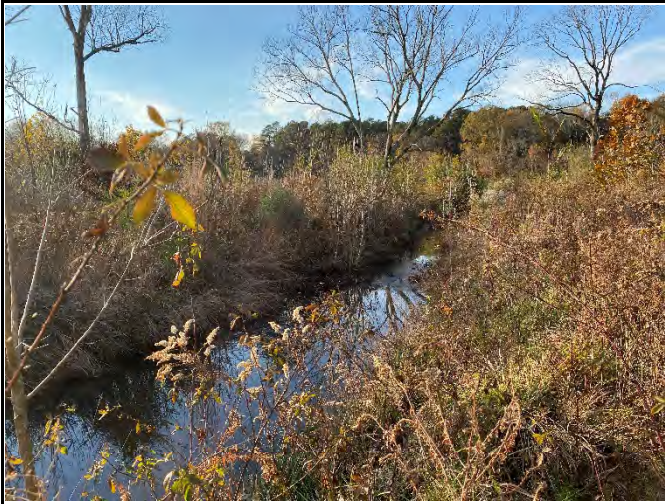
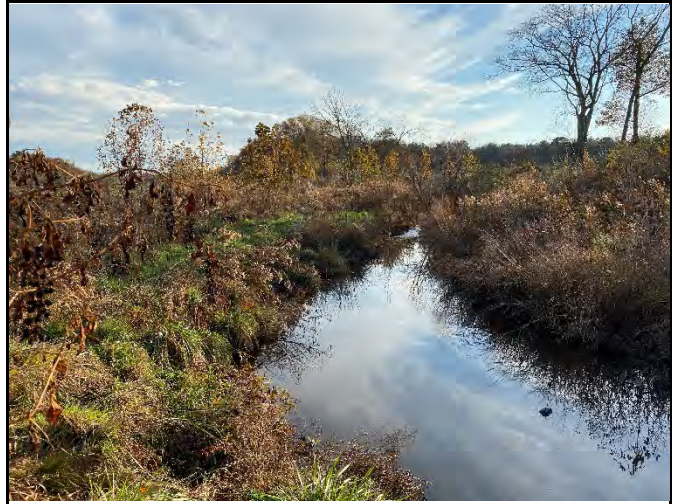
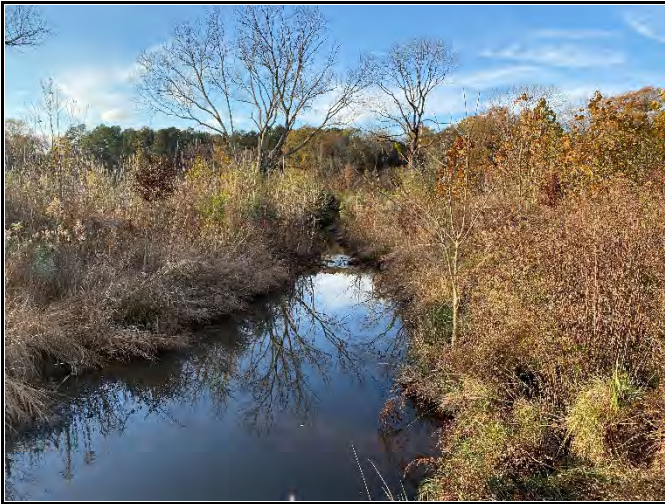
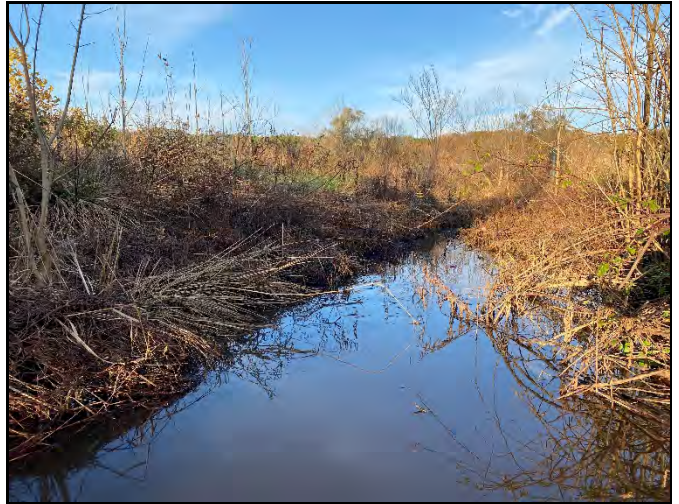
Previously during MY6 site inspections in November 2020, several beaver dams were discovered on both portions of the project. A professional beaver wildlife specialist was employed to trap the beaver prior to his demolition of each of the dams with explosives and hand raking to remove the debris in March 2021 (see photographs in Appendix B). Fortunately, the vast majority of the vegetation used for the dams was the adjacent black willow, which is present in abundance and naturally regrows well. Subsequent field inspections revealed that no further beaver activity has been noted since that time.

HC-R2: Photo showing normal flow restored and maintained after beaver dams removed in the spring.

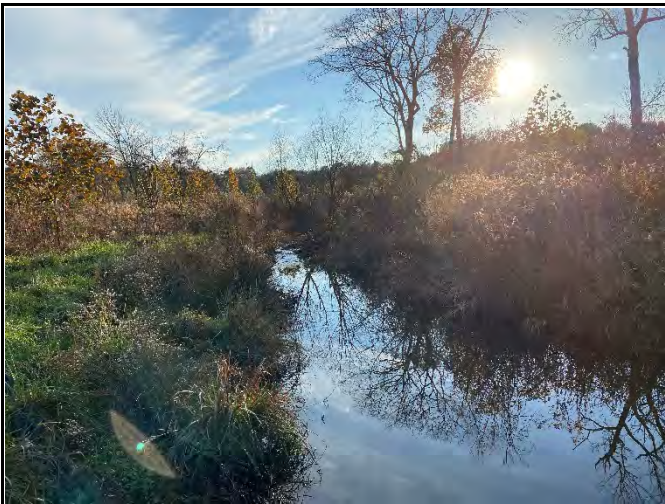
HC-R2: Photo showing normal flow restored and maintained after beaver dams removed in the spring.

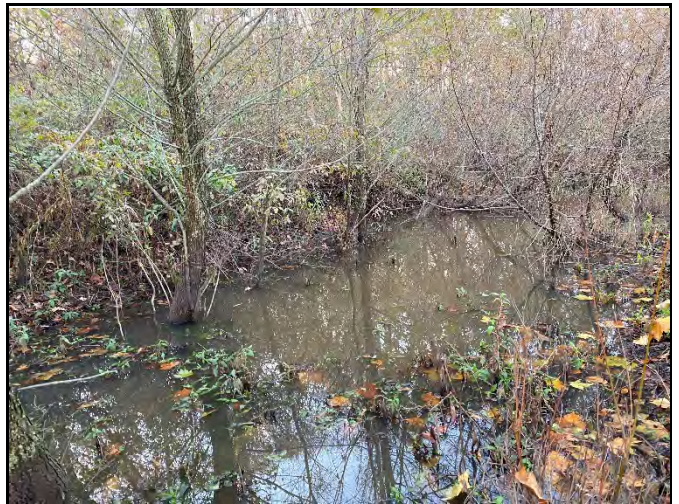
HC-R1: Photo showing normal flow restored and maintained after beaver dams removed in the spring.

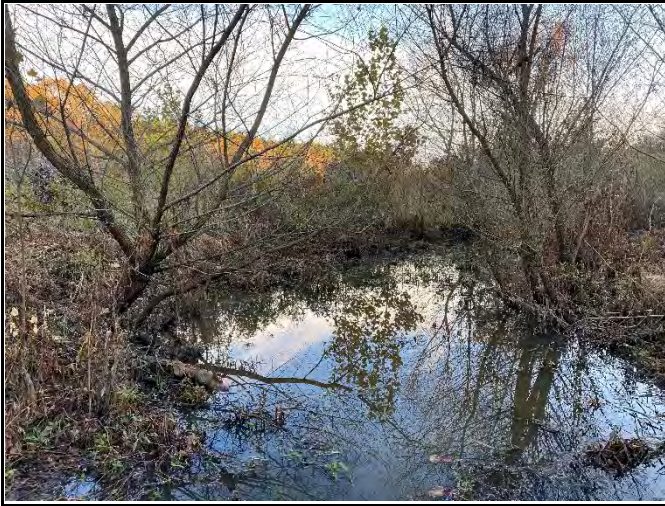
HC-R1: Photo showing normal flow restored and maintained after beaver dams removed in the spring.

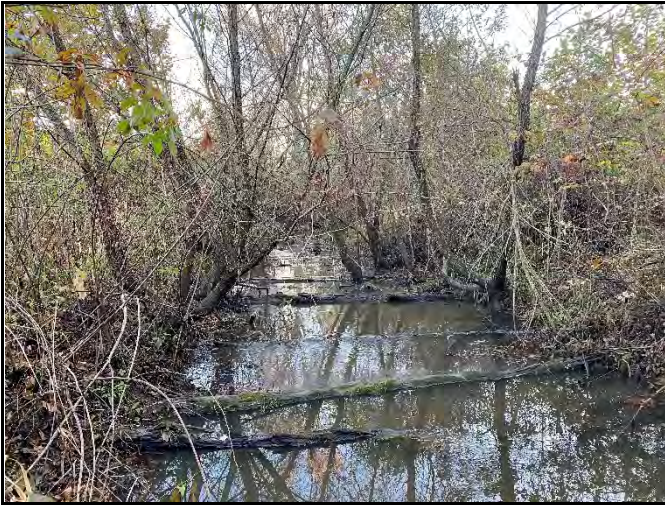
HC-R1: Photo showing normal flow restored and maintained after beaver dams removed in the spring.

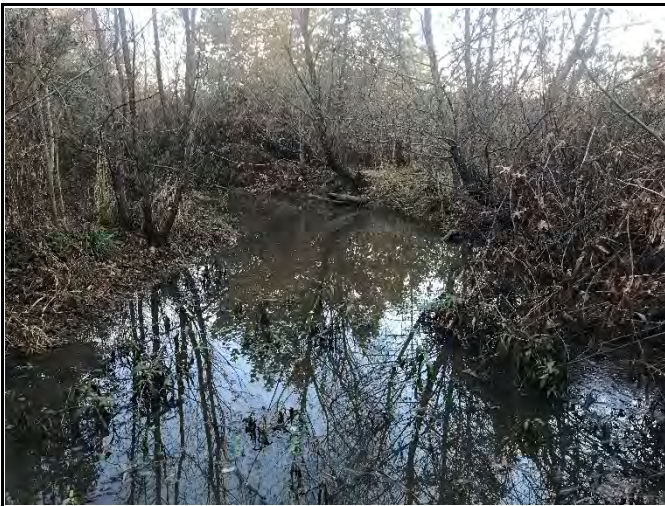
HC-R1: Photo showing normal flow restored and maintained after beaver dams removed in the spring.

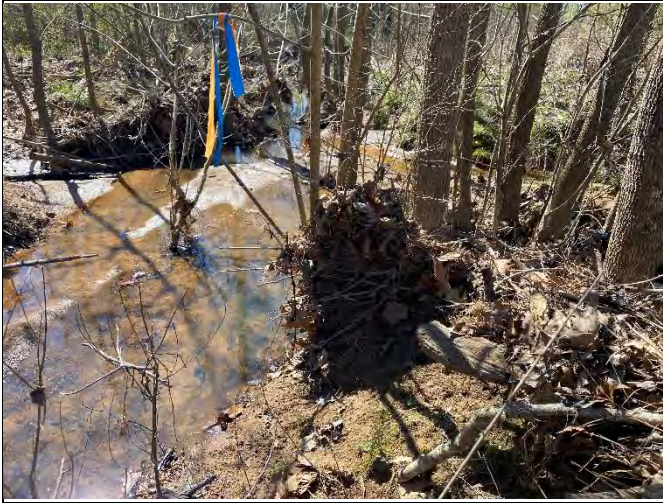
Reach UT4-R1b: Evidence of overbank event  
(photo from 3/8/21)

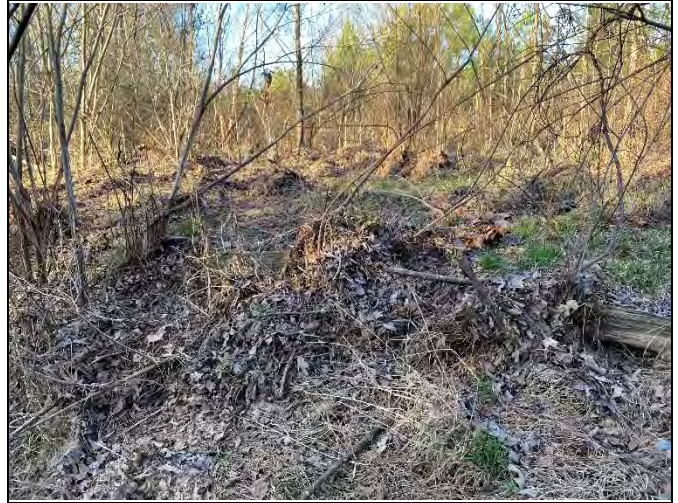
Reach UT4-R2: Evidence of overbank event  
(photo from 3/8/21)

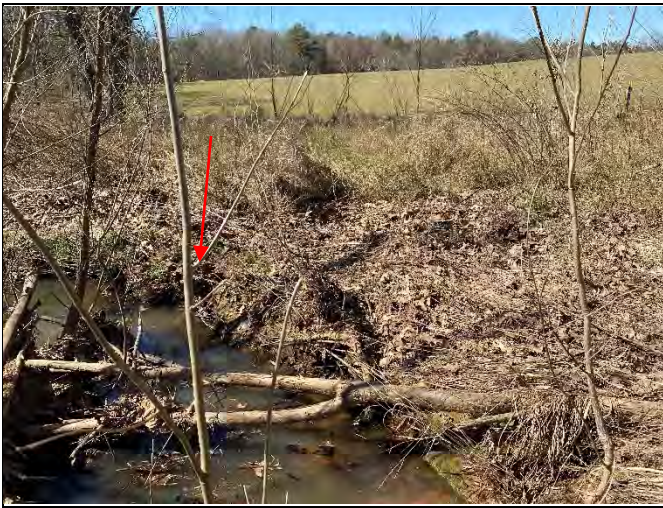
Reach UT4-R4b: Evidence of overbank event  
(photo from 3/8/21)

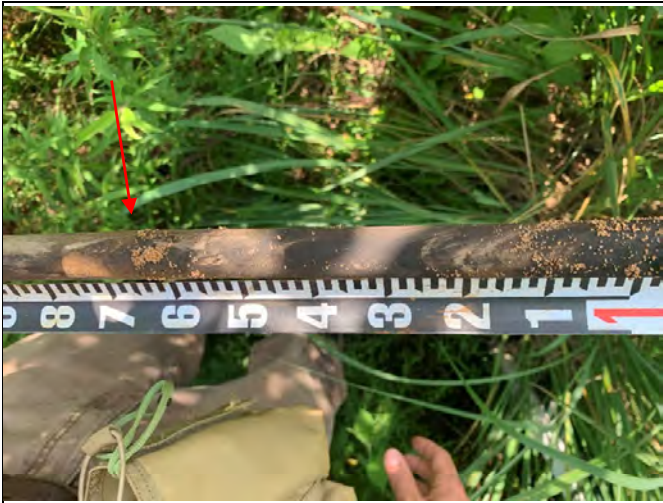
Crest Gauge Reach HC-R1: Close-up of gauge reading of 1.65' (photo from 7/22/21)

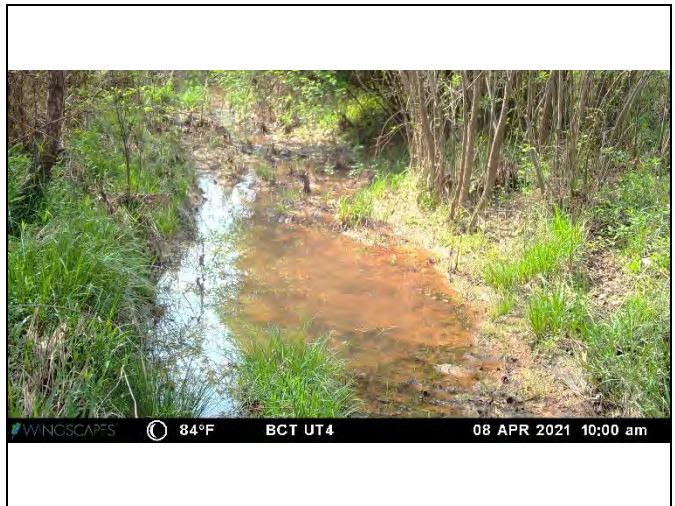
Reach UT4-R4: Flow Camera Photo (flow gauge indicates that channel is no longer flowing, though water remains in channel)

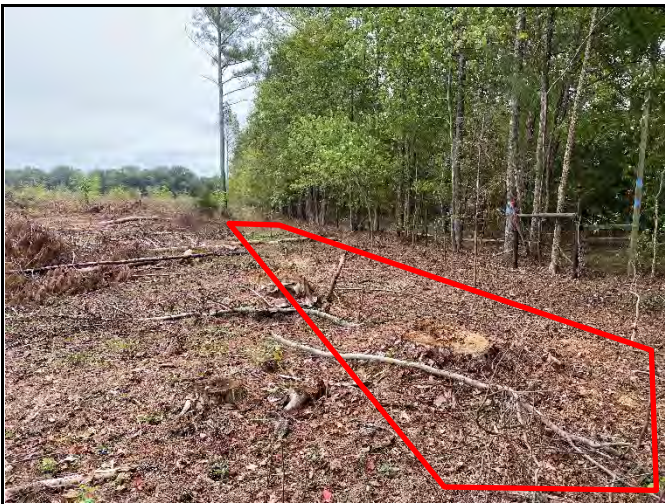
UT4: CE boundary line conflict of 20-ft at the greatest extent (photo Aug. 2021)

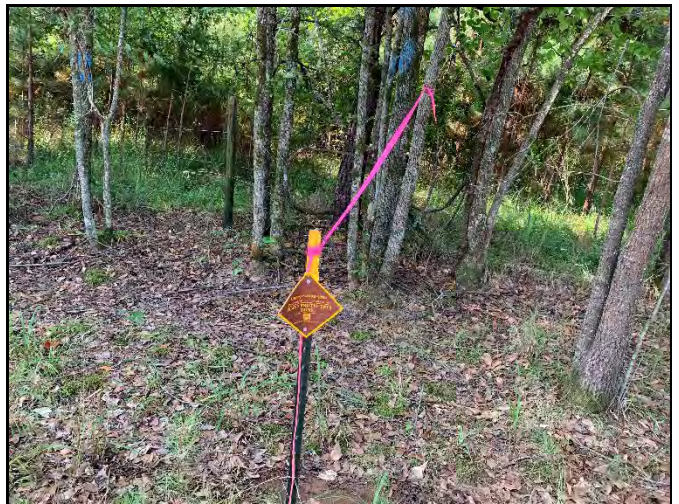
UT4: Outer row of mature pines cut along a narrow 100-ft long sliver (photo Aug. 2021)
