Browns Summit Creek Restoration Project Year 5 Monitoring Report

Guilford County, North Carolina

DMS Project ID No. 96313, DEQ Contract No. 5792

Project Info: Monitoring Year: 5 of 7
 Year of Data Collection: 2021
 Year of Completed Construction (including planting): 2017
 Submission Date: December 2021

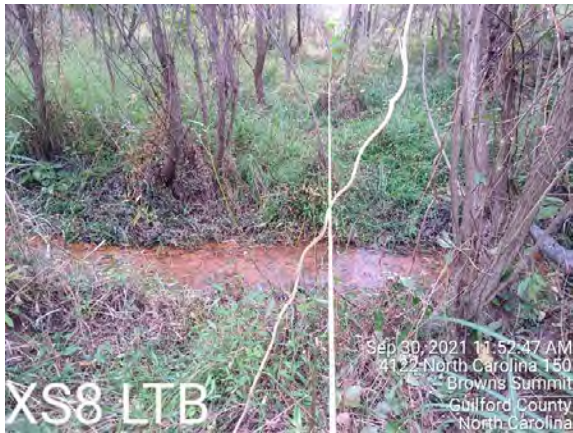
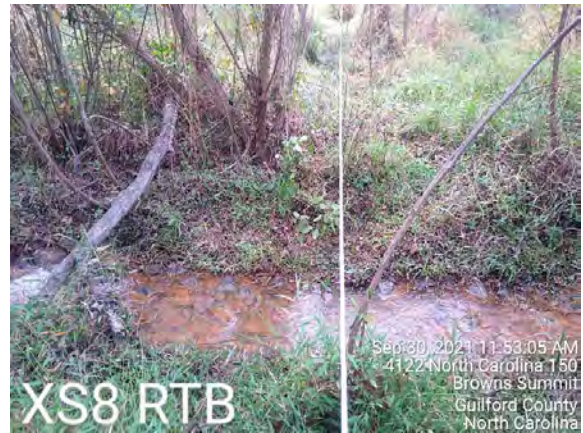
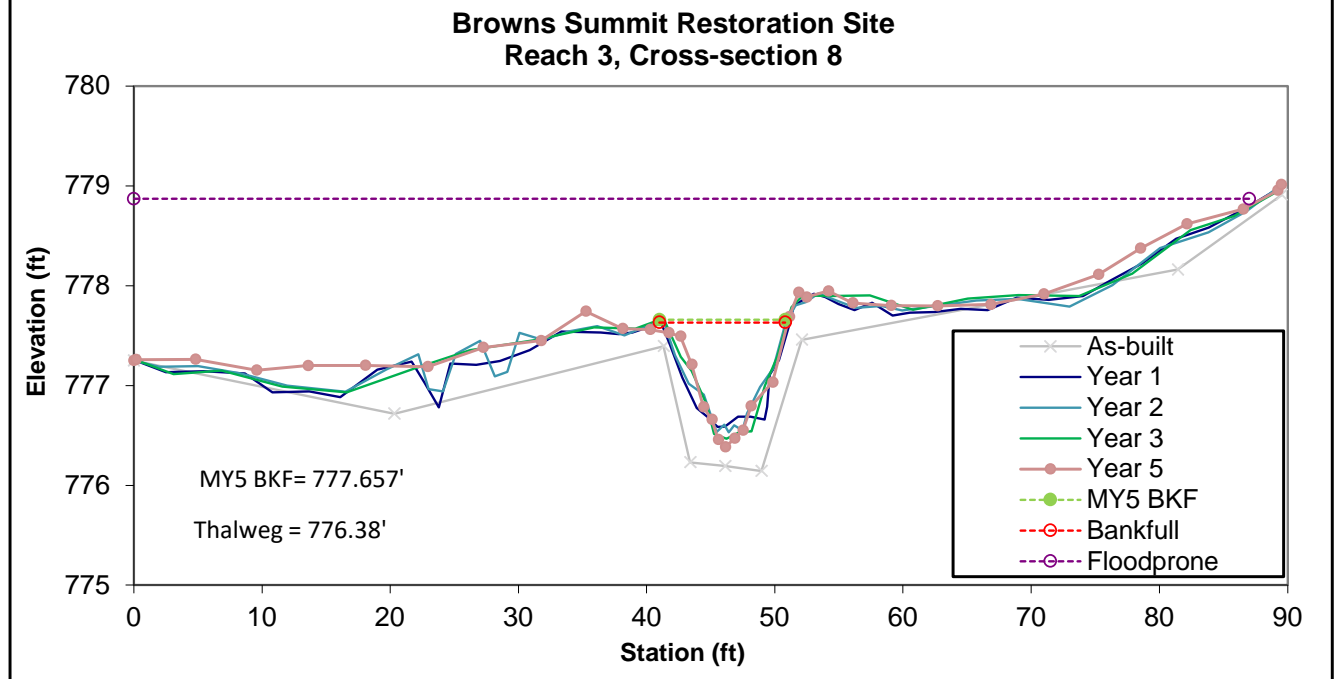
Permanent Cross-section 8
(Year 5 Data - Collected September 2021)

Feature	Stream Type	BKF Area	BKF Width	BKF Depth	Max BKF Depth	W/D	BH Ratio	ER	BKF Elev	TOB Elev
Riffle	C	6.8	13.9	0.5	1.2	28.3	0.9	6.3	777.63	777.49

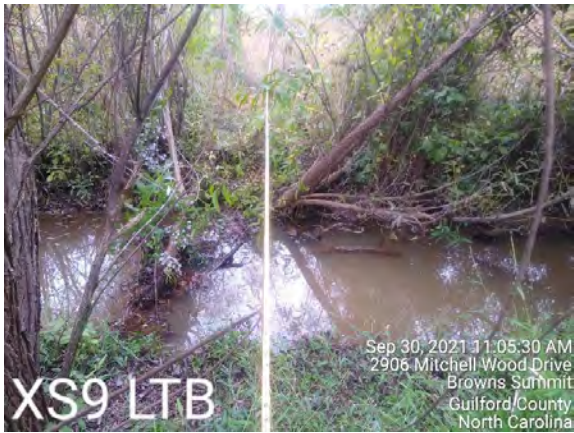
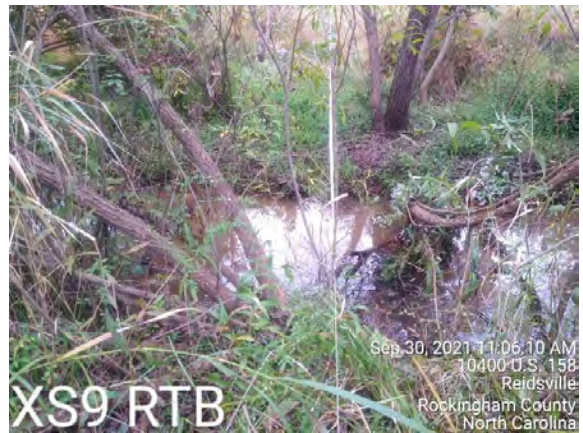
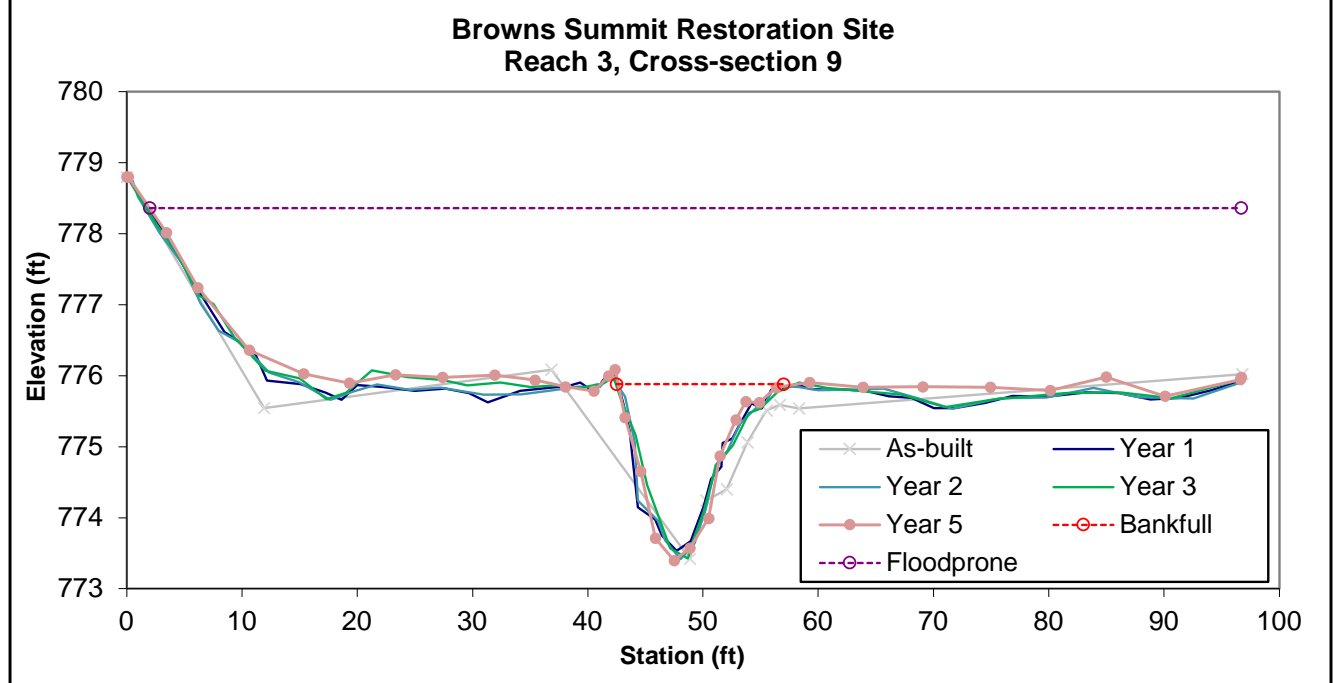
Permanent Cross-section 9
(Year 5 Data - Collected September 2021)

Feature	Stream Type	BKF Area	BKF Width	BKF Depth	Max BKF Depth	W/D	BH Ratio	ER	BKF Elev	TOB Elev
Pool	--	17.3	15.6	1.1	2.5	14	--	--	775.88	775.64

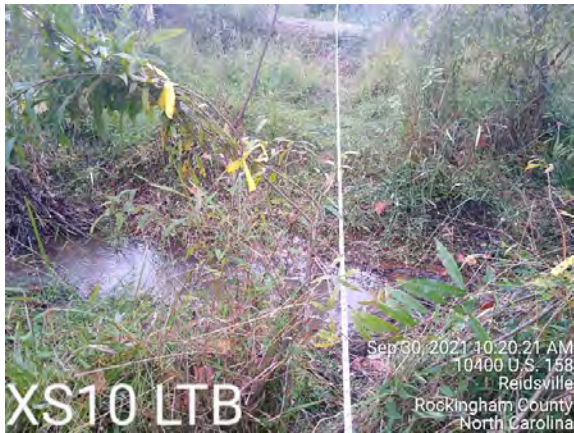
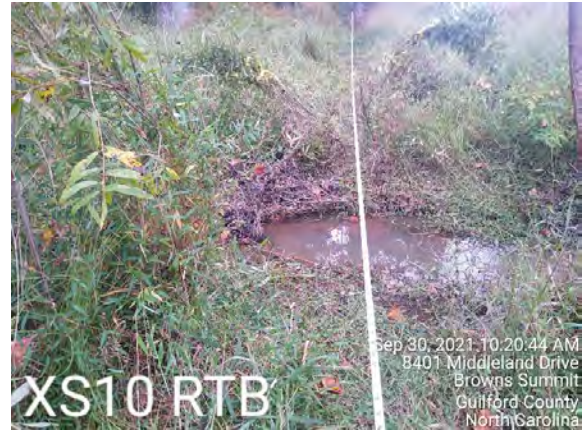
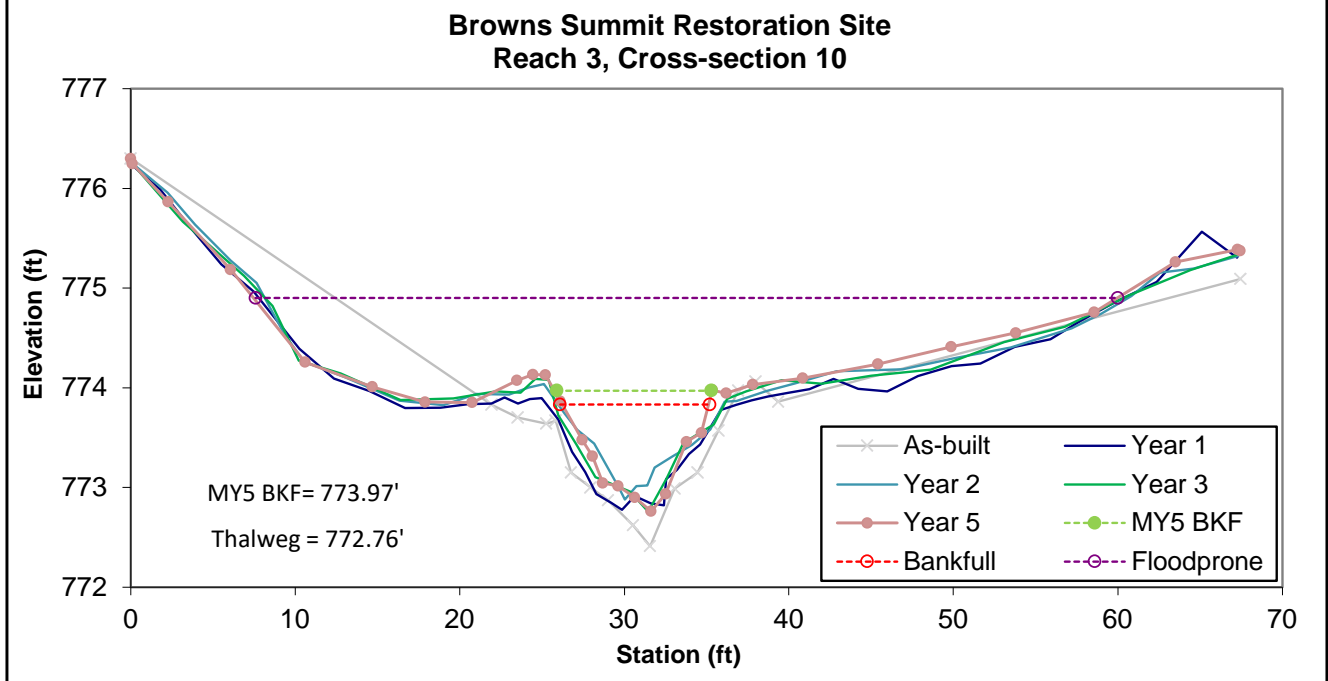
Permanent Cross-section 10
 (Year 5 Data - Collected September 2021)

Feature	Stream Type	BKF Area	BKF Width	BKF Depth	Max BKF Depth	W/D	BH Ratio	ER	BKF Elev	TOB Elev
Riffle	C	5.6	8.9	0.6	1.1	14.3	1	5.9	773.83	773.98

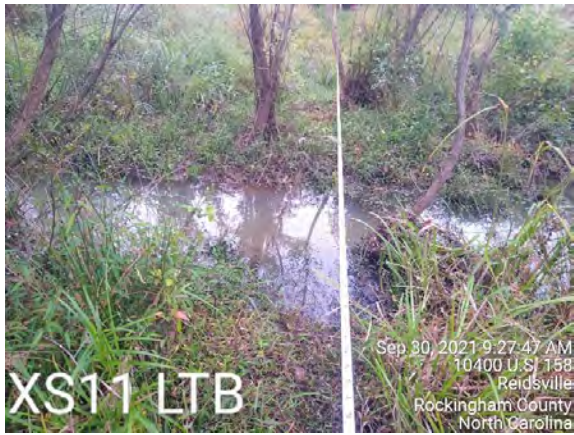
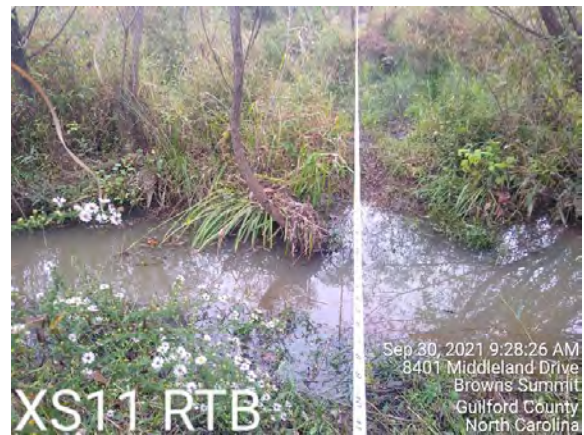
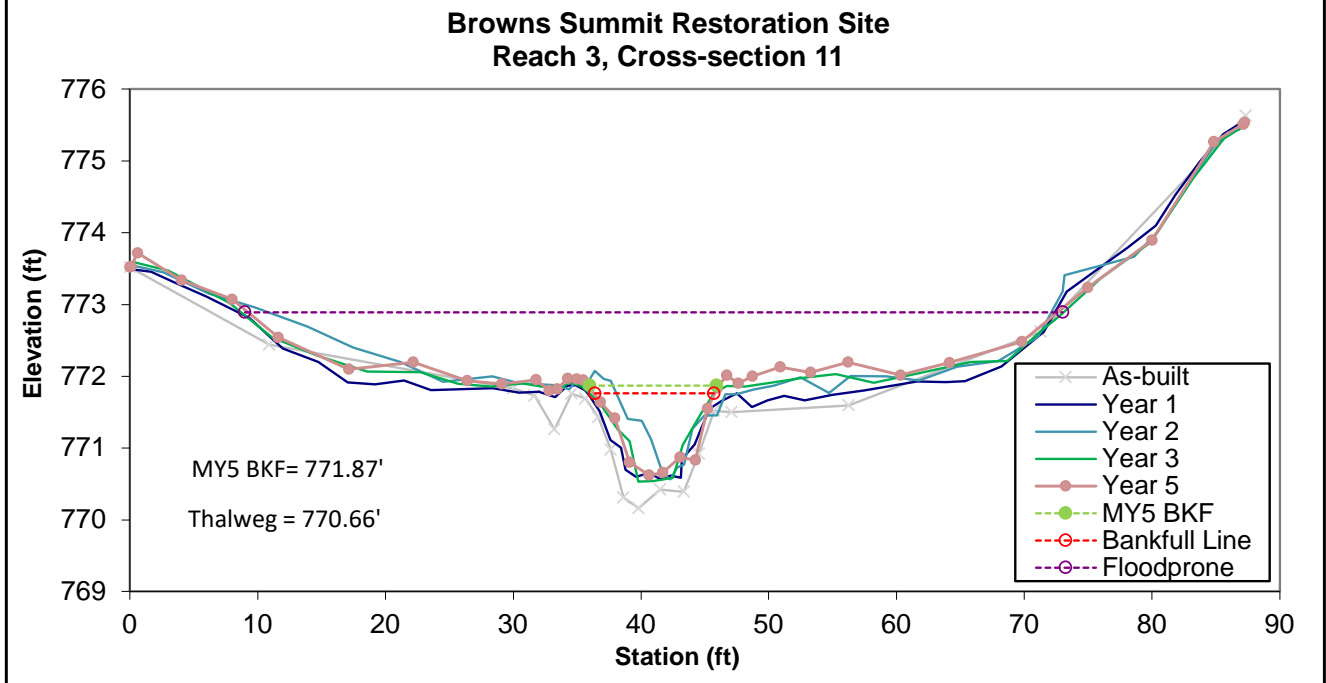
Permanent Cross-section 11
 (Year 5 Data - Collected September 2021)

Feature	Stream Type	BKF Area	BKF Width	BKF Depth	Max BKF Depth	W/D	BH Ratio	ER	BKF Elev	TOB Elev
Riffle	C	6.9	9.5	0.7	1.1	13.1	1.1	6.9	771.76	771.95

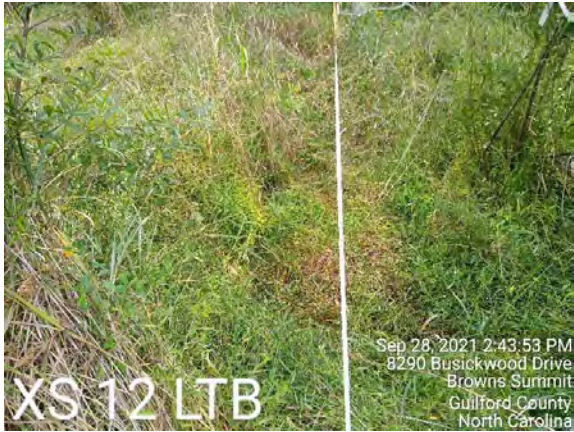
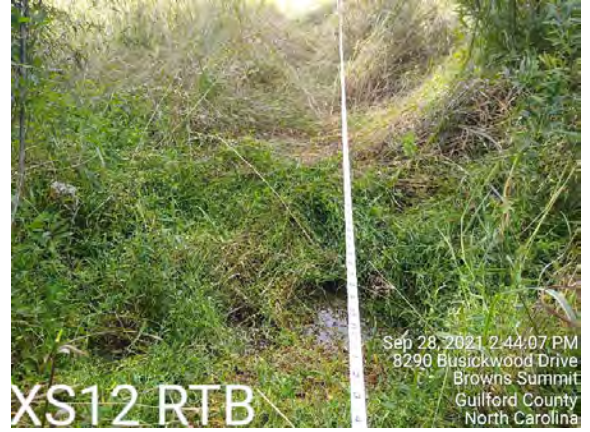
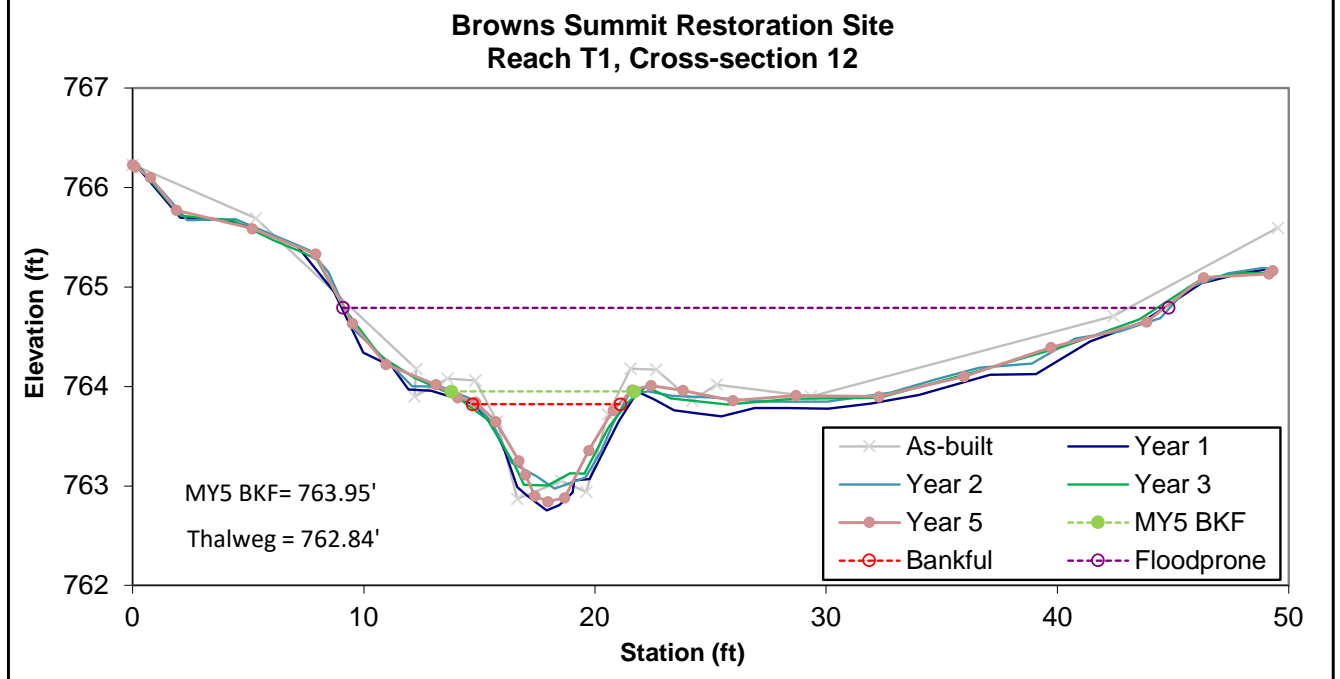
Permanent Cross-section 12
 (Year 5 Data - Collected October 2021)

Feature	Stream Type	BKF Area	BKF Width	BKF Depth	Max BKF Depth	W/D	BH Ratio	ER	BKF Elev	TOB Elev
Riffle	C	3.2	6.1	0.5	1	11.5	0.9	5.5	763.82	763.84

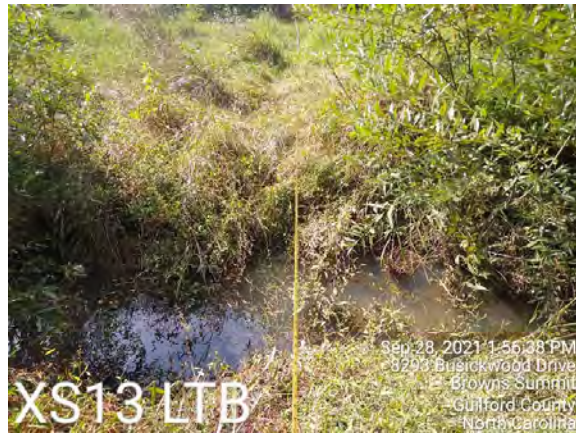
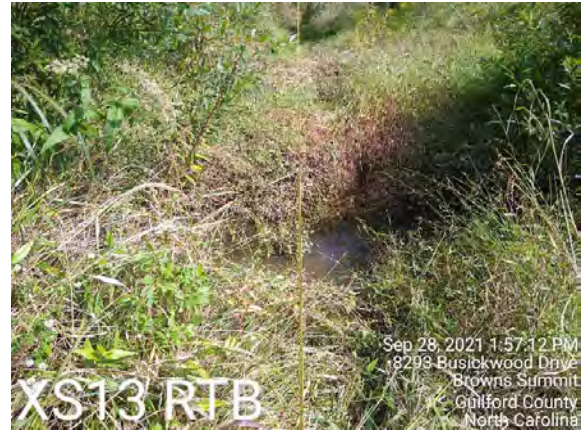
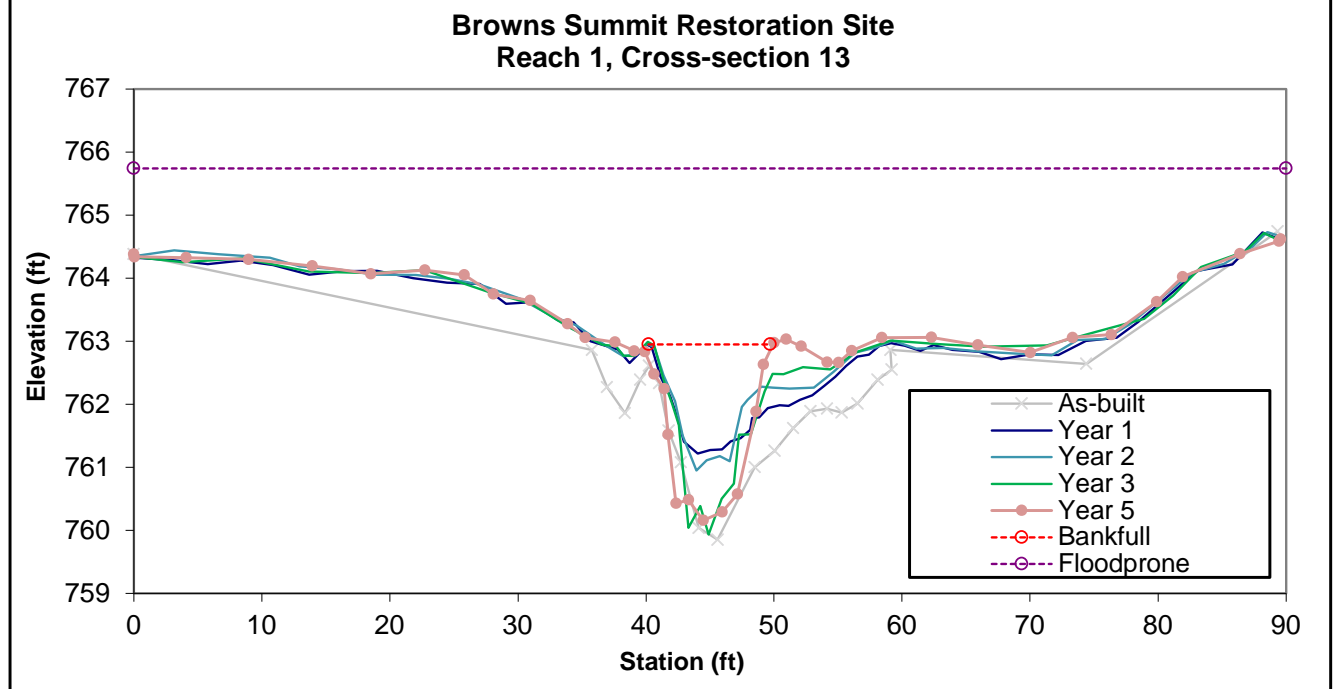
Permanent Cross-section 13
(Year 5 Data - Collected September 2021)

Feature	Stream Type	BKF Area	BKF Width	BKF Depth	Max BKF Depth	W/D	BH Ratio	ER	BKF Elev	TOB Elev
Pool	--	17.9	12	1.5	2.8	8	--	--	762.95	762.83

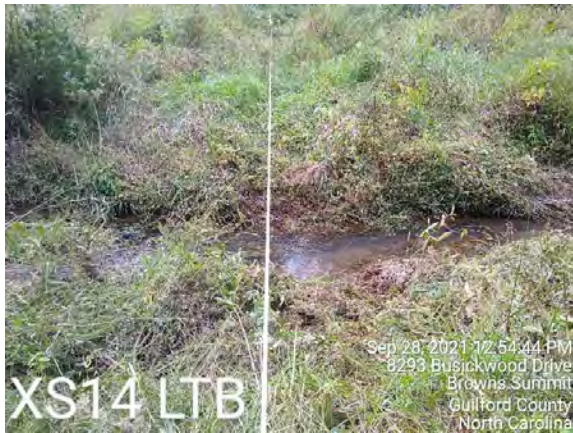
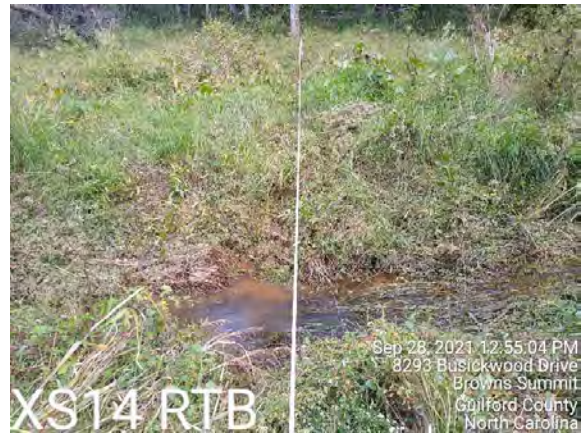
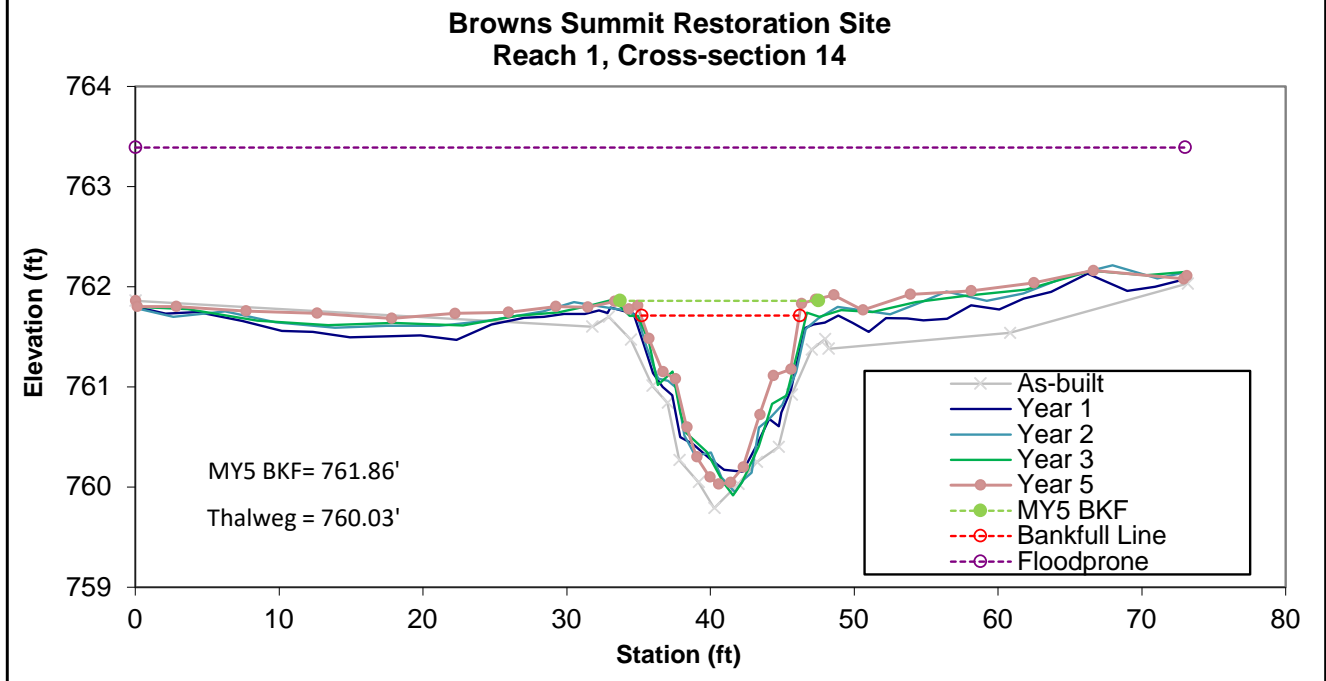
Permanent Cross-section 14
 (Year 5 Data - Collected September 2021)

Feature	Stream Type	BKF Area	BKF Width	BKF Depth	Max BKF Depth	W/D	BH Ratio	ER	BKF Elev	TOB Elev
Riffle	C	10.7	11	1.0	1.7	11.3	1.0	6.6	761.71	761.81

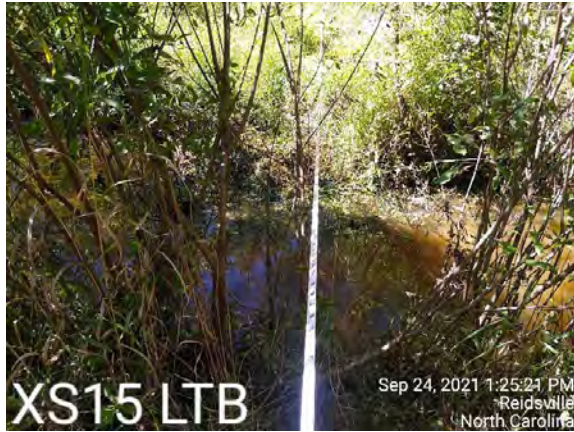
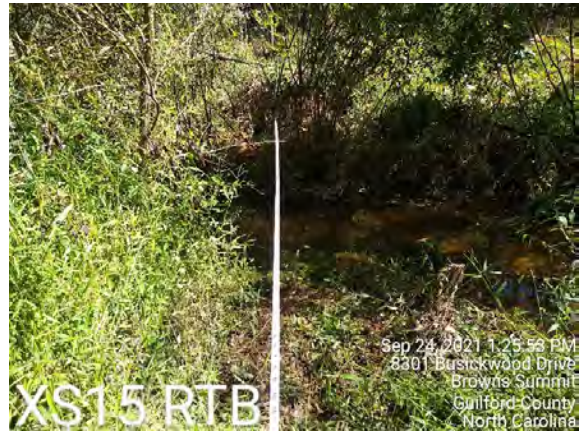
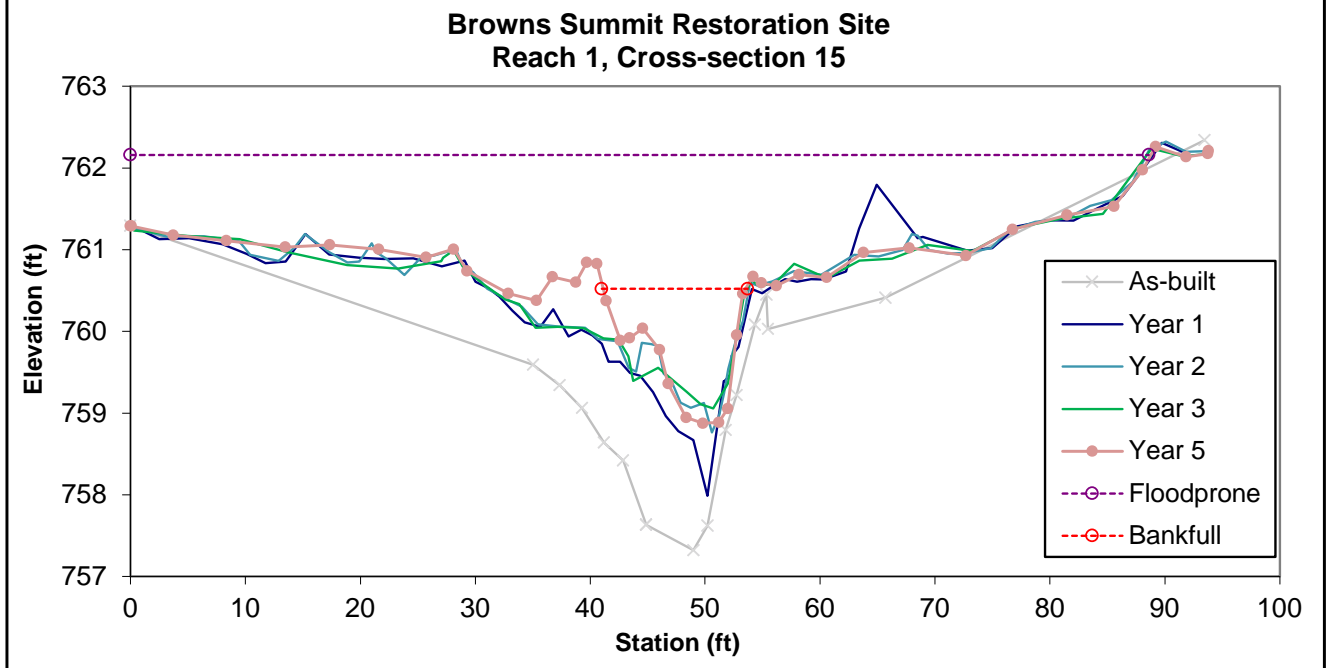
Permanent Cross-section 15
(Year 5 Data - Collected September 2021)

Feature	Stream Type	BKF Area	BKF Width	BKF Depth	Max BKF Depth	W/D	BH Ratio	ER	BKF Elev	TOB Elev
Pool	--	12.1	12.4	1	1.6	12.6	--	--	760.52	760.67

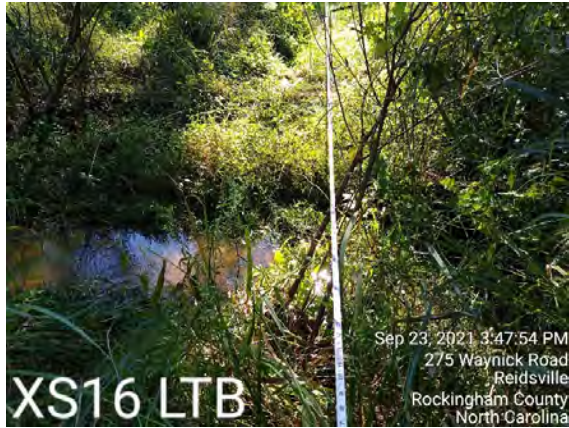
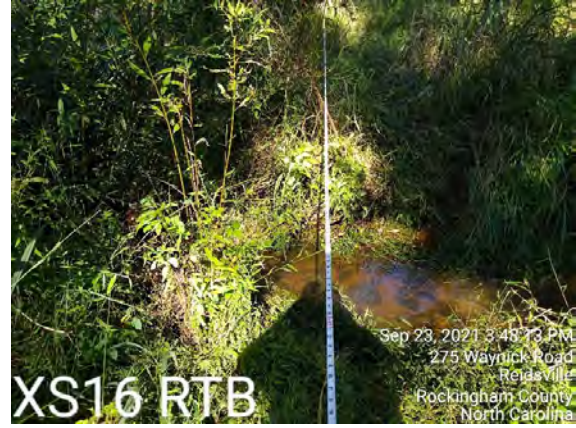
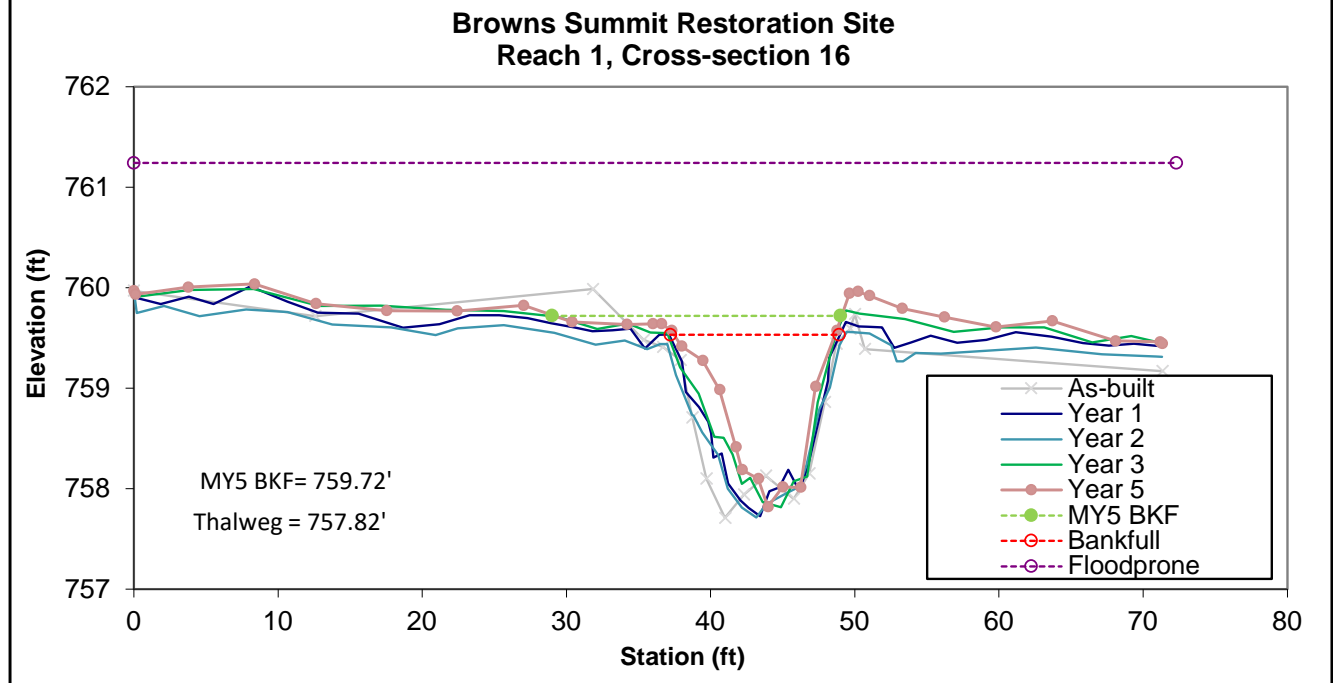
Permanent Cross-section 16
(Year 5 Data - Collected September 2021)

Feature	Stream Type	BKF Area	BKF Width	BKF Depth	Max BKF Depth	W/D	BH Ratio	ER	BKF Elev	TOB Elev
Riffle	C	9.8	11.1	0.9	1.7	12.7	0.9	6.4	759.53	759.57

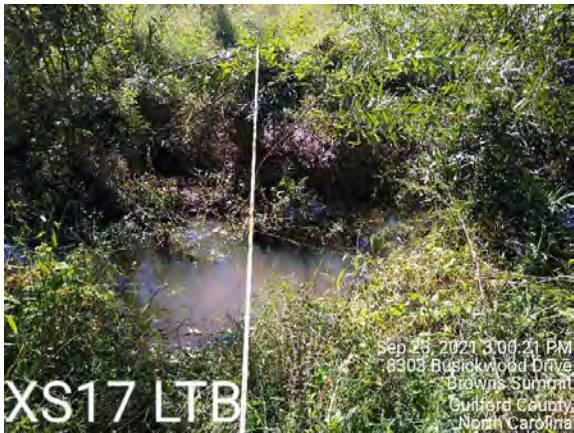
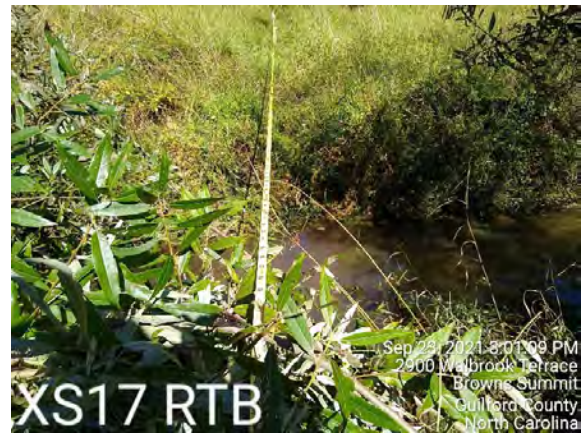
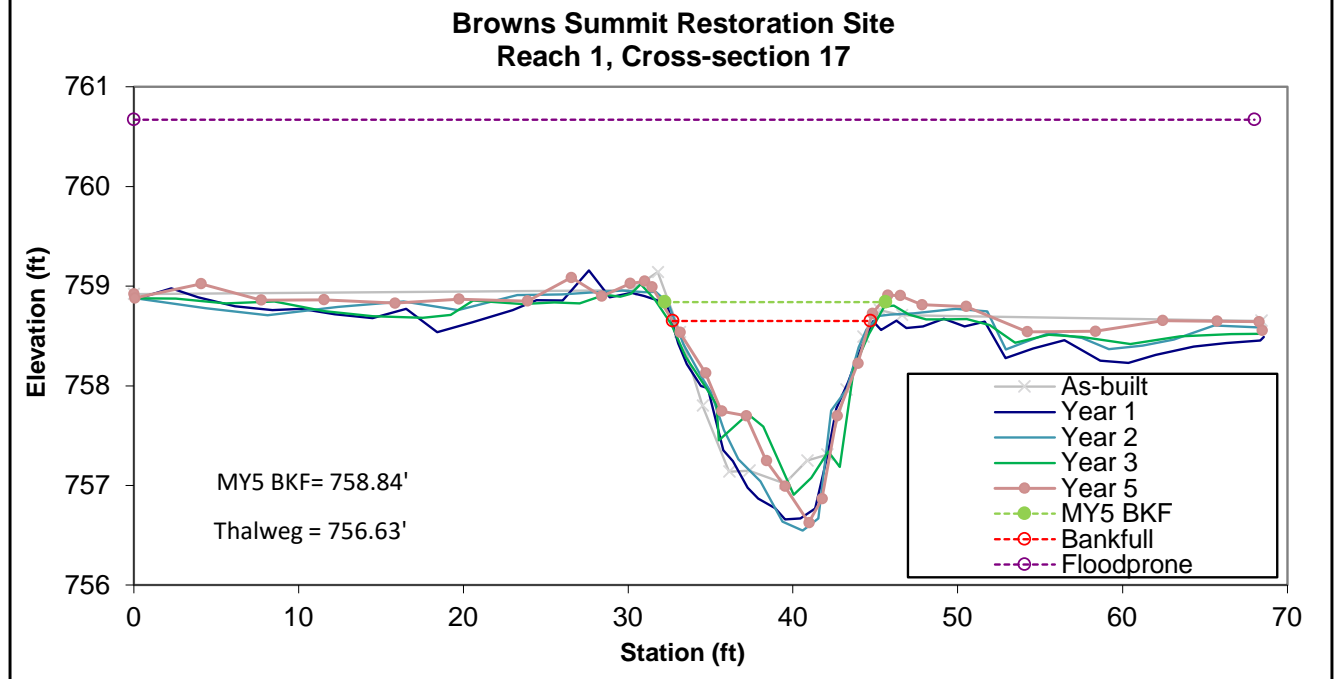
Permanent Cross-section 17
 (Year 5 Data - Collected September 2021)

Feature	Stream Type	BKF Area	BKF Width	BKF Depth	Max BKF Depth	W/D	BH Ratio	ER	BKF Elev	TOB Elev
Riffle	C	12.2	12	1.0	2	11.7	1.0	5.7	758.65	758.91

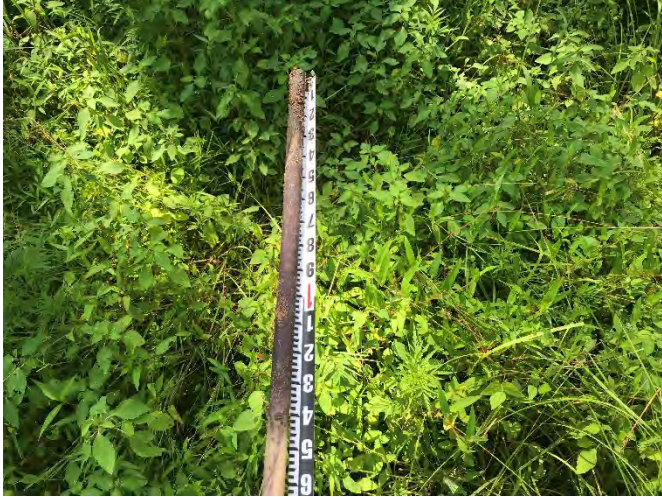
Manual Crest Gauge – Reading 7/1/2021 (1.43')

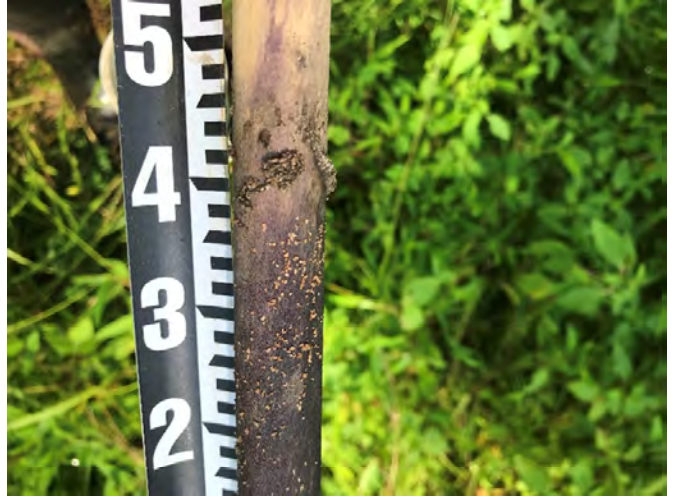
Manual Crest Gauge – Reading 7/1/2021 (1.43')
