# MONITORING YEAR 5 ANNUAL REPORT

## CANDY CREEK MITIGATION SITE

Guilford County, NC

NCDMS Project Number 96315

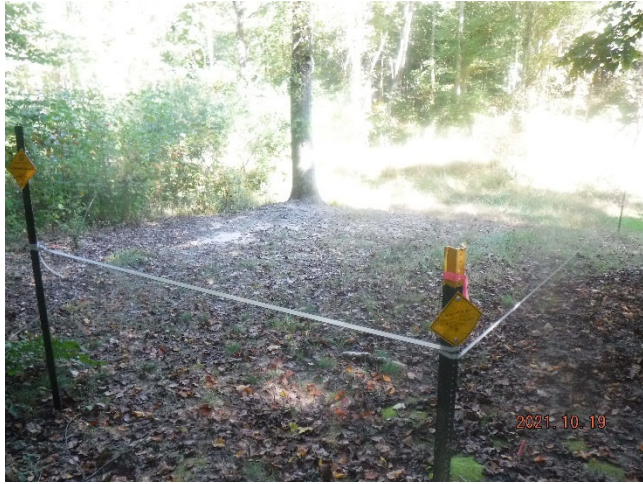
Candy Creek Reach 1 - Easement encroachment at upstream extent, LB (Sta. 100+00-100+60) (10/19/2021)

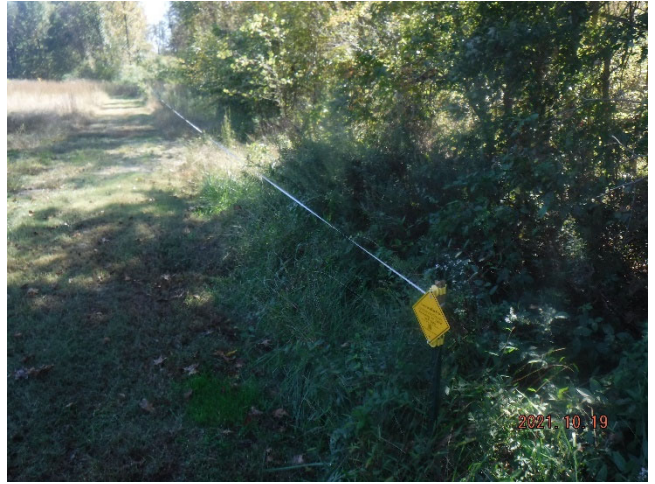
Candy Creek Reach 1 - Easement encroachment, RB (Sta. 111+00-113+00) (10/19/2021)

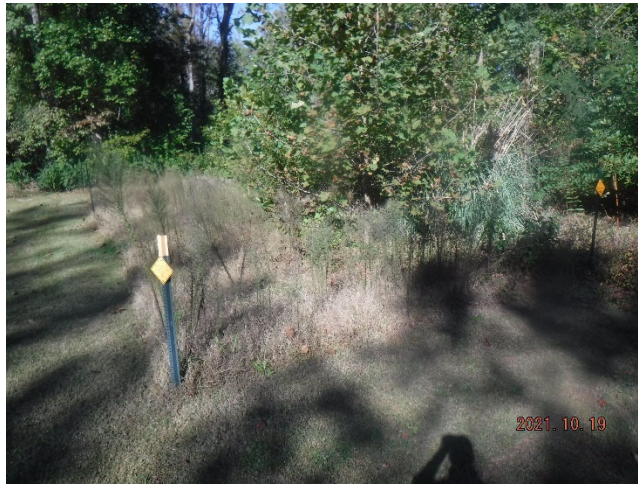
Candy Creek Reach 3 - Easement encroachment at Hopkins Road, LB (Sta. 149+00-150+00) (10/19/2021)

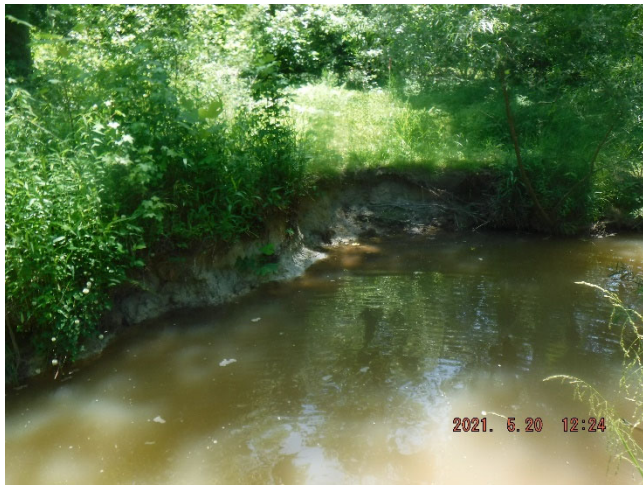
Candy Creek Reach 3 - Bank erosion, RB (Sta. 151+70-152+00) (05/20/2021)

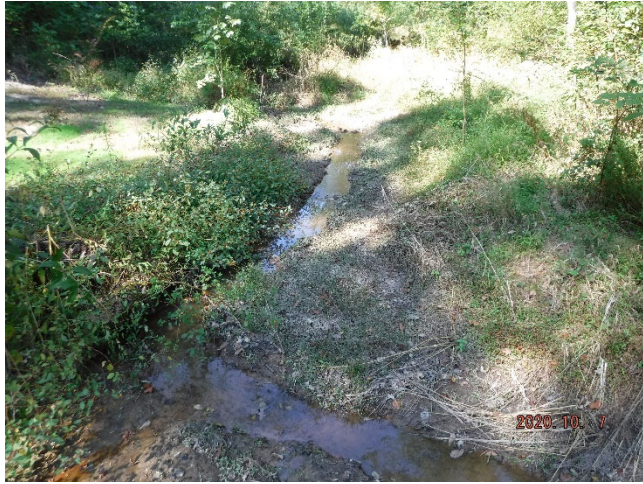
Candy Creek Reach 1 - stream aggradation (Sta. 100+20-101+50) (10/07/2020)

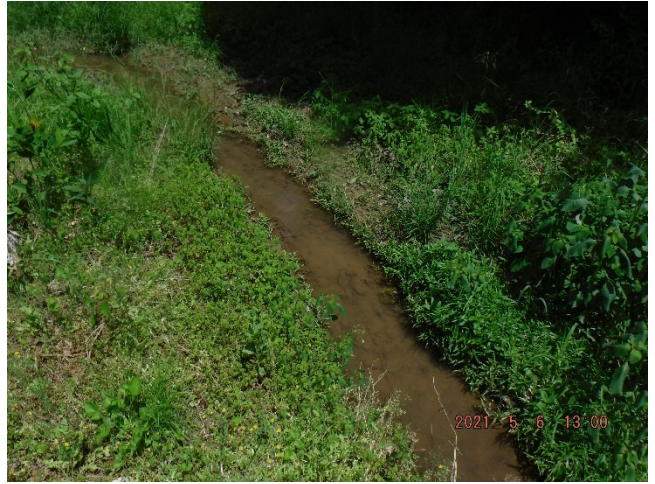
Candy Creek Reach 1 - Improved stream aggradation (Sta. 100+20-101+50) (5/6/2021)

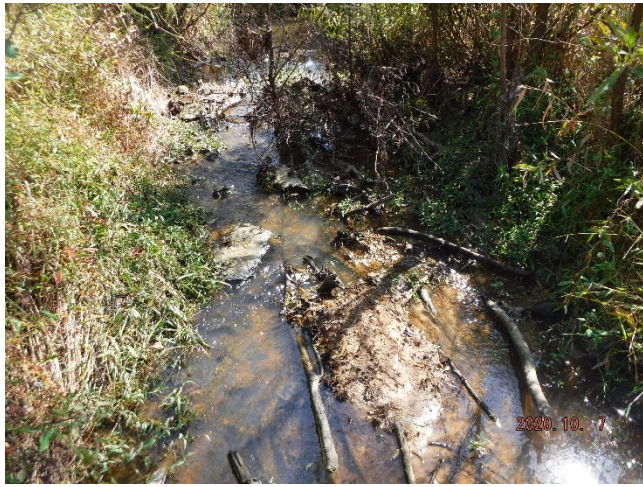
Candy Creek R2 - stream aggradation (Sta. 140+50-140+65) (10/07/2020)

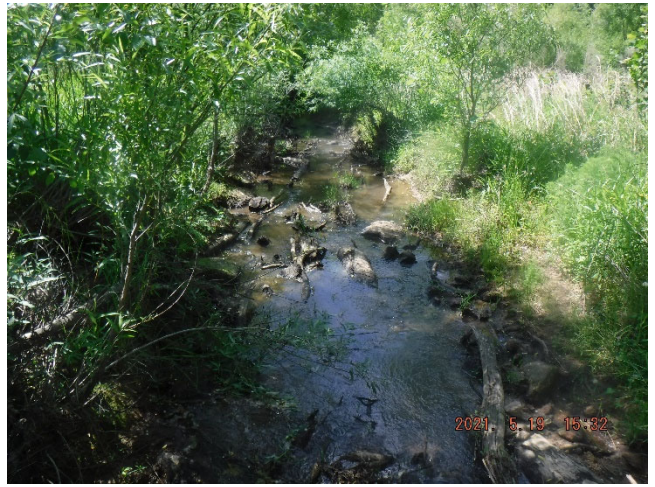
Candy Creek R2 - Improved stream aggradation (Sta. 140+50-140+65) (05/13/2021)

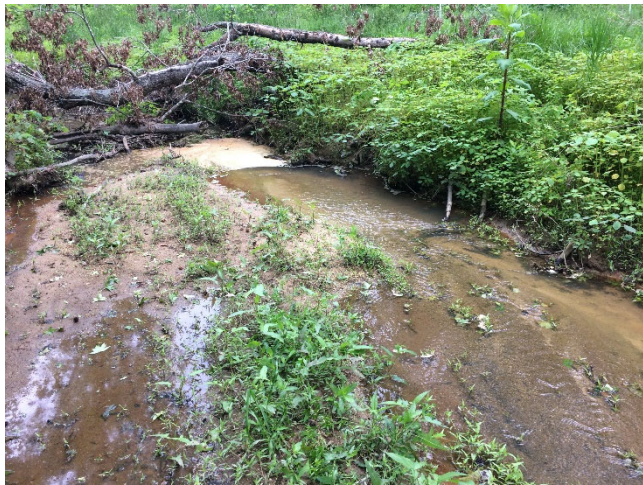
Candy Creek R3 - stream aggradation (Sta. 156+10-156+40) (05/13/2020)

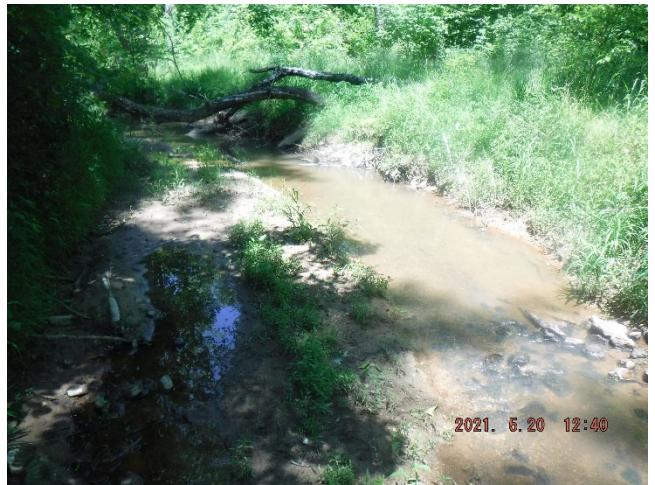
Candy Creek R3 - Improved stream aggradation; point bar development (Sta. 156+10-156+40) (05/20/2021)

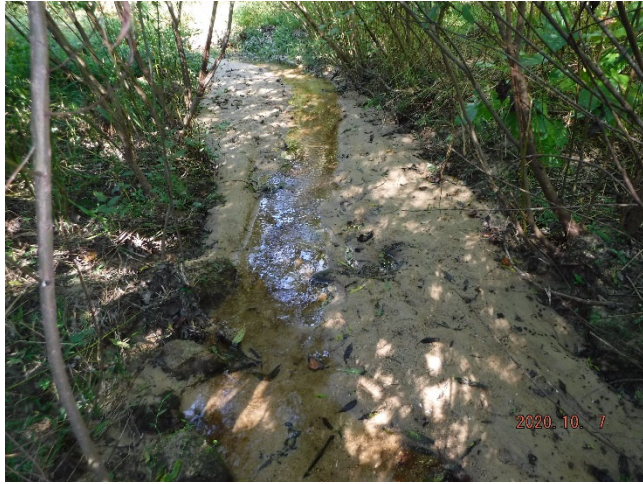
UT5 - stream aggradation (Sta. 603+70-604+70)  
(10/19/2020)

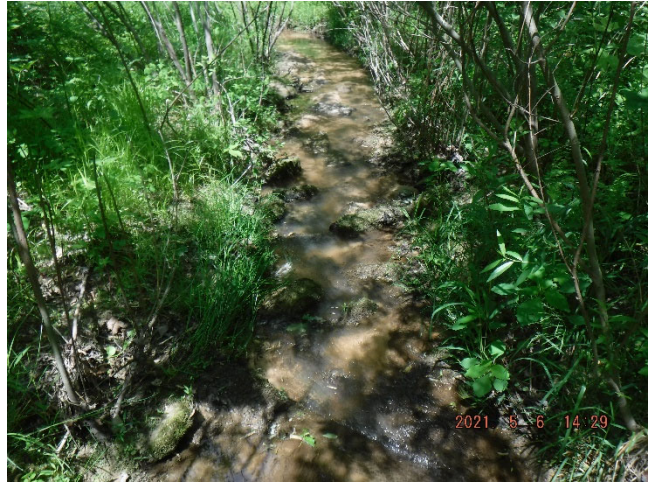
UT5 - Improved stream aggradation (Sta. 603+70-604+70)  
(05/06/2021)

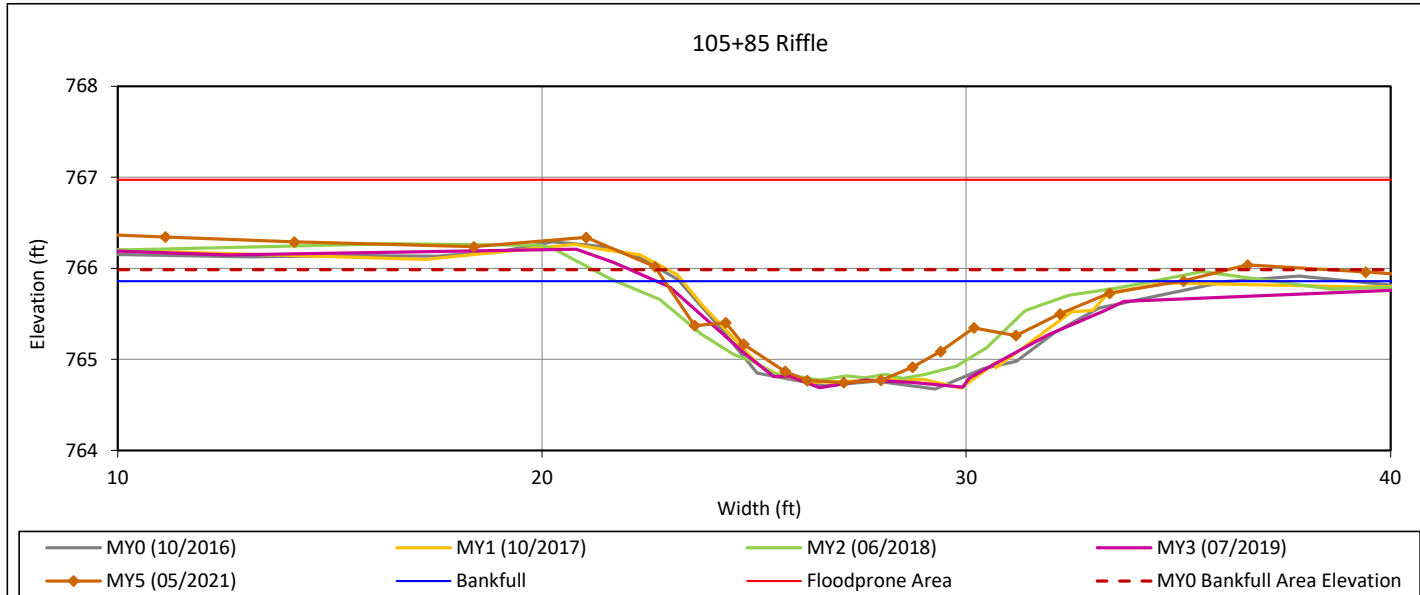
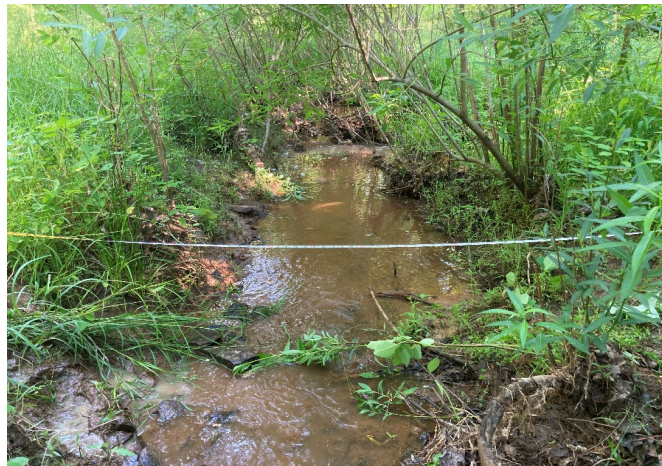
#### Cross-Section 1 - Candy Creek Reach 1

7.3	x-section area (ft.sq.)
12.2	width (ft)
0.6	mean depth (ft)
1.1	max depth (ft)
12.6	wetted perimeter (ft)
0.6	hydraulic radius (ft)
20.4	width-depth ratio
54.6	W flood prone area (ft)
4.5	entrenchment ratio
0.9	low bank height ratio

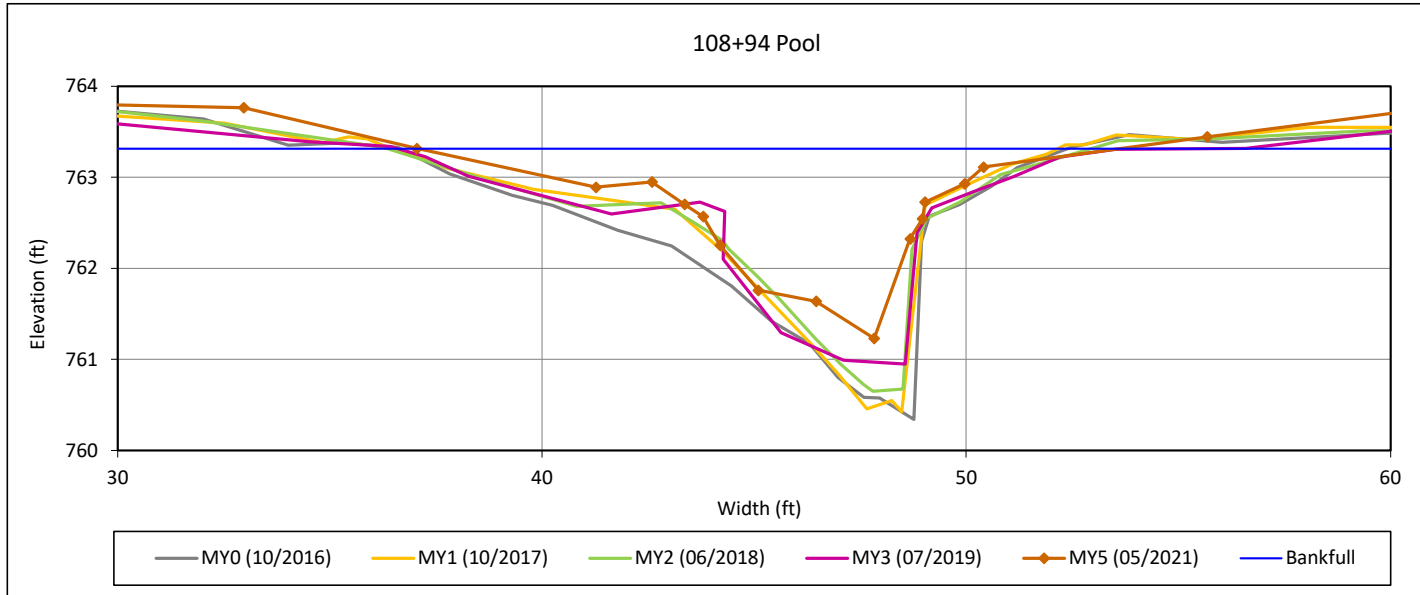
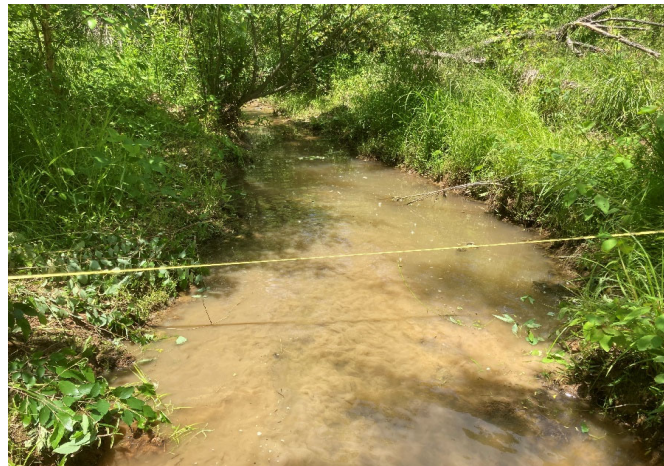
#### Cross-Section 2 - Candy Creek Reach 1

10.9	x-section area (ft.sq.)
16.6	width (ft)
0.7	mean depth (ft)
2.1	max depth (ft)
17.8	wetted perimeter (ft)
0.6	hydraulic radius (ft)
25.2	width-depth ratio

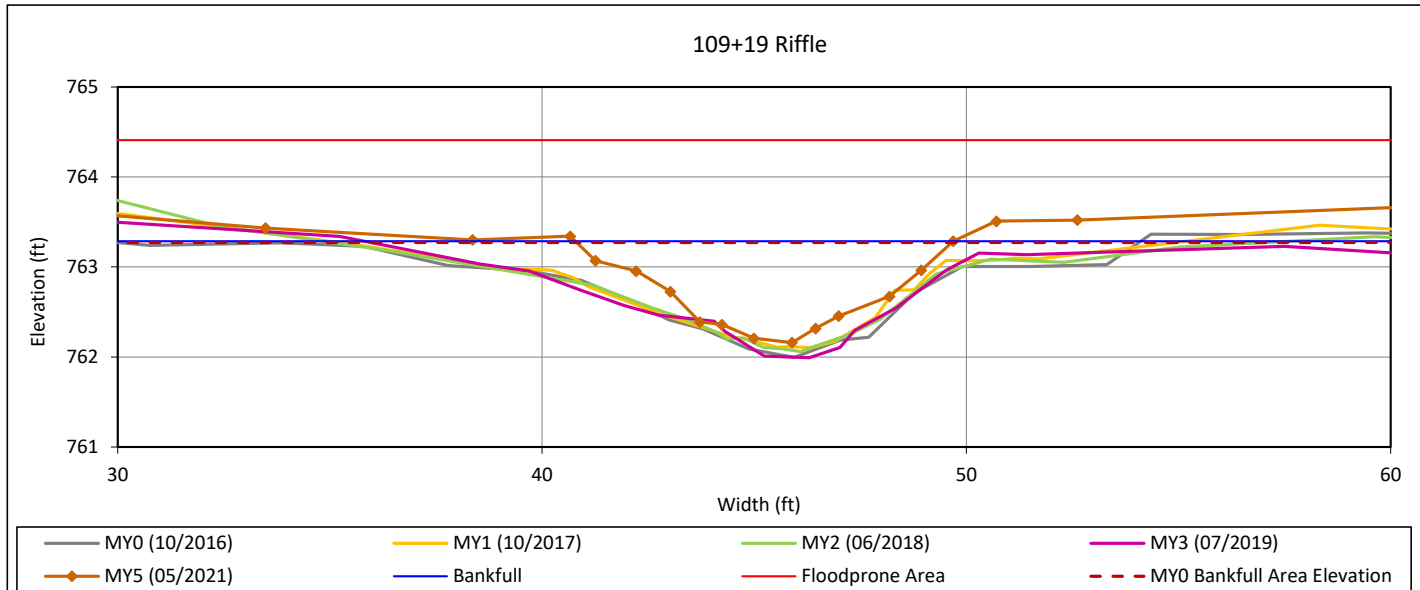
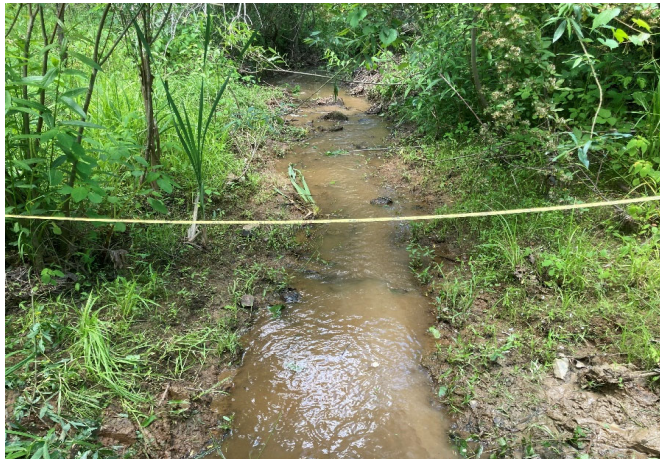
#### Cross-Section 3 - Candy Creek Reach 1

5.8	x-section area (ft.sq.)
8.9	width (ft)
0.7	mean depth (ft)
1.1	max depth (ft)
9.3	wetted perimeter (ft)
0.6	hydraulic radius (ft)
13.7	width-depth ratio
101.7	W flood prone area (ft)
11.4	entrenchment ratio
1.0	low bank height ratio

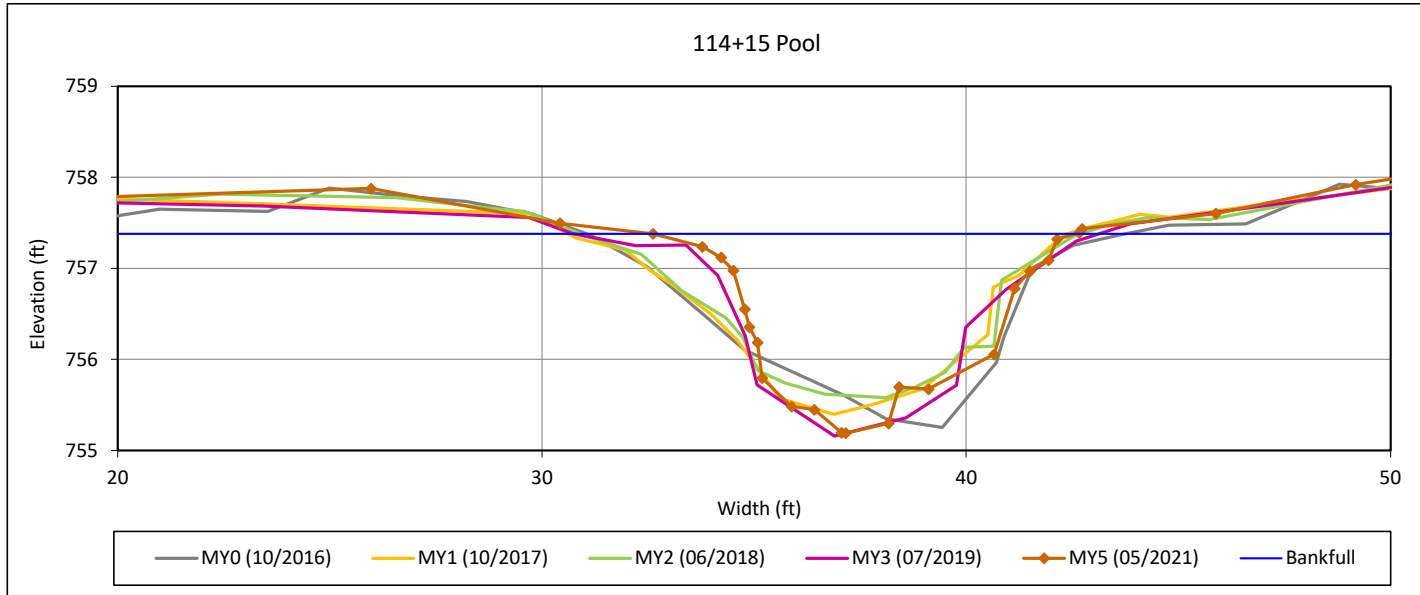
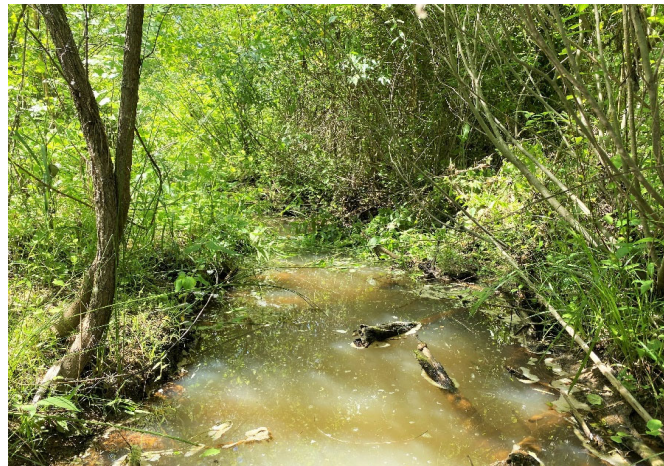
#### Cross Section 4 - Candy Creek Reach 1

11.7	x-section area (ft.sq.)
10.0	width (ft)
1.2	mean depth (ft)
2.2	max depth (ft)
11.7	wetted perimeter (ft)
1.0	hydraulic radius (ft)
8.5	width-depth ratio

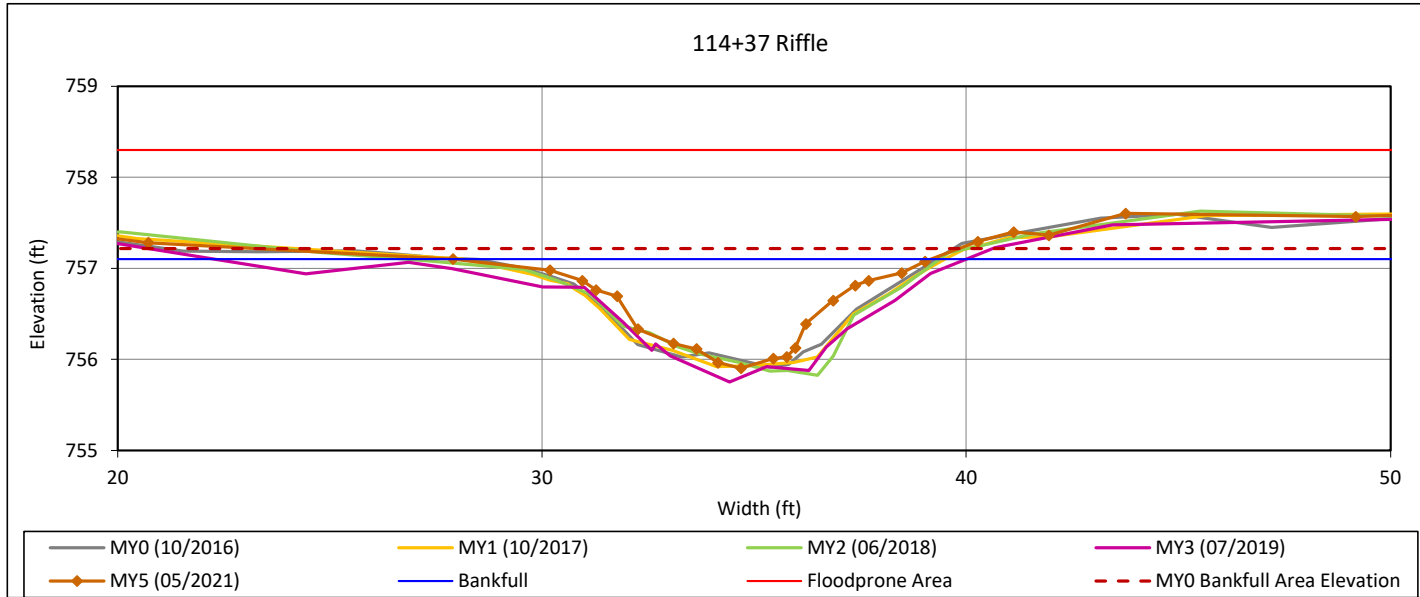
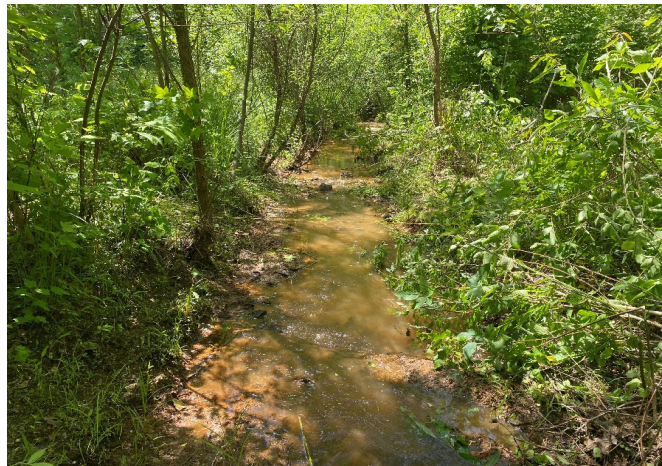
#### Cross-Section 5 - Candy Creek Reach 1

5.7	x-section area (ft.sq.)
11.3	width (ft)
0.5	mean depth (ft)
1.2	max depth (ft)
11.7	wetted perimeter (ft)
0.5	hydraulic radius (ft)
22.2	width-depth ratio
74.8	W flood prone area (ft)
6.6	entrenchment ratio
0.9	low bank height ratio

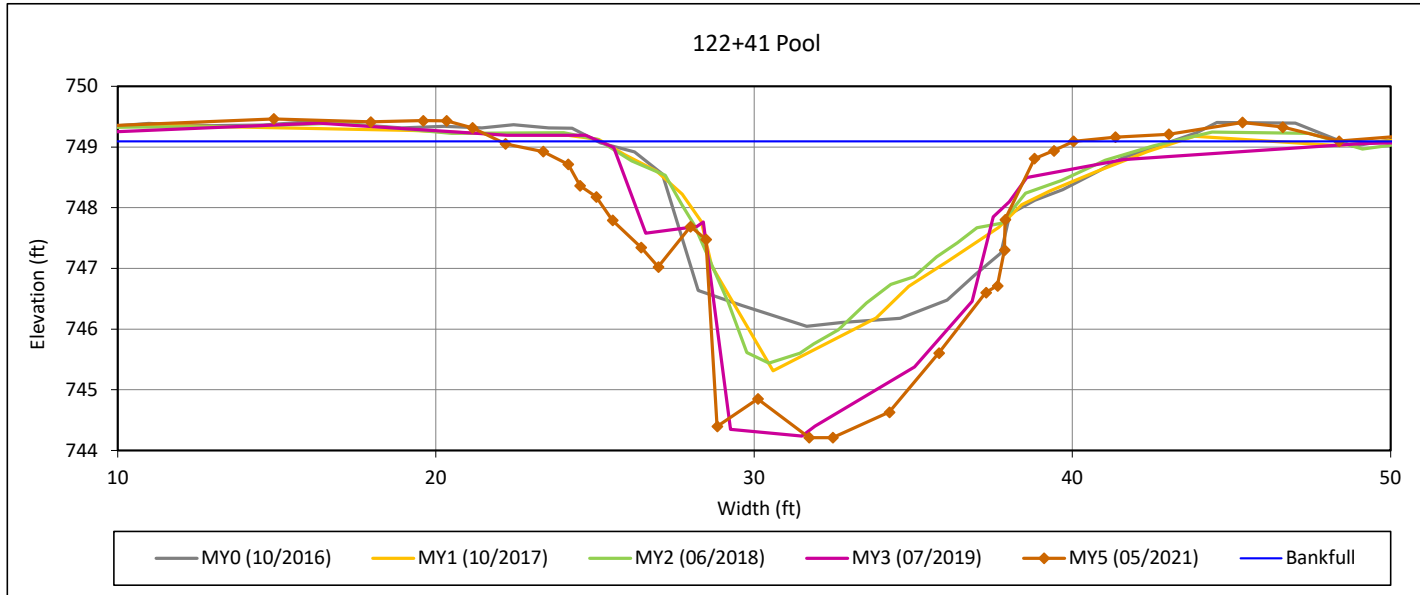
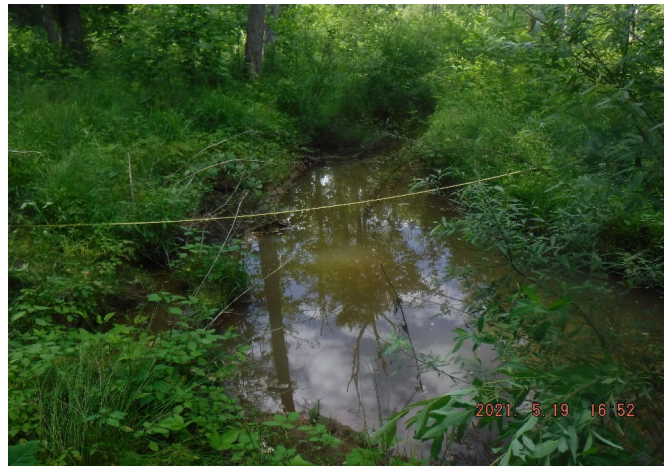
#### Cross-Section 6 - Candy Creek Reach 1

45.4	x-section area (ft.sq.)
18.0	width (ft)
2.5	mean depth (ft)
4.9	max depth (ft)
23.8	wetted perimeter (ft)
1.9	hydraulic radius (ft)
7.1	width-depth ratio

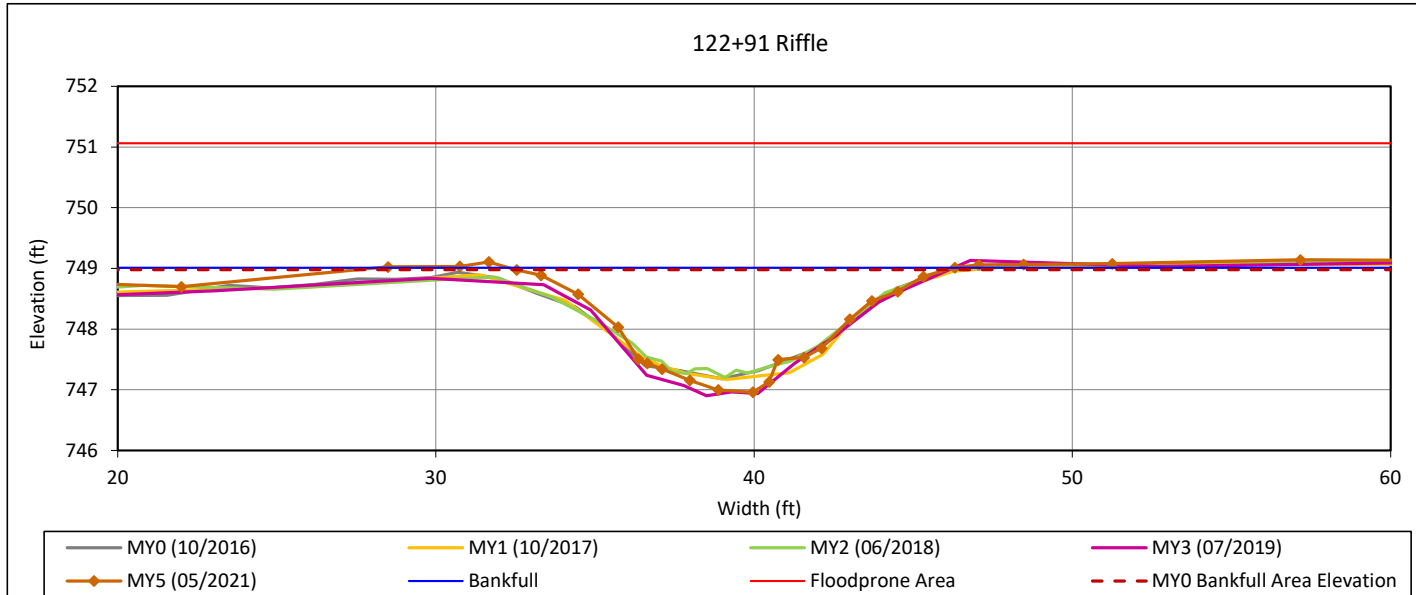
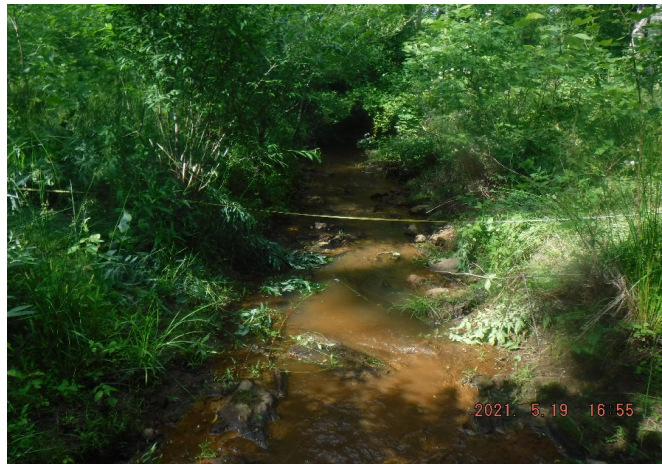
#### Cross-Section 7 - Candy Creek Reach 1

14.4	x-section area (ft.sq.)
14.0	width (ft)
1.0	mean depth (ft)
2.1	max depth (ft)
14.9	wetted perimeter (ft)
1.0	hydraulic radius (ft)
13.7	width-depth ratio
82.7	W flood prone area (ft)
5.9	entrenchment ratio
1.0	low bank height ratio

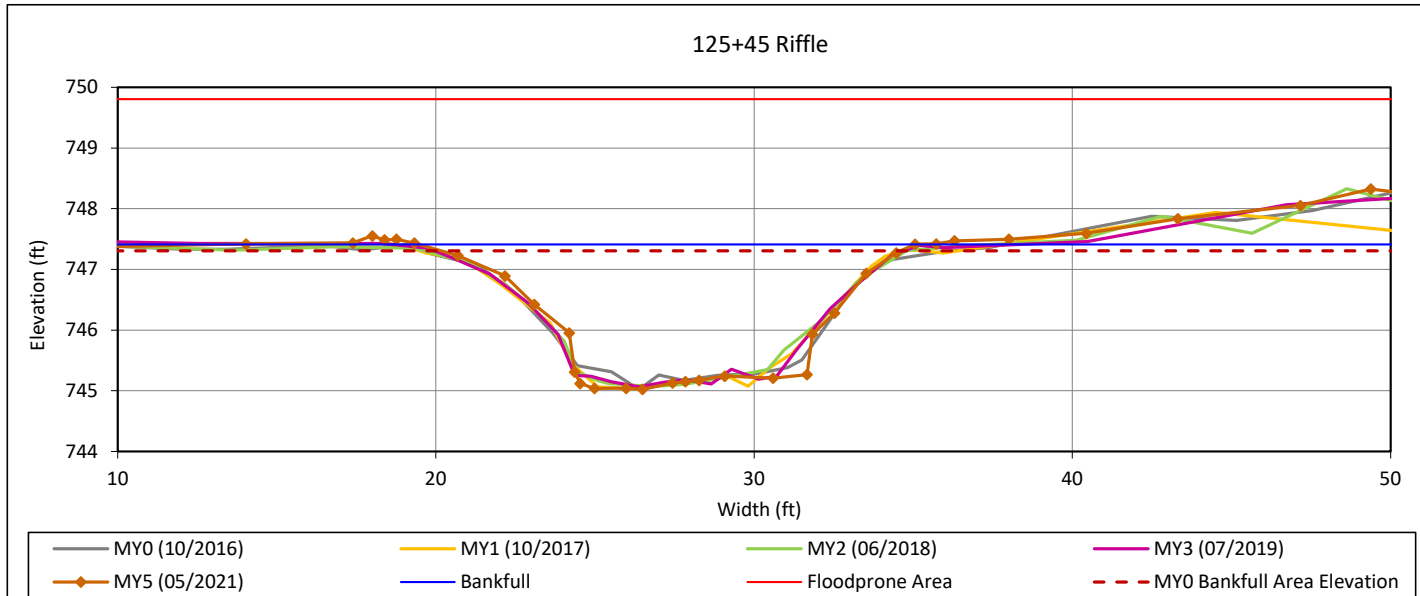
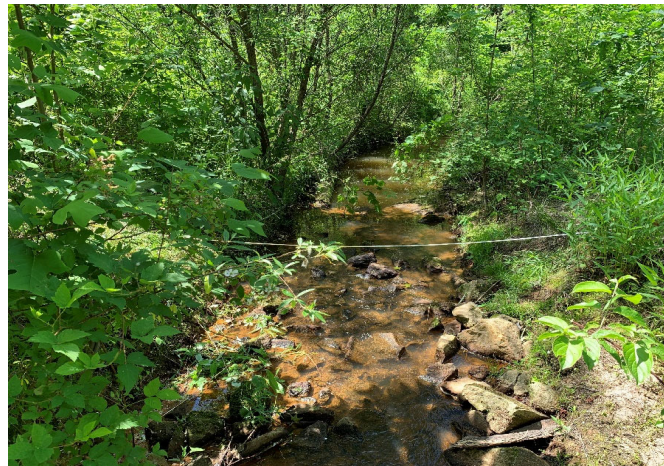
#### Cross-Section 8 - Candy Creek Reach 1

21.9	x-section area (ft.sq.)
15.6	width (ft)
1.4	mean depth (ft)
2.4	max depth (ft)
17.3	wetted perimeter (ft)
1.3	hydraulic radius (ft)
11.1	width-depth ratio
64.0	W flood prone area (ft)
4.1	entrenchment ratio
1.0	low bank height ratio

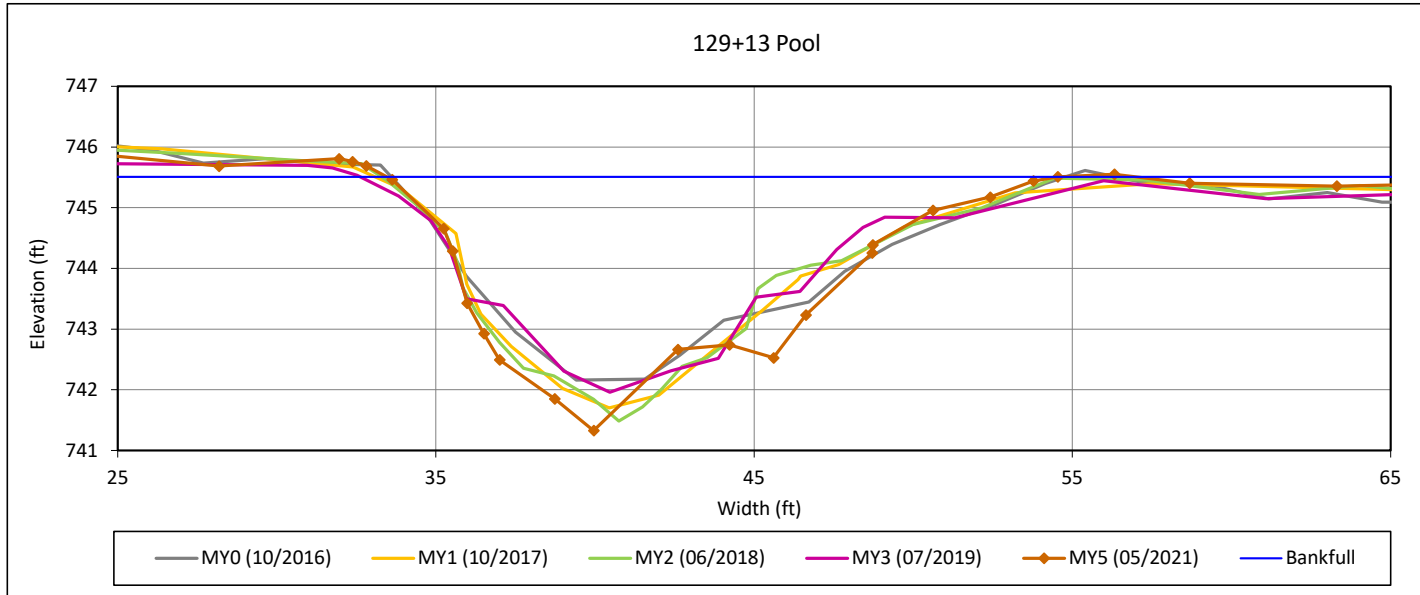
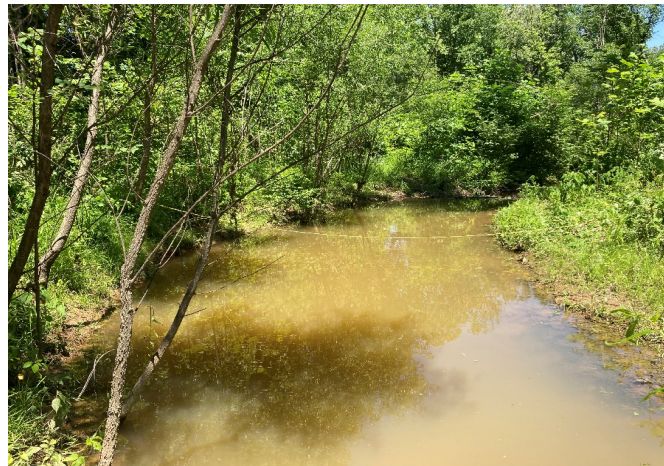
#### Cross-Section 9 - Candy Creek Reach 2

41.8	x-section area (ft.sq.)
21.1	width (ft)
2.0	mean depth (ft)
4.2	max depth (ft)
23.6	wetted perimeter (ft)
1.8	hydraulic radius (ft)
10.6	width-depth ratio

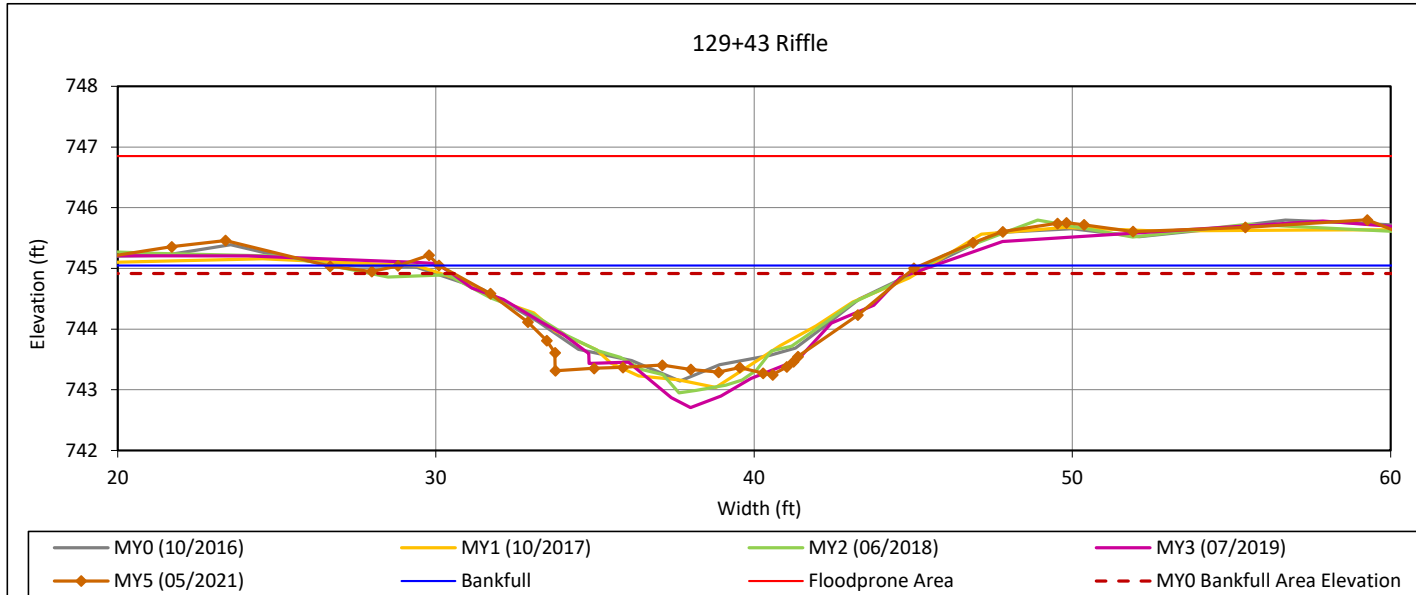
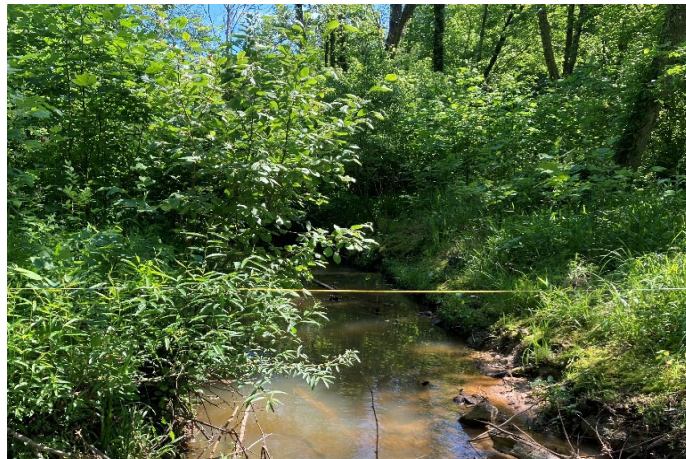
#### Cross-Section 10 - Candy Creek Reach 2

18.2	x-section area (ft.sq.)
15.2	width (ft)
1.2	mean depth (ft)
1.8	max depth (ft)
16.1	wetted perimeter (ft)
1.1	hydraulic radius (ft)
12.6	width-depth ratio
93.3	W flood prone area (ft)
6.2	entrenchment ratio
1.1	low bank height ratio

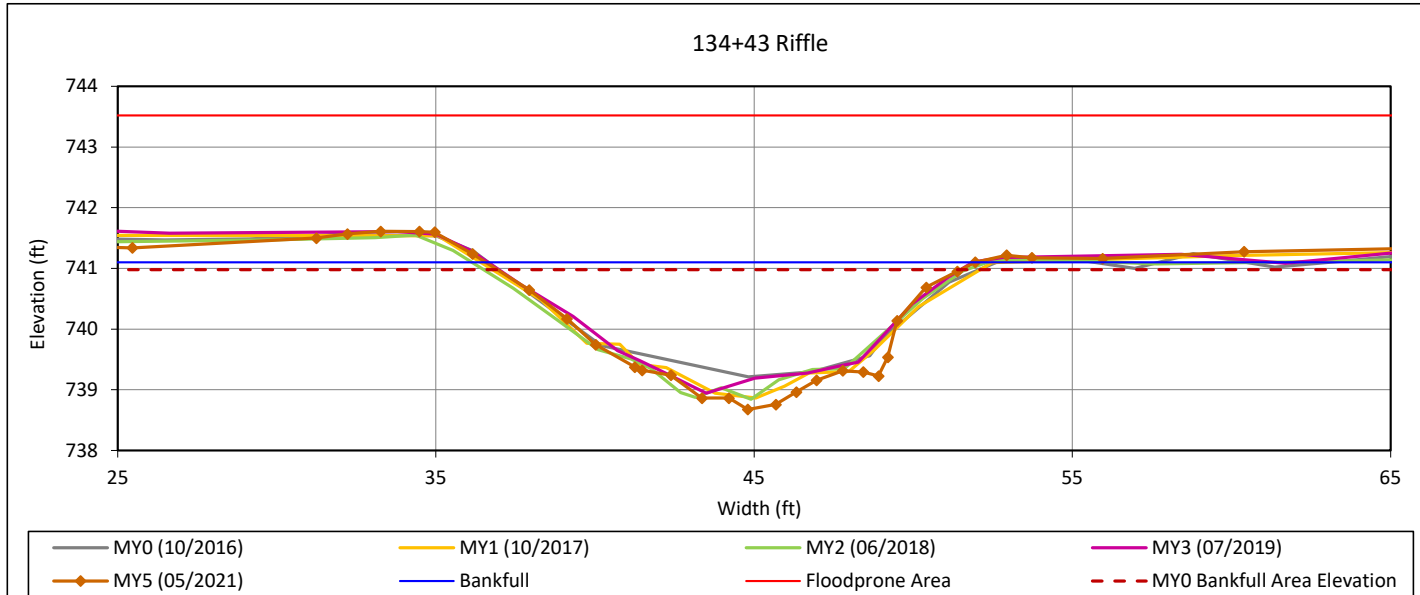
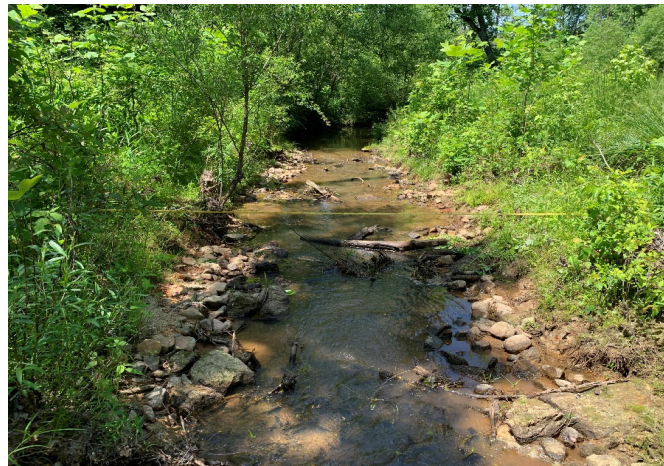
#### Cross-Section 11 - Candy Creek Reach 2

21.6	x-section area (ft.sq.)
15.4	width (ft)
1.4	mean depth (ft)
2.4	max depth (ft)
16.6	wetted perimeter (ft)
1.3	hydraulic radius (ft)
11.0	width-depth ratio
79.0	W flood prone area (ft)
5.1	entrenchment ratio
1.1	low bank height ratio

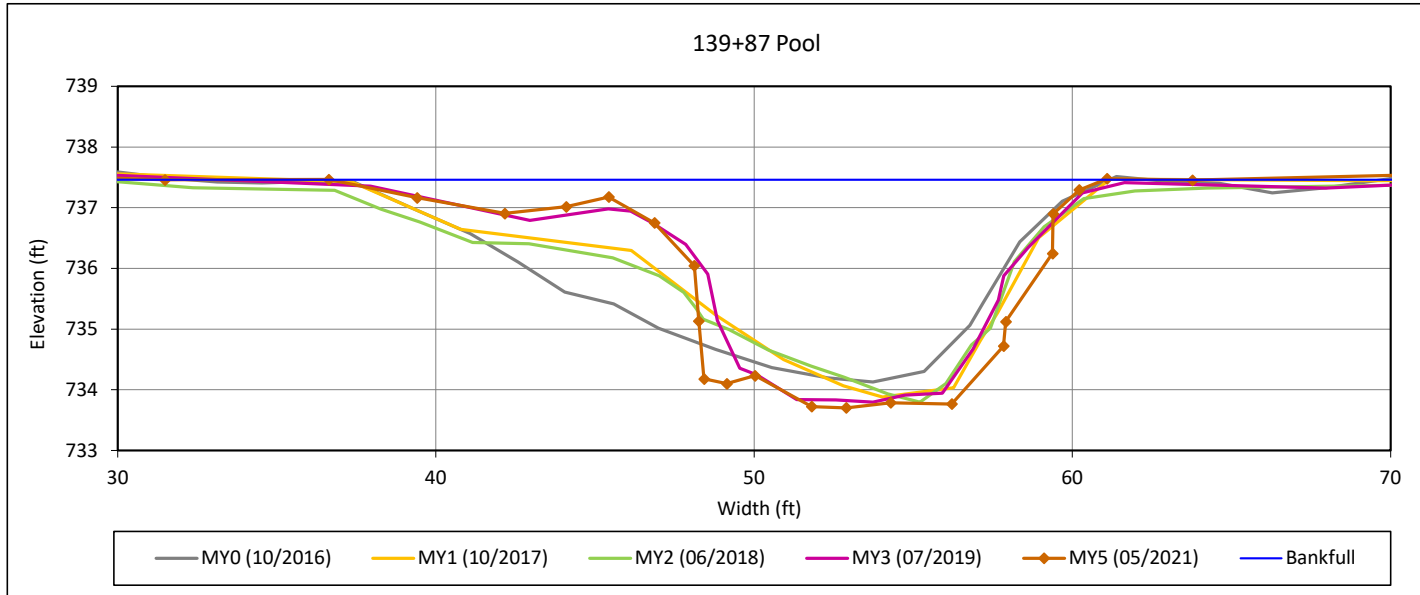
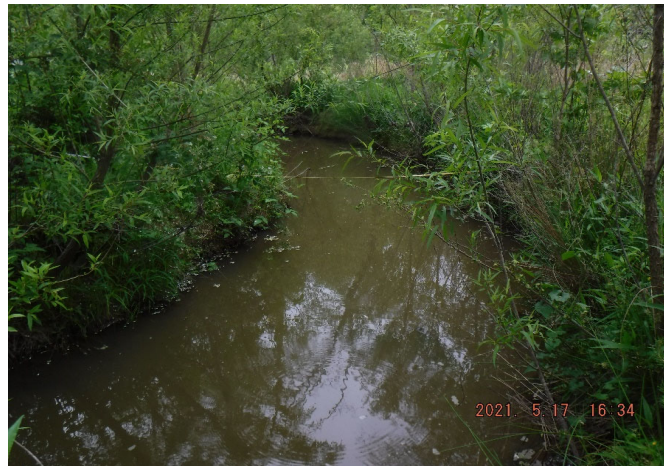
#### Cross-Section 12 - Candy Creek Reach 2

42.1	x-section area (ft.sq.)
24.4	width (ft)
1.7	mean depth (ft)
3.8	max depth (ft)
28.1	wetted perimeter (ft)
1.5	hydraulic radius (ft)
14.1	width-depth ratio

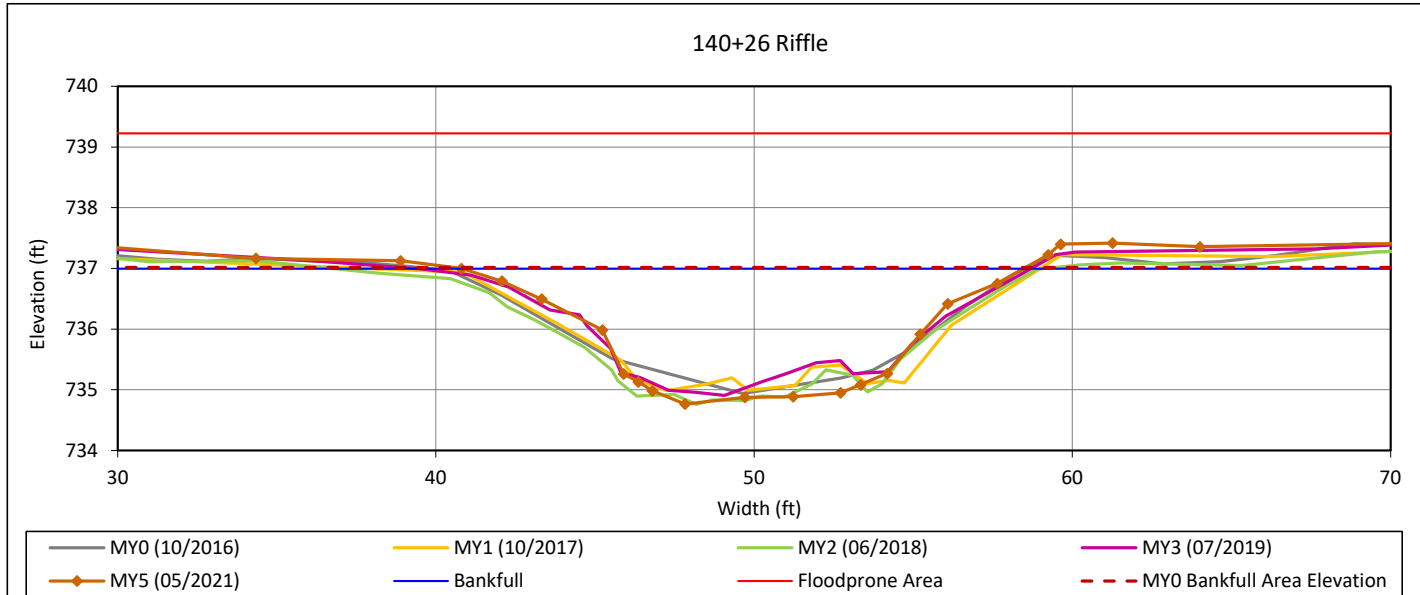
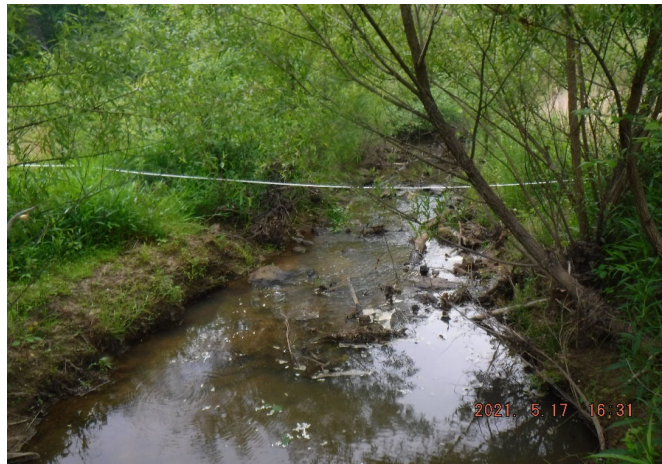
#### Cross-Section 13 - Candy Creek Reach 2

22.9	x-section area (ft.sq.)
17.7	width (ft)
1.3	mean depth (ft)
2.2	max depth (ft)
18.6	wetted perimeter (ft)
1.2	hydraulic radius (ft)
13.7	width-depth ratio
95.8	W flood prone area (ft)
5.4	entrenchment ratio
1.0	low bank height ratio

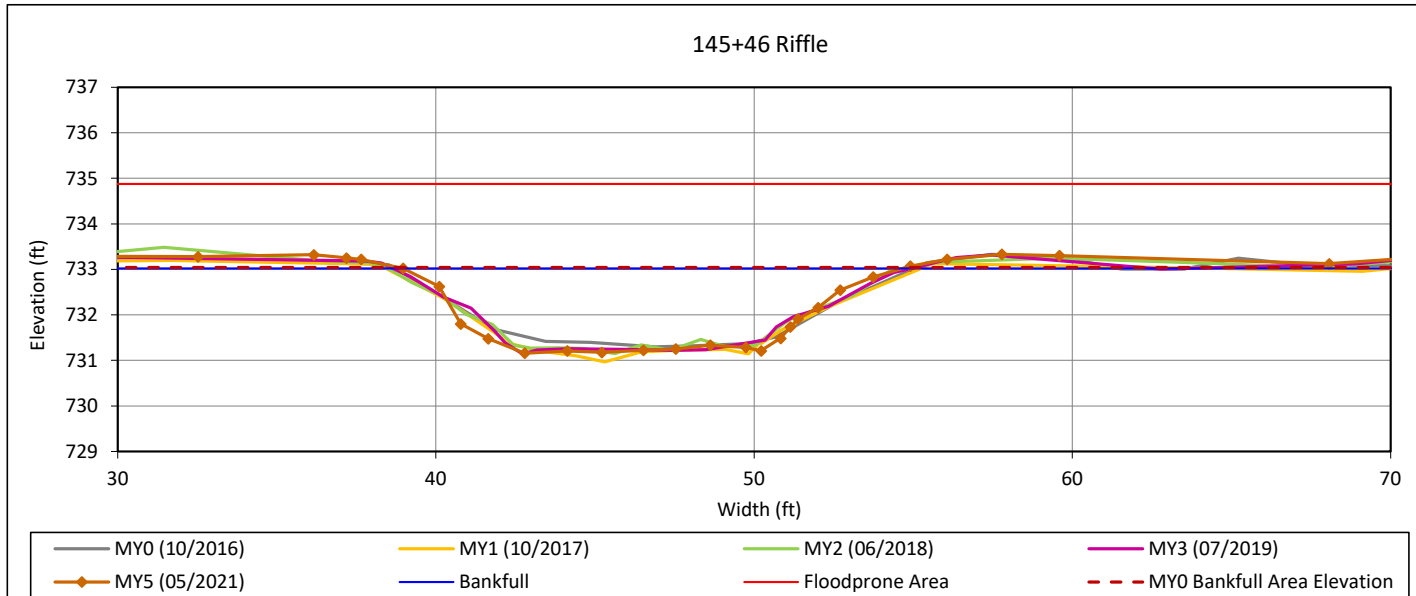
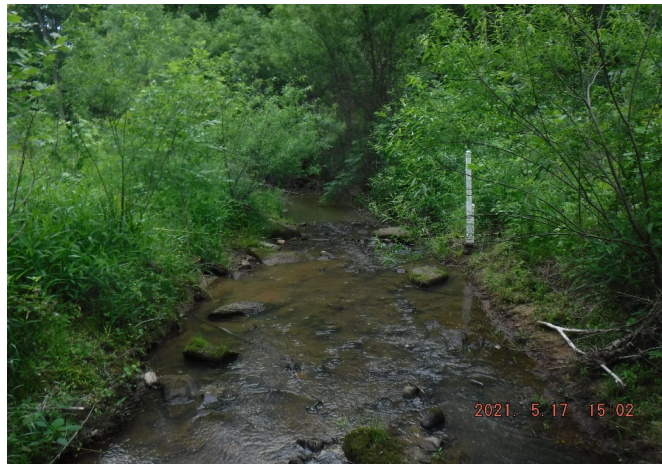
#### Cross-Section 14 - Candy Creek Reach 2

20.5	x-section area (ft.sq.)
15.7	width (ft)
1.3	mean depth (ft)
1.9	max depth (ft)
16.7	wetted perimeter (ft)
1.2	hydraulic radius (ft)
12.1	width-depth ratio
75.0	W flood prone area (ft)
4.8	entrenchment ratio
1.0	low bank height ratio

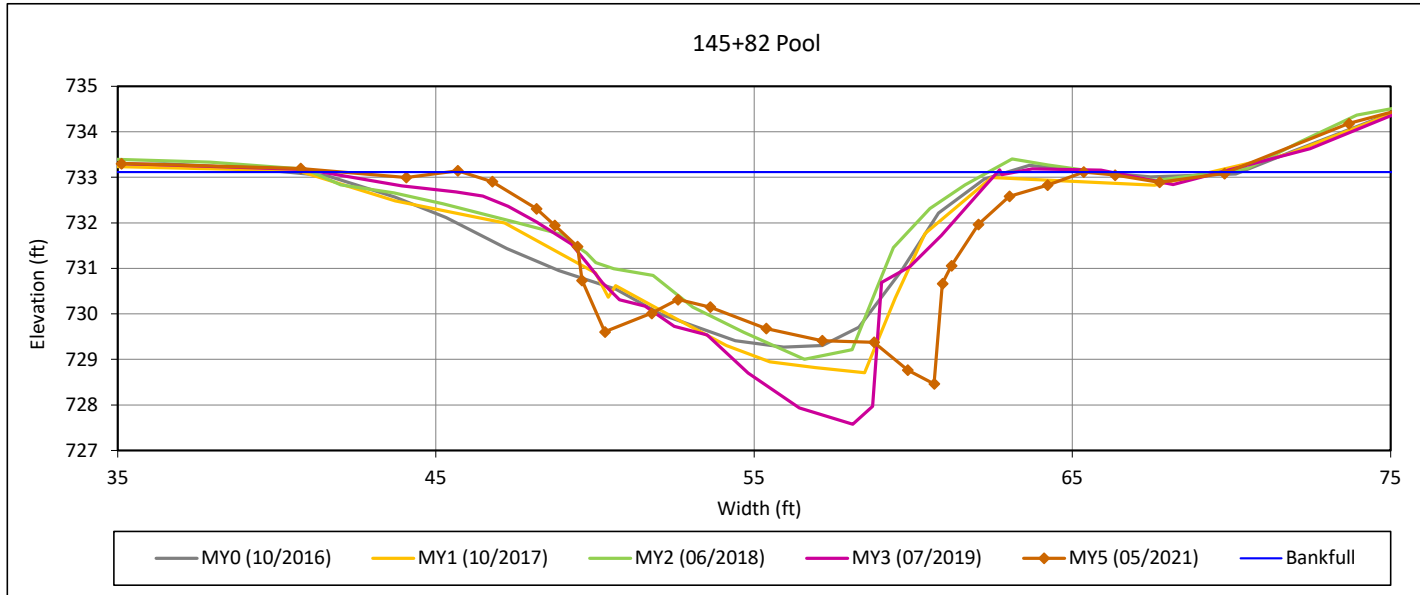
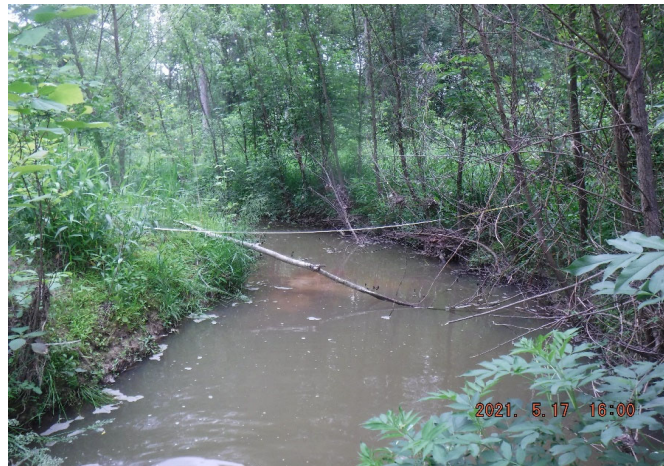
### Cross-Section 15 - Candy Creek Reach 2

45.4	x-section area (ft.sq.)
19.5	width (ft)
2.3	mean depth (ft)
4.7	max depth (ft)
24.4	wetted perimeter (ft)
1.9	hydraulic radius (ft)
8.4	width-depth ratio
