# MONITORING YEAR 5 ANNUAL REPORT

## CANDY CREEK MITIGATION SITE

Guilford County, NC

NCDMS Project Number 96315

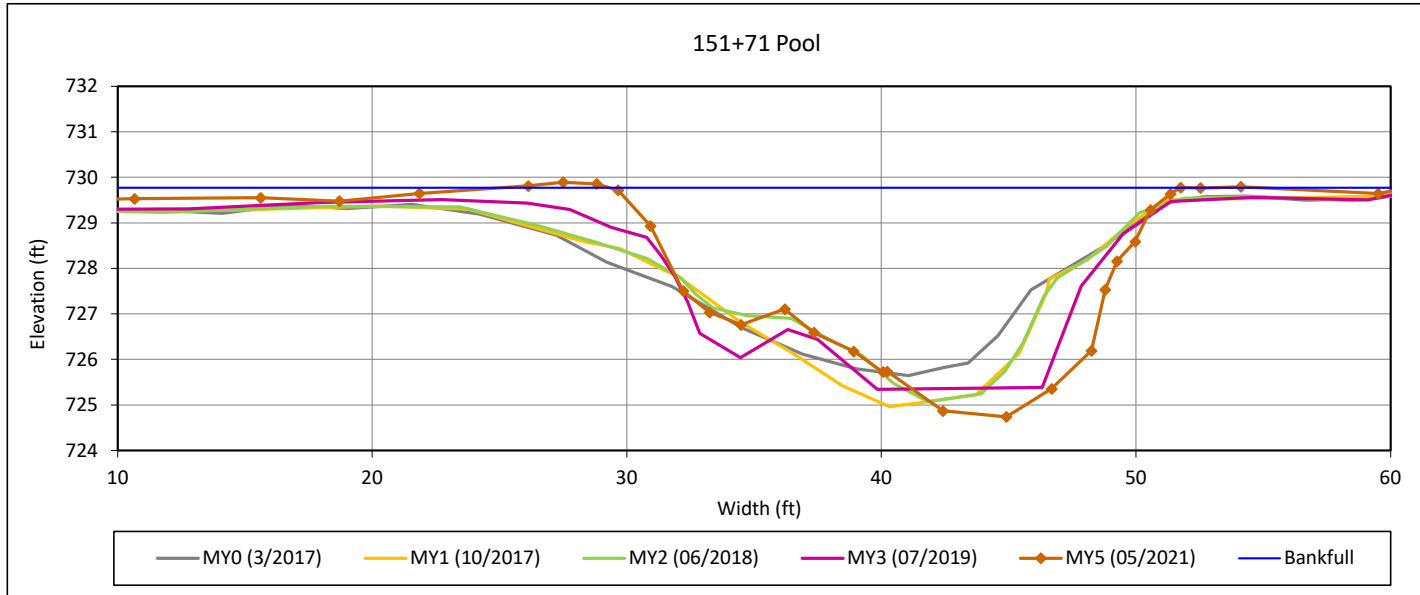
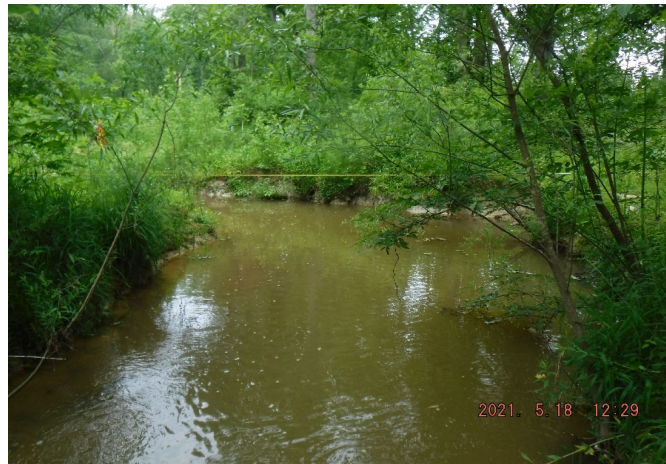
### Cross-Section 16 - Candy Creek Reach 3

68.5	x-section area (ft.sq.)
22.5	width (ft)
3.1	mean depth (ft)
5.0	max depth (ft)
26.0	wetted perimeter (ft)
2.6	hydraulic radius (ft)
7.4	width-depth ratio

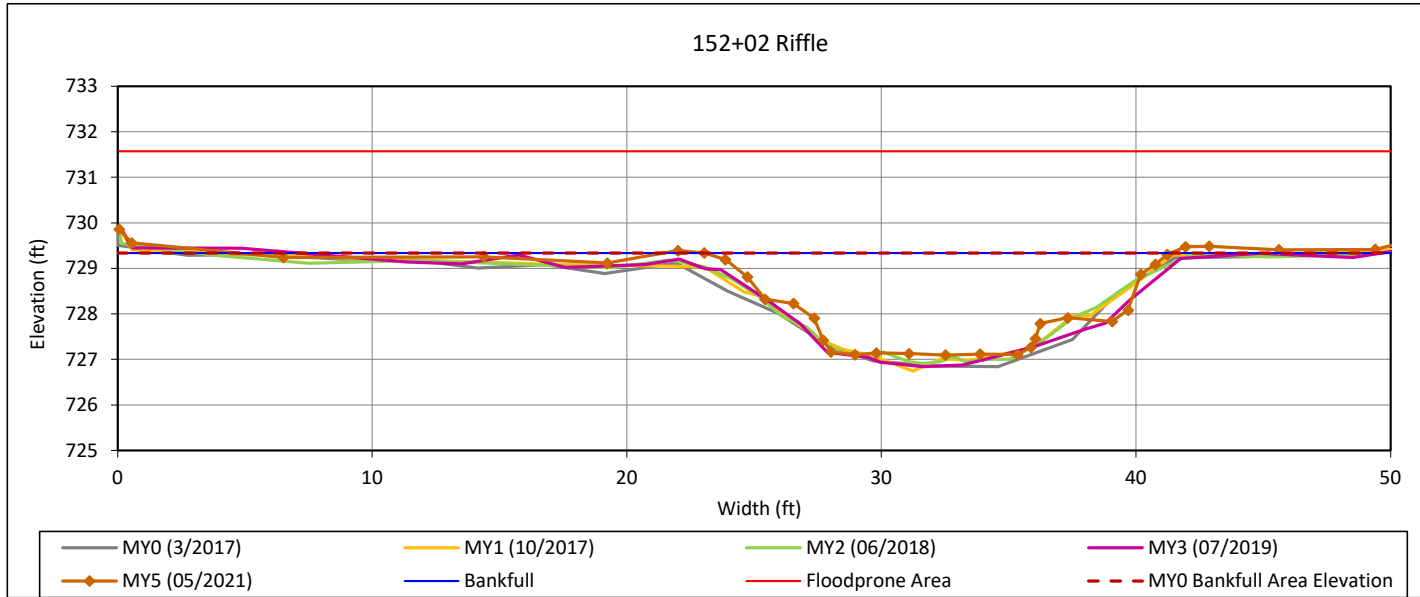
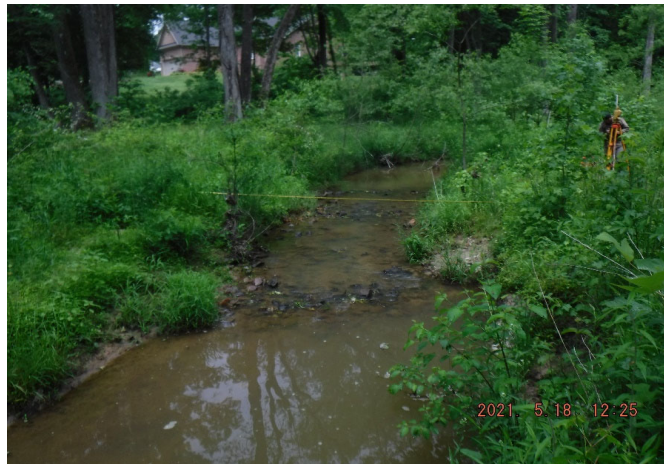
#### Cross-Section 17 - Candy Creek Reach 3

28.1	x-section area (ft.sq.)
18.3	width (ft)
1.5	mean depth (ft)
2.2	max depth (ft)
19.9	wetted perimeter (ft)
1.4	hydraulic radius (ft)
12.0	width-depth ratio
53.8	W flood prone area (ft)
2.9	entrenchment ratio
1.0	low bank height ratio

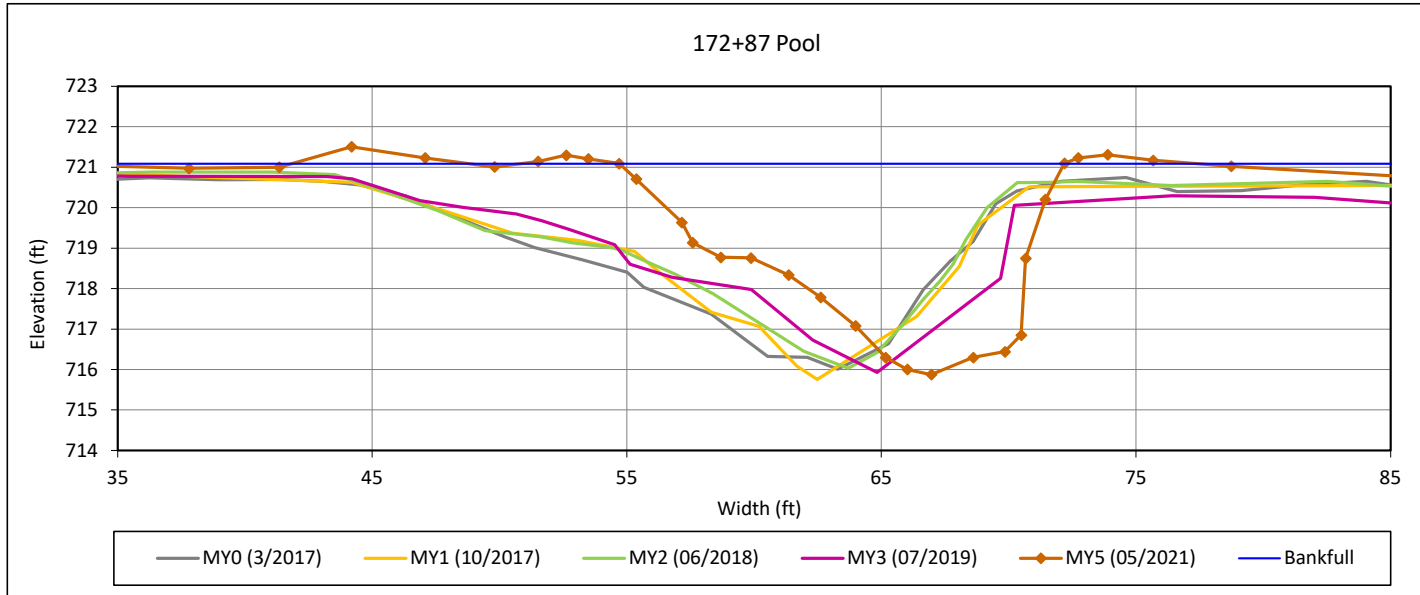
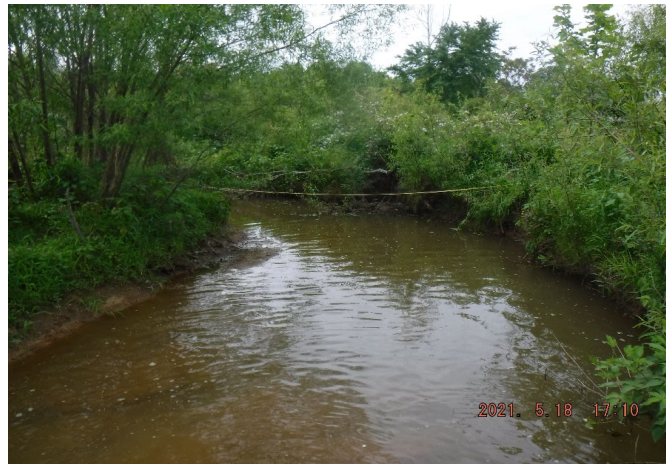
#### Cross-Section 18 - Candy Creek Reach 4

53.6	x-section area (ft.sq.)
17.5	width (ft)
3.1	mean depth (ft)
5.2	max depth (ft)
22.0	wetted perimeter (ft)
2.4	hydraulic radius (ft)
5.7	width-depth ratio

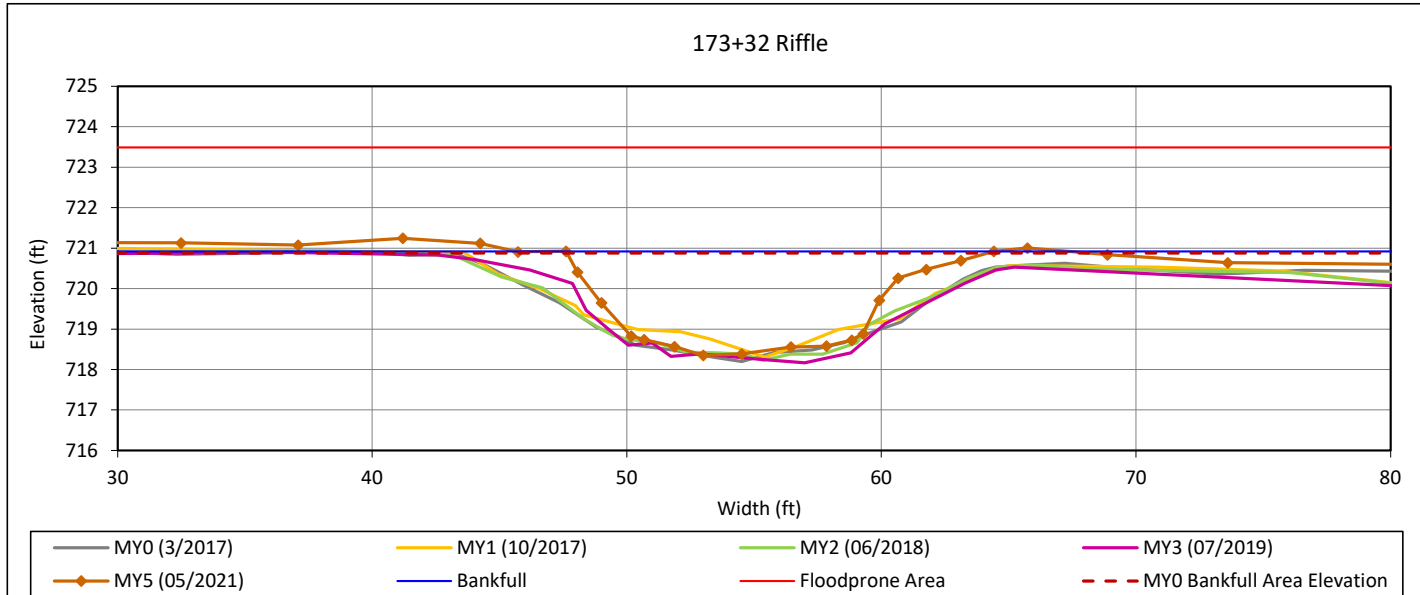
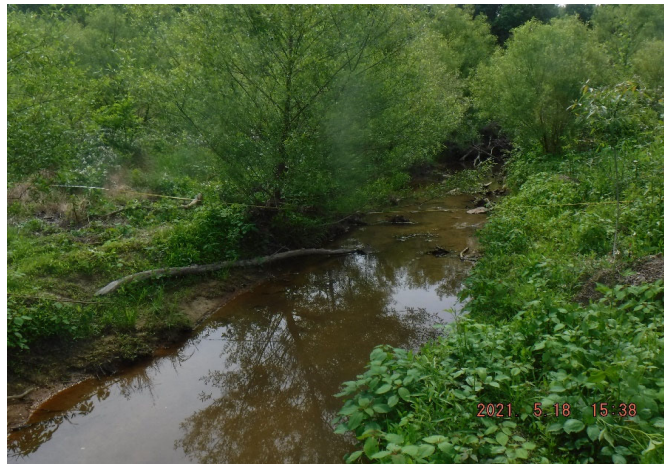
#### Cross-Section 19 - Candy Creek Reach 4

27.5	x-section area (ft.sq.)
16.8	width (ft)
1.6	mean depth (ft)
2.6	max depth (ft)
18.3	wetted perimeter (ft)
1.5	hydraulic radius (ft)
10.3	width-depth ratio
86.0	W flood prone area (ft)
5.1	entrenchment ratio
1.0	low bank height ratio

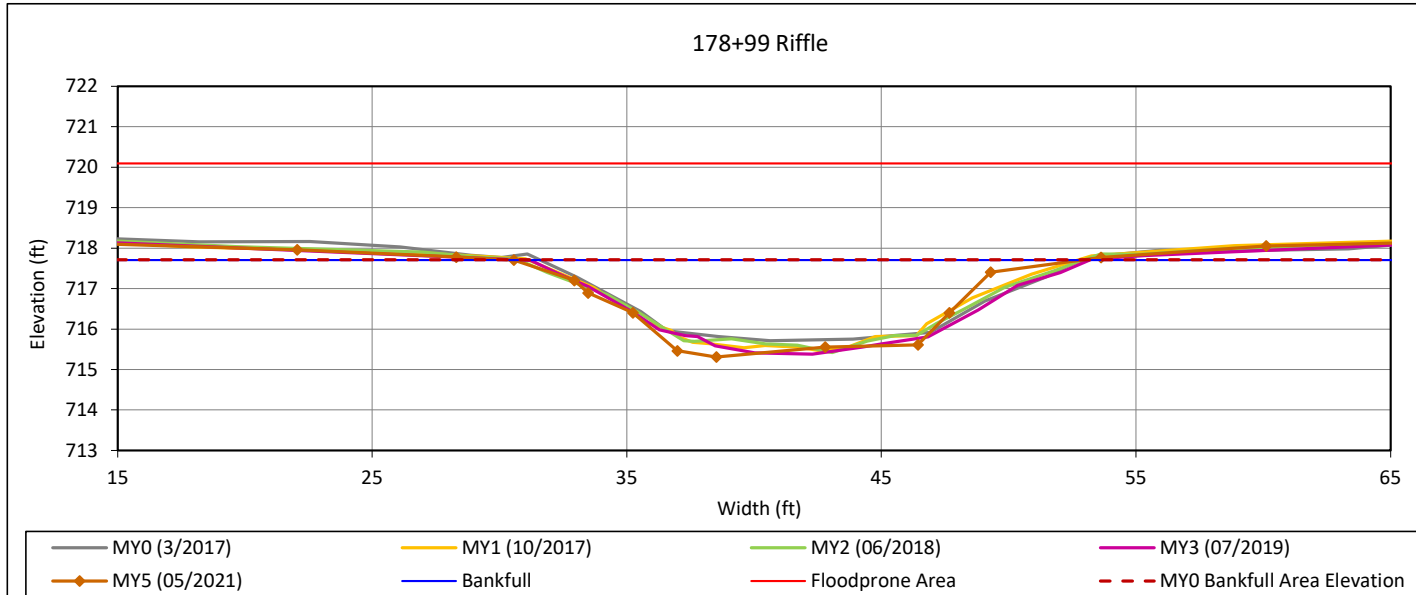
#### Cross-Section 20 - Candy Creek Reach 4

30.8	x-section area (ft.sq.)
22.3	width (ft)
1.4	mean depth (ft)
2.4	max depth (ft)
23.3	wetted perimeter (ft)
1.3	hydraulic radius (ft)
16.1	width-depth ratio
100.4	W flood prone area (ft)
4.5	entrenchment ratio
1.0	low bank height ratio

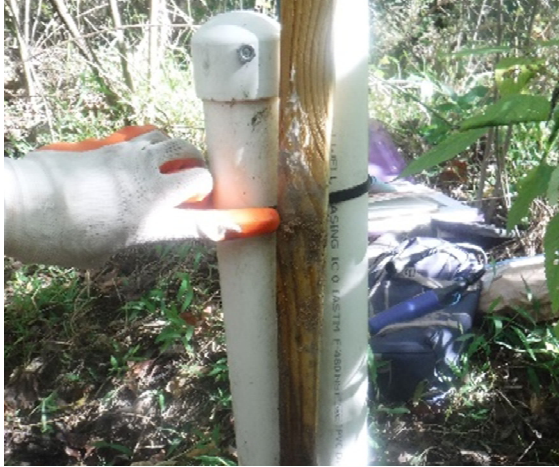
UT3 - Bankfull event recorded with Manual Crest Gage  
(Sta. 413+00) (10/19/2021)

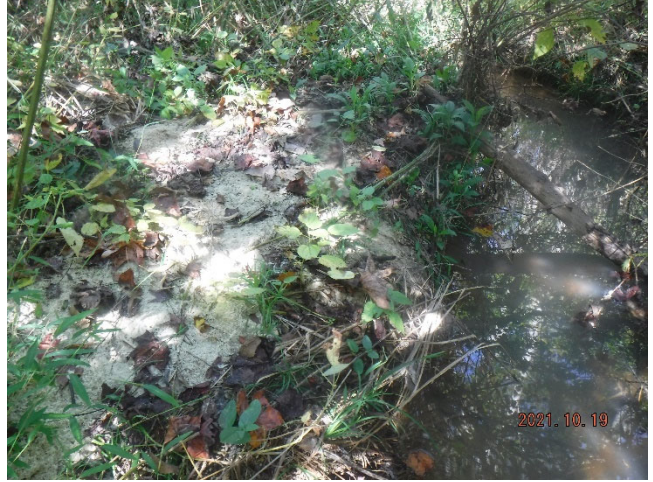
UT3 - Bankfull event recorded from recent sand deposition  
on floodplain (Sta. 413+00) (10/19/2021)
