Year 6 Monitoring Report

Hudson Property

DMS Project ID #: 95361
DMS Contract #: 004638
DWR Project #: 20140422v1
USACE Action ID# SAW-2012-01394
Beaufort County, North Carolina

Submitted: February 2022

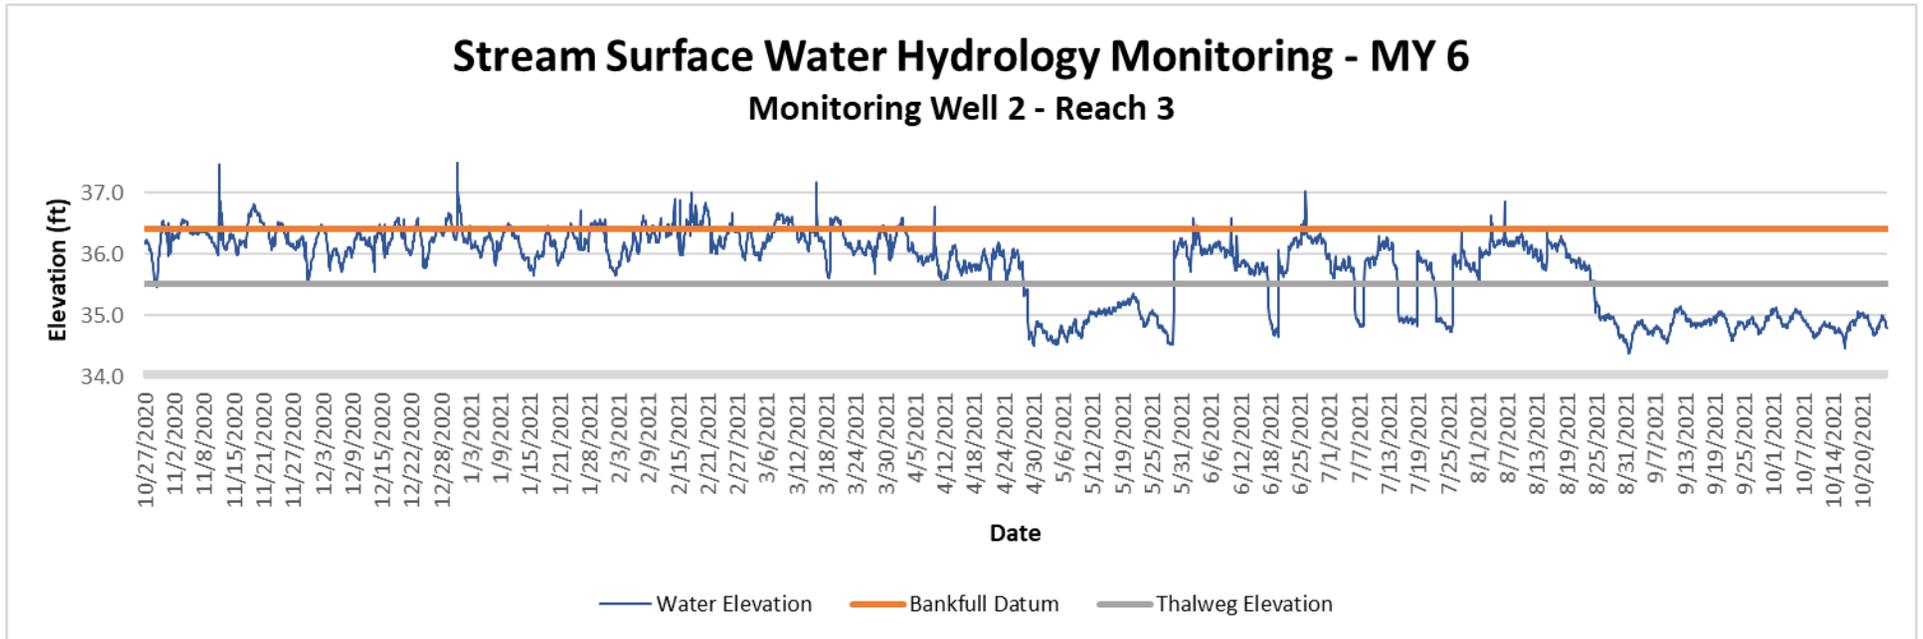
Figure 4
Monitoring Well 2 – Reach 3

- 4. The figure for monitoring well 2 has numeric values on the x-axis instead of dates.*
Ecotone Response: Figure 4 on page 56 has been corrected to show dates on the x-axis.
