**CEDAR CREEK STREAM AND WETLAND RESTORATION  
PROJECT  
MONITORING REPORT  
MONITORING YEAR 6  
FINAL**

SAMPSON COUNTY, NORTH CAROLINA  
CONTRACT No. 005011 - PROJECT No. 95718  
USACE ACTION ID No. 2012-00389 – NCDWR PROJECT No. 2013-0186

January 2021

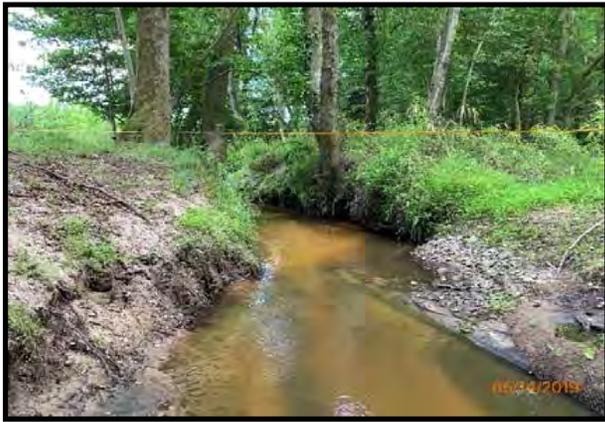
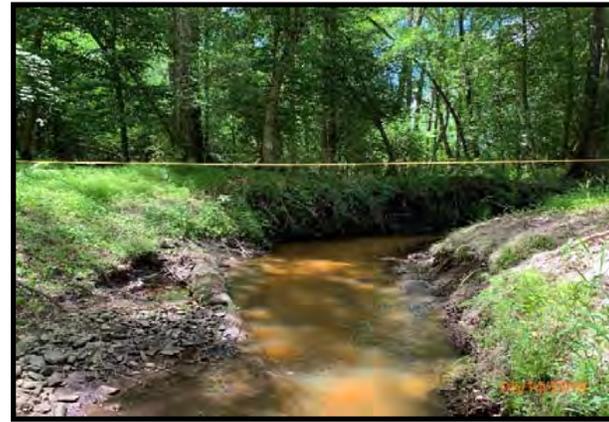
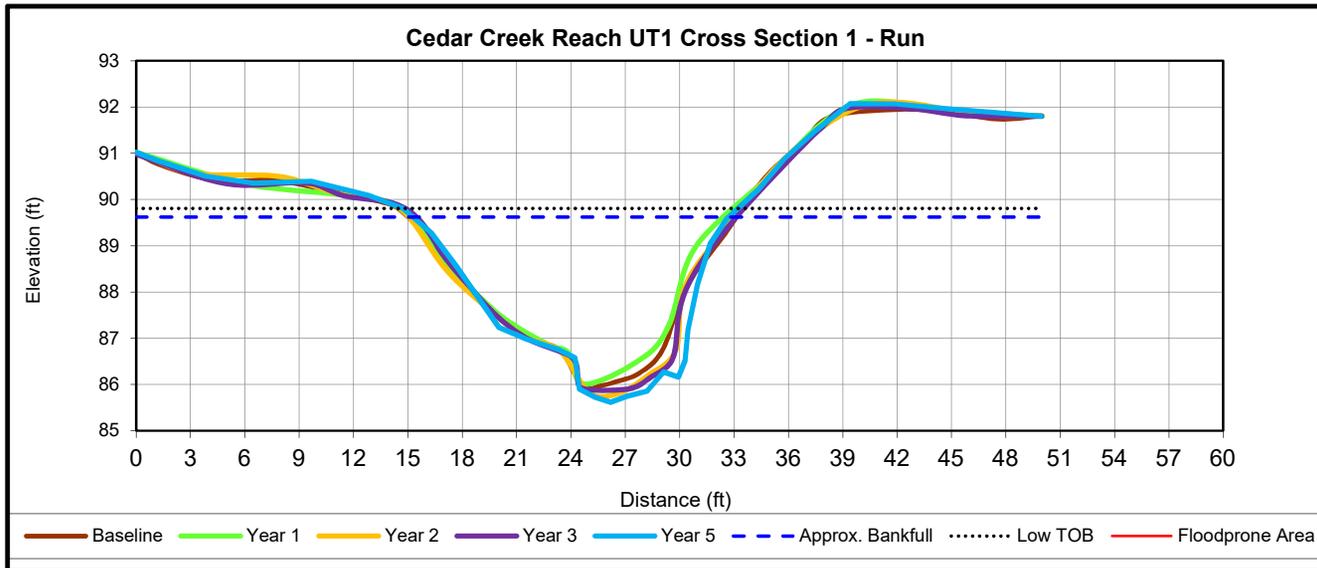
Dimension	Cross Section 1 (Run)						
	Base	MY1	MY2	MY3	MY5	MY7	MY+
Bankfull Elevation (ft) - Based on AB-XSA <sup>1</sup>	89.8	89.8	89.8	89.8	89.6		
Bankfull Width (ft) <sup>1</sup>	19.0	18.5	19.0	18.9	17.4		
Floodprone Width (ft) <sup>1</sup>	50.0	50.0	50.0	50.0	50.0		
Bankfull Mean Depth (ft)	2.2	2.1	2.3	2.3	-		
Bankfull Max Depth (ft) <sup>2</sup>	3.8	3.8	4.0	3.9	4.2		
Low Bank Elevation (ft)	-	-	-	-	89.8		
Bankfull Cross Sectional Area (ft <sup>2</sup> ) <sup>2</sup>	41.6	38.9	43.6	42.8	45.0		
Bankfull Width/Depth Ratio	8.6	8.8	8.2	8.3	-		
Bankfull Entrenchment Ratio <sup>1</sup>	>2.2	>2.2	>2.2	>2.2	>2.2		
Bankfull Bank Height Ratio <sup>1</sup>	1.0	1.0	1.0	1.0	1.0

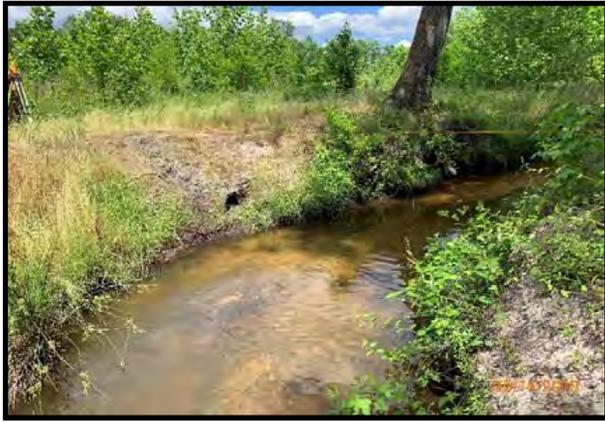
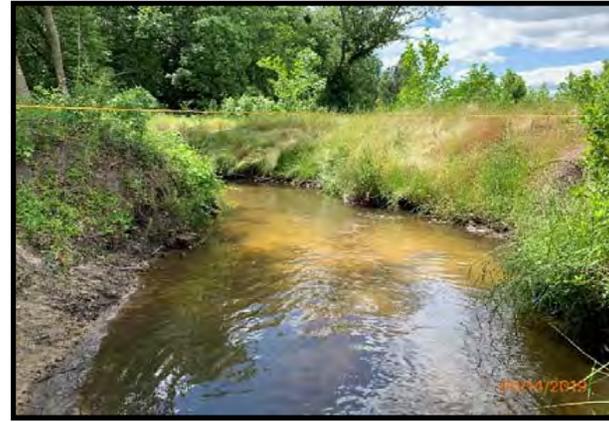
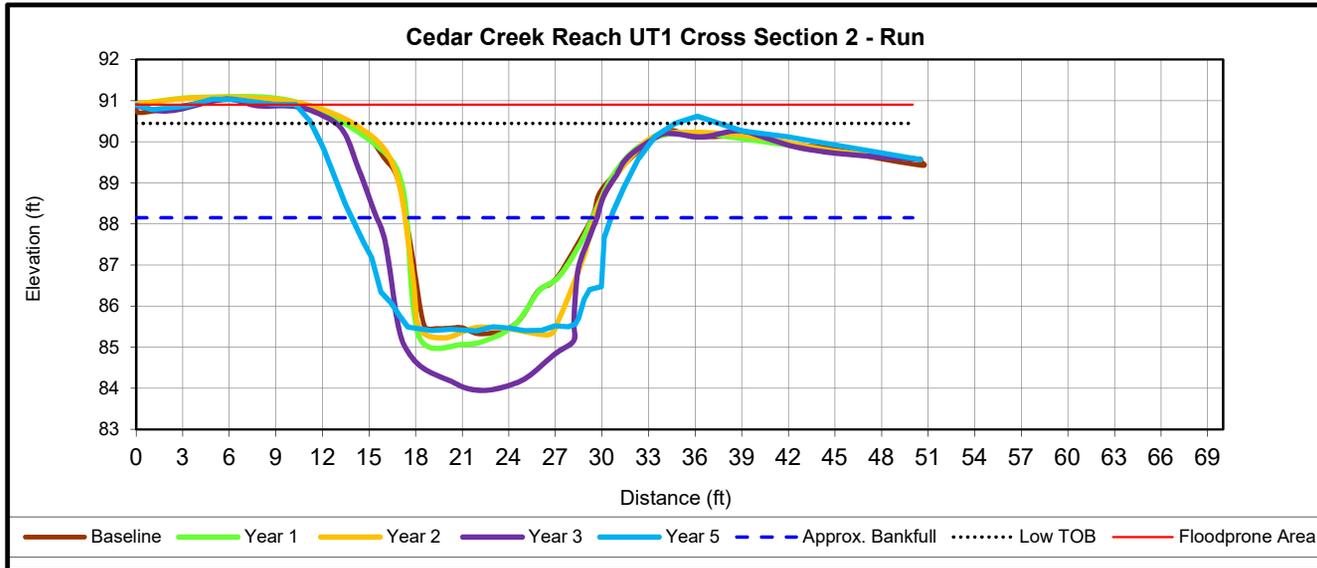
Dimension	Cross Section 2 (Run)						
	Base	MY1	MY2	MY3	MY5	MY7	MY+
<b>Bankfull Elevation (ft) - Based on AB-XSA<sup>1</sup></b>	89.2	89.2	89.2	89.2	88.2		
Bankfull Width (ft) <sup>1</sup>	14.3	14.2	14.4	16.5	16.7		
Floodprone Width (ft) <sup>1</sup>	50.0	50.0	50.0	50.0	43.8		
Bankfull Mean Depth (ft)	2.7	2.8	3.0	3.7	-		
Bankfull Max Depth (ft) <sup>2</sup>	3.9	4.1	4.0	5.3	5.1		
Low Bank Elevation (ft)	-	-	-	-	90.4		
Bankfull Cross Sectional Area (ft <sup>2</sup> ) <sup>2</sup>	38.0	40.1	43.1	61.3	82.9		
Bankfull Width/Depth Ratio	5.4	5.1	4.8	44.0	-		
Bankfull Entrenchment Ratio <sup>1</sup>	>2.2	>2.2	>2.2	>2.2	>2.2		
Bankfull Bank Height Ratio <sup>1</sup>	1.0	1.0	1.0	1.1	1.8

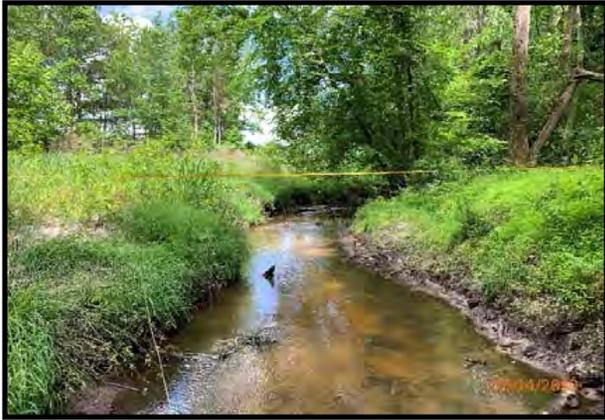
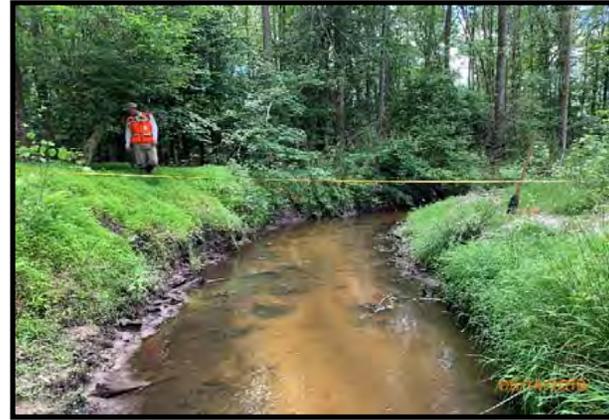
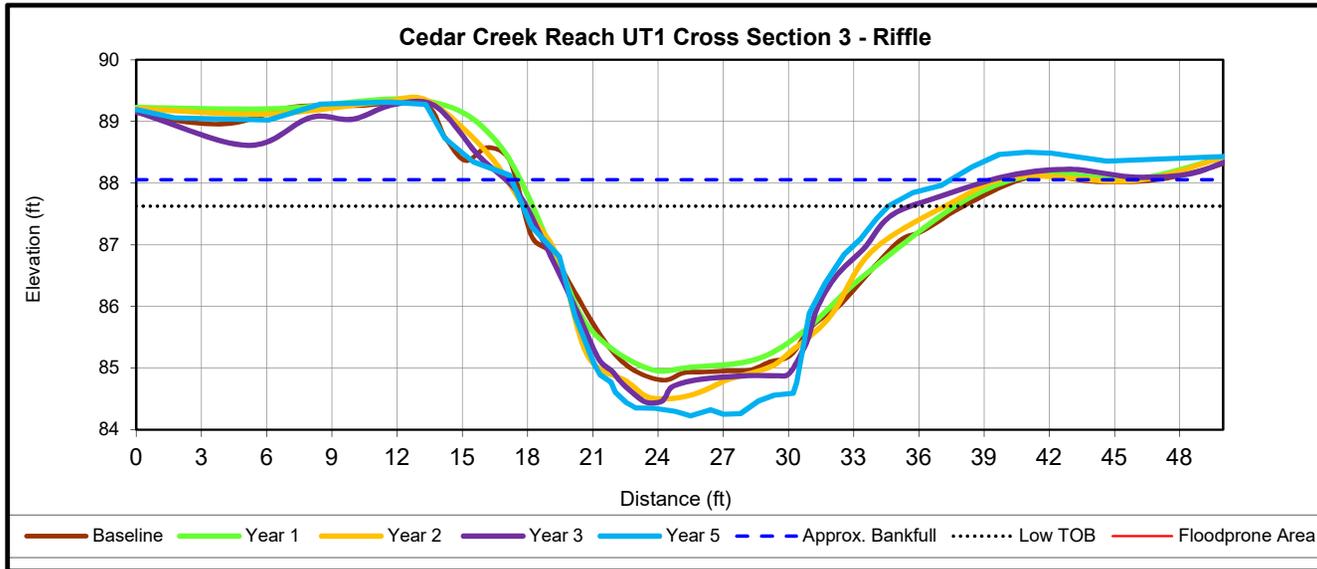
Dimension	Cross Section 3 (Riffle)						
	Base	MY1	MY2	MY3	MY5	MY7	MY+
Bankfull Elevation (ft) - Based on AB-XSA <sup>1</sup>	88.1	88.1	88.1	88.1	88.1		
Bankfull Width (ft) <sup>1</sup>	23.8	26.1	23.5	23.1	20.2		
Floodprone Width (ft) <sup>1</sup>	50.0	50.0	50.0	50.0	50.2		
Bankfull Mean Depth (ft)	1.9	1.7	2.0	1.9	-		
Bankfull Max Depth (ft) <sup>2</sup>	3.3	3.1	3.6	3.7	3.4		
Low Bank Elevation (ft)	-	-	-	-	87.6		
Bankfull Cross Sectional Area (ft <sup>2</sup> ) <sup>2</sup>	45.5	43.7	46.8	44.6	37.6		
Bankfull Width/Depth Ratio	12.4	15.6	11.8	12.0	-		
Bankfull Entrenchment Ratio <sup>1</sup>	2.1	1.9	2.1	2.2	>2.2		
Bankfull Bank Height Ratio <sup>1</sup>	1.0	1.0	1.0	1.1	<1

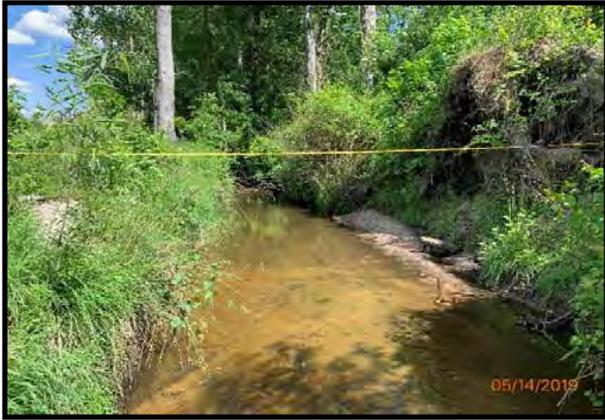
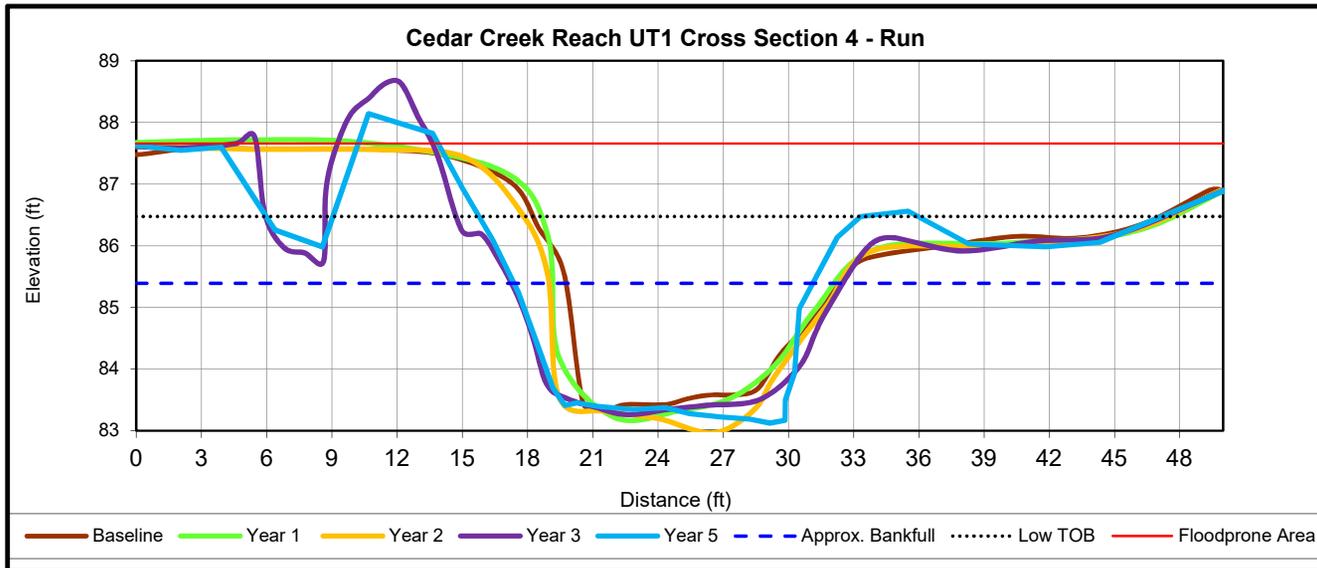
Left Bank \*Note Downed Tree

Dimension	Cross Section 4 (Run)						
	Base	MY1	MY2	MY3	MY5	MY7	MY+
Bankfull Elevation (ft) - Based on AB-XSA <sup>1</sup>	85.8	85.8	85.8	85.8	85.4		
Bankfull Width (ft) <sup>1</sup>	14.4	14.5	15.0	16.7	13.7		
Floodprone Width (ft) <sup>1</sup>	50.0	50.0	50.0	50.0	46.4		
Bankfull Mean Depth (ft)	1.7	1.8	2.0	1.9	-		
Bankfull Max Depth (ft) <sup>2</sup>	2.5	2.6	2.8	2.5	3.3		
Low Bank Elevation (ft)	-	-	-	-	86.5		
Bankfull Cross Sectional Area (ft <sup>2</sup> ) <sup>2</sup>	24.7	26.3	29.8	31.4	41.4		
Bankfull Width/Depth Ratio	8.4	8.0	7.5	8.9	-		
Bankfull Entrenchment Ratio <sup>1</sup>	>2.2	>2.2	>2.2	>2.2	>2.2		
Bankfull Bank Height Ratio <sup>1</sup>	1.0	1.0	1.0	1.1	1.5

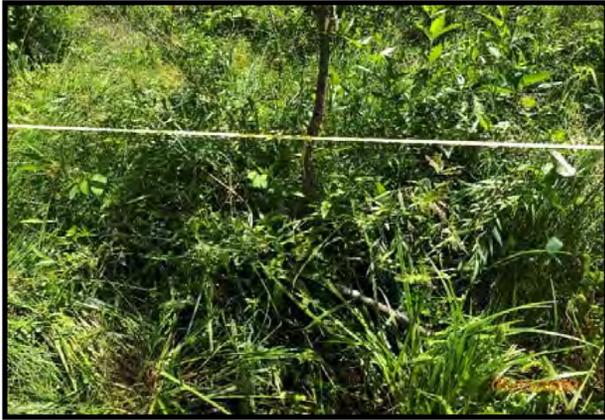
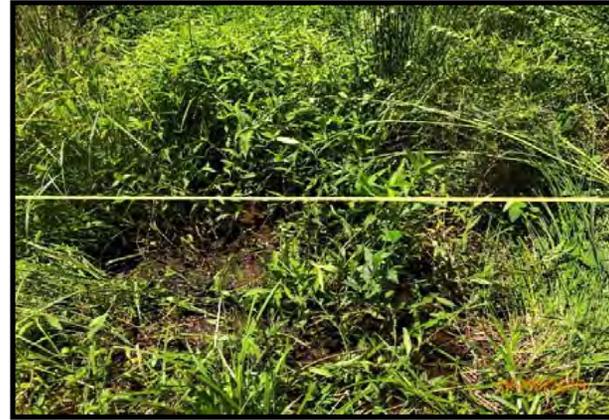
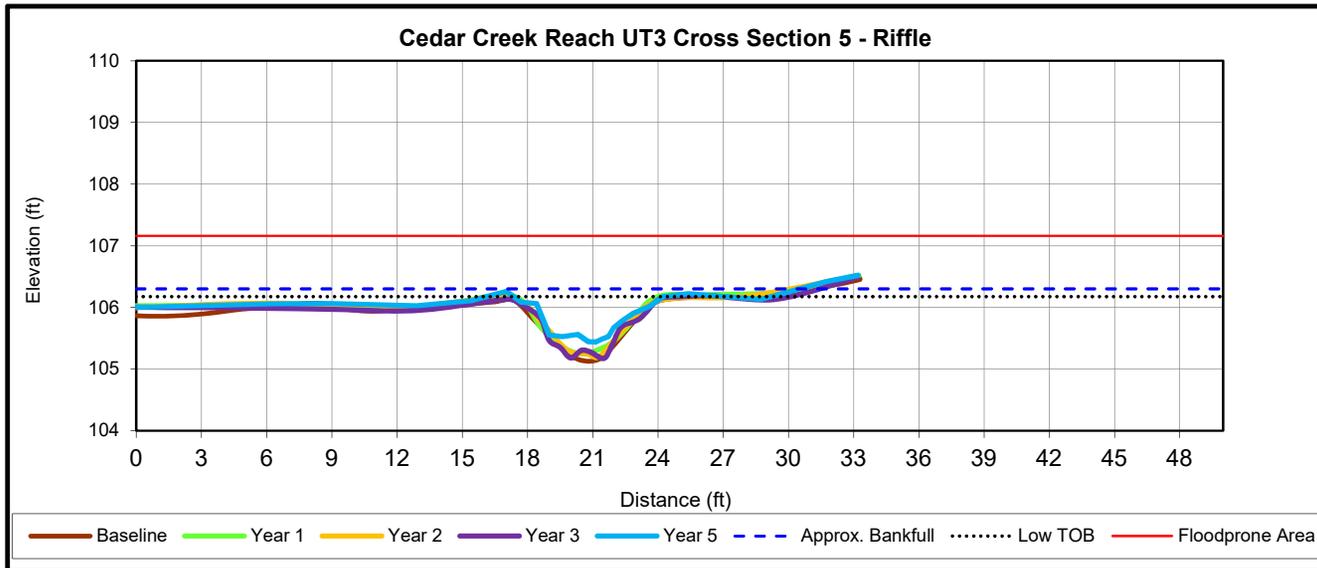
Dimension	Cross Section 5 (Riffle)						
	Base	MY1	MY2	MY3	MY5	MY7	MY+
Bankfull Elevation (ft) - Based on AB-XSA <sup>1</sup>	106.1	106.1	106.1	106.1	106.3		
Bankfull Width (ft) <sup>1</sup>	6.9	6.3	6.9	6.6	7.2		
Floodprone Width (ft) <sup>1</sup>	50.0	50.0	50.0	50.0	33.2		
Bankfull Mean Depth (ft)	0.5	0.5	0.5	0.5	-		
Bankfull Max Depth (ft) <sup>2</sup>	1.0	0.8	0.9	0.9	0.7		
Low Bank Elevation (ft)	-	-	-	-	106.2		
Bankfull Cross Sectional Area (ft <sup>2</sup> ) <sup>2</sup>	3.7	3.2	3.2	3.3	2.8		
Bankfull Width/Depth Ratio	12.8	12.2	14.5	13.1	-		
Bankfull Entrenchment Ratio <sup>1</sup>	>2.2	>2.2	>2.2	>2.2	>2.2		
Bankfull Bank Height Ratio <sup>1</sup>	1.0	1.0	1.0	1.0	<1

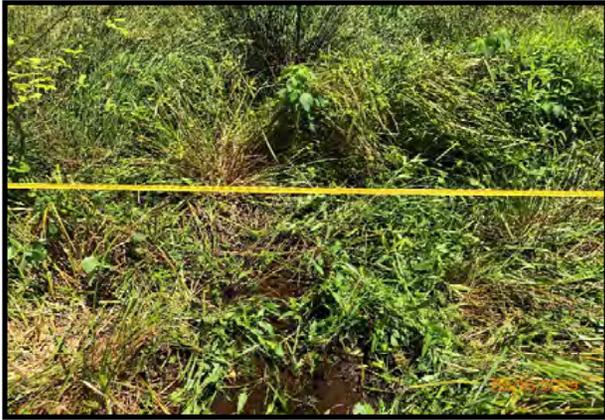
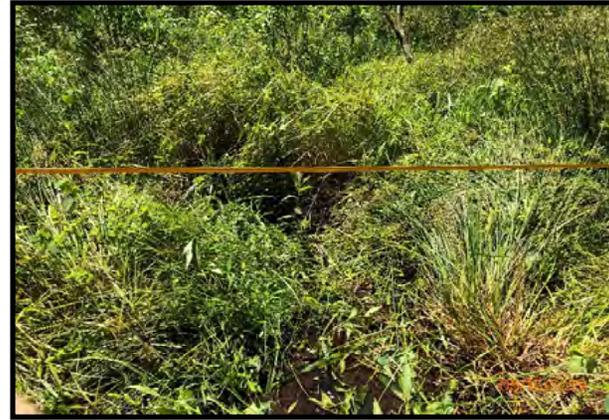
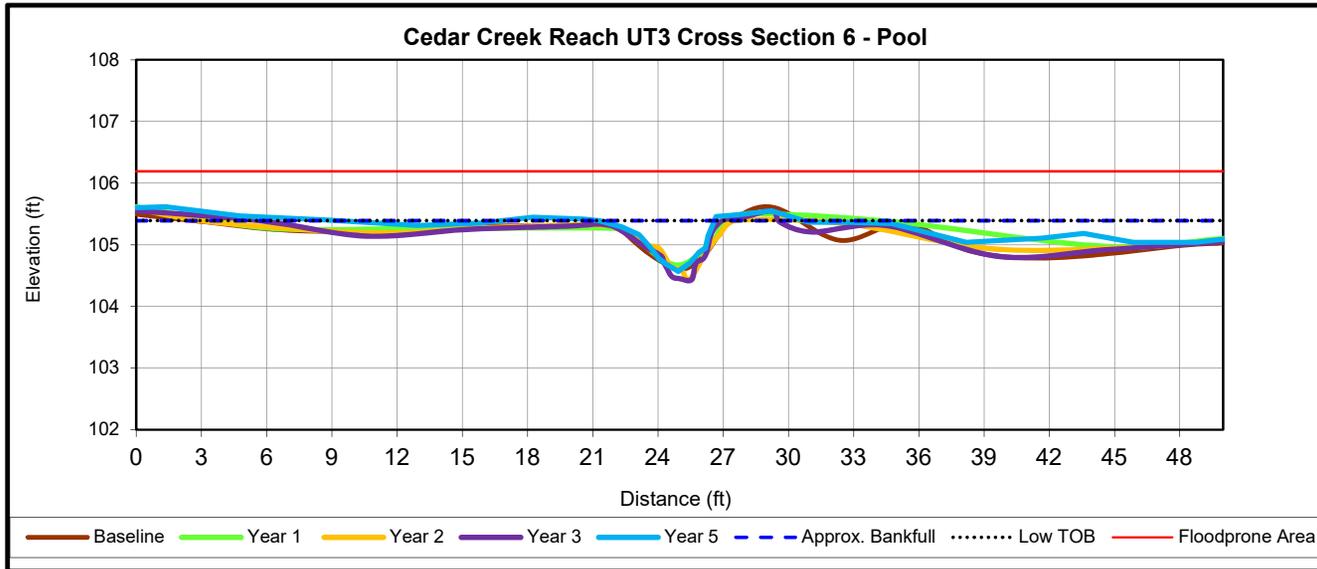
Dimension	Cross Section 6 (Pool)						
	Base	MY1	MY2	MY3	MY5	MY7	MY+
Bankfull Elevation (ft) - Based on AB-XSA <sup>1</sup>	105.3	105.3	105.3	105.3	105.4		
Bankfull Width (ft) <sup>1</sup>	5.9	4.6	5.3	4.9	5.3		
Floodprone Width (ft) <sup>1</sup>	50.0	50.0	50.0	50.0	50.0		
Bankfull Mean Depth (ft)	0.4	0.4	0.4	0.4	-		
Bankfull Max Depth (ft) <sup>2</sup>	0.7	0.6	0.9	0.9	0.8		
Low Bank Elevation (ft)	-	-	-	-	105.4		
Bankfull Cross Sectional Area (ft <sup>2</sup> ) <sup>2</sup>	2.1	1.6	2.0	2.1	2.1		
Bankfull Width/Depth Ratio	16.0	12.8	13.7	11.2	-		
Bankfull Entrenchment Ratio <sup>1</sup>	>2.2	>2.2	>2.2	N/A	N/A		
Bankfull Bank Height Ratio <sup>1</sup>	1.0	1.0	1.0	N/A	N/A

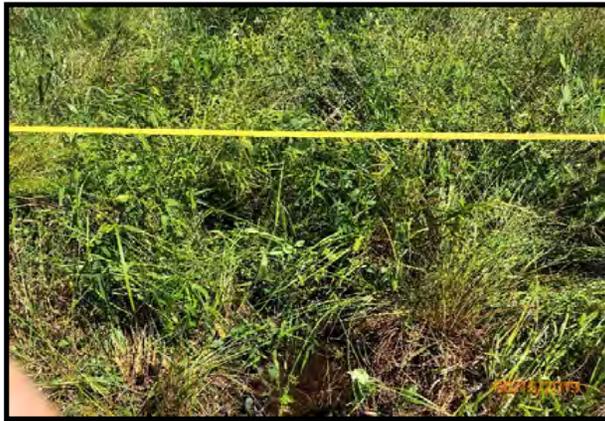
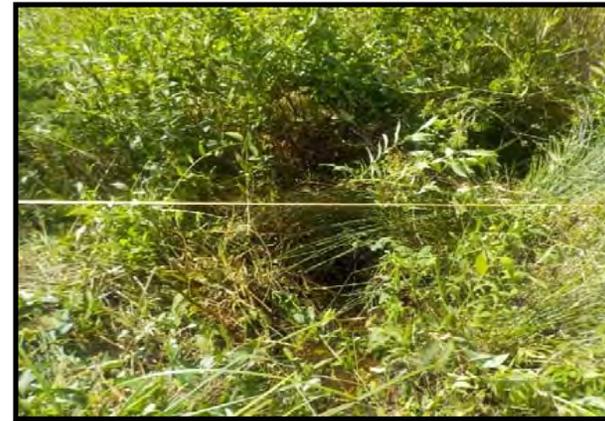
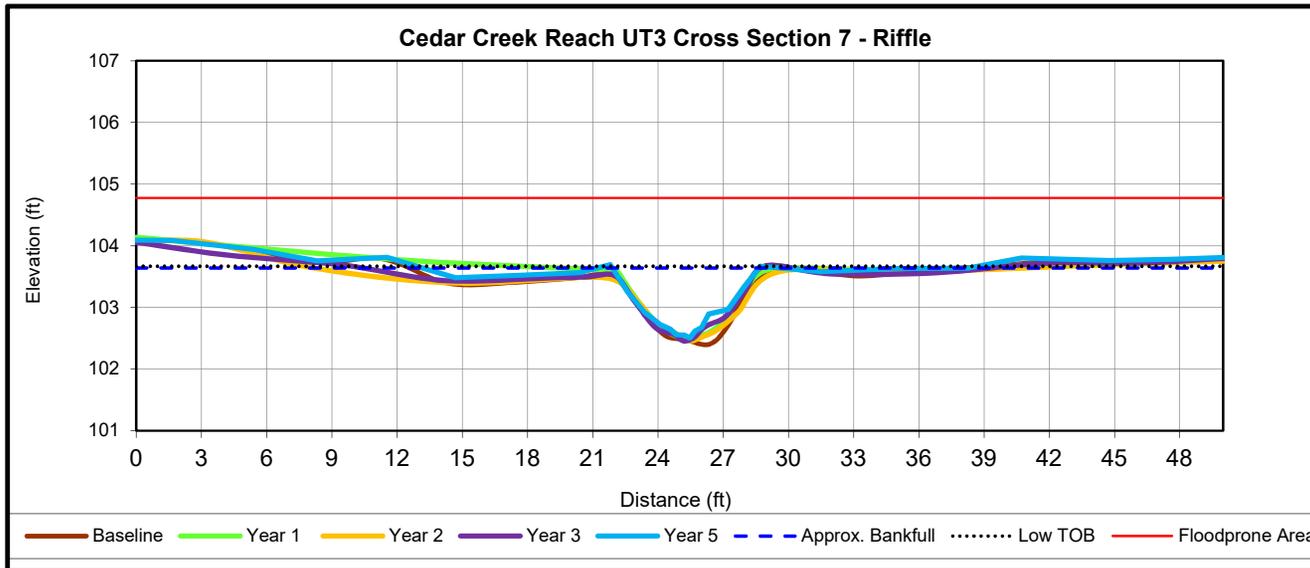
Dimension	Cross Section 7 (Riffle)						
	Base	MY1	MY2	MY3	MY5	MY7	MY+
Bankfull Elevation (ft) - Based on AB-XSA <sup>1</sup>	103.5	103.5	103.5	103.5	103.7		
Bankfull Width (ft) <sup>1</sup>	7.3	6.5	7.7	6.5	6.7		
Floodprone Width (ft) <sup>1</sup>	50.0	50.0	50.0	50.0	50.2		
Bankfull Mean Depth (ft)	0.6	0.6	0.6	0.6	-		
Bankfull Max Depth (ft) <sup>2</sup>	1.1	1.0	1.0	1.0	1.2		
Low Bank Elevation (ft)	-	-	-	-	103.7		
Bankfull Cross Sectional Area (ft <sup>2</sup> ) <sup>2</sup>	4.5	3.9	4.6	4.1	4.7		
Bankfull Width/Depth Ratio	11.8	10.9	12.9	10.5	-		
Bankfull Entrenchment Ratio <sup>1</sup>	>2.2	>2.2	>2.2	>2.2	>2.2		
Bankfull Bank Height Ratio <sup>1</sup>	1.0	1.0	1.0	1.0	1.0

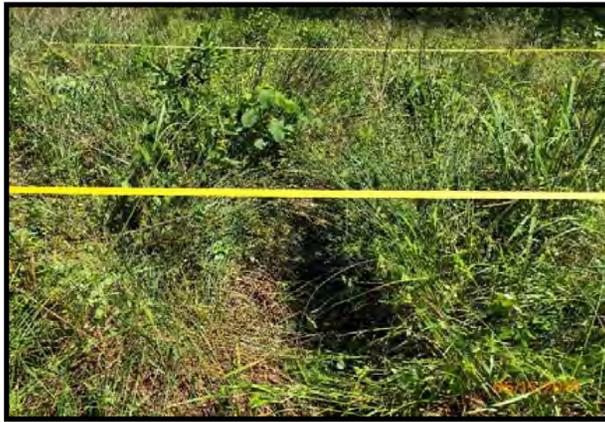
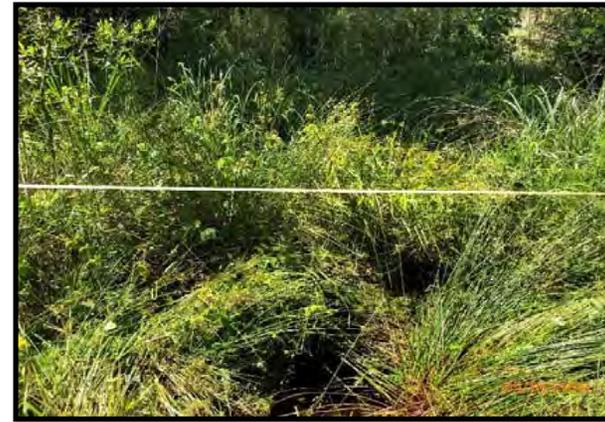
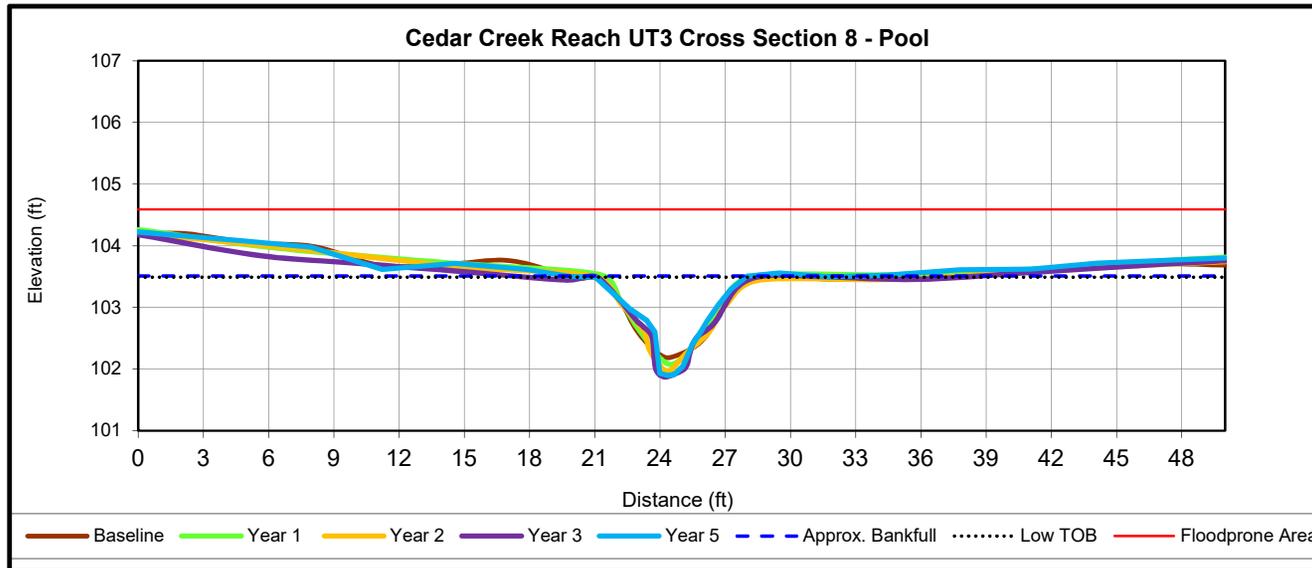
Dimension	Cross Section 8 (Pool)						
	Base	MY1	MY2	MY3	MY5	MY7	MY+
Bankfull Elevation (ft) - Based on AB-XSA <sup>1</sup>	103.5	103.5	103.5	103.5	103.5		
Bankfull Width (ft) <sup>1</sup>	7.1	8.1	7.6	7.8	8.3		
Floodprone Width (ft) <sup>1</sup>	50.0	50.0	50.0	50.0	50.0		
Bankfull Mean Depth (ft)	0.7	0.6	0.7	0.7	-		
Bankfull Max Depth (ft) <sup>2</sup>	1.2	1.4	1.5	1.6	1.6		
Low Bank Elevation (ft)	-	-	-	-	103.5		
Bankfull Cross Sectional Area (ft <sup>2</sup> ) <sup>2</sup>	5.0	5.1	5.6	5.5	4.8		
Bankfull Width/Depth Ratio	9.9	13.0	10.3	10.9	-		
Bankfull Entrenchment Ratio <sup>1</sup>	>2.2	>2.2	>2.2	N/A	N/A		
Bankfull Bank Height Ratio <sup>1</sup>	1.0	1.0	1.0	N/A	N/A

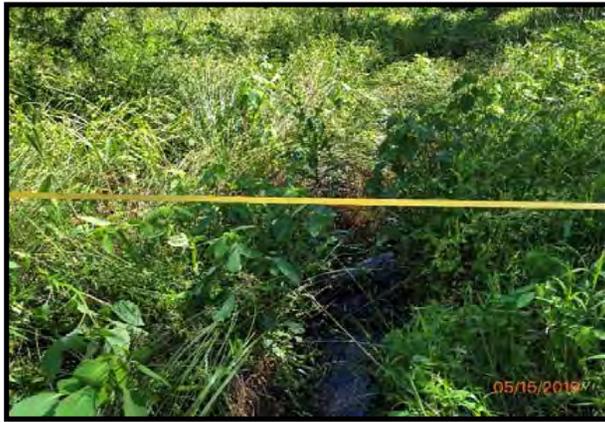
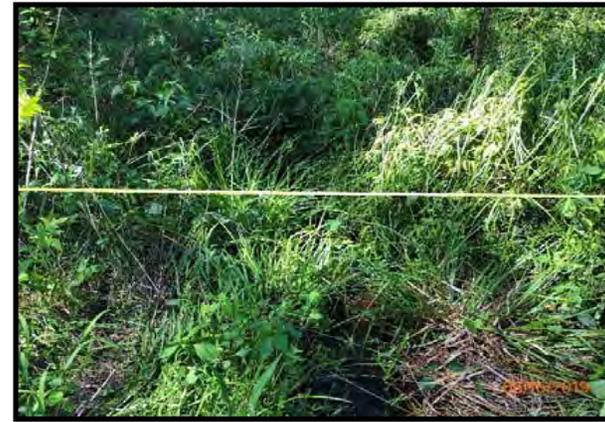
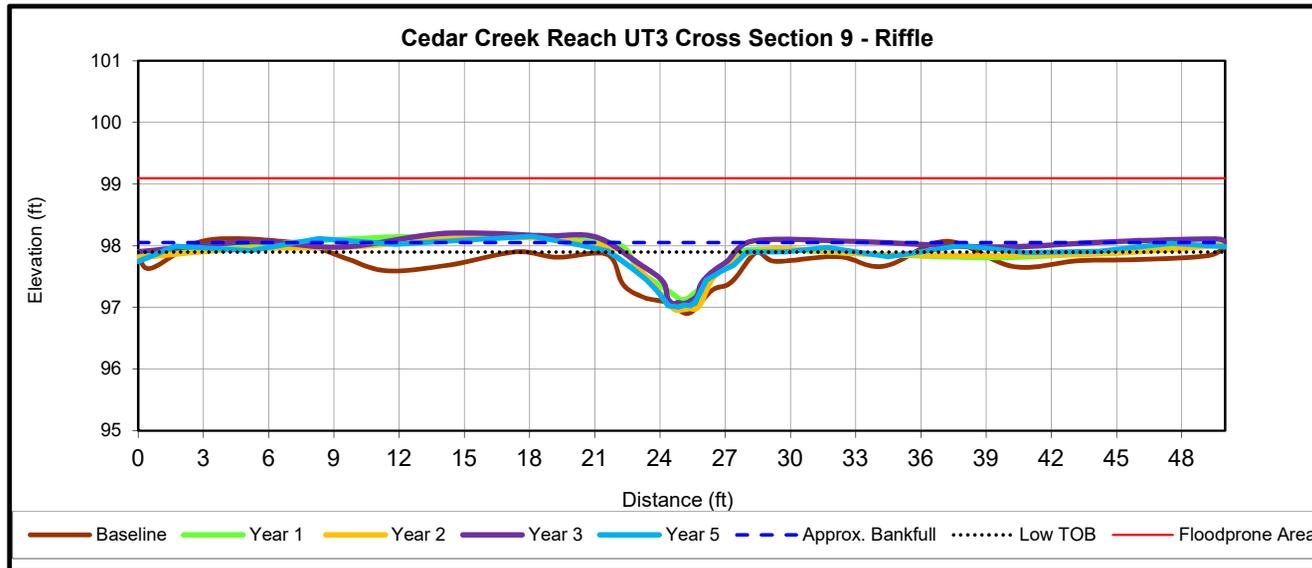
Dimension	Cross Section 9 (Riffle)						
	Base	MY1	MY2	MY3	MY5	MY7	MY+
Bankfull Elevation (ft) - Based on AB-XSA <sup>1</sup>	97.9	97.9	97.9	97.9	98.1		
Bankfull Width (ft) <sup>1</sup>	7.5	5.7	6.6	5.5	8.3		
Floodprone Width (ft) <sup>1</sup>	50.0	50.0	50.0	50.0	50.3		
Bankfull Mean Depth (ft)	0.5	0.4	0.5	0.4	-		
Bankfull Max Depth (ft) <sup>2</sup>	1.0	0.8	0.9	0.8	0.9		
Low Bank Elevation (ft)	-	-	-	-	97.9		
Bankfull Cross Sectional Area (ft <sup>2</sup> ) <sup>2</sup>	4.0	2.4	3.0	2.2	2.9		
Bankfull Width/Depth Ratio	14.2	13.5	14.4	13.7	-		
Bankfull Entrenchment Ratio <sup>1</sup>	>2.2	>2.2	>2.2	>2.2	>2.2		
Bankfull Bank Height Ratio <sup>1</sup>	1.0	1.0	1.0	1.2	<1

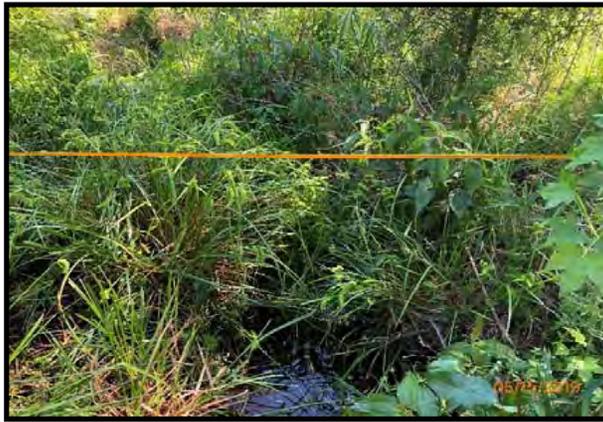
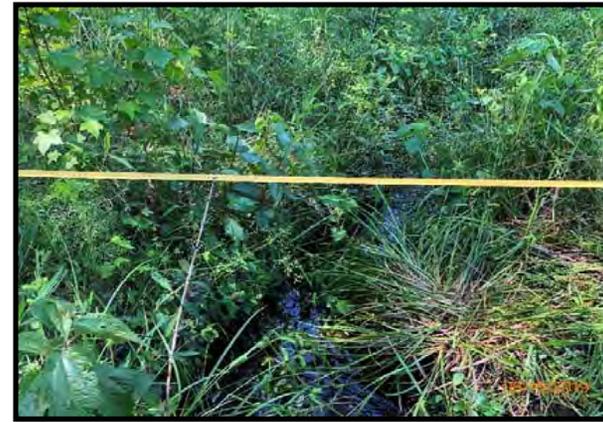
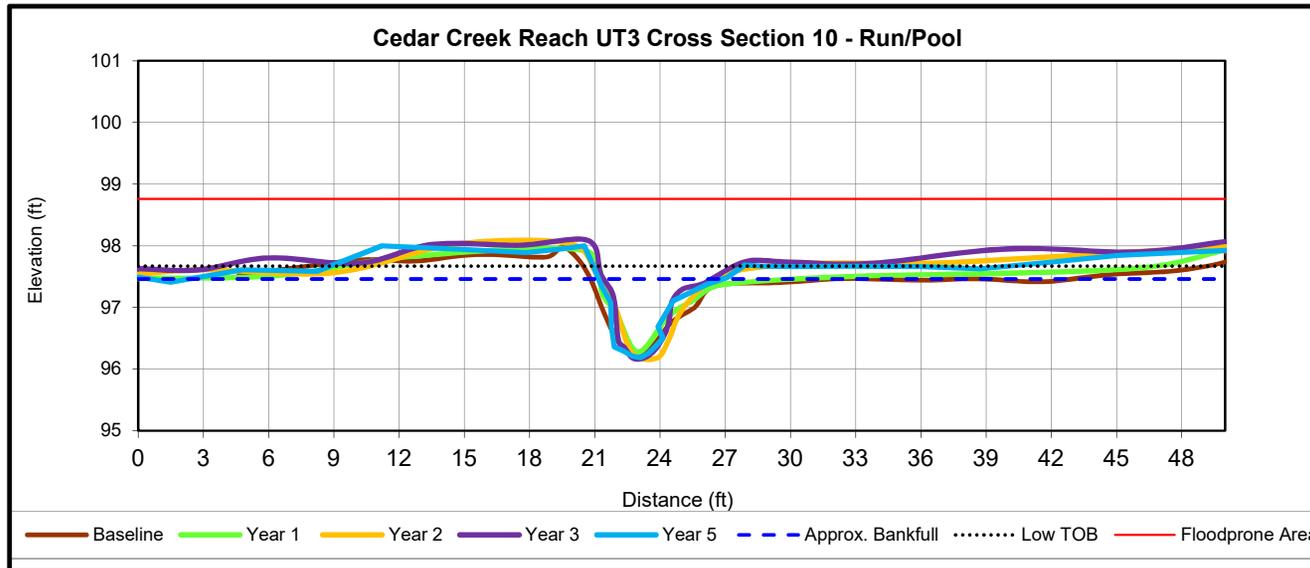
Dimension	Cross Section 10 (Pool)						
	Base	MY1	MY2	MY3	MY5	MY7	MY+
Bankfull Elevation (ft) - Based on AB-XSA <sup>1</sup>	97.4	97.4	97.4	97.4	97.5		
Bankfull Width (ft) <sup>1</sup>	5.7	5.3	4.9	4.6	7.5		
Floodprone Width (ft) <sup>1</sup>	50.0	50.0	50.0	50.0	50.0		
Bankfull Mean Depth (ft)	0.6	0.5	0.7	0.6	-		
Bankfull Max Depth (ft) <sup>2</sup>	1.1	1.0	1.0	1.2	1.5		
Low Bank Elevation (ft)	-	-	-	-	97.7		
Bankfull Cross Sectional Area (ft <sup>2</sup> ) <sup>2</sup>	3.5	2.4	3.3	2.9	5.0		
Bankfull Width/Depth Ratio	9.1	11.7	7.2	7.2	-		
Bankfull Entrenchment Ratio <sup>1</sup>	>2.2	>2.2	>2.2	N/A	N/A		
Bankfull Bank Height Ratio <sup>1</sup>	1.0	1.0	1.0	N/A	N/A

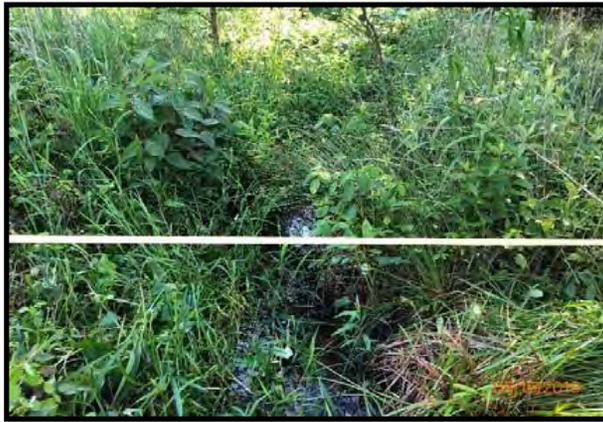
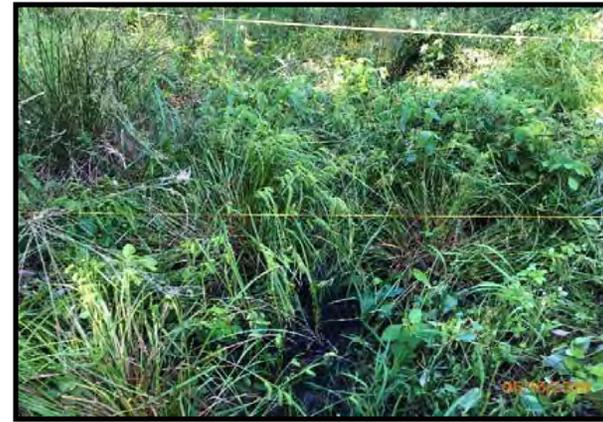
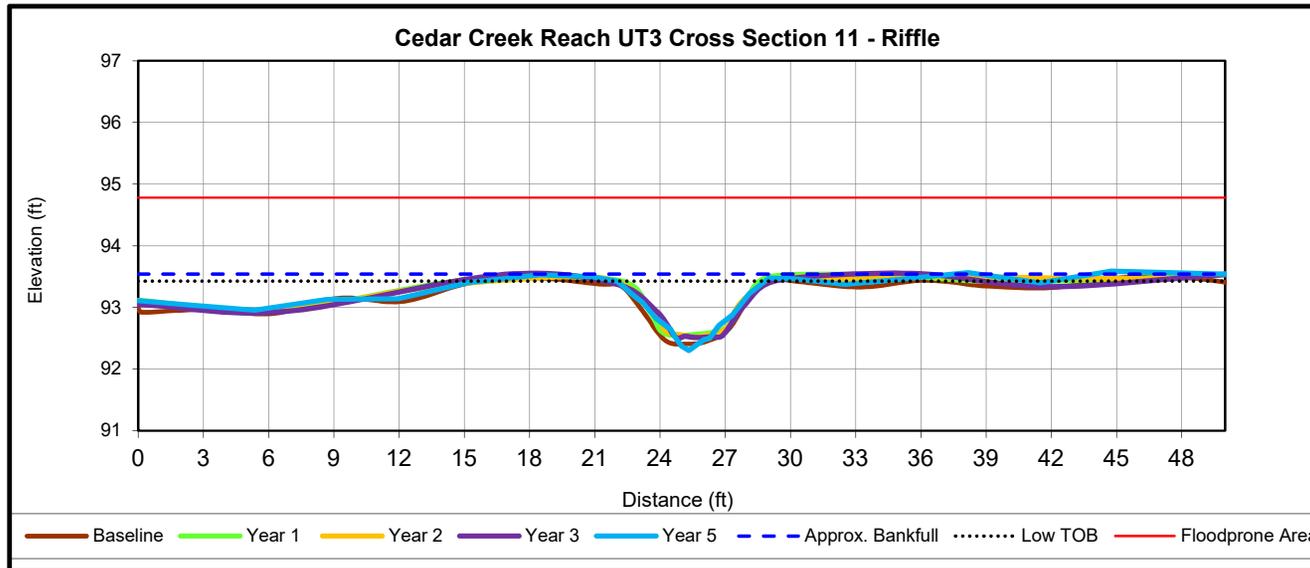
Dimension	Cross Section 11 (Riffle)						
	Base	MY1	MY2	MY3	MY5	MY7	MY+
Bankfull Elevation (ft) - Based on AB-XSA <sup>1</sup>	93.5	93.5	93.5	93.5	93.5		
Bankfull Width (ft) <sup>1</sup>	10.4	6.9	9.3	11.7	10.6		
Floodprone Width (ft) <sup>1</sup>	50.0	50.0	50.0	50.0	50.2		
Bankfull Mean Depth (ft)	0.5	0.6	0.4	0.4	-		
Bankfull Max Depth (ft) <sup>2</sup>	1.1	0.9	1.0	1.0	1.1		
Low Bank Elevation (ft)	-	-	-	-	93.4		
Bankfull Cross Sectional Area (ft <sup>2</sup> ) <sup>2</sup>	4.8	4.2	3.6	4.8	3.9		
Bankfull Width/Depth Ratio	22.2	11.1	24.0	28.6	-		
Bankfull Entrenchment Ratio <sup>1</sup>	>2.2	>2.2	>2.2	>2.2	>2.2		
Bankfull Bank Height Ratio <sup>1</sup>	1.0	1.0	1.0	0.9	<1

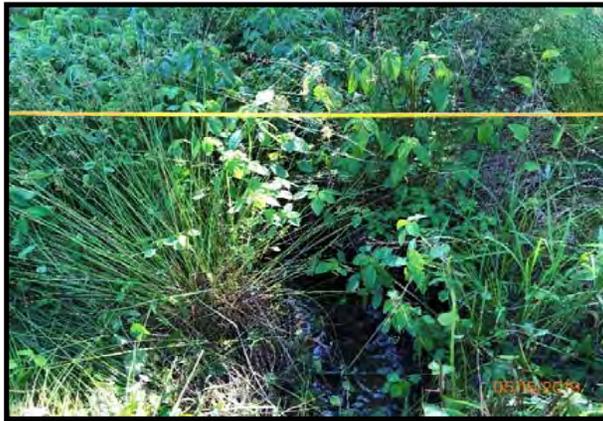
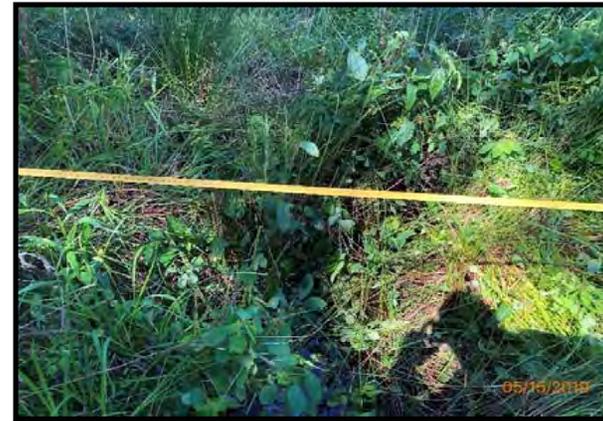
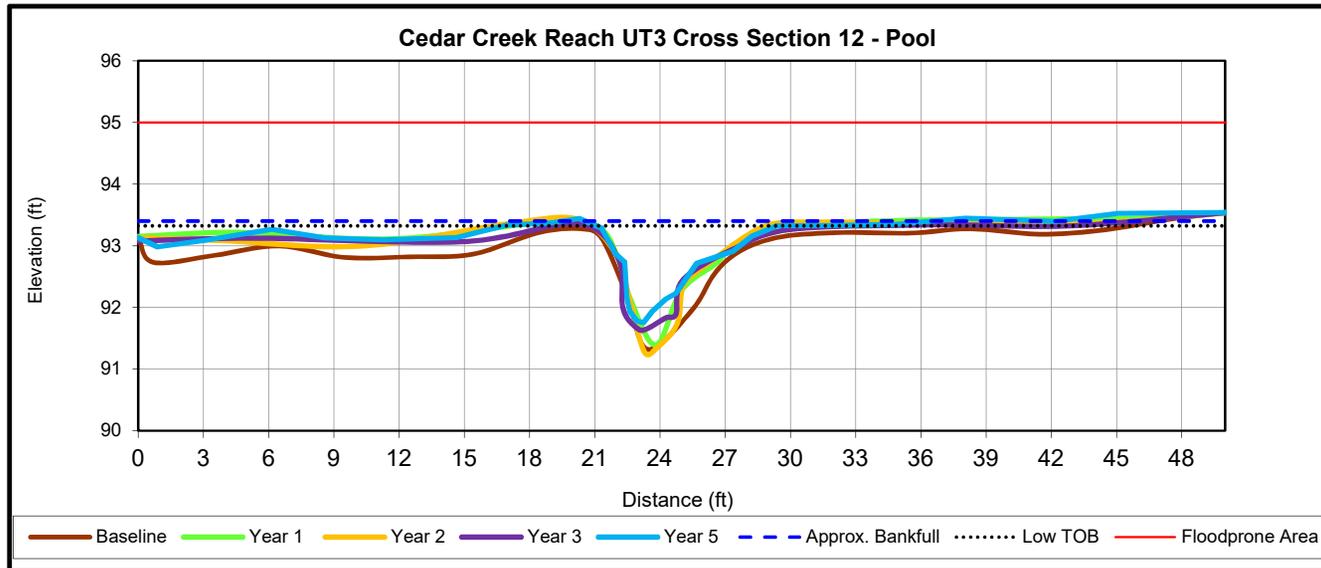
Dimension	Cross Section 12 (Pool)						
	Base	MY1	MY2	MY3	MY5	MY7	MY+
Bankfull Elevation (ft) - Based on AB-XSA <sup>1</sup>	93.1	93.1	93.1	93.1	93.4		
Bankfull Width (ft) <sup>1</sup>	8.1	6.6	6.5	7.6	17.0		
Floodprone Width (ft) <sup>1</sup>	50.0	50.0	50.0	50.0	50.2		
Bankfull Mean Depth (ft)	0.8	0.7	0.8	0.6	-		
Bankfull Max Depth (ft) <sup>2</sup>	1.8	1.7	1.8	1.4	1.6		
Low Bank Elevation (ft)	-	-	-	-	93.3		
Bankfull Cross Sectional Area (ft <sup>2</sup> ) <sup>2</sup>	6.6	4.7	5.1	4.9	5.5		
Bankfull Width/Depth Ratio	10.0	9.3	8.3	11.7	-		
Bankfull Entrenchment Ratio <sup>1</sup>	>2.2	>2.2	>2.2	N/A	N/A		
Bankfull Bank Height Ratio <sup>1</sup>	1.0	1.0	1.0	N/A	N/A

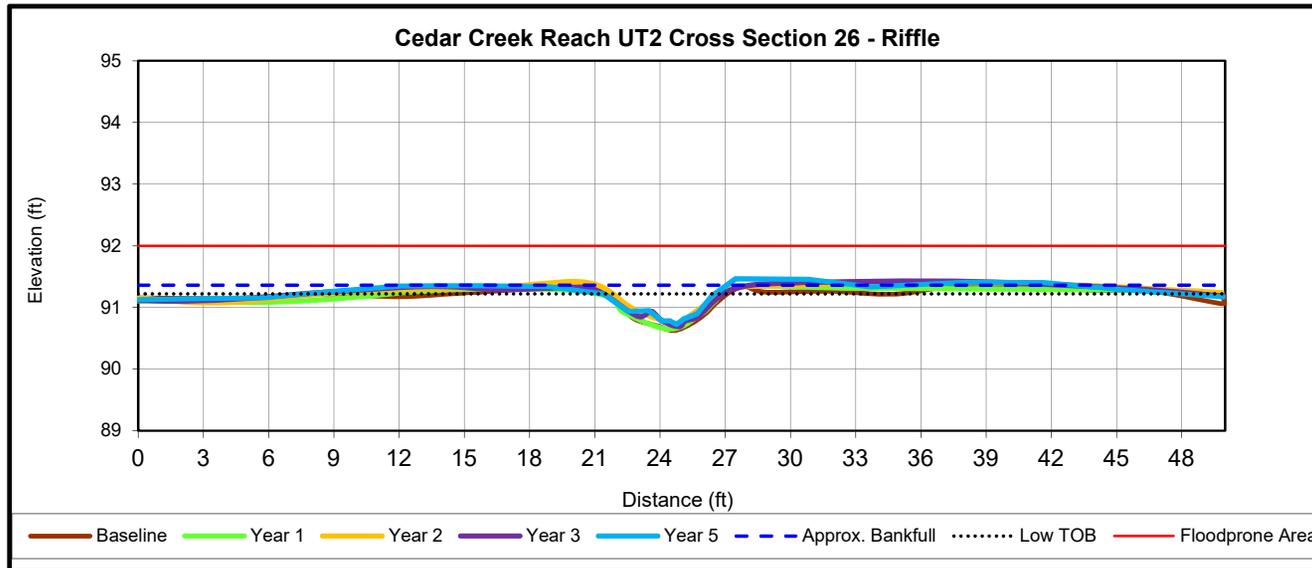
Dimension	Cross Section 26 (Riffle)						
	Base	MY1	MY2	MY3	MY5	MY7	MY+
Bankfull Elevation (ft) - Based on AB-XSA <sup>1</sup>	91.3	91.3	91.3	91.3	91.4		
Bankfull Width (ft) <sup>1</sup>	6.8	8.2	6.0	6.8	11.5		
Floodprone Width (ft) <sup>1</sup>	50.0	50.0	50.0	50.0	49.9		
Bankfull Mean Depth (ft)	0.4	0.3	0.3	0.3	-		
Bankfull Max Depth (ft) <sup>2</sup>	0.7	0.7	0.6	0.6	0.5		
Low Bank Elevation (ft)					91.2		
Bankfull Cross Sectional Area (ft <sup>2</sup> ) <sup>2</sup>	2.5	2.4	1.9	2.1	1.4		
Bankfull Width/Depth Ratio	18.1	27.3	18.9	21.8	-		
Bankfull Entrenchment Ratio <sup>1</sup>	>2.2	>2.2	>2.2	>2.2	>2.2		
Bankfull Bank Height Ratio <sup>1</sup>	1.0	1.0	1.0	1.0	<1

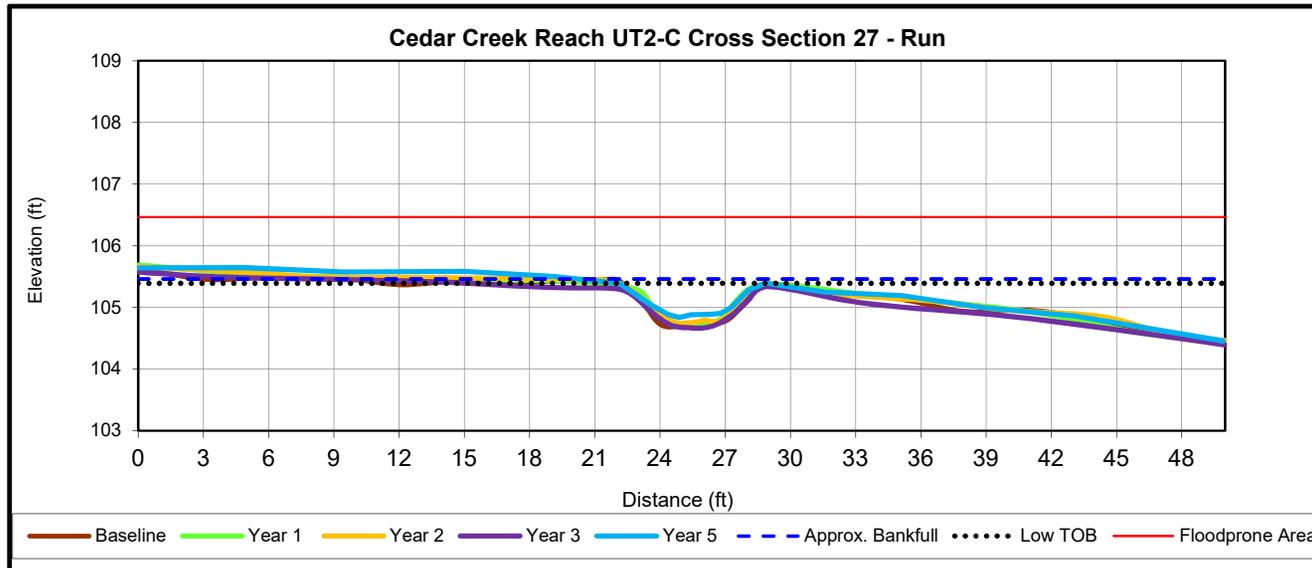
Dimension	Cross Section 27 (Run)						
	Base	MY1	MY2	MY3	MY5	MY7	MY+
<b>Bankfull Elevation (ft) - Based on AB-XSA<sup>1</sup></b>	105.3	105.3	105.3	105.3	105.5		
Bankfull Width (ft) <sup>1</sup>	6.4	5.7	5.7	6.8	8.6		
Floodprone Width (ft) <sup>1</sup>	50.0	50.0	50.0	50.0	49.9		
Bankfull Mean Depth (ft)	0.4	0.4	0.4	0.4	-		
Bankfull Max Depth (ft) <sup>2</sup>	0.9	0.8	0.8	0.9	0.9		
Low Bank Elevation (ft)					105.4		
Bankfull Cross Sectional Area (ft <sup>2</sup> ) <sup>2</sup>	2.8	2.1	2.1	2.6	2.3		
Bankfull Width/Depth Ratio	14.8	15.2	15.5	17.9	-		
Bankfull Entrenchment Ratio <sup>1</sup>	>2.2	>2.2	>2.2	>2.2	>2.2		
Bankfull Bank Height Ratio <sup>1</sup>	1.0	1.0	1.0	1.0	<1
