**CEDAR CREEK STREAM AND WETLAND RESTORATION  
PROJECT  
MONITORING REPORT  
MONITORING YEAR 6  
FINAL**

SAMPSON COUNTY, NORTH CAROLINA  
CONTRACT No. 005011 - PROJECT No. 95718  
USACE ACTION ID No. 2012-00389 – NCDWR PROJECT No. 2013-0186

January 2021

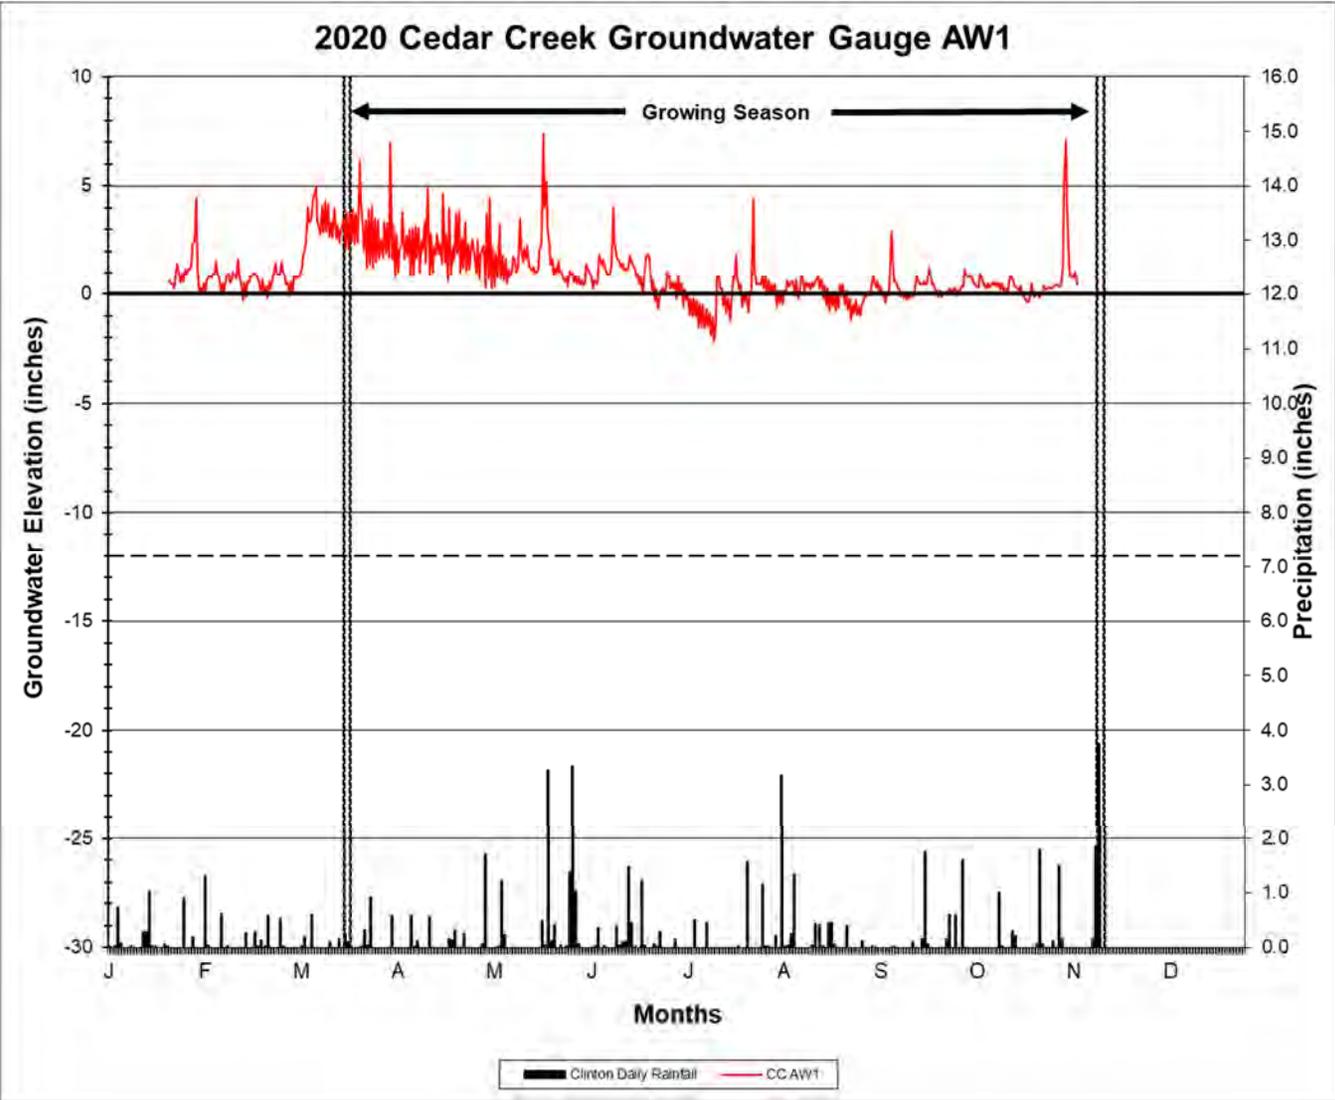
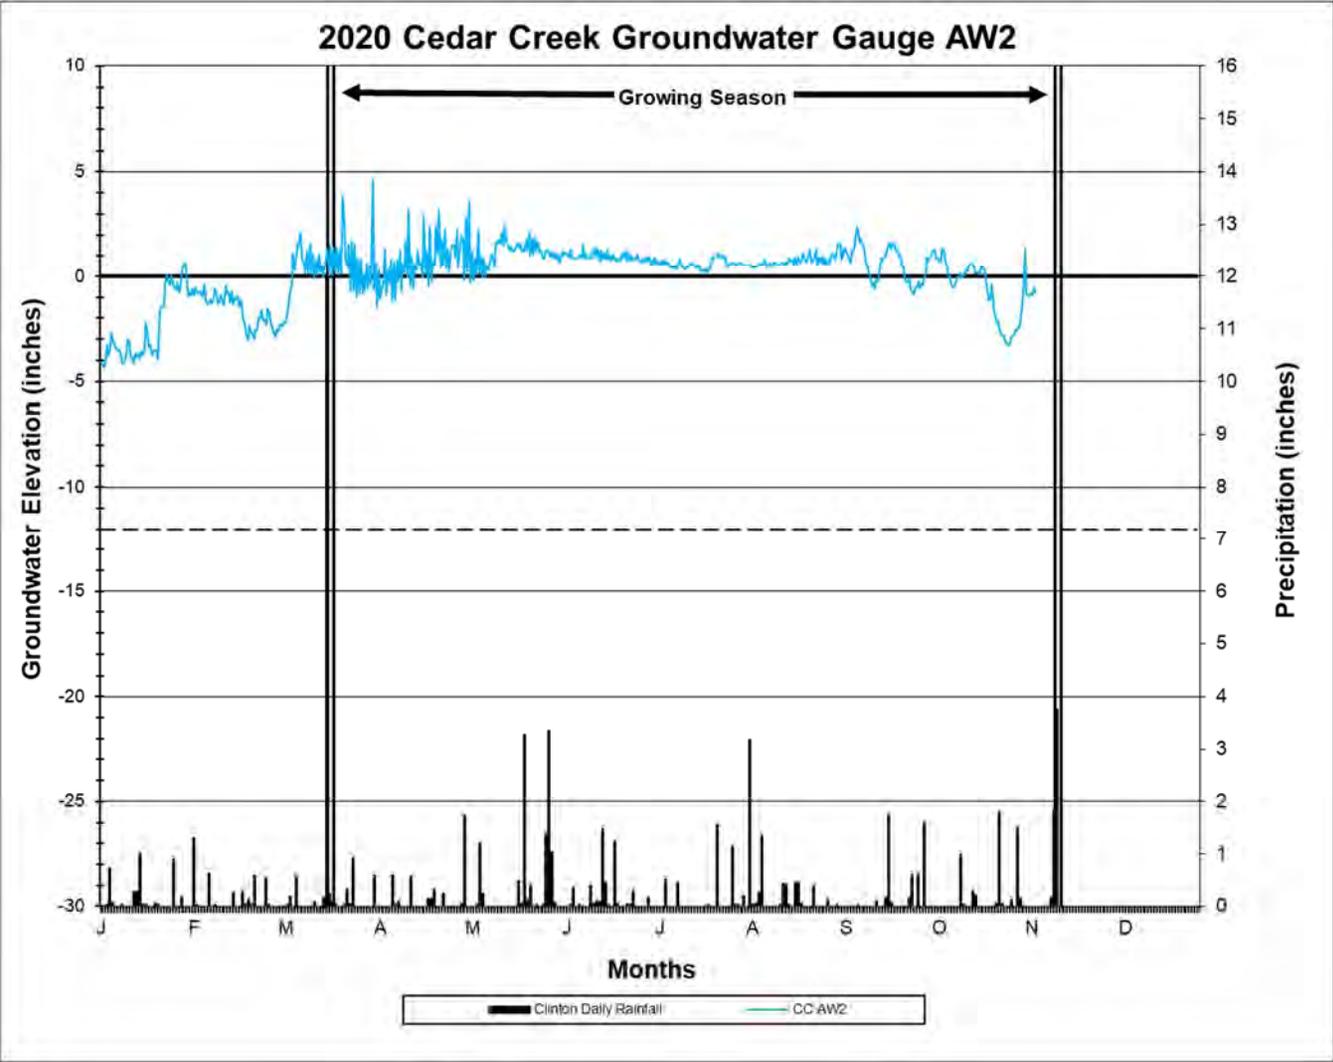
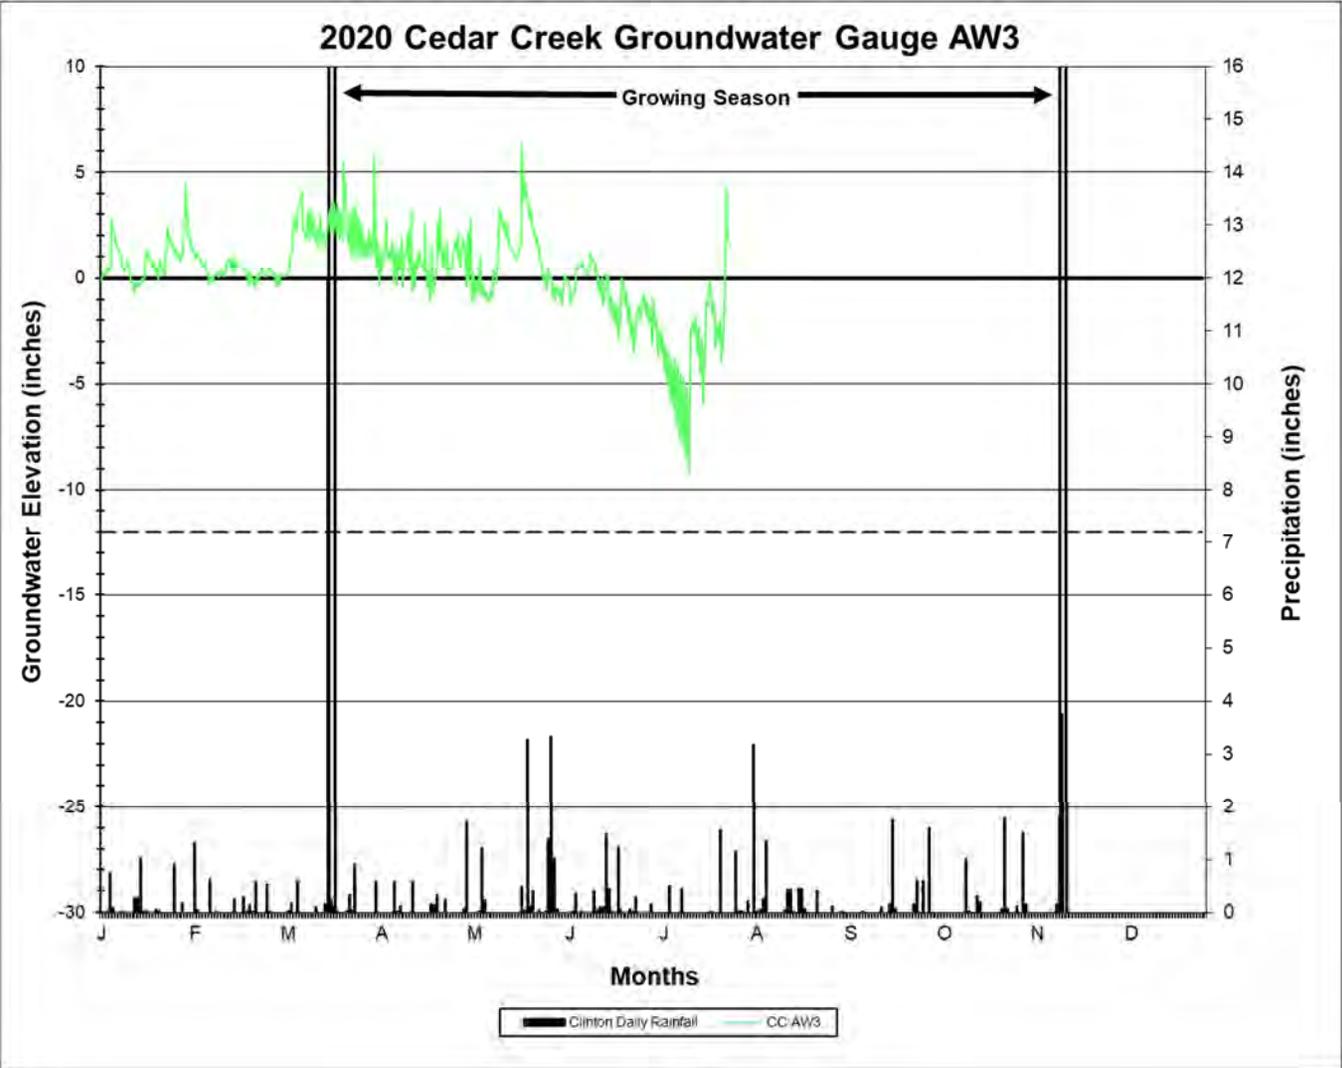
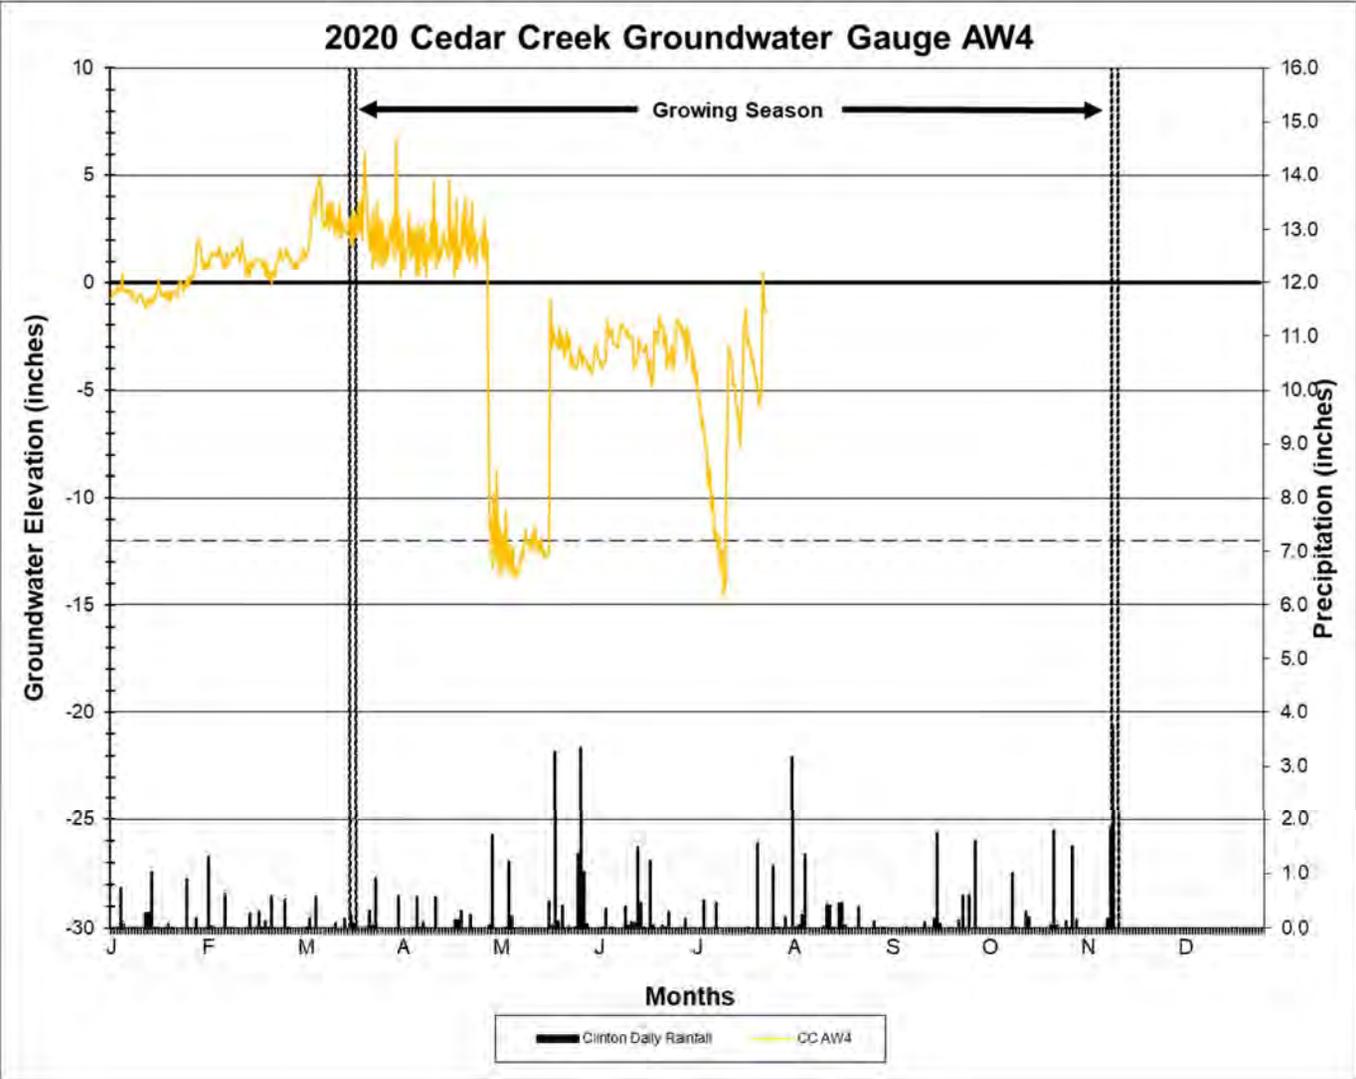
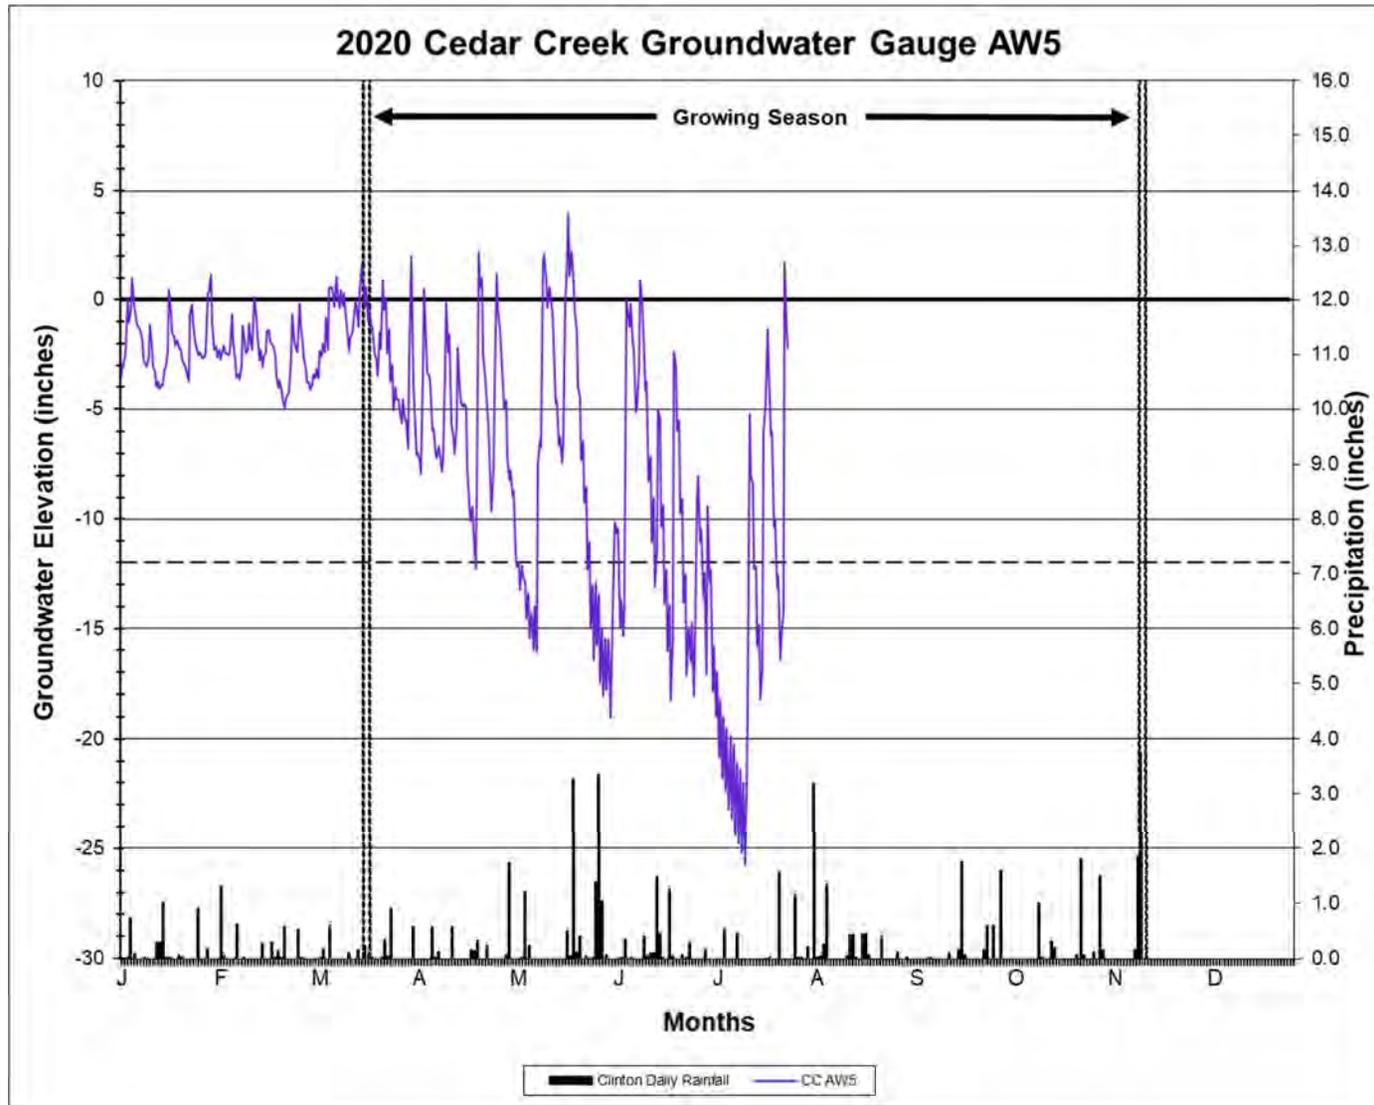
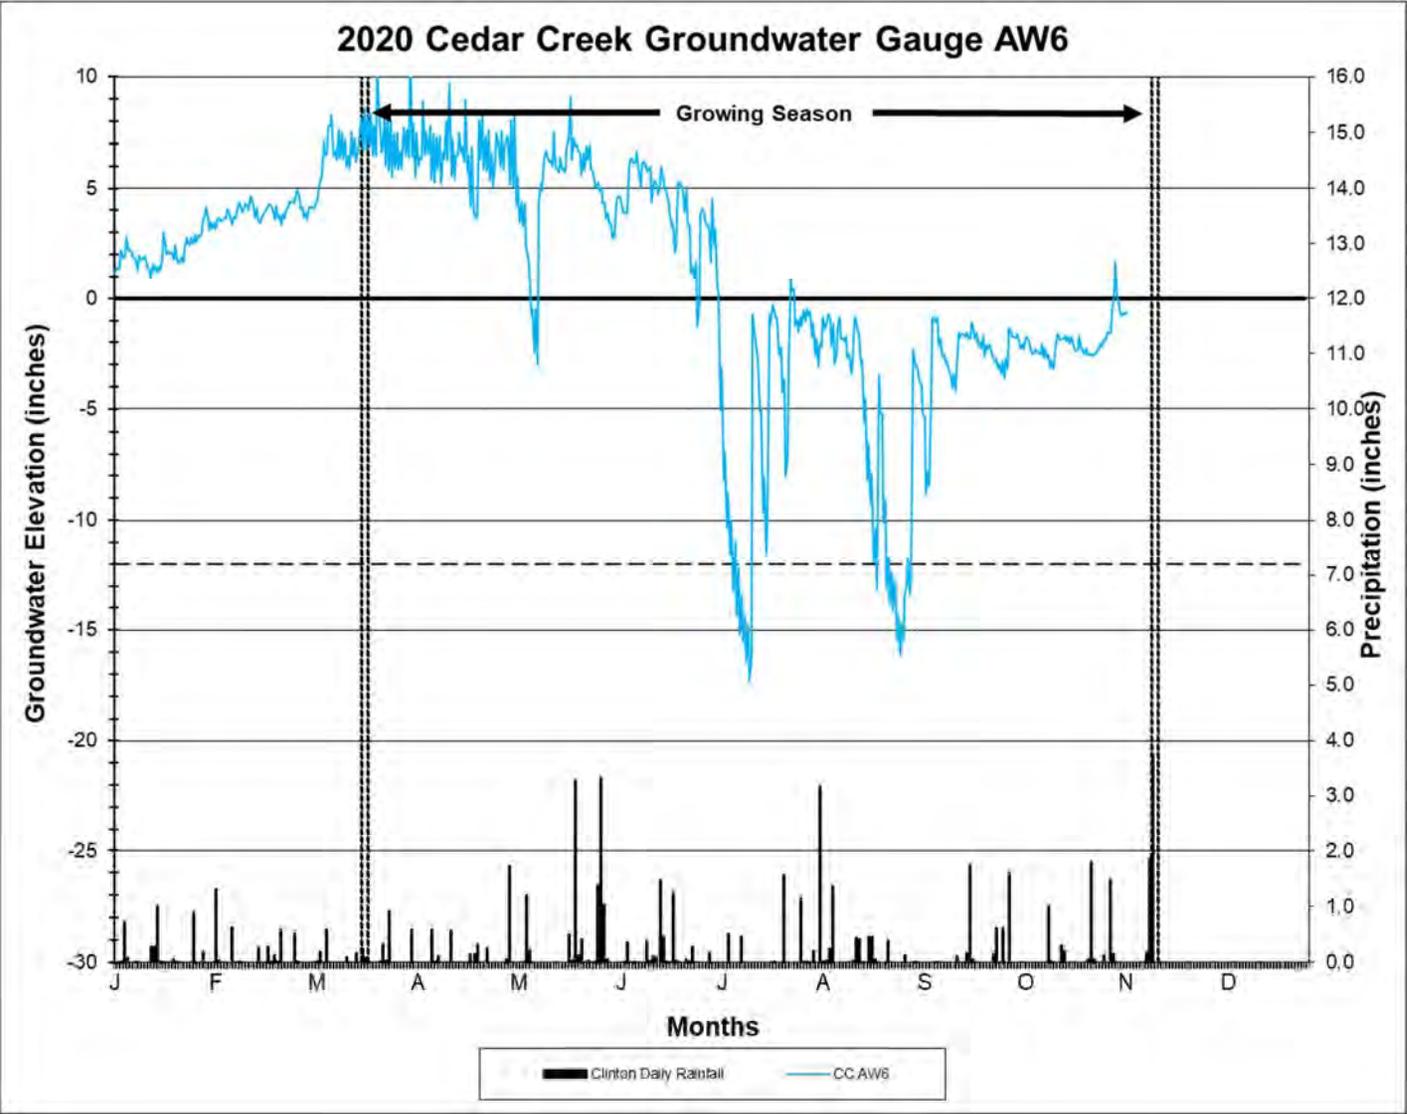
Figure 8. 2020 Cedar Creek Groundwater Monitoring Gauge Hydrographs

Ten of the eleven wetland gauges achieved the success criteria by remaining continuously within 12 inches of the soil surface for at least nine percent of the growing season. Groundwater gauge data indicate the hydroperiods being very responsive to rainfall events. Wetland hydrology gauge AW7 fell short of the nine percent success criteria. AW7 documented 13 days consecutively (five percent) throughout the growing season. AW7 did not meet success criteria for the sixth year in a row. However, in MY5 and MY6 the hydroperiod did increase compared to the previous years and is trending in the right direction. An area, about 1.20 acres, has been considered as at-risk credits. If this well does not meet success again in MY7, RES will perform a wetland delineation and soil development investigation to refine and remove the unsuccessful area from crediting. REFAW2 and REFAW3 reference gauges documented hydroperiods well above the nine percent success criteria at 52 and 51 percent of the growing season, respectively. Wetland gauge and rainfall data is presented in **Table 15** and **Figure 8**.
