MONITORING YEAR 0 ANNUAL REPORT FINAL

DYNAMITE CREEK MITIGATION SITE

Rockingham County, NC
Roanoke River Basin
HUC 03010103

DYNAMITE CREEK MITIGATION SITE
Monitoring Year 0 Annual Report

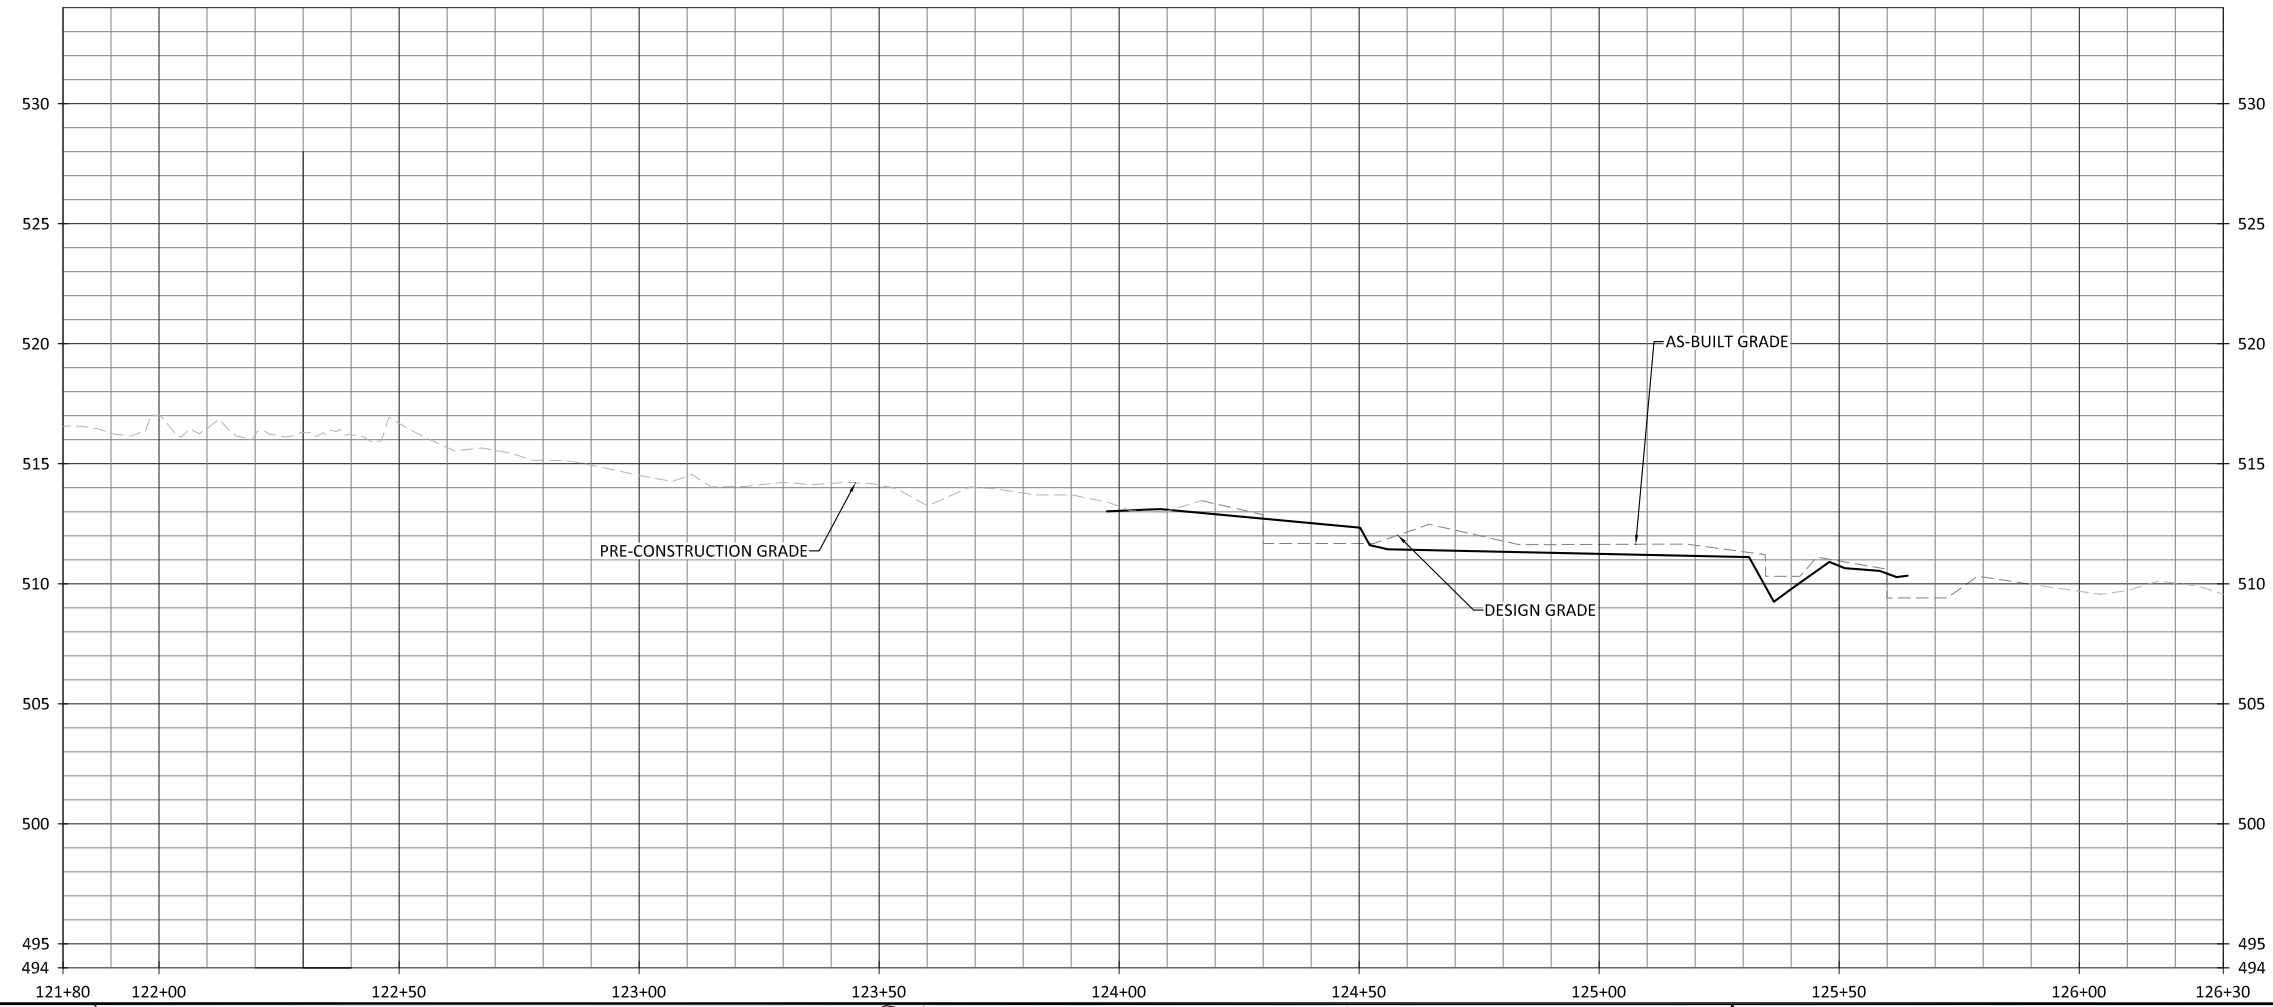
- NOTES:**
1. DEVIATIONS FROM THE DESIGN WILL BE SHOWN IN RED.
 2. STA 124+29, STA 125+35 & STA 125+59:
LOG SILLS NOT INSTALLED TO SAVE EXISTING TREES AND REDUCE OVERALL IMPACT.
 3. STA 124+35 - STA 124+83 (80 LF) & STA 125+36 - STA 125+80 (75.5 LF)
DYNAMITE CREEK REACH 5 WAS DESIGNED TO BE A LIGHT TOUCH ENHANCEMENT APPROACH WITH THE FOCUS ON REPAIRING MEANDER BENDS. TWO AREAS WERE PROPOSED FOR RE-ALIGNMENT IN ORDER TO REPAIR BENDS. THE BENDS WERE ABLE TO BE REPAIRED WITHOUT RE-ALIGNING THE ADJACENT RIFFLES. STREAM CREDITS ARE PRESENTED BASED ON THE ORIGINAL DESIGN ALIGNMENT IN THE MITIGATION PLAN.
 4. STA 124+17 - STA 124+30 & 125+18 - STA 125+34:
RIFFLES NOT INSTALLED BECAUSE CHANNEL NOT REALIGNED.

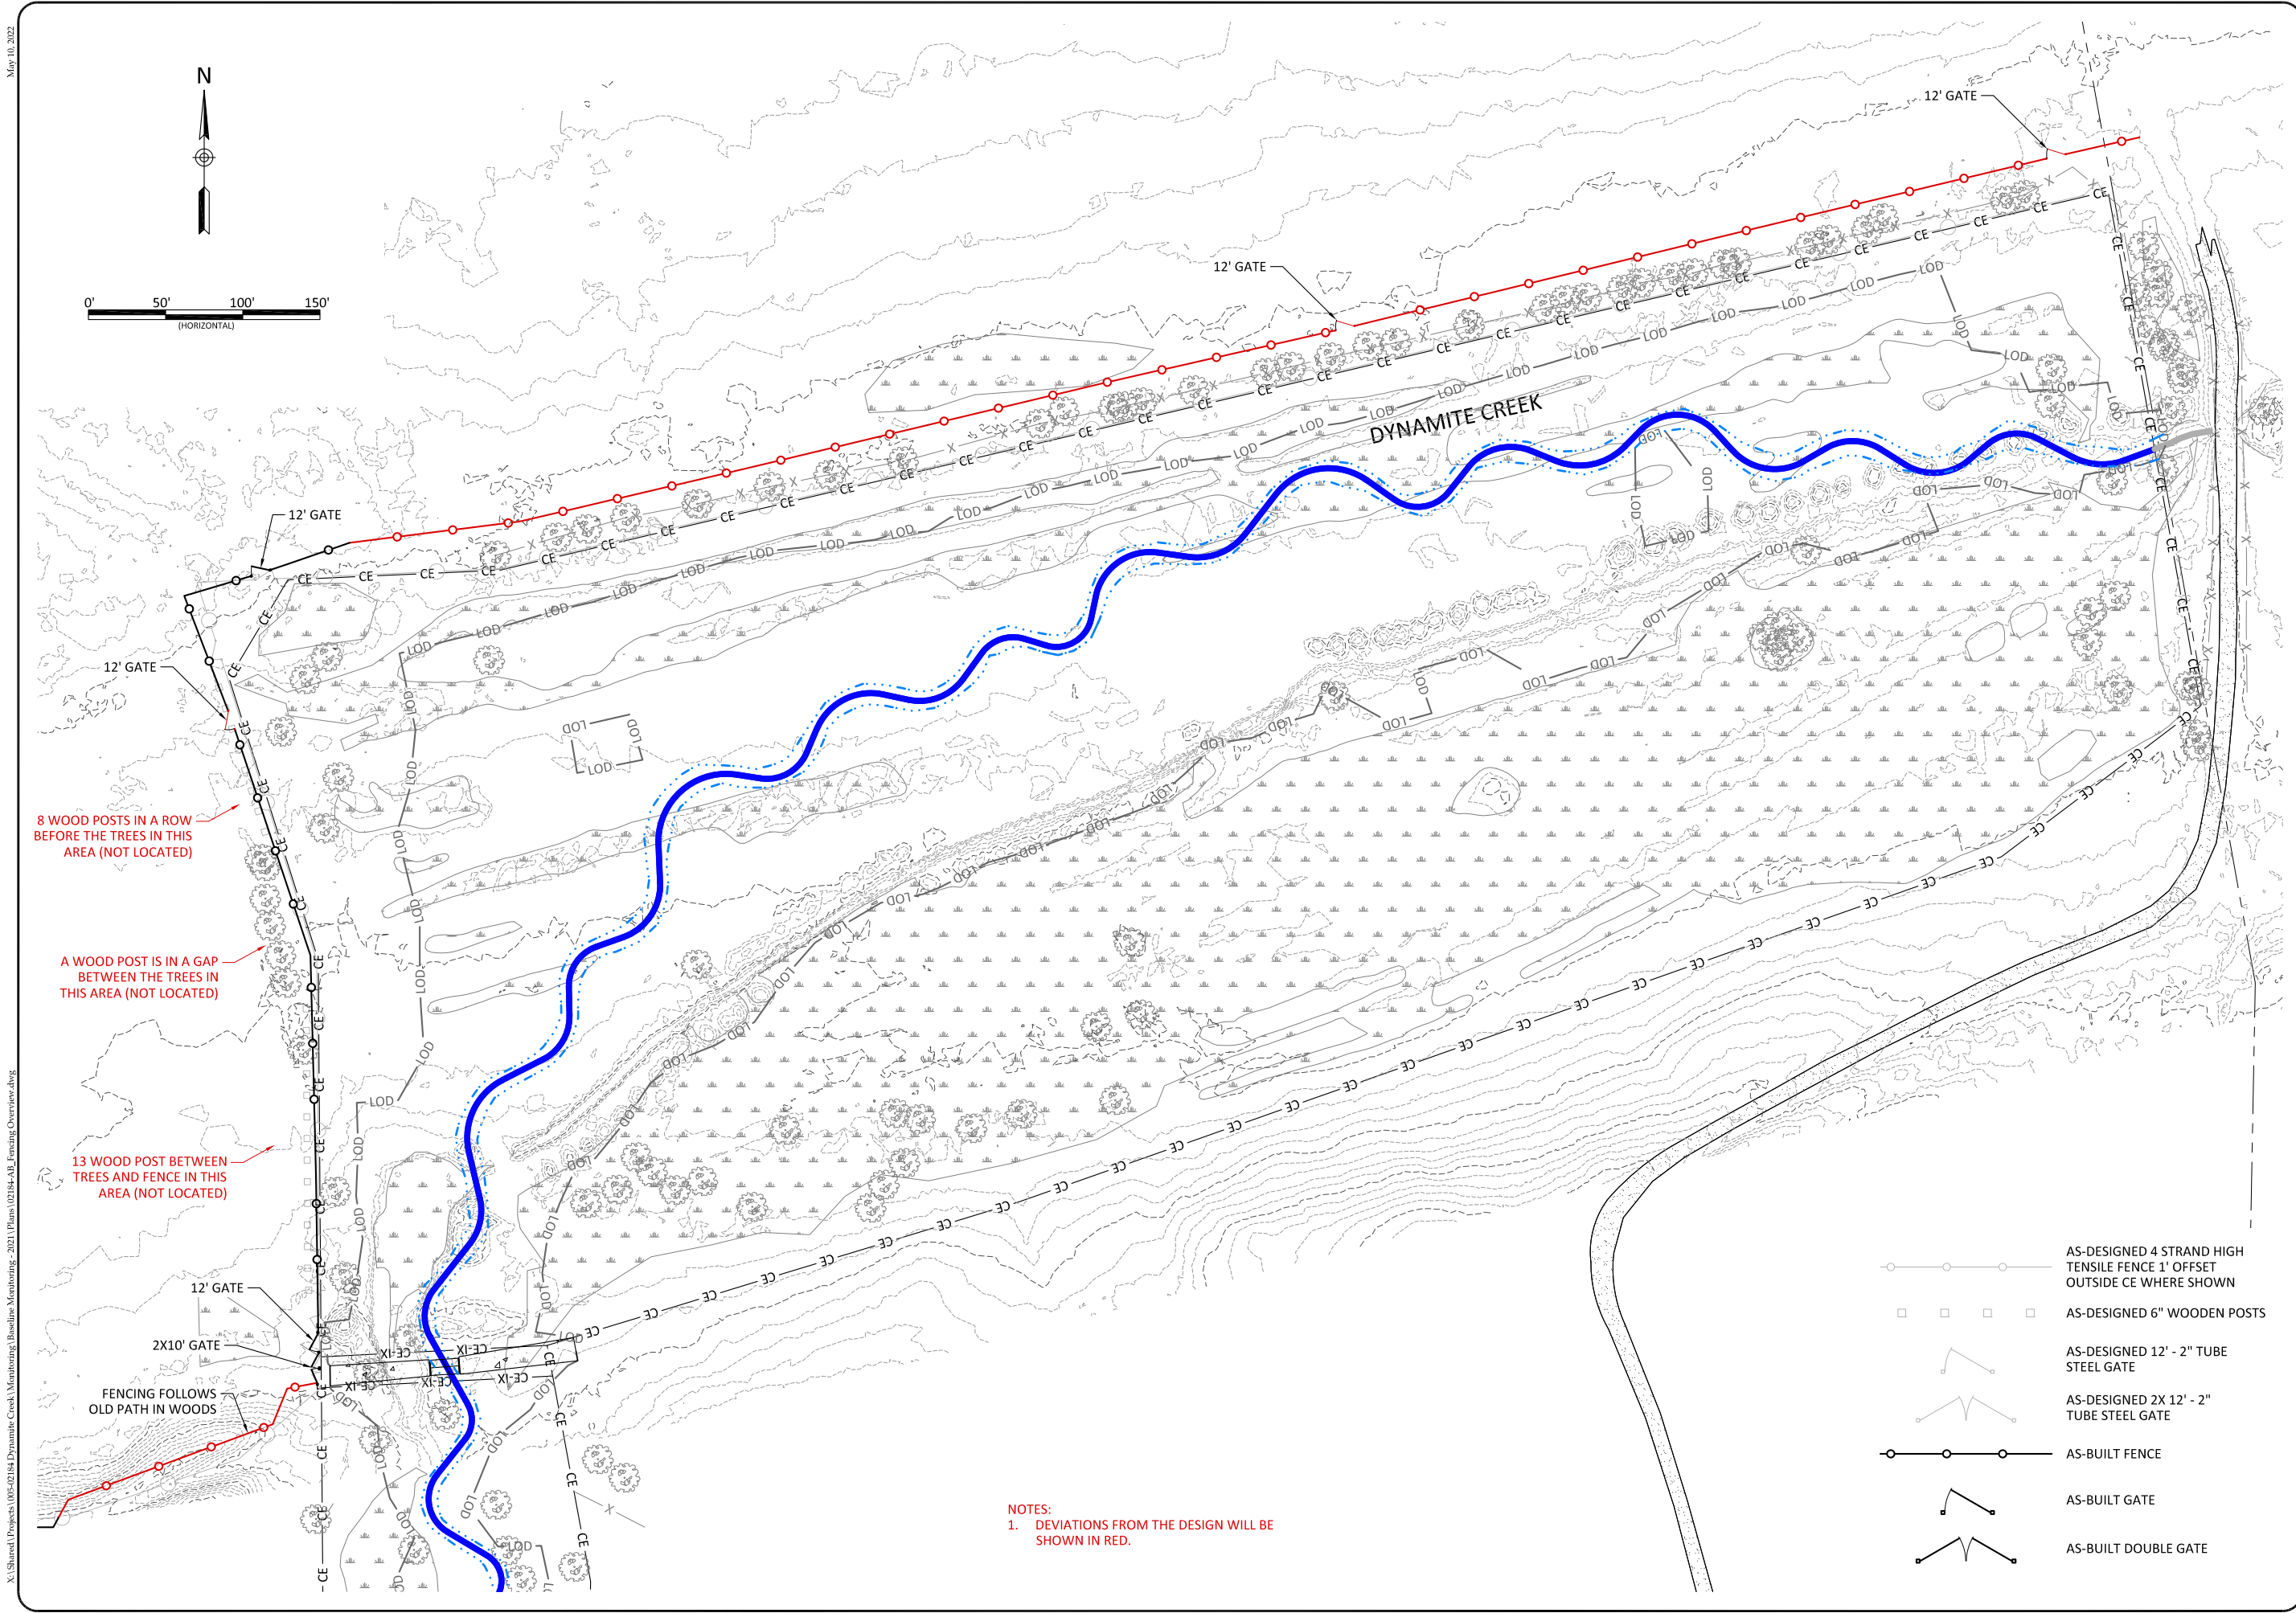
3.1

8 WOOD POSTS IN A ROW BEFORE THE TREES IN THIS AREA (NOT LOCATED)

A WOOD POST IS IN A GAP BETWEEN THE TREES IN THIS AREA (NOT LOCATED)
