MONITORING YEAR 0 ANNUAL REPORT FINAL

CARPENTER BOTTOM MITIGATION SITE

Gaston County, NC
Catawba River Basin
HUC 03050102
(03050103 Expanded Service Area)

DMS Project No. 100090
NC DEQ Contract No. 7731
DMS RFP No. 16-007133-CT03
Date of Issue: April 24, 2017
USACE Action ID No. SAW-2018-02062
DWR Project No. 2019-0049
Data Collection Dates: August 2021 - February 2022

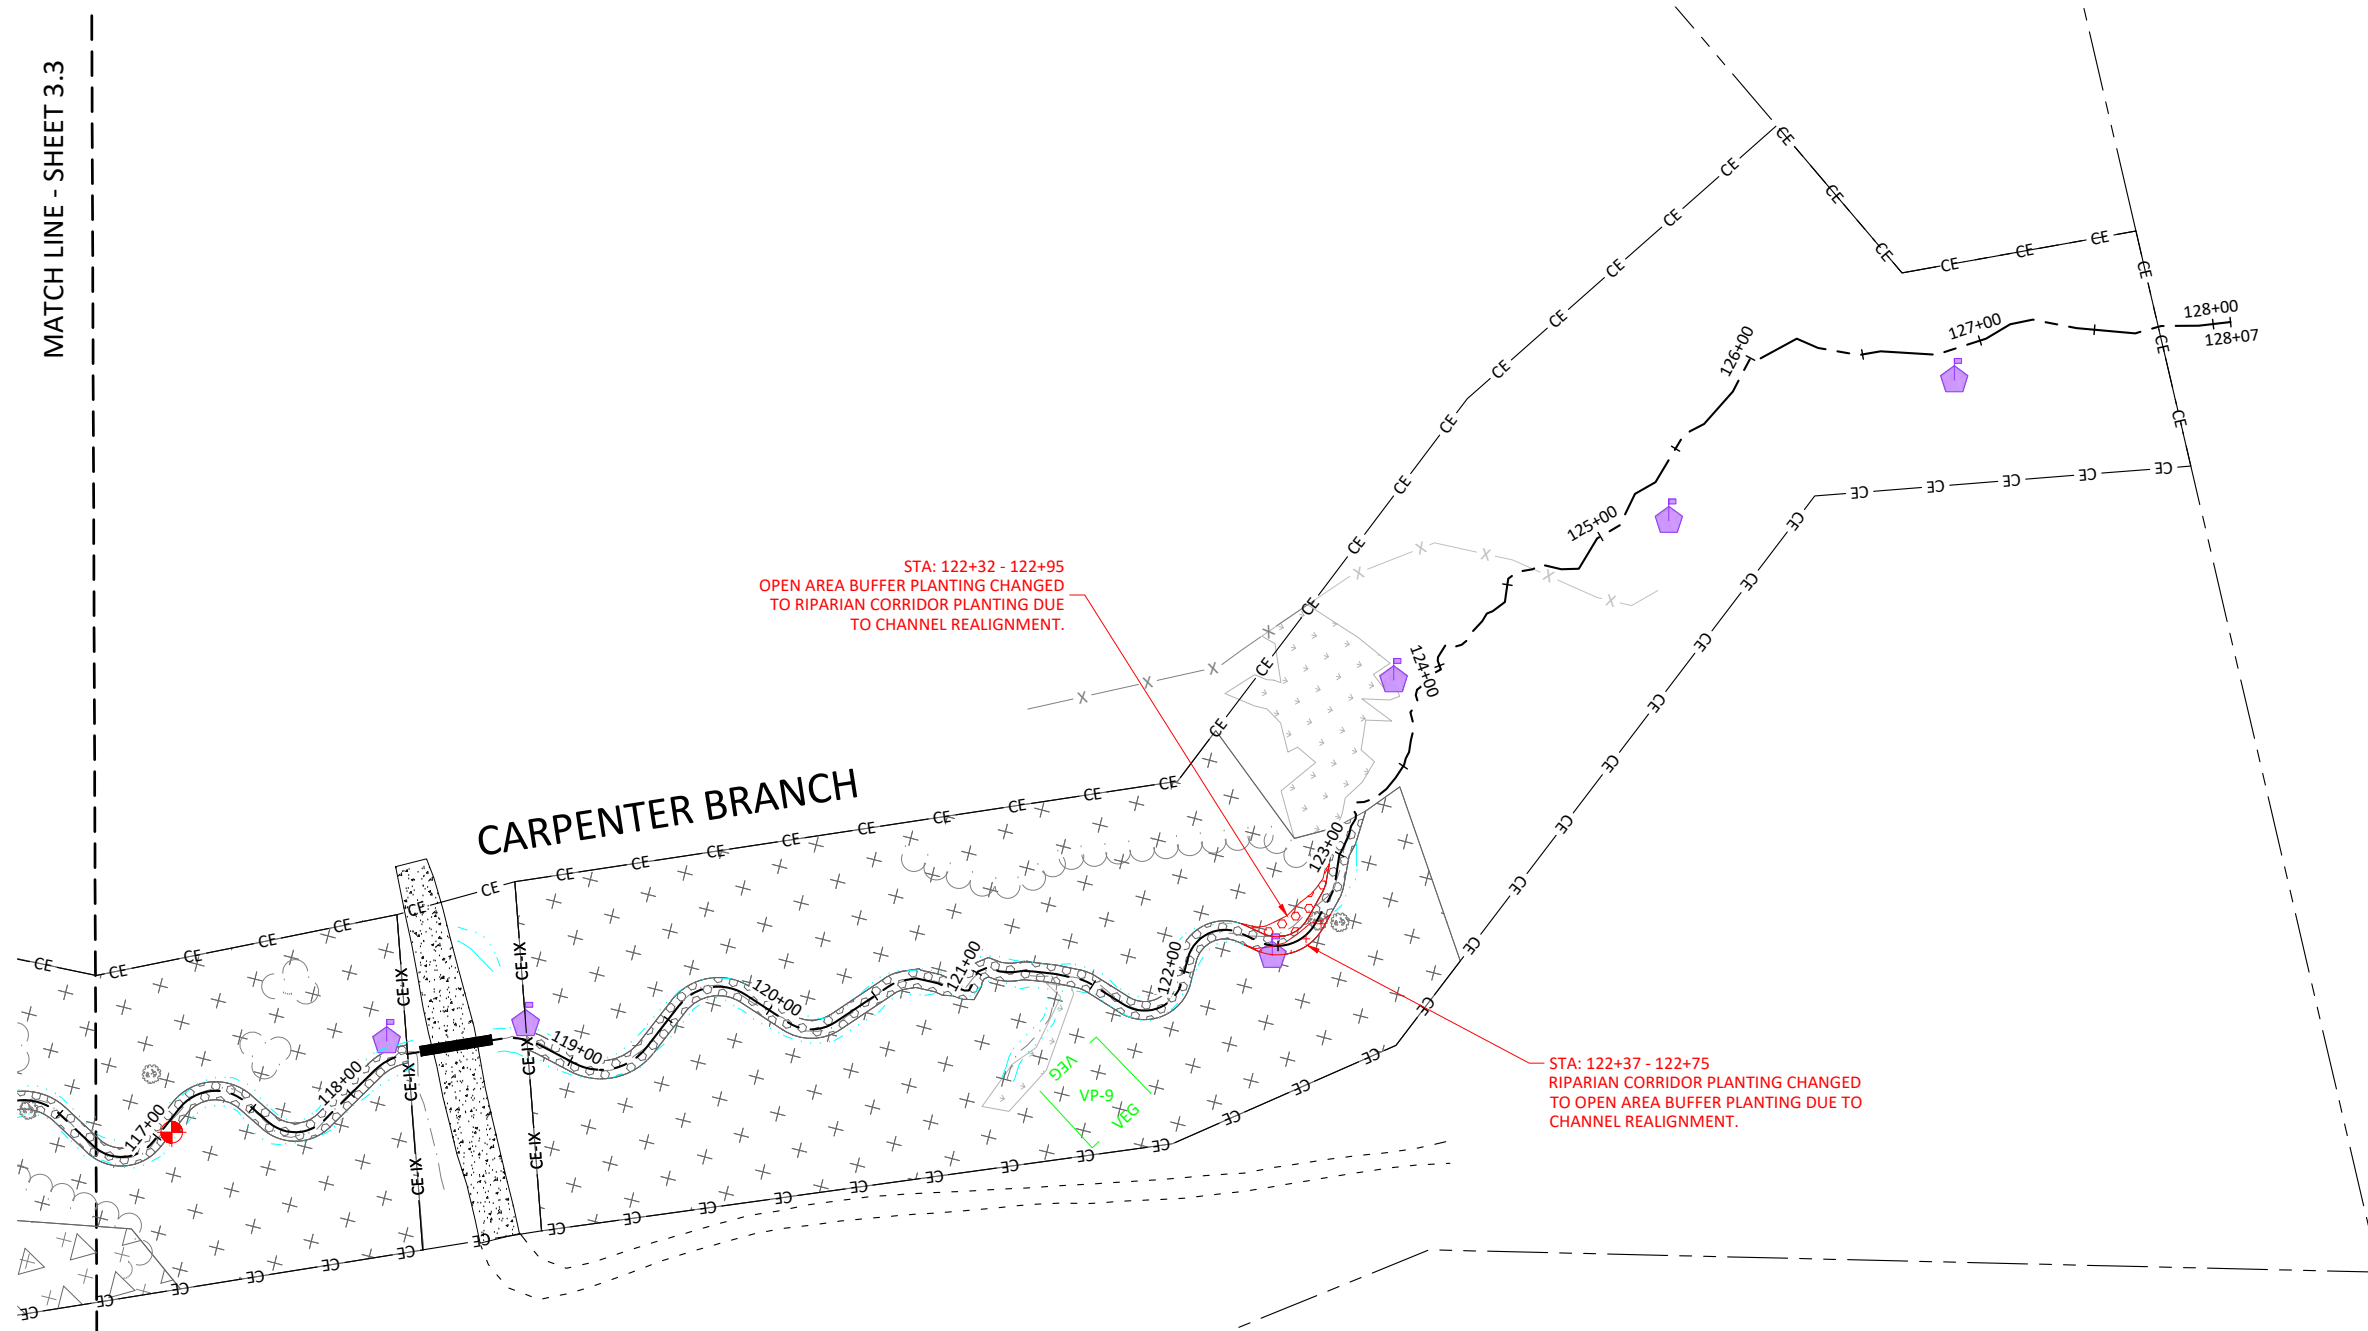
CARPENTER BRANCH

STA: 122+32 - 122+95
OPEN AREA BUFFER PLANTING CHANGED
TO RIPARIAN CORRIDOR PLANTING DUE
TO CHANNEL REALIGNMENT.

STA: 122+37 - 122+75
RIPARIAN CORRIDOR PLANTING CHANGED
TO OPEN AREA BUFFER PLANTING DUE TO
CHANNEL REALIGNMENT.
