MONITORING YEAR 0 ANNUAL REPORT FINAL

HUNTSMAN MITIGATION SITE

Wilkes County, NC
Yadkin River Basin
HUC 03040102

DMS Project No. 100123

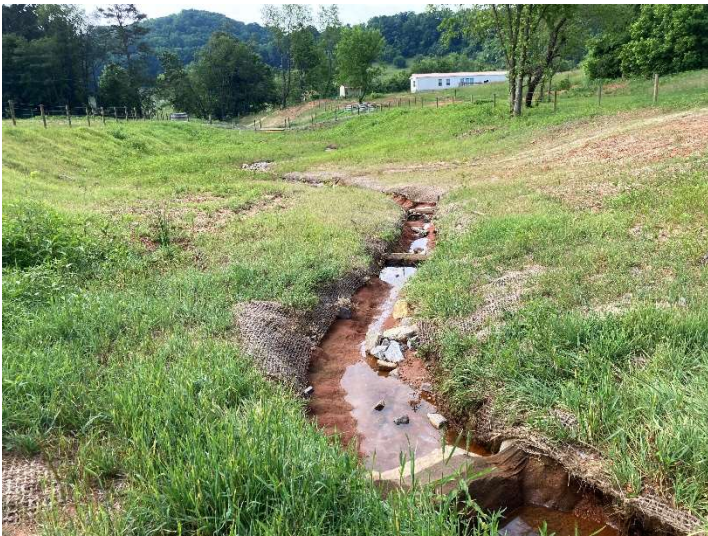
Displaced Riffle Material – UT1 Reach 1 STA 210+50 - 212+50
(06/01/2022)

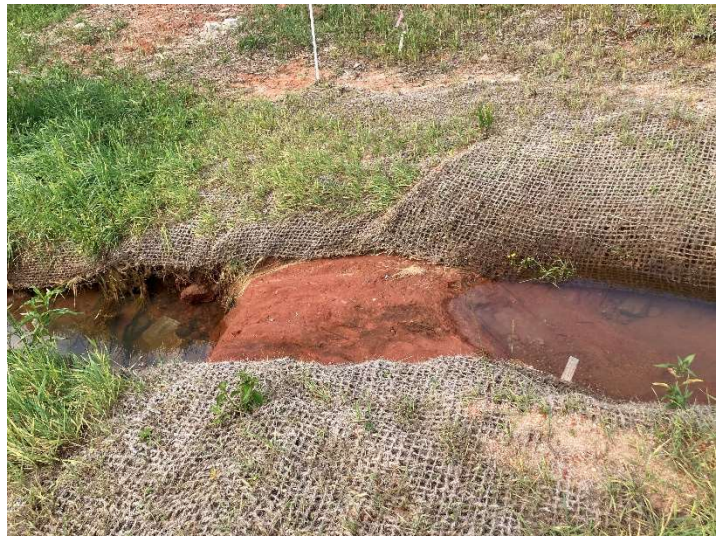
Displaced Riffle Material – UT1 Reach 1 STA 211+20
(06/01/2022)

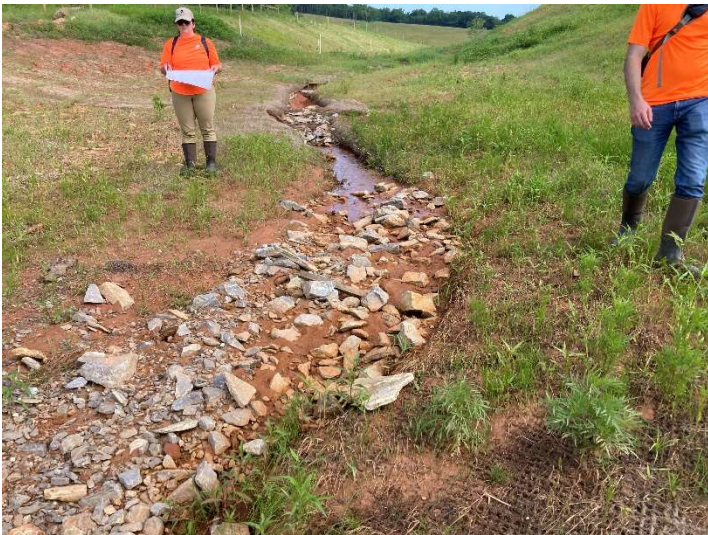
Displaced Riffle Material in Pool – UT1 Reach 1 STA 212+75
(06/01/2022)

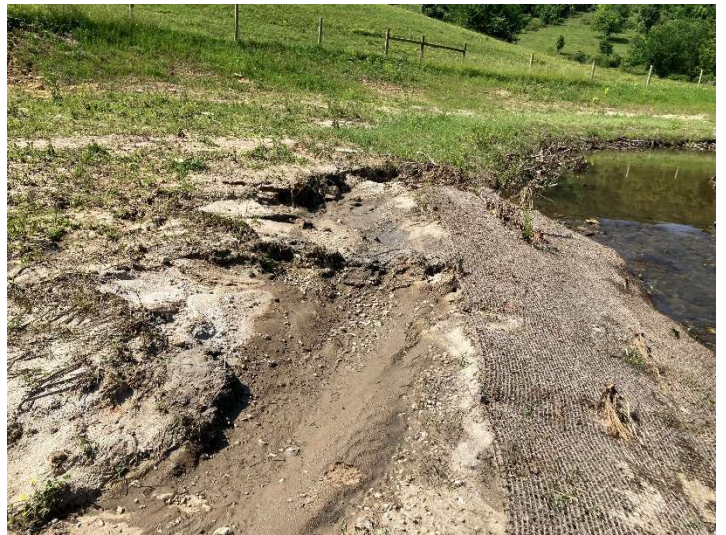
Floodplain Scour behind Top of Bank – NL Hunting Creek R1
STA 102+60 (06/01/2022)
