# **PHASE II MONITORING YEAR 0 ANNUAL REPORT**

## **MILLSTONE CREEK MITIGATION SITE**

Randolph County, NC  
Cape Fear River Basin  
HUC 03030003

DMS Project No. # 204  
NCDEQ Contract No. 6741  
USACE Action ID No. 2018-01788  
DWR Project No. 16-1200  
Data Collection Dates: February 2024 – April 2024

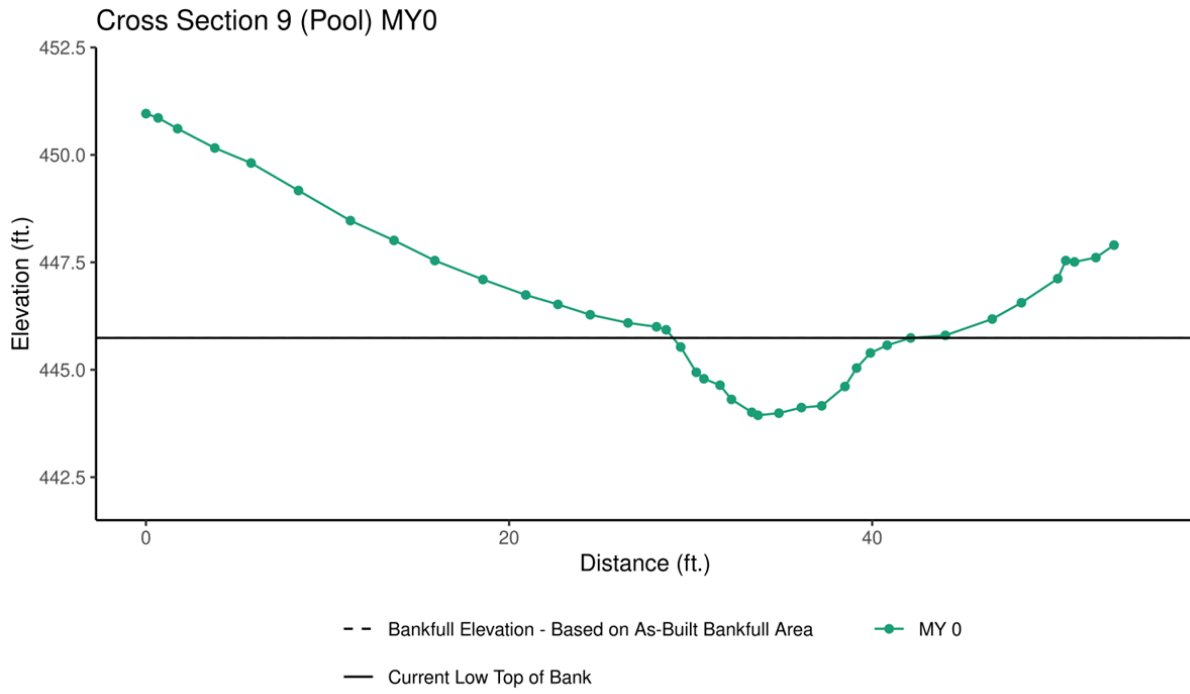
UTA-R1 – Cross Section 9 (Pool)	MY0	MY1	MY2	MY3	MY5	MY7
<b>Bankfull Elevation - Based on As-Built Bankfull Area</b>	445.74					
<b>Bank Height Ratio - Based on As-Built Bankfull Area</b>	1.00					
<b>Thalweg Elevation</b>	443.94					
<b>LTOB Elevation</b>	445.74					
<b>LTOB Max Depth</b>	1.80					
<b>LTOB Cross Sectional Area</b>	13.92

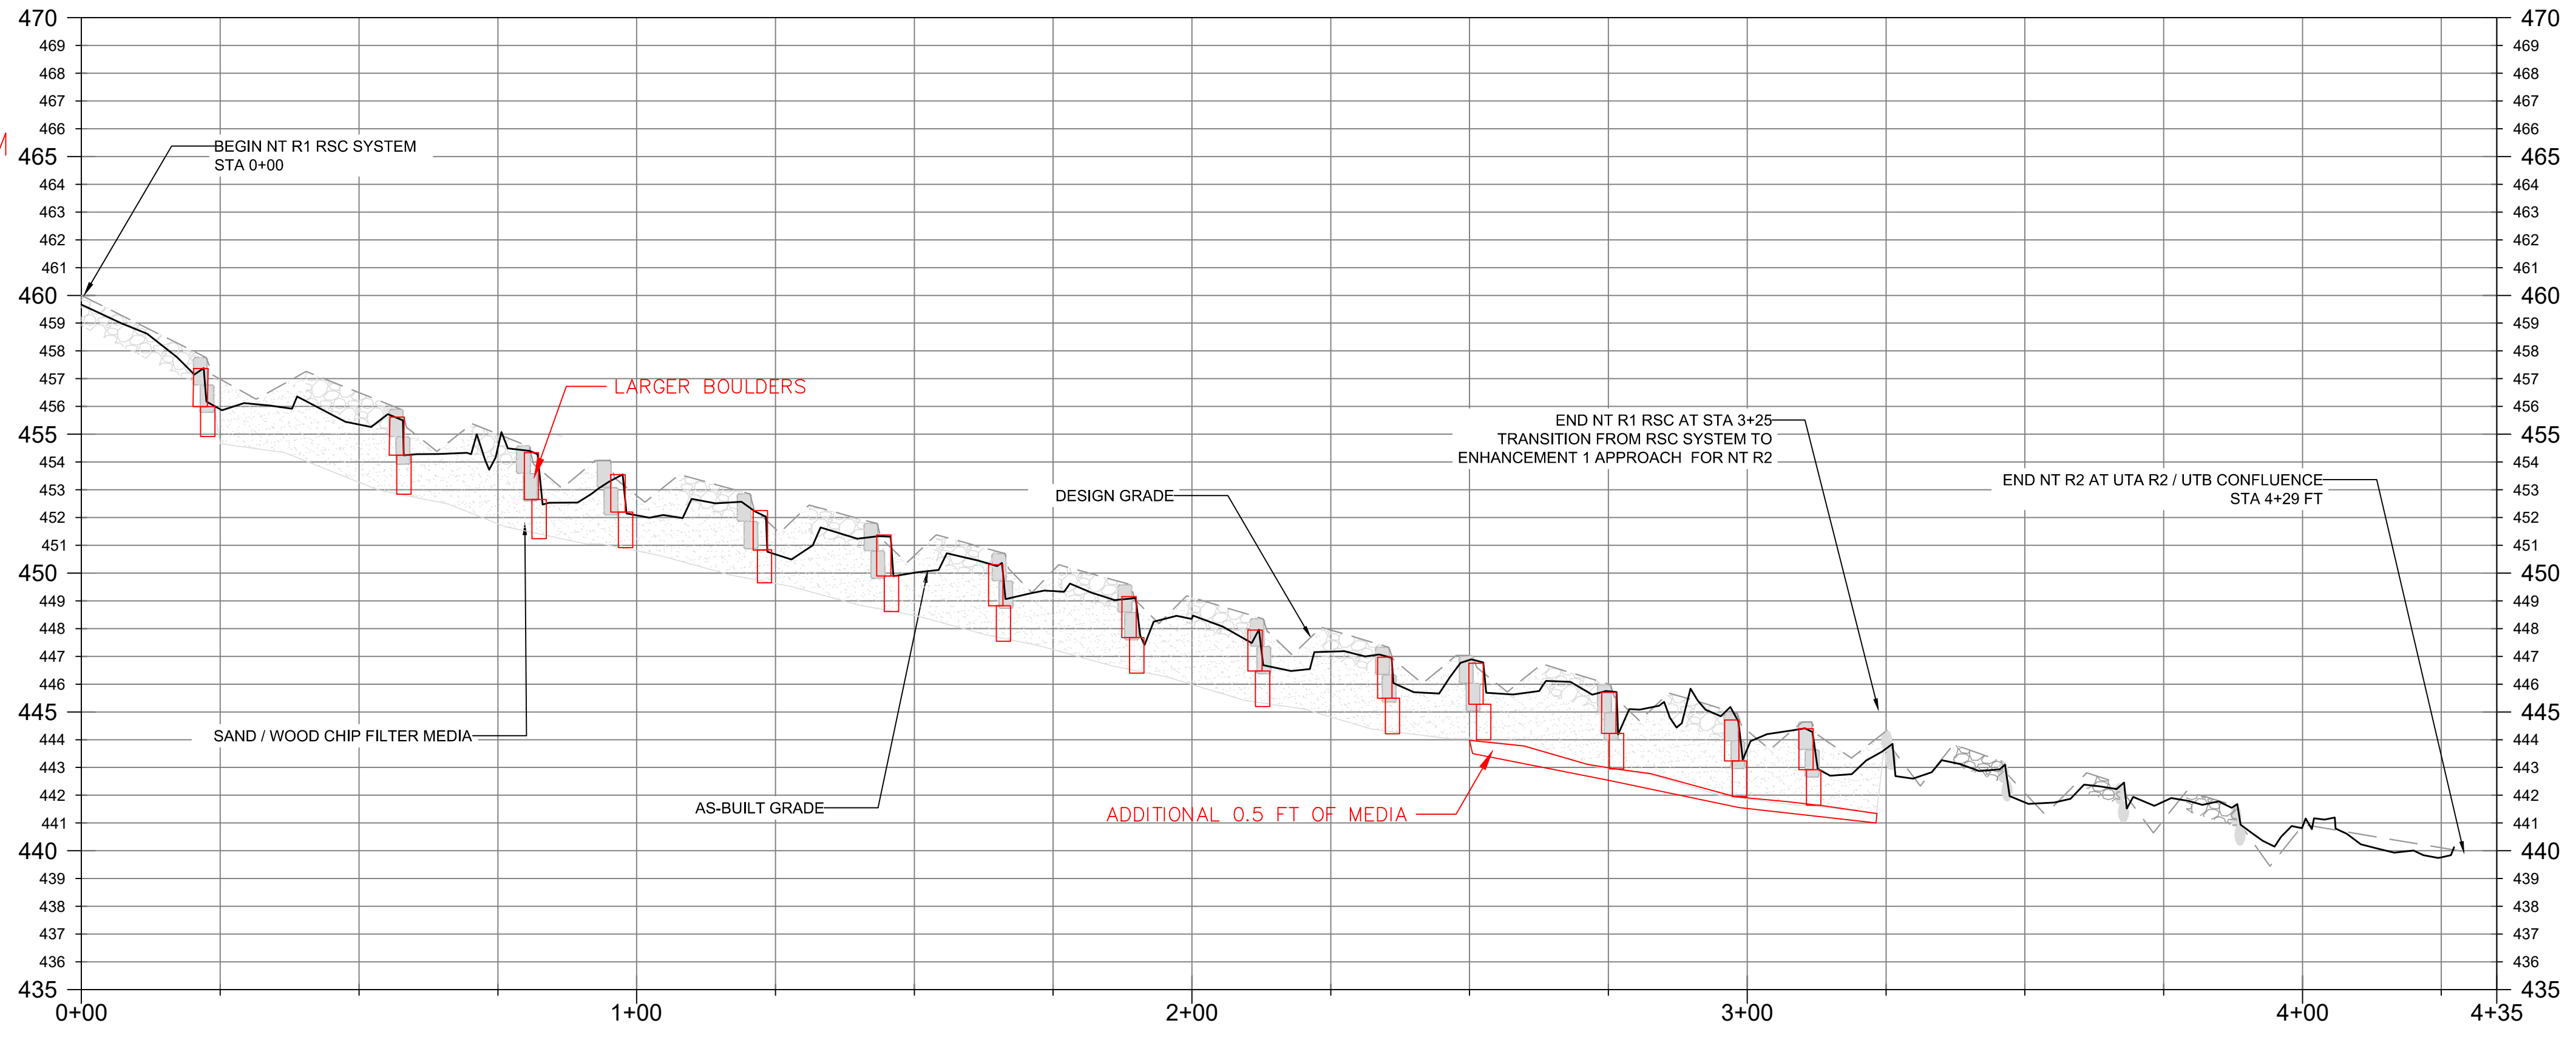
- NOTES:**
1. DEVIATIONS FROM THE DESIGN WILL BE SHOWN IN RED
  2. BOULDERS ARE LARGER THAN SPECIFIED AND EXTEND TO THE BOTTOM OF THE MEDIA TRENCH. AN ADDITIONAL 0.5 FT OF MEDIA WAS ADDED FROM STA 2+50 TO STA 3+25 TO COMPENSATE FOR THE LOSS IN MEDIA VOLUME DUE TO THE LARGER BOULDERS

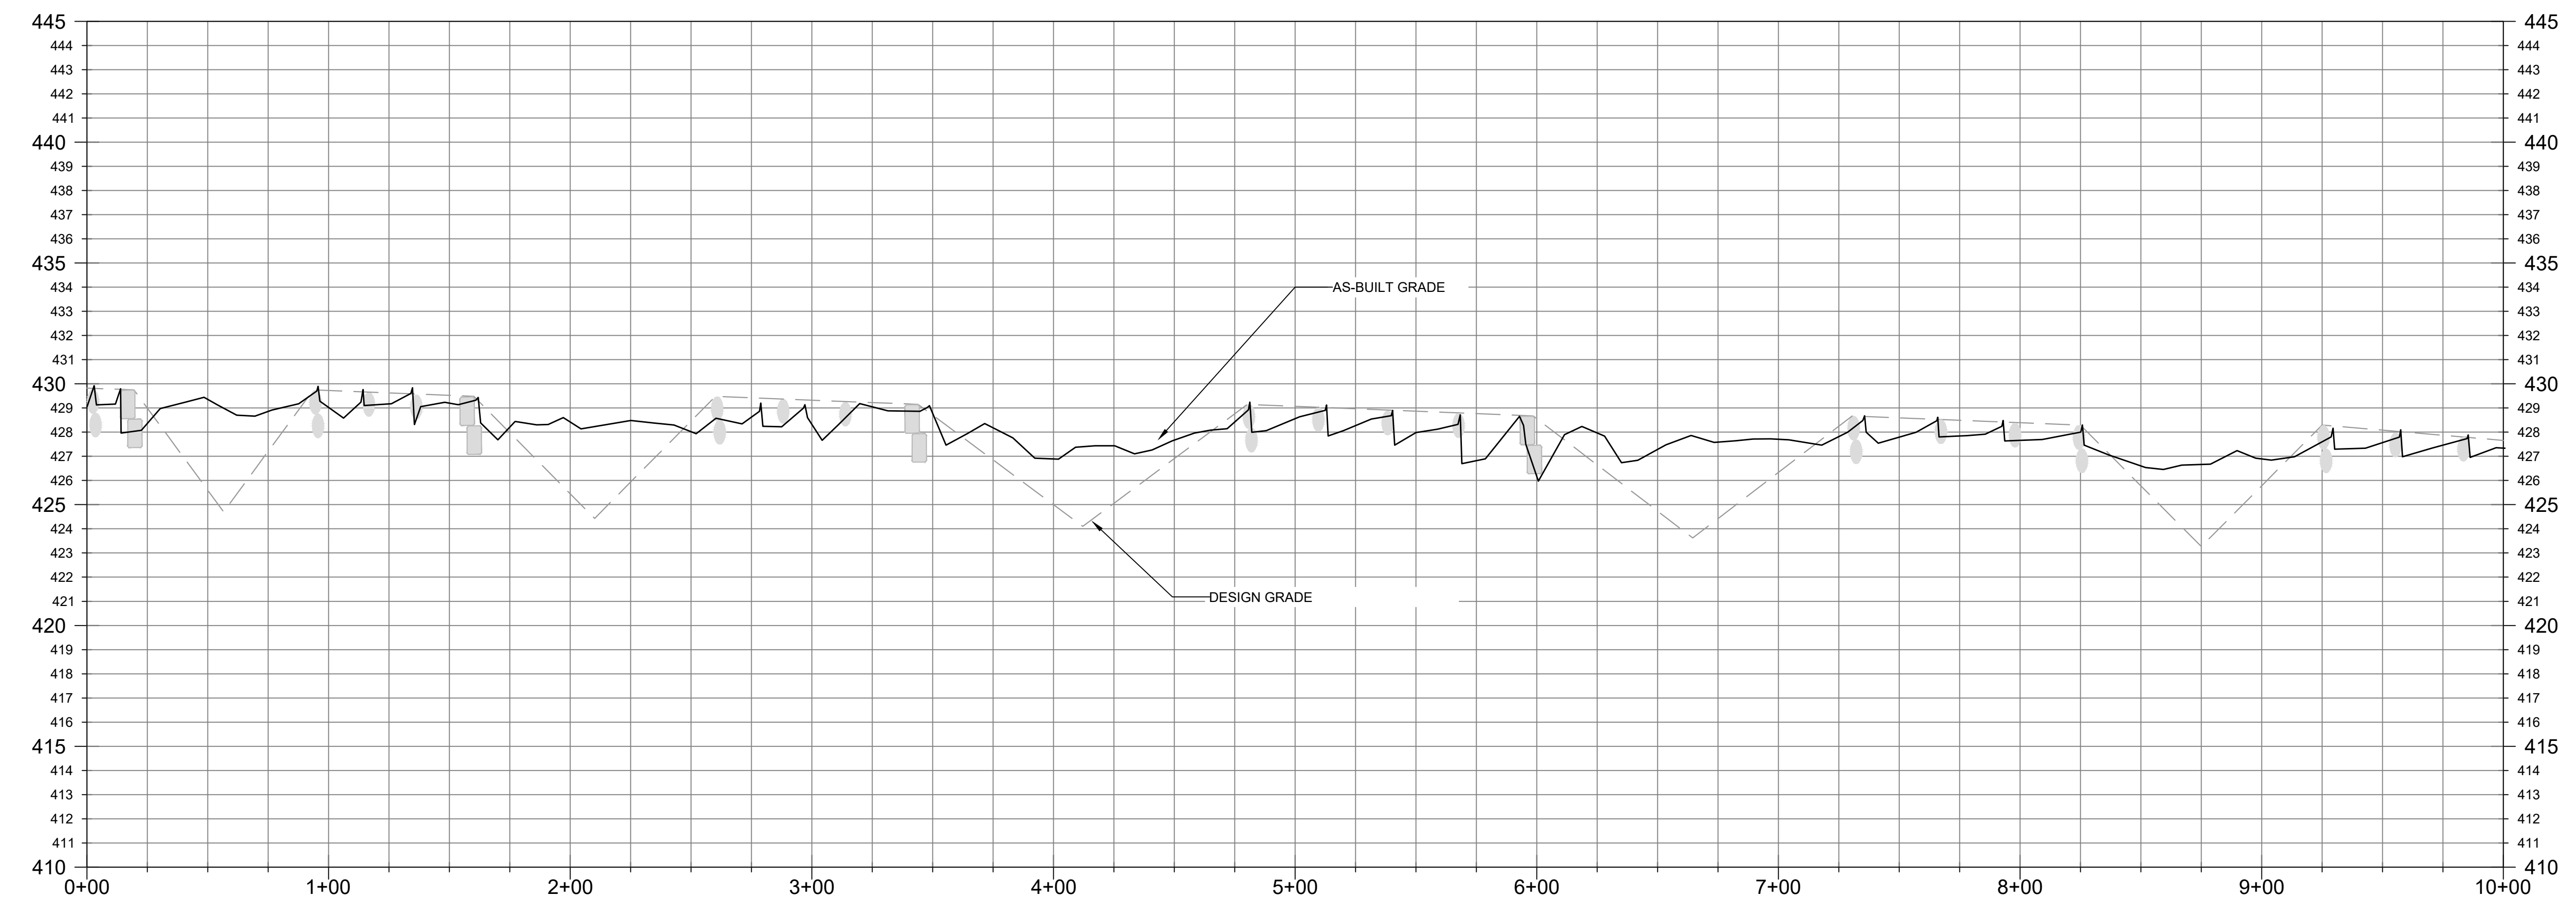
- NOTES:
1. DEVIATIONS FROM THE DESIGN WILL BE SHOWN IN RED
  2. ALL J-HOOKS WERE LOCATED AND ORIENTED ACCORDING TO THE DESIGN DETAIL NOT THE PLAN VIEW LOCATION
  3. ALL POOL DEPTHS WERE MODIFIED TO BE TWO (2) FT BELOW THE THALWEG FOR THE UPSTREAM PC DUE TO THE PRESENCE OF RUNNING SAND

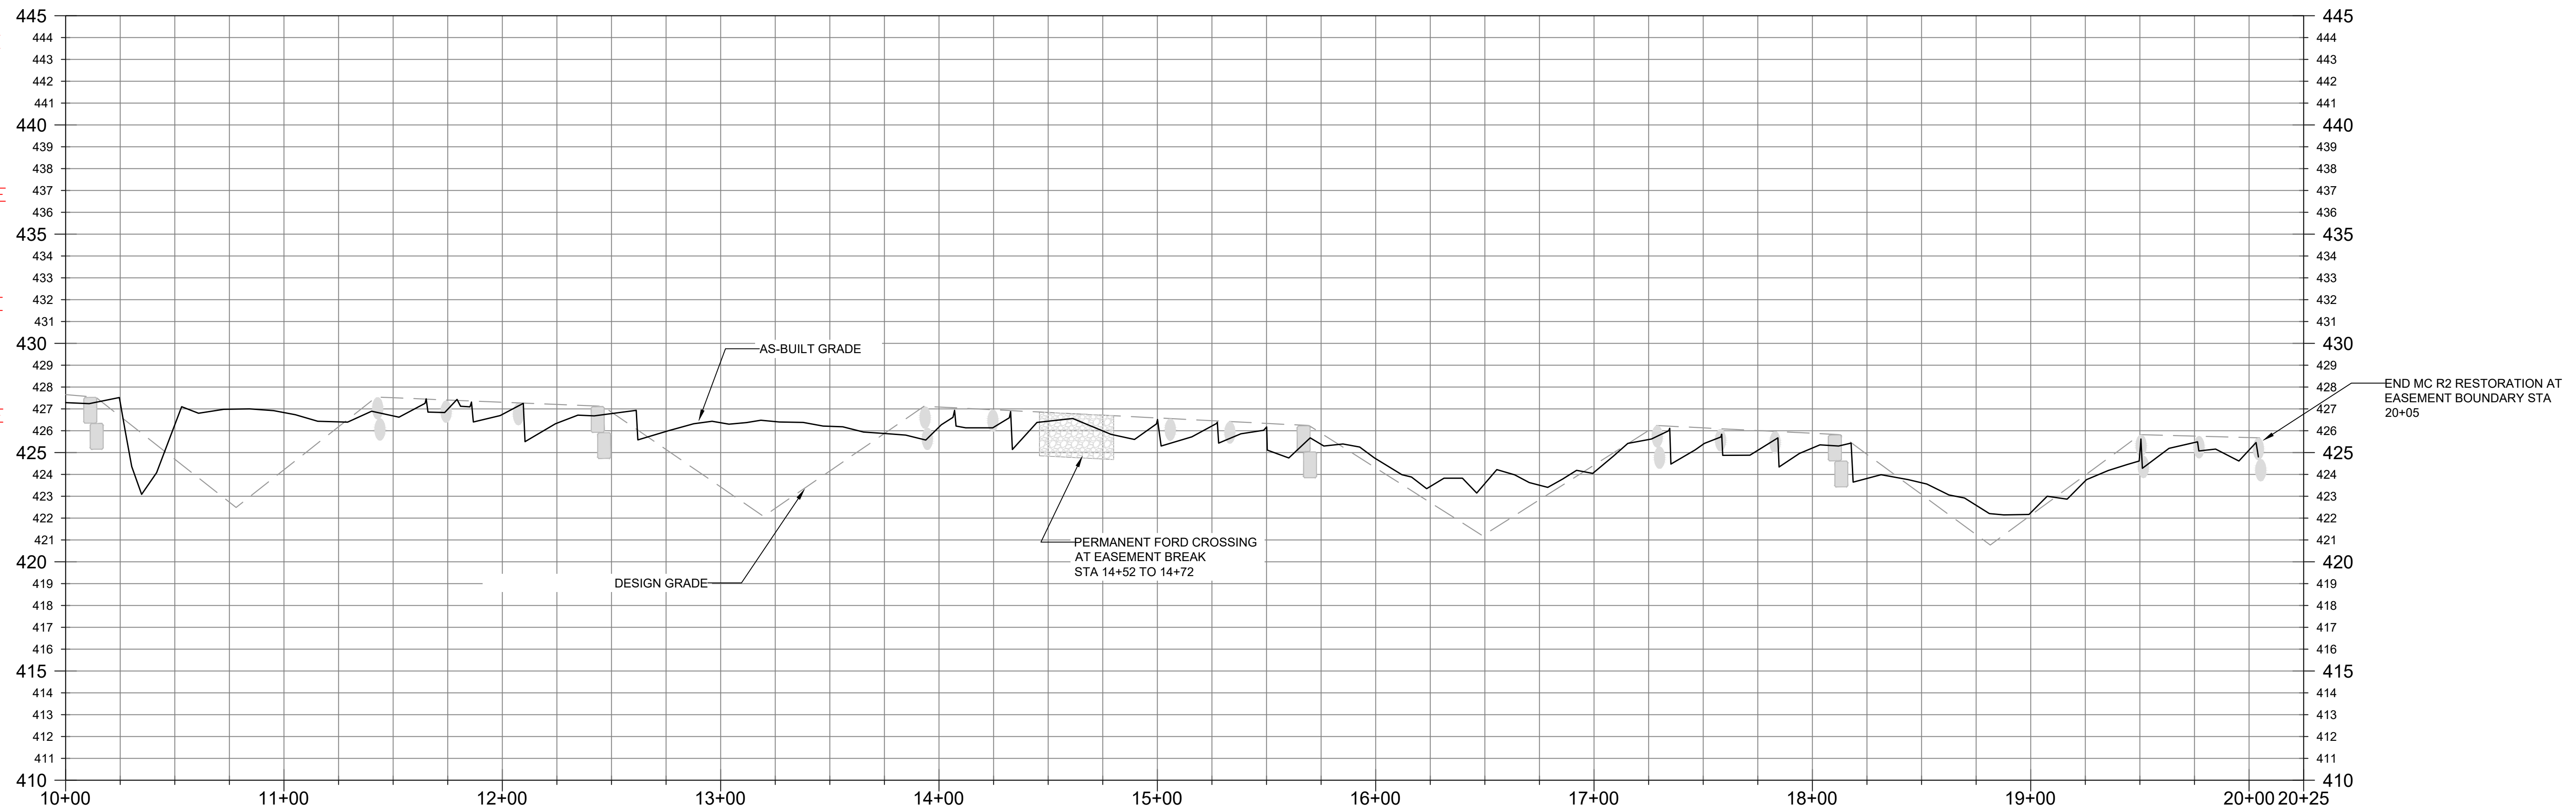
1. DEVIATIONS FROM THE DESIGN WILL BE SHOWN IN RED
2. ALL J-HOOKS WERE LOCATED AND ORIENTED ACCORDING TO THE DESIGN DETAIL NOT THE PLAN VIEW LOCATION
3. ALL POOL DEPTHS WERE MODIFIED TO BE TWO (2) FT BELOW THE THALWEG FOR THE UPSTREAM PC DUE TO THE PRESENCE OF RUNNING SAND
