PHASE I MONITORING YEAR 0 ANNUAL REPORT

MILLSTONE CREEK MITIGATION SITE

DMS Project No. # 204
NCDEQ Contract No. 6741
USACE Action ID No. 2018-01788
DWR Project No. 16-1200
Data Collection Dates: August 2021 – January 2022

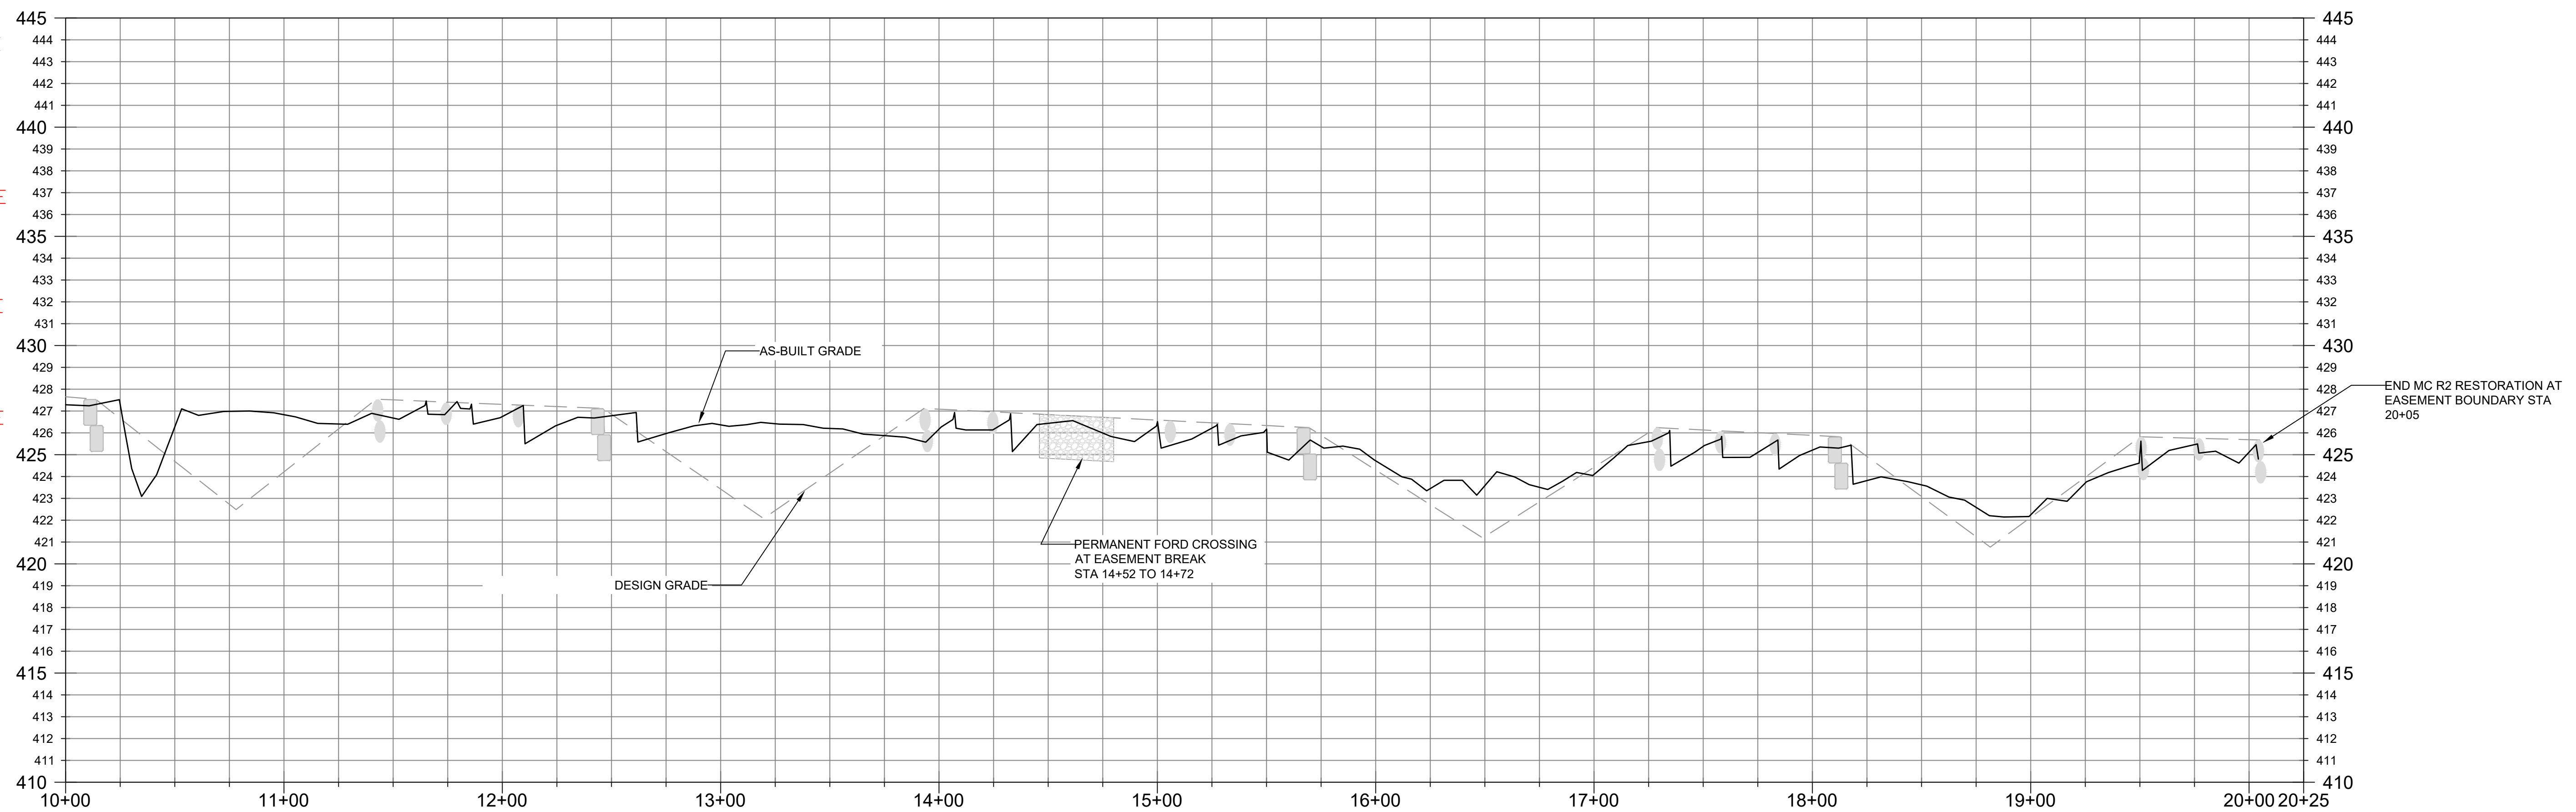
1. DEVIATIONS FROM THE DESIGN WILL BE SHOWN IN RED
2. ALL J-HOOKS WERE LOCATED AND ORIENTED ACCORDING TO THE DESIGN DETAIL NOT THE PLAN VIEW LOCATION
3. ALL POOL DEPTHS WERE MODIFIED TO BE TWO (2) FT BELOW THE THALWEG FOR THE UPSTREAM PC DUE TO THE PRESENCE OF RUNNING SAND
