# Monitoring Report MY06

**Sandy Bridge Restoration Site  
DMS Contract 6400  
DMS Project Number 96920**

**DWR #: 15-0414  
USACE Action ID: 201500827  
Rutherford County, North Carolina**

**Monitoring Data Collected: 2022  
Date Submitted: December 2022**

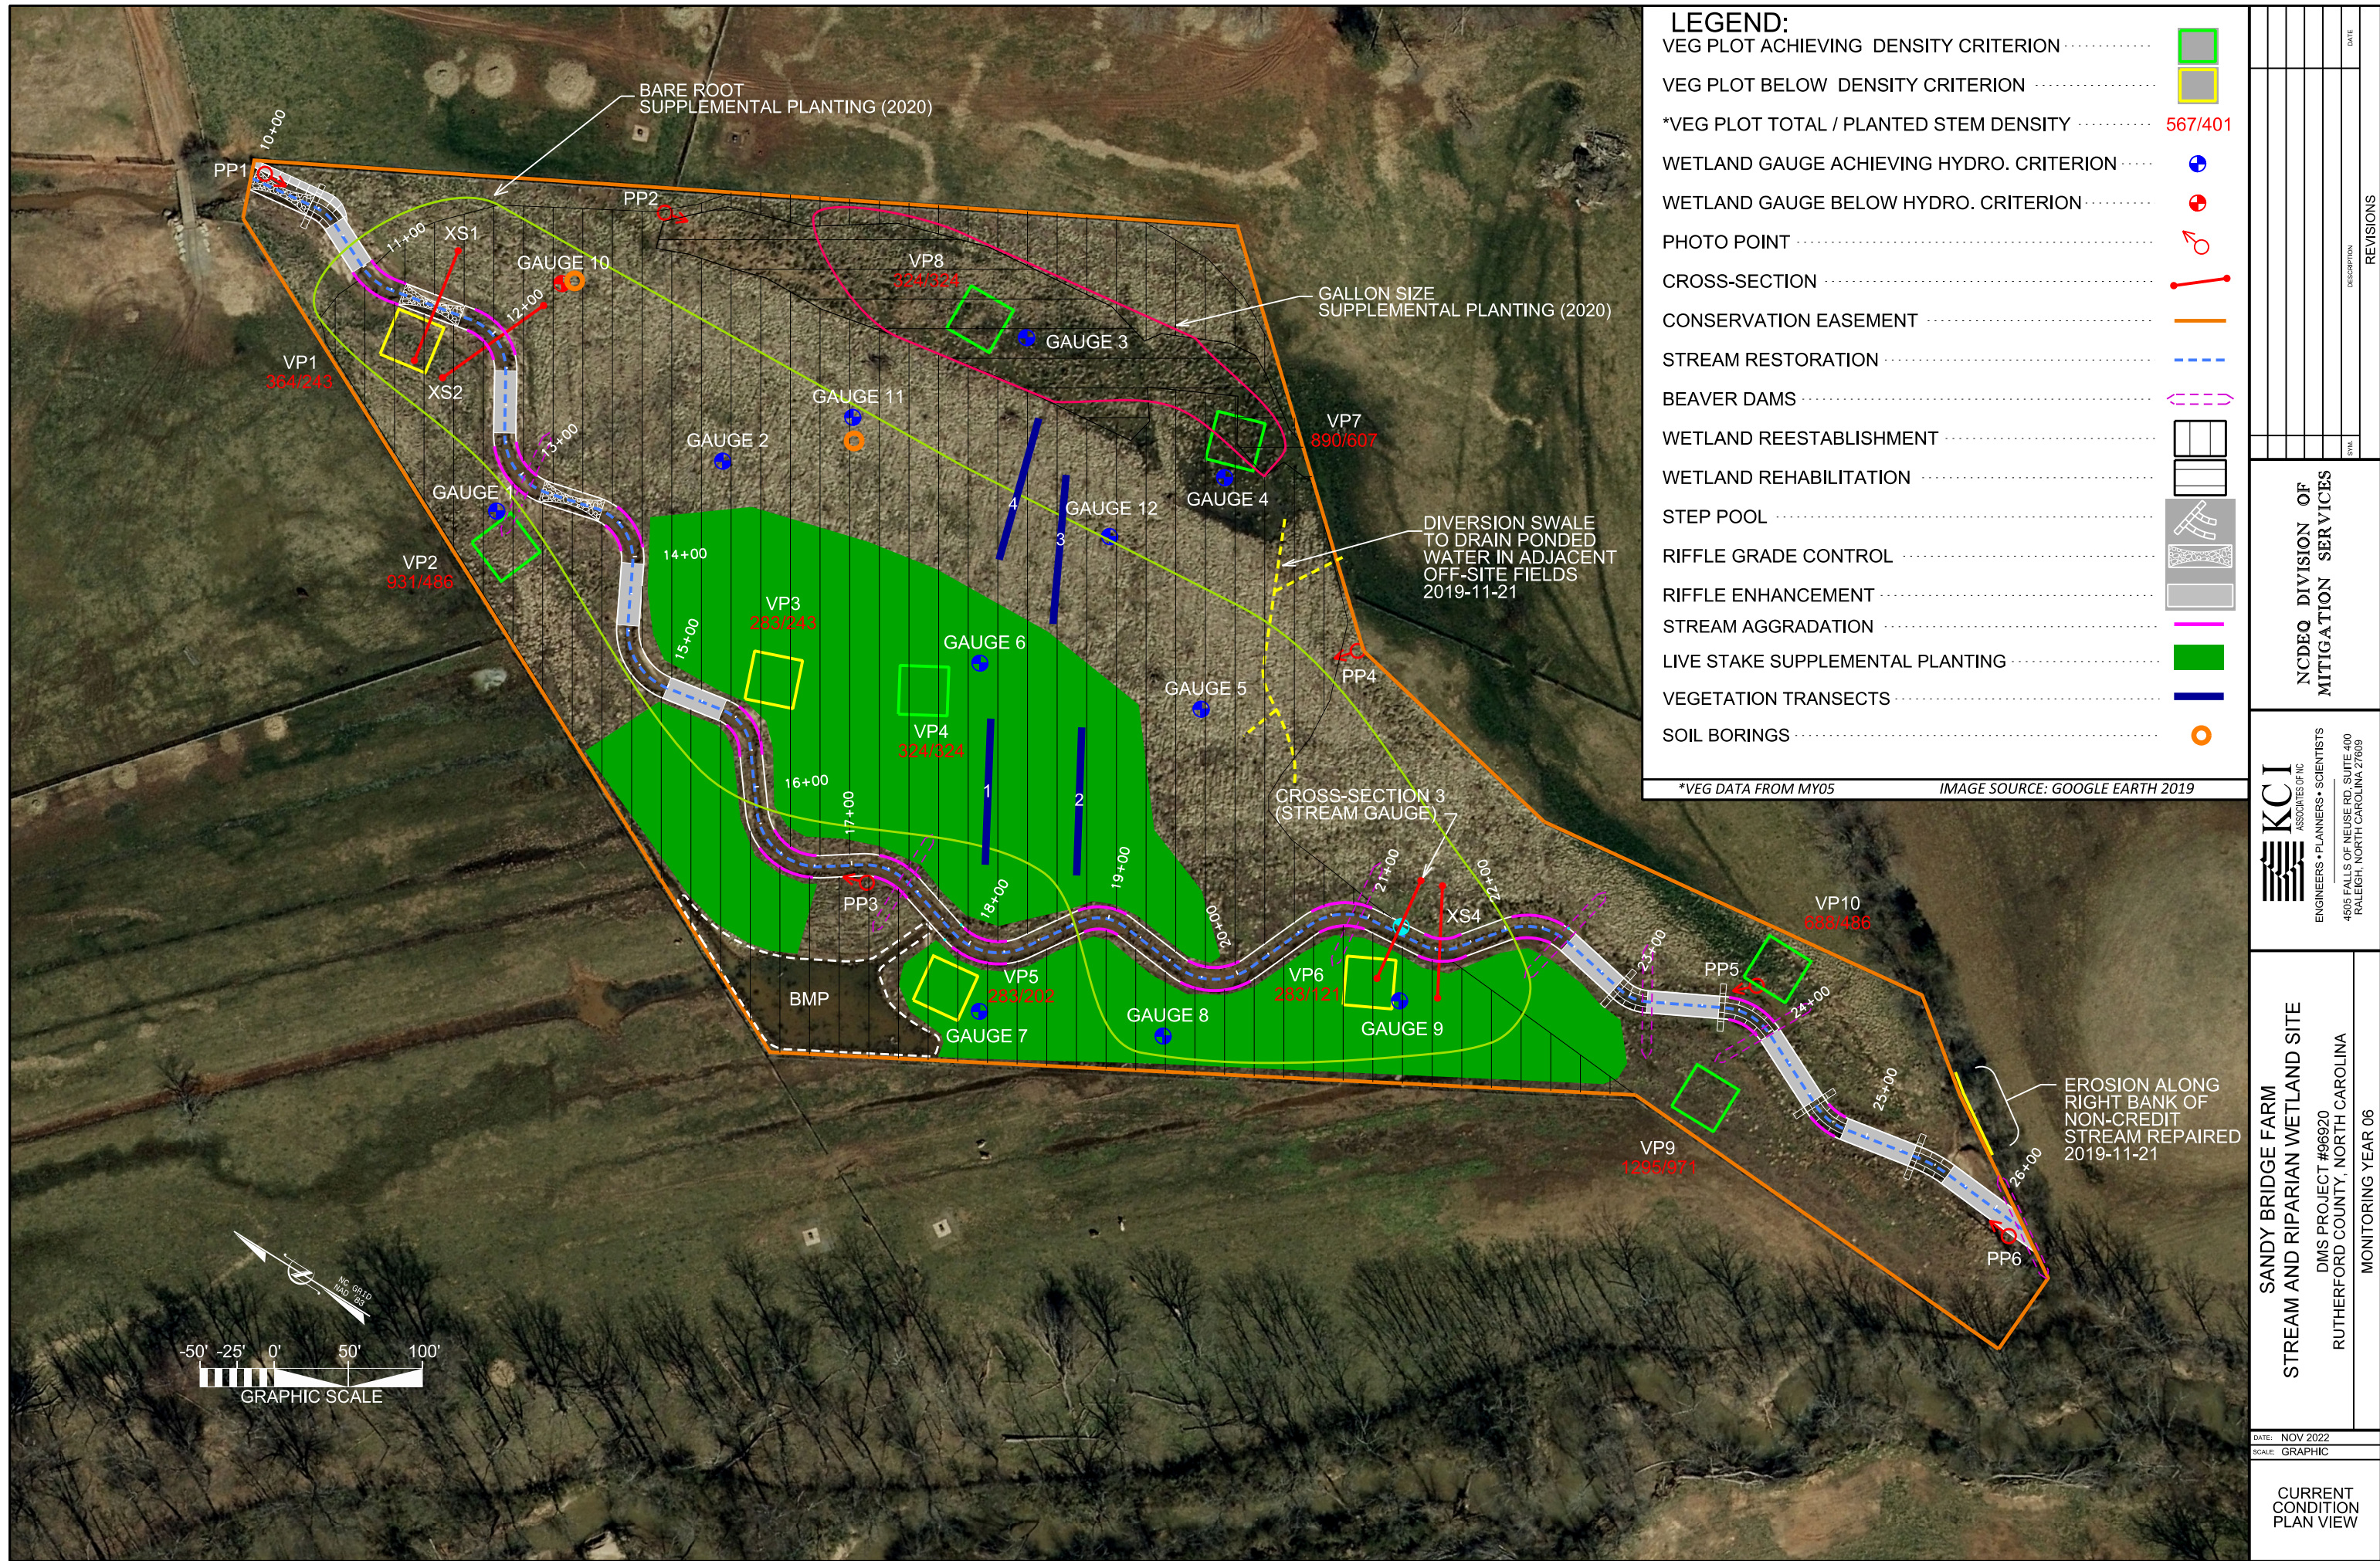
DATE: NOV 2022  
SCALE: GRAPHIC  
**CURRENT  
CONDITION  
PLAN VIEW**

note that even with the rebuilding of the dams, the stream flow has stayed within the restored channel and no evidence of other channels forming in this system has been noted.

The right bank of the stream flowing adjacent to the project's southern boundary had been experiencing significant erosion due to several areas of obstruction in the center of this channel that were diverting water into the banks. Although this stream is not part of the project, and is located outside of the easement bounds, the erosion on the right bank had encroached into the easement. In November 2019, KCI repaired and stabilized this area. This work involved removing the mid-channel obstructions and sloping back the eroding bank. 150 live stakes were planted along this bank in March 2020. During this work, several farm gates that had become buried in the project stream bank were removed and a small swale was dug to direct water into the site from fields adjacent to the eastern boundary of the site. This swale was designed to drain ponded conditions in these fields and dissipate the water throughout the wetlands on-site. See Appendix B for more information.
