601 East Stream Restoration Site
(EEP Project #95756)
Union County, North Carolina

Baseline Monitoring Document and As-Built Baseline Report Final

Data Collected from December 2014 – February 2015

Submitted May 12, 2015

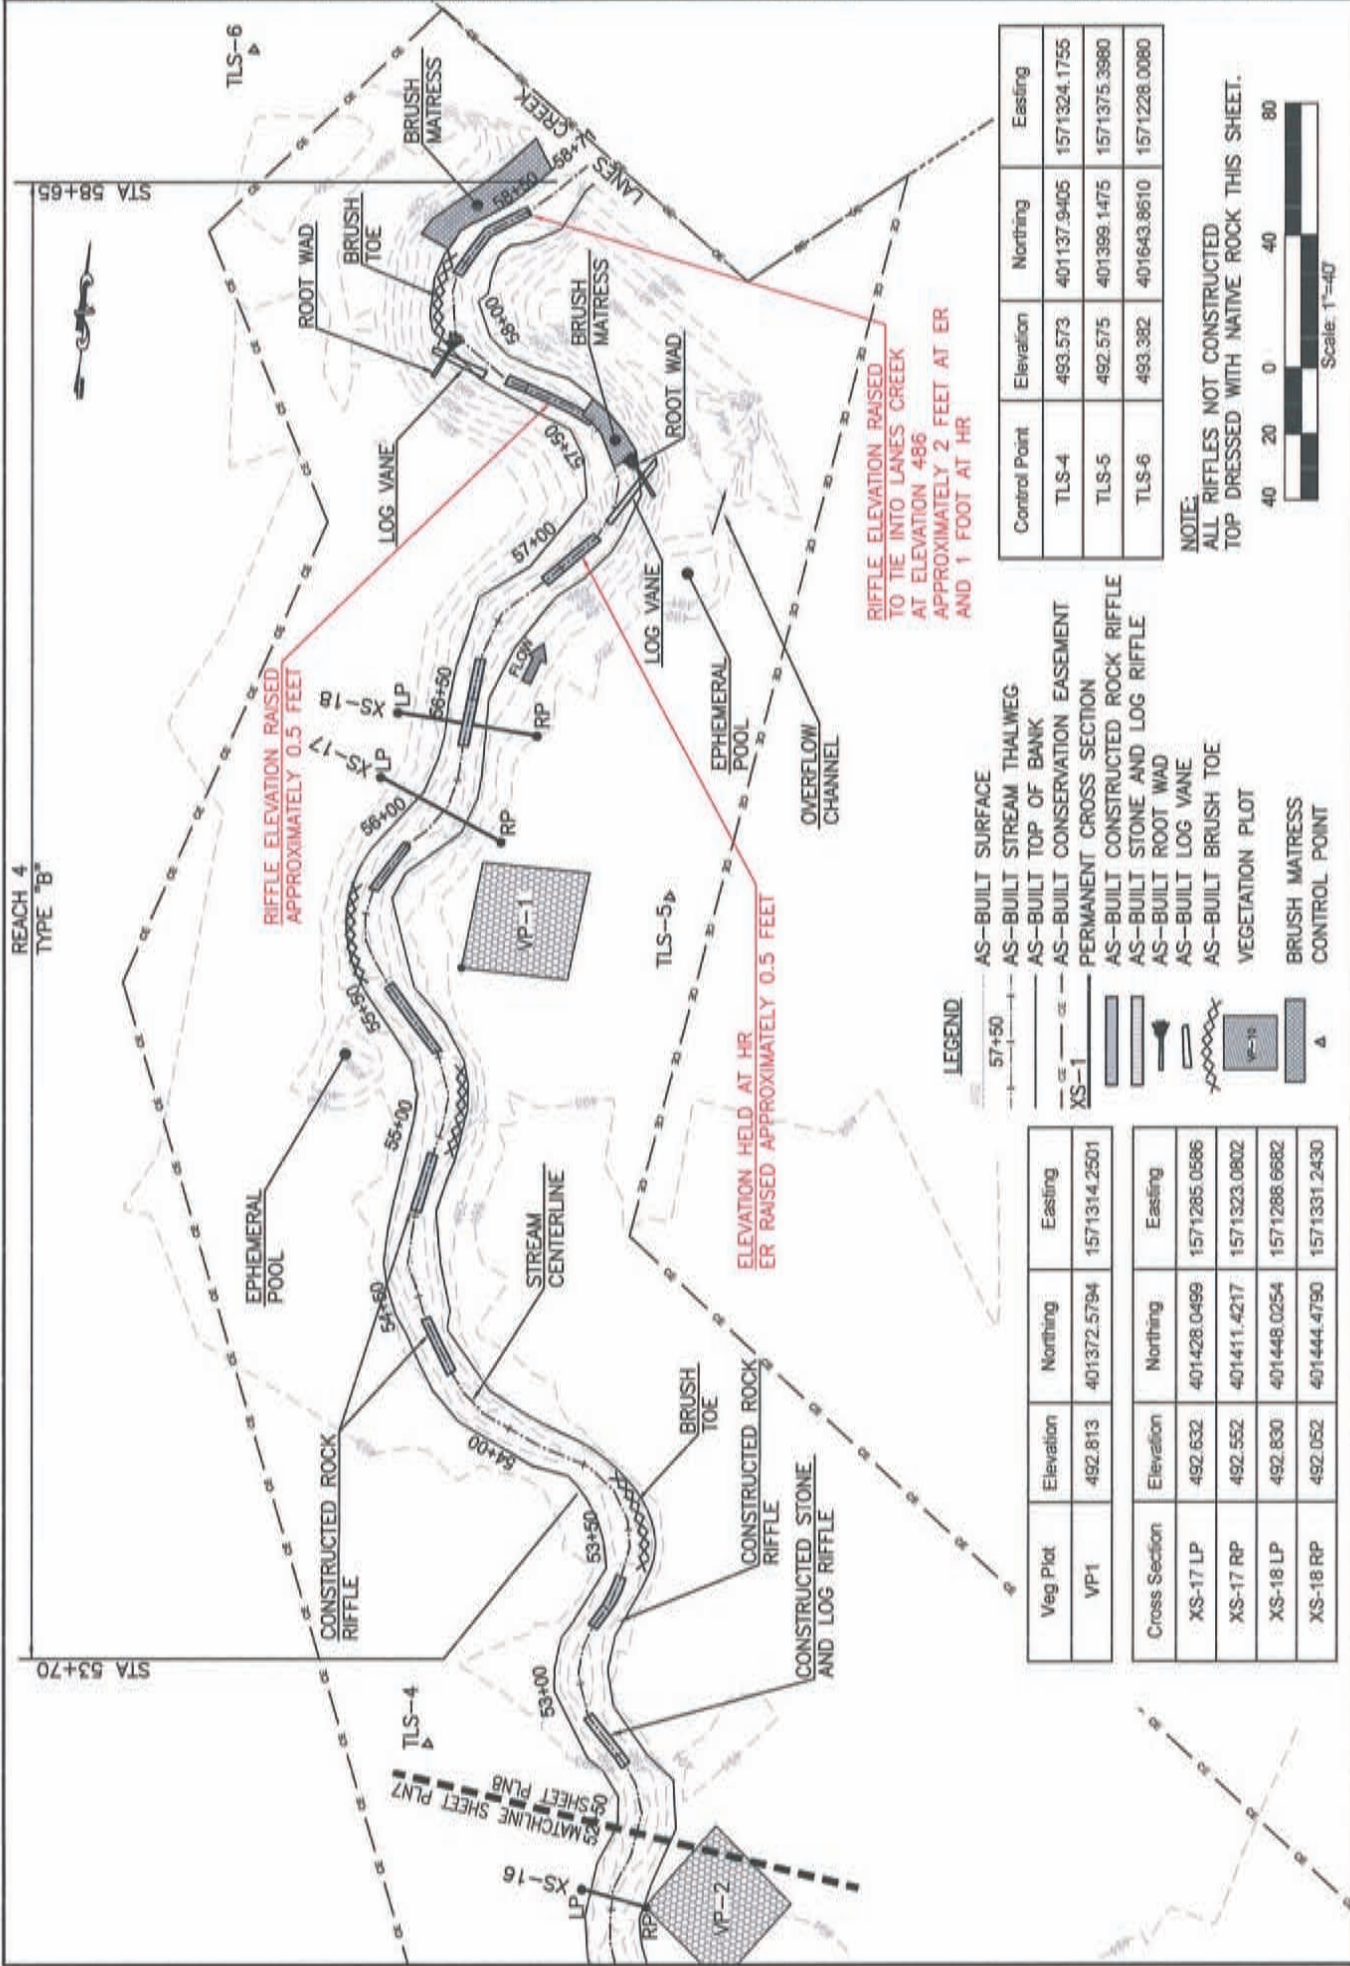
Reach 3: The twin 42 inch pipe crossing was constructed to a length of 48 feet. Native rock was excavated on site and used for the constructed riffles. Native rock was added to dress the top of all of the riffles in this reach to stabilize the riffles that were not constructed as some erosion was observed.

NOTE:
 ALL RIFFLES NOT CONSTRUCTED
 TOP DRESSED WITH NATIVE ROCK THIS SHEET.
