# **Annual Monitoring Report**

Monitoring Year 1 of 7

Project Name: 601 East Stream Restoration

Data Collected: September 2015 – November 2015

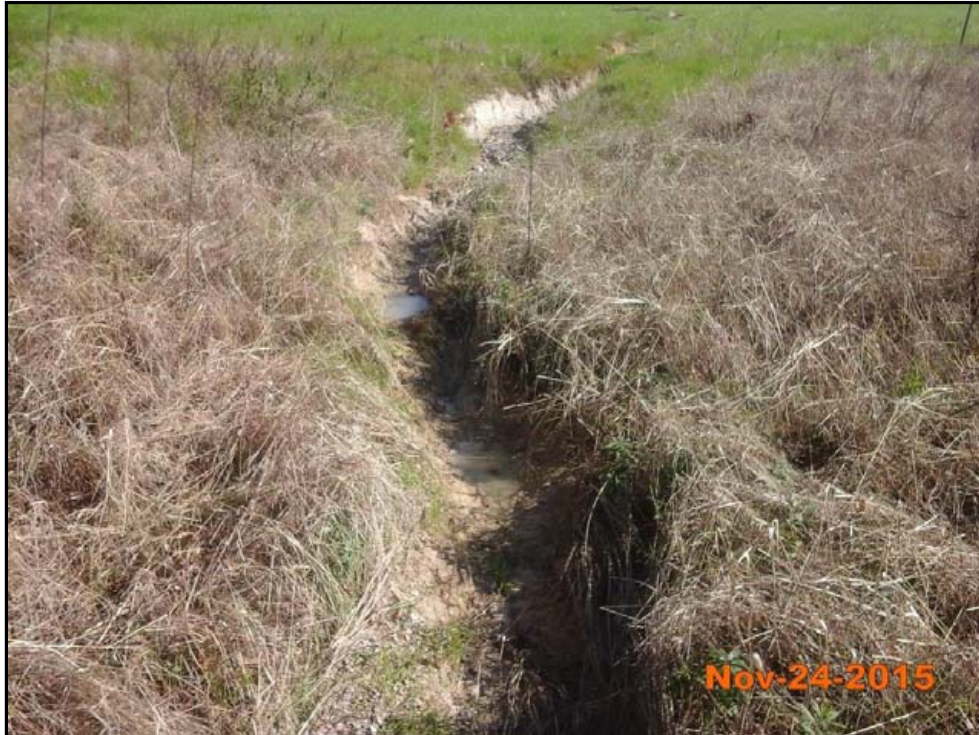
Project Reach 1 – Ditch/ Bare Area 20+75 Right Descending Bank

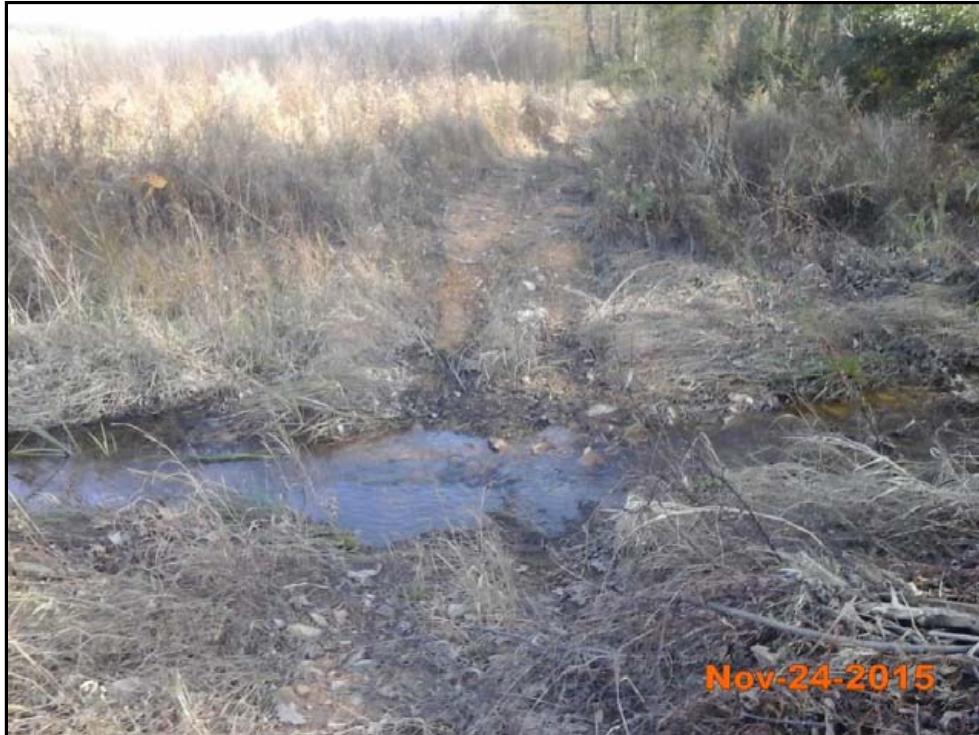
Project Reach 3 – Encroachment 43+50

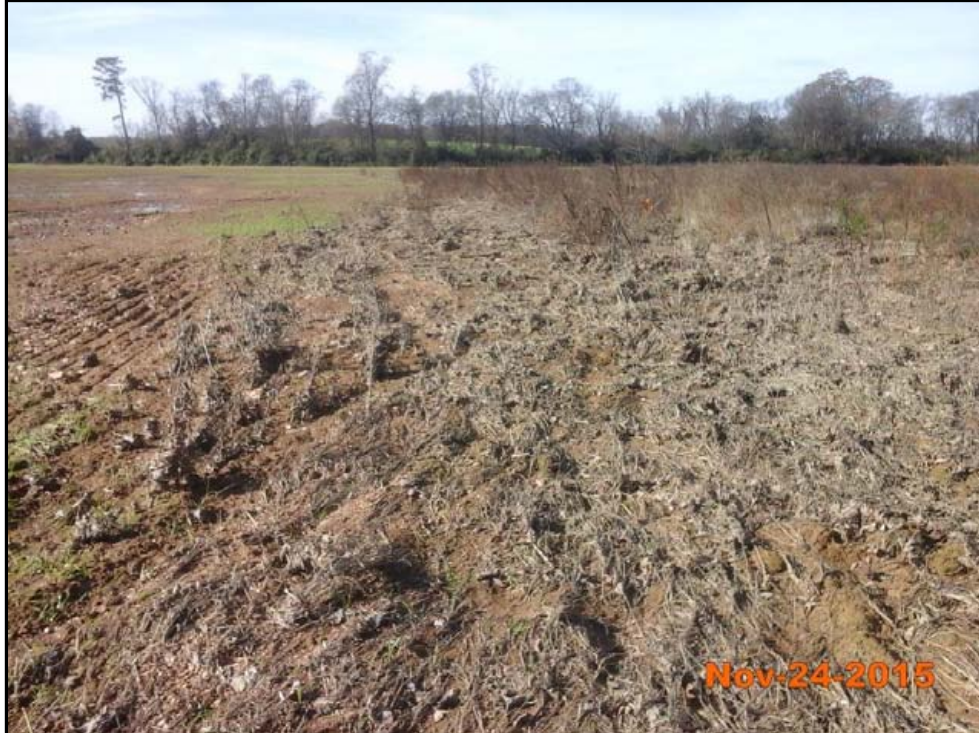
Project Reach 3 – Encroachment 47+50 Left Descending Bank
