# **Annual Monitoring Report**

Monitoring Year 2 of 7

Project Name: 601 East Stream Restoration

NCDMS Project No.: 95756

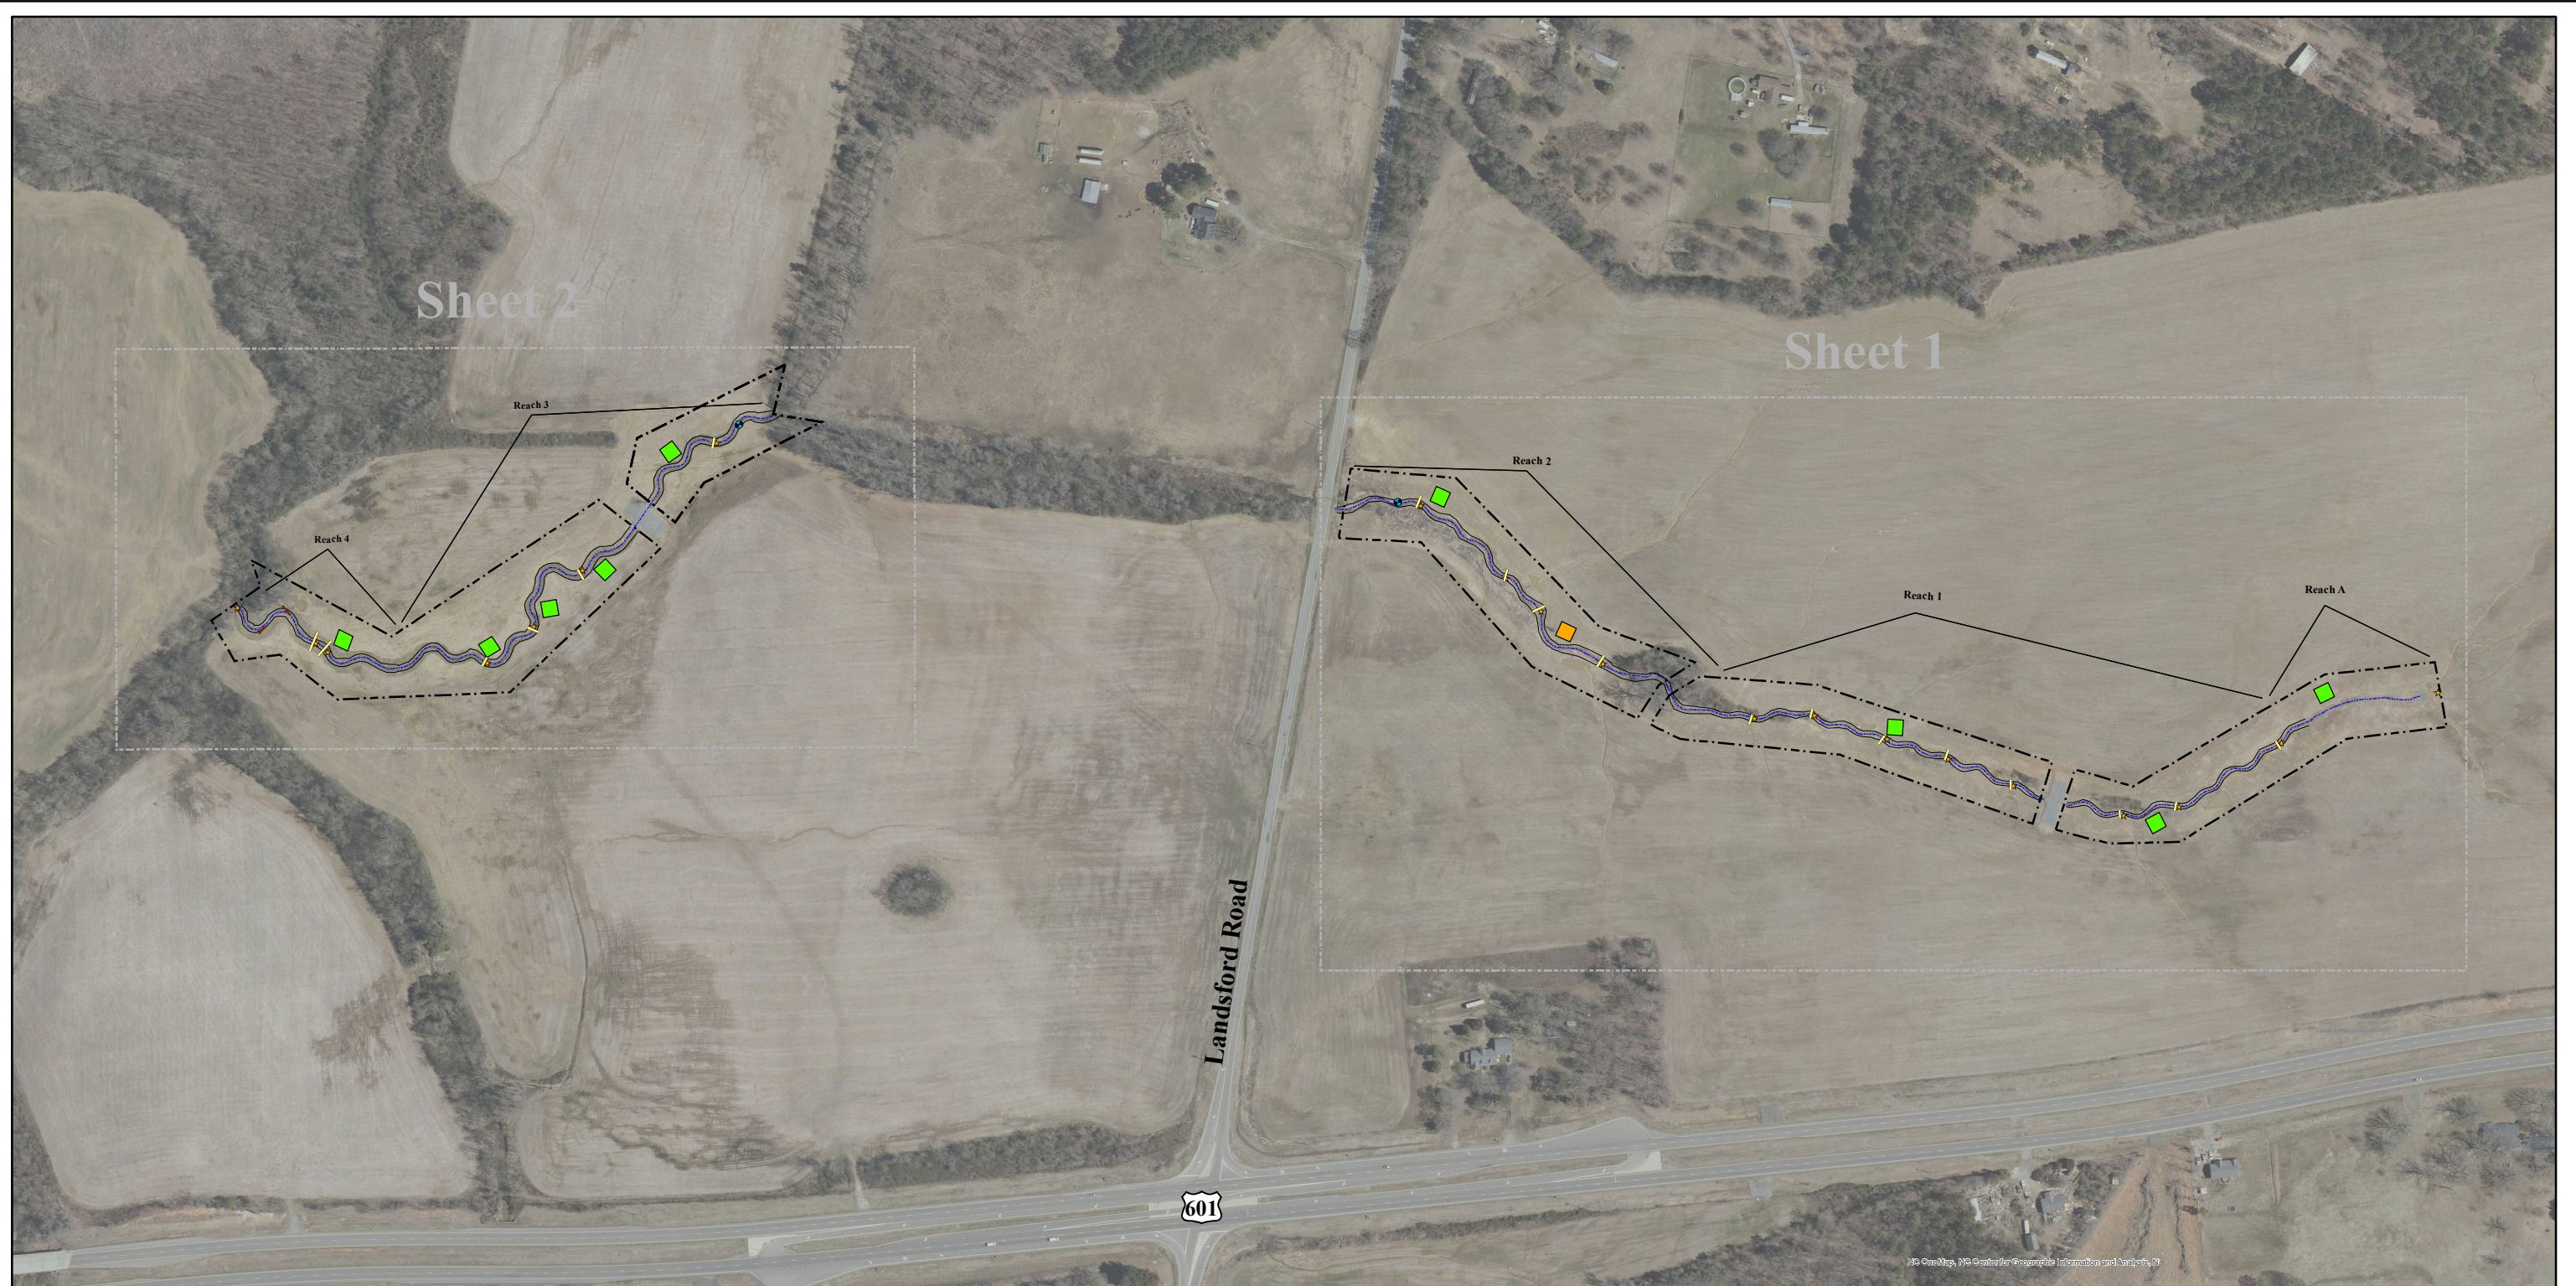
Figure 2. Current Condition Plan View  
 Overview  
 601 East Stream Restoration Site  
 Union County, North Carolina  
 NCDMS Contract No. 004925  
 NCDMS Project No.: 95756  
 September 2016

Visual assessment of the easement (Appendix B – Table 6; Figure 2) indicates that with the exception of a few bare areas, totaling 0.13 acre, vegetation is becoming well established throughout the easement (Figure 2 and Table 6). Small bare areas are typical of a newly constructed mitigation site and usually become vegetated after a couple of growing seasons. These areas will be monitored in subsequent site

Visual assessment of the stream was performed to document signs of instability, such as eroding banks, structural instability, or excessive sedimentation. Only a few stream problem areas were noted during visual assessment (Table 5 and Figure 2). Structures are intact and performing as designed. The project approach on the ephemeral channel at the upstream end of the project—Reach A—was to install a series of energy dissipating structures to provide vertical stability and sediment settling capacity within the reach. Two small areas of degradation were noted on reach 1. These areas are associated with small headcuts that formed within riffles located at STA 9+25 and 10+00. The headcuts have remained stable between MY1 and MY2 and have not migrated upstream or caused the riffle to cut down any further. Visual assessment of this reach indicates that the structures are performing as designed, reducing downcutting and capturing sediment from the upstream contributing area. No indications of new incision were observed during the assessment.

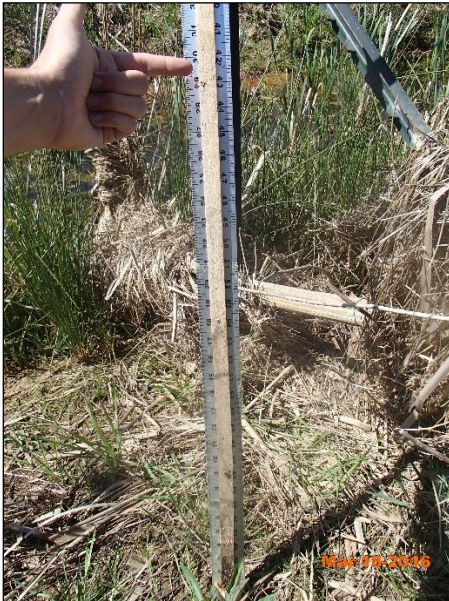
Reach 2 Crest Gauge

Table 13. Verification of Bankfull Events 601 East Stream Restoration Site				
Date of Data Collection	Date of Occurrence	Method	Feet Above Bankfull Elevation	Photo # (if available)
<b>Reach 2</b>				
November - 2015	Unknown <sup>1</sup>	Crest Gauge/ Wrack Lines	Unknown	-
March - 2016	Unknown	Crest Gauge	1.4	Figure 3
<b>Reach 3</b>				
March - 2016	Unknown	Crest gauge	0.2	Figure 4
