Annual Monitoring Report

Monitoring Year 4 of 7

601 East Stream Restoration Project
NCDMS Contract No.: 004925
NCDMS Project No.: 95756
USACE Permit Action ID: 2013-00265
DWR Project No.: 14-0547

Union County, NC
Data Collected: November 2018
Date Submitted: January 2019

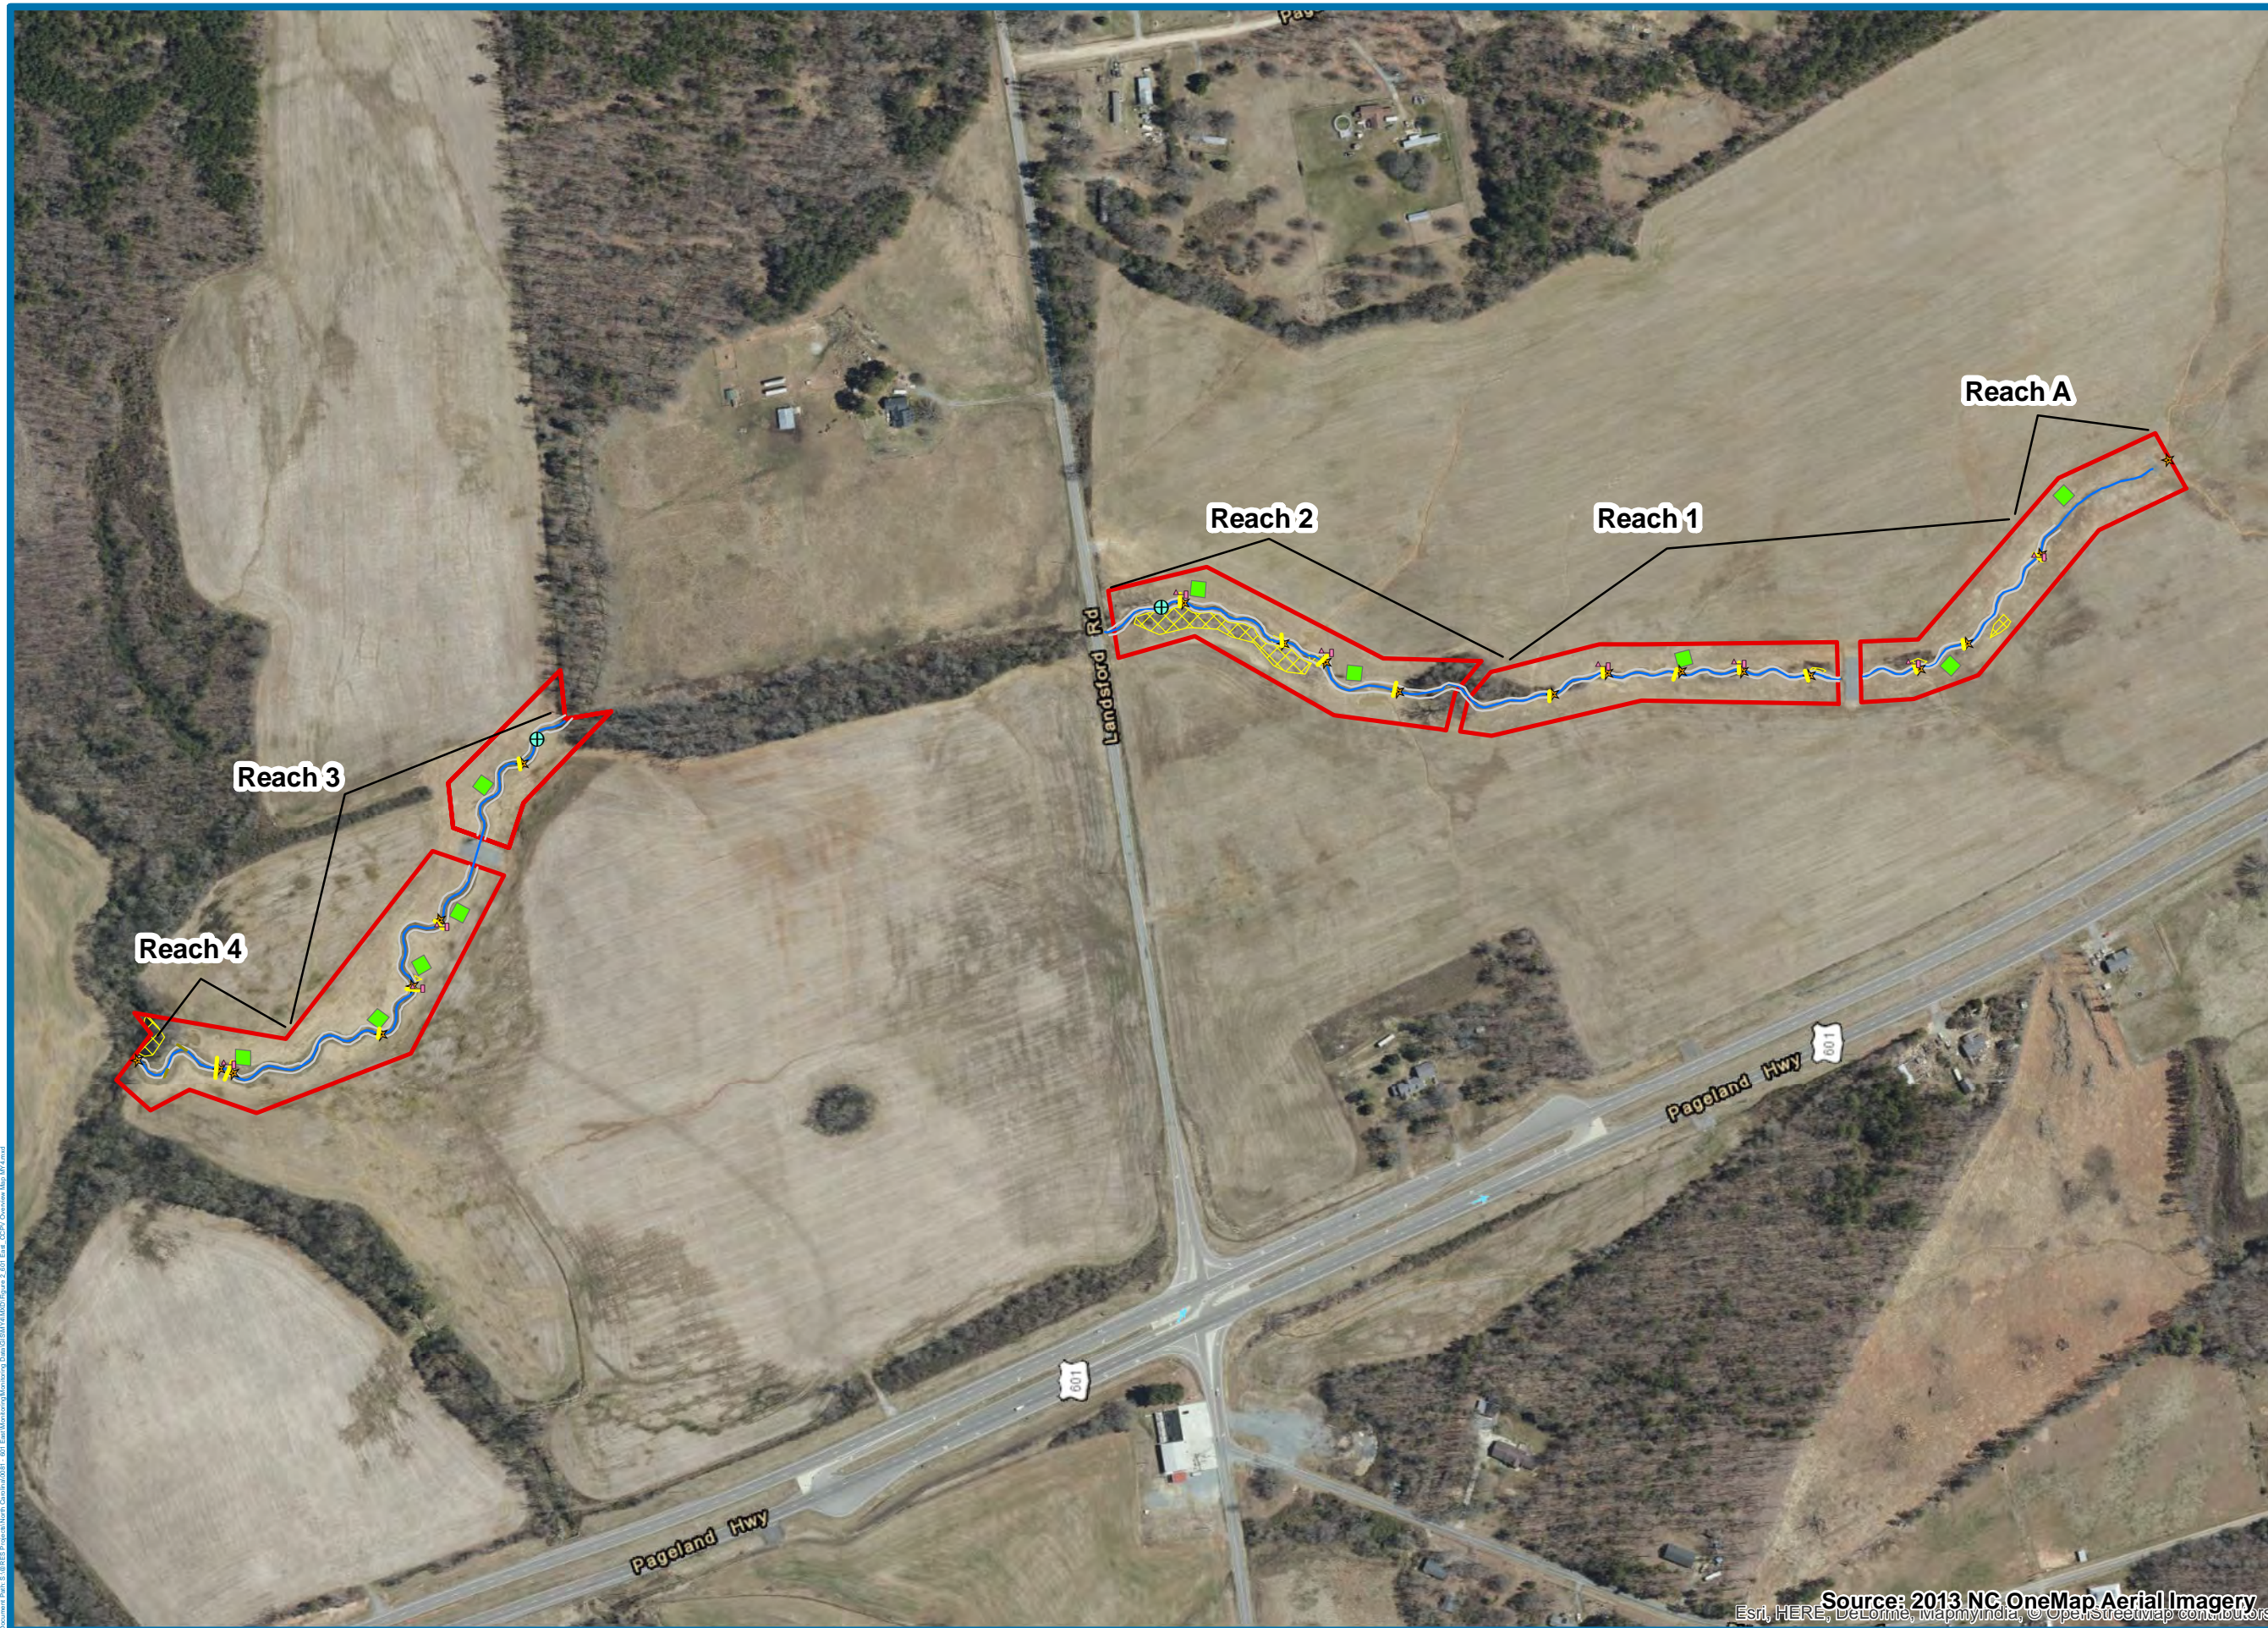
Figure 2a

Visual assessment of the easement (**Table 5; Figure 2**) indicates vegetation is well established throughout the easement. The bare areas and encroachment areas that were lacking vegetation were addressed in March 2018. 250 container trees were planted in these areas and the encroachment on Reach 3 and 4 was blocked off by t-posts. Additionally, the Chinese Privet and Parrot Feather areas were treated in the spring and fall of 2018. RES used an aquatic safe herbicide to treat the Parrot Feather. As of November 2018, it was still present in the areas noted on **Figure 2**. RES will reevaluate the efficacy of the aquatic herbicide in early 2019. These areas will continue to be monitored and treated as necessary. Per the November 2018 site visit, the encroachment has been eliminated. A memo from May 2018 that describes the Adaptive Management in more detail is attached in **Appendix F**.

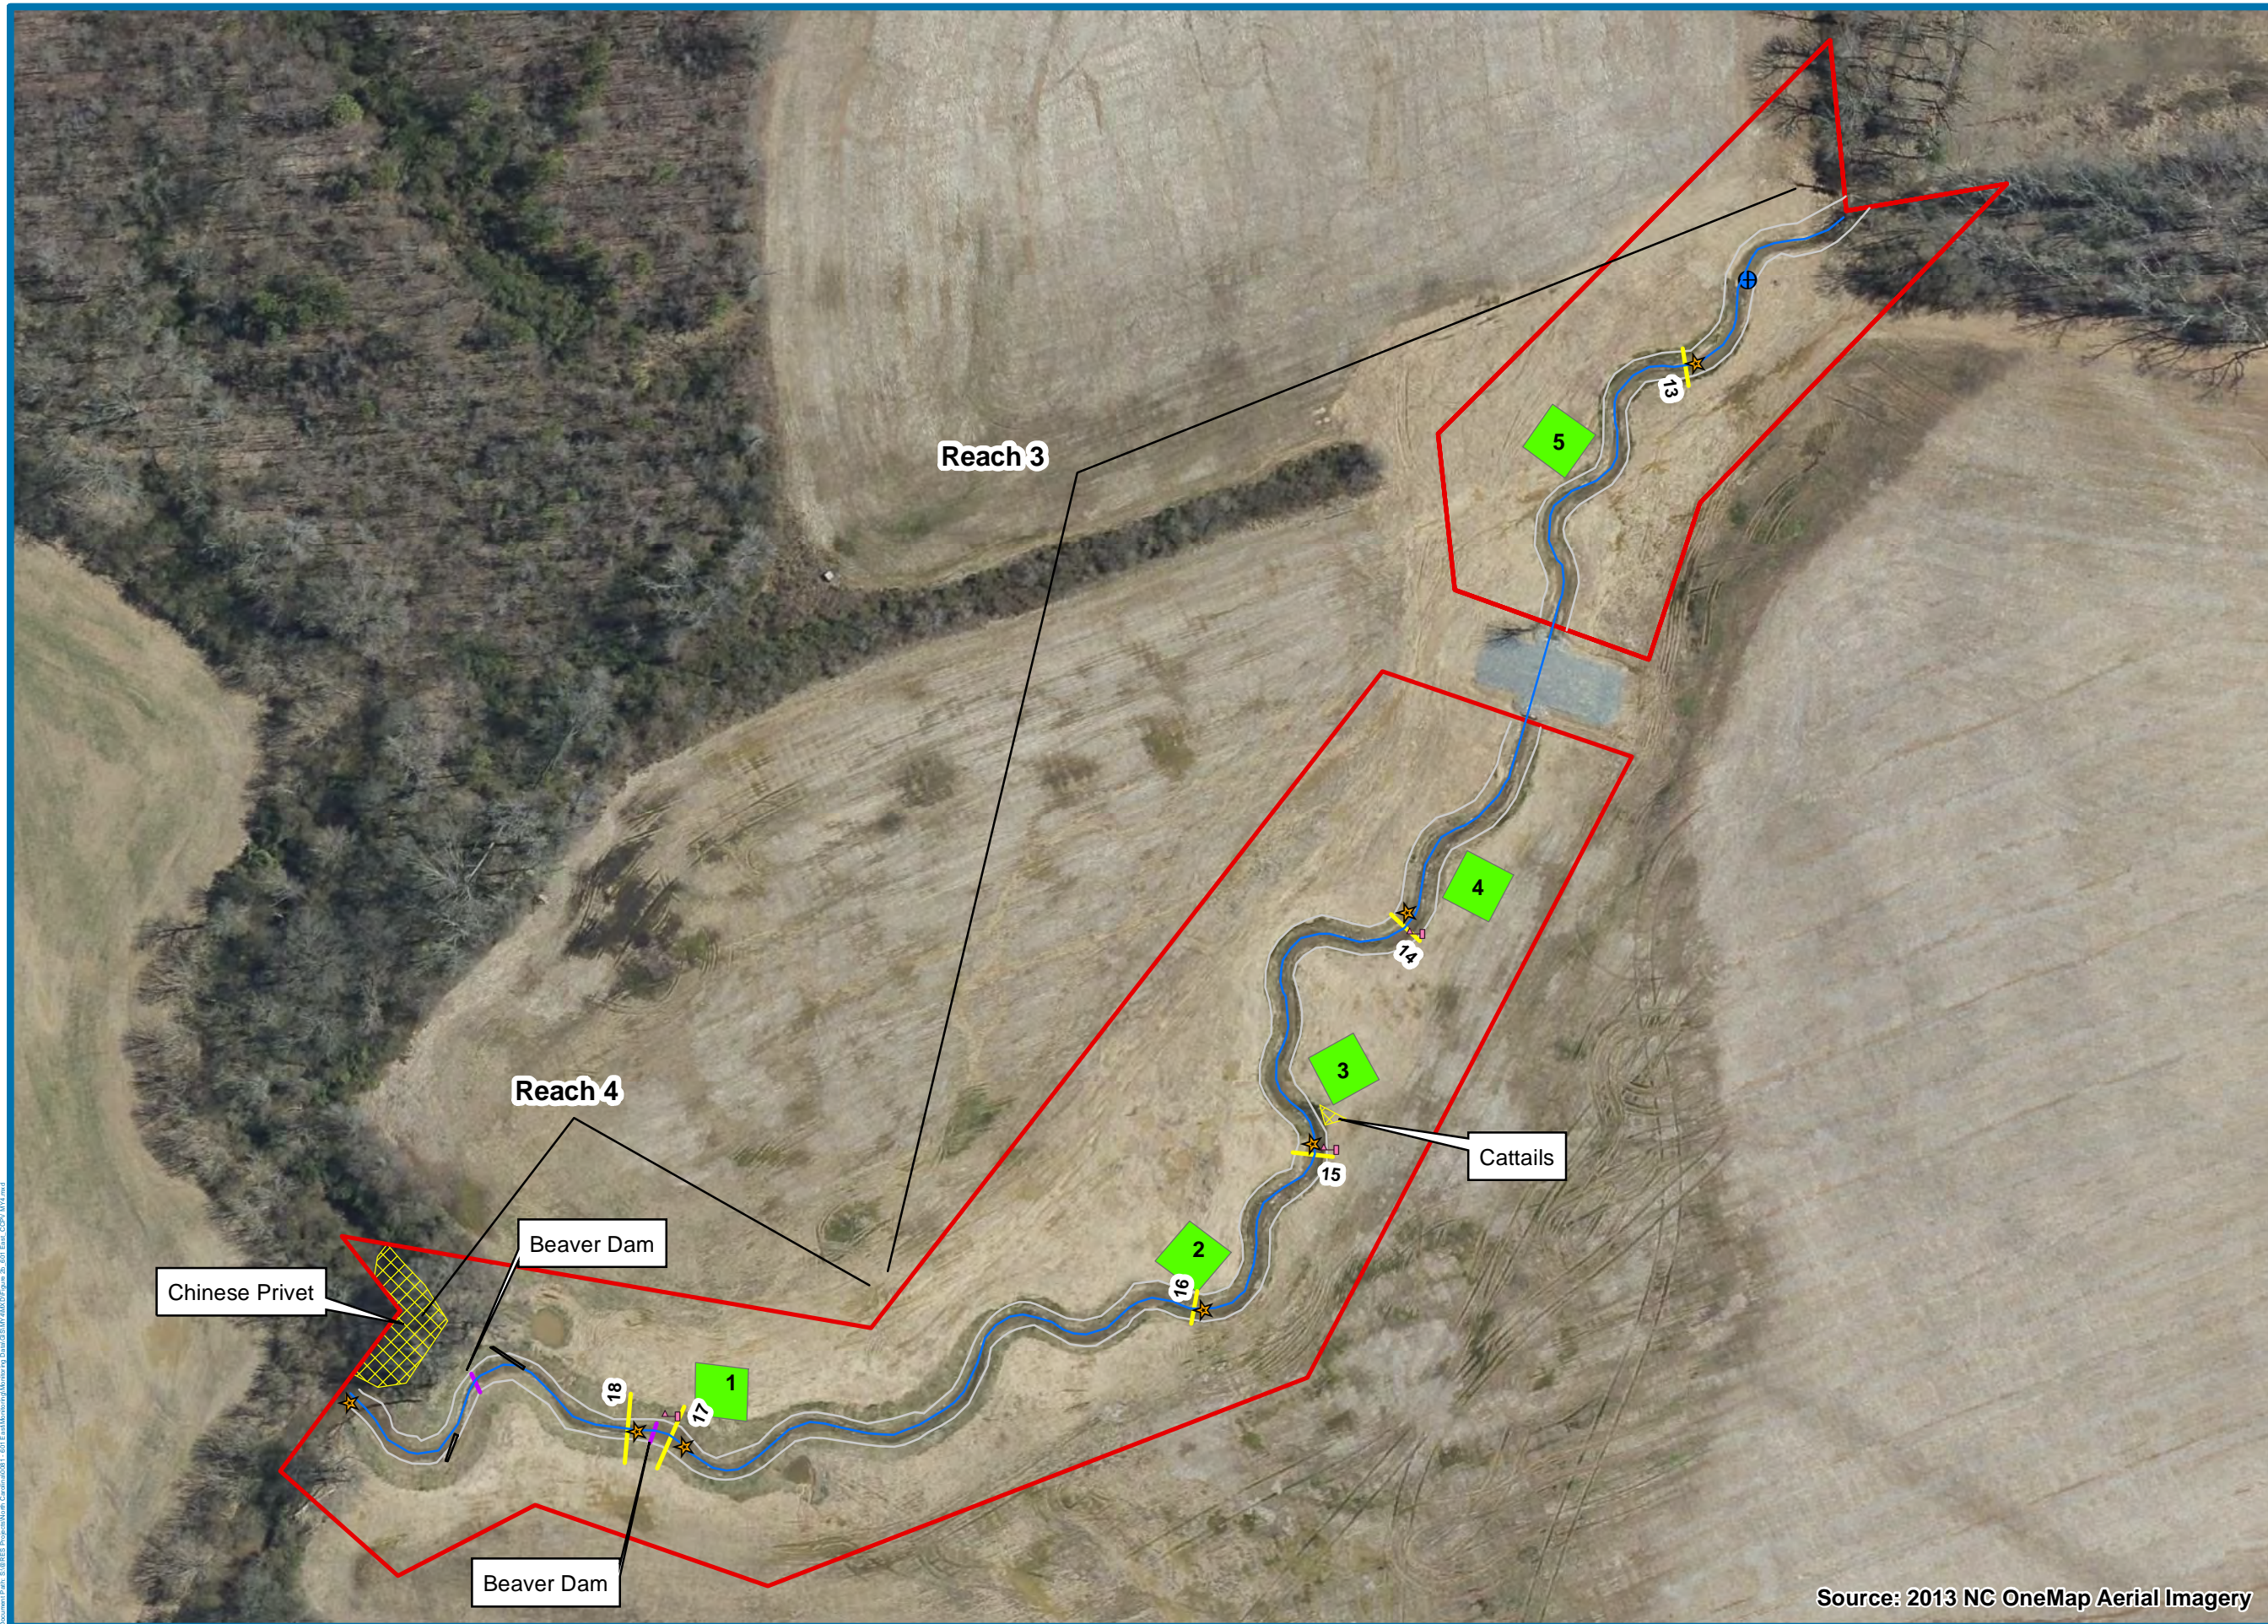
CCPV Sheets/ Report Text: In the report text, please describe/ discuss the erosional feature shown on Figure 2b (Reach 1). The erosional feature is a small headcut that formed at the edge of the easement from a field drain. The feature has stabilized with the maturation of vegetation in the buffer. If conditions worsen, RES will stabilize the headcut with rock and add coir logs along the feature. This has been added to the report.

Visual assessment of the stream was performed to document signs of instability, such as eroding banks, structural instability, or excessive sedimentation (**Table 6**). The erosional feature noted in the right buffer of Reach 1 is a headcut that formed at the edge of the easement from a field drain. The feature has stabilized with the maturation of vegetation in the buffer. If conditions worsen, RES will stabilize the headcut with rock and add coir logs along the feature. The major stream problem areas from MY3 were two beaver dams on Reach 4. These dams and beavers were removed in March 2018 and the dams were completely taken out and the banks were stabilized and replanted. The beavers, however, returned in MY4 and built new dams on Reach 4. Beaver management, including trapping and dam removal, will be performed again in MY5.
