601 West Stream Restoration Project Annual Monitoring Report

Monitoring Year: 2011

Monitoring Year: 4

NCEEP Project Number: D 06054-E

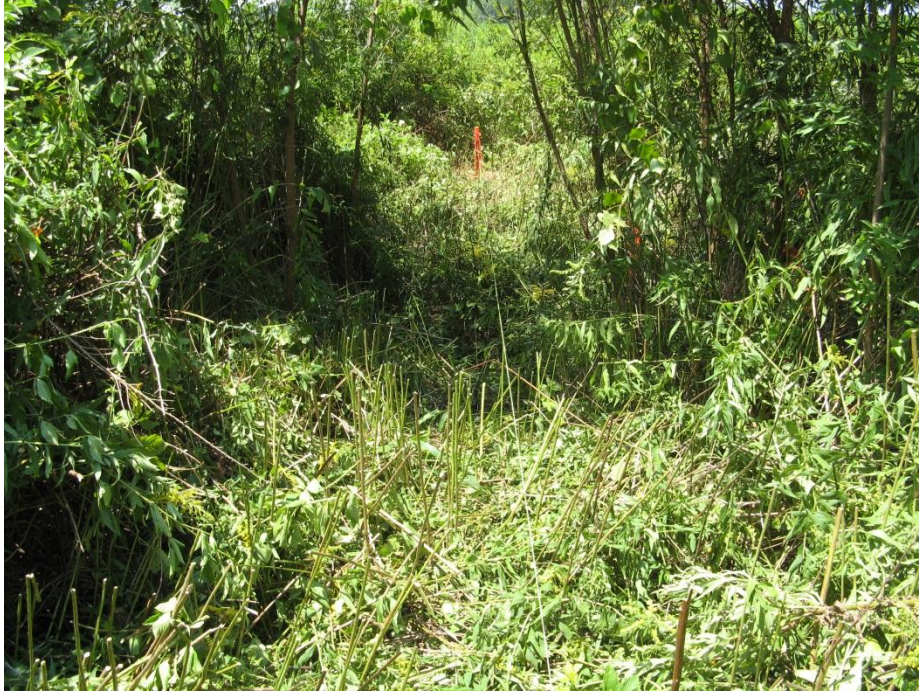
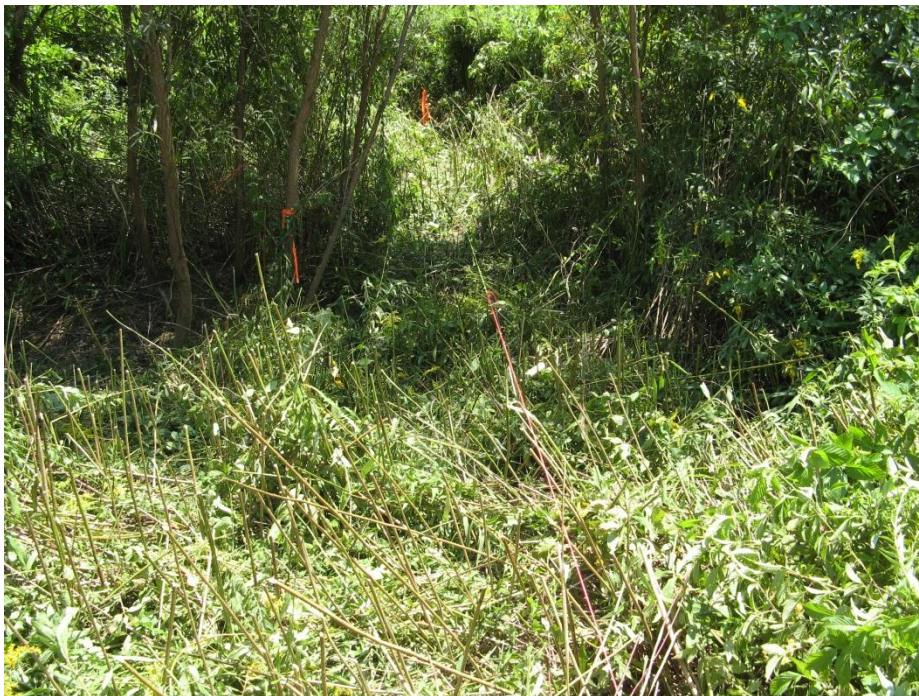
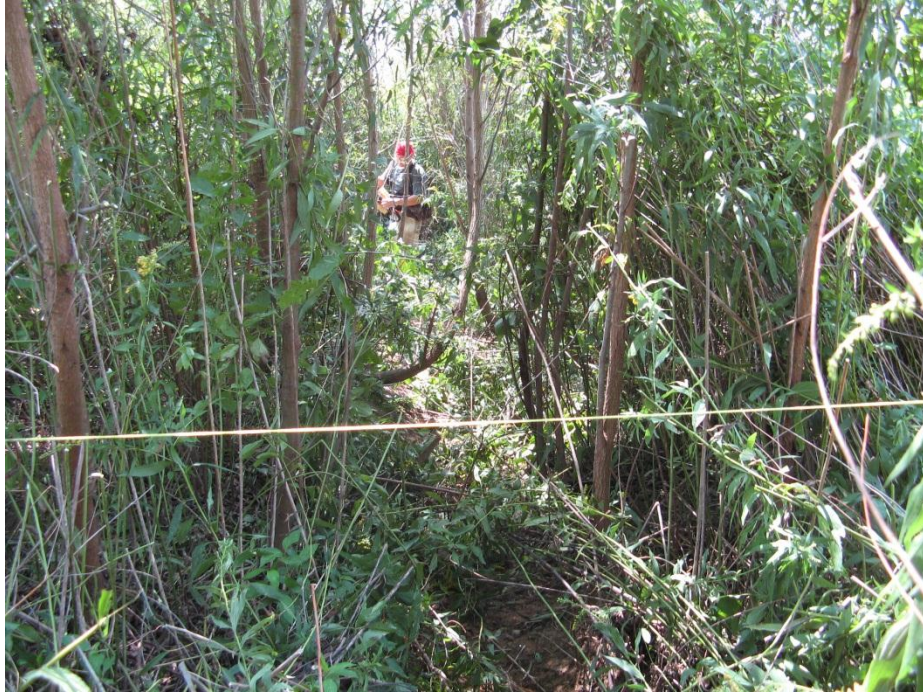
The survey data was collected in September 2011, and the results are presented in Appendix C. Cross sections appear to be stable. Reach 2 Riffle Cross Section 1 seems to have degraded along the right bank but the photos show it has not. One explanation might be that in clearing a lane in the vegetation to allow surveying, the bank was trampled down. The cross sectional area and width did not change significantly. The 2012 monitoring will resolve this question.

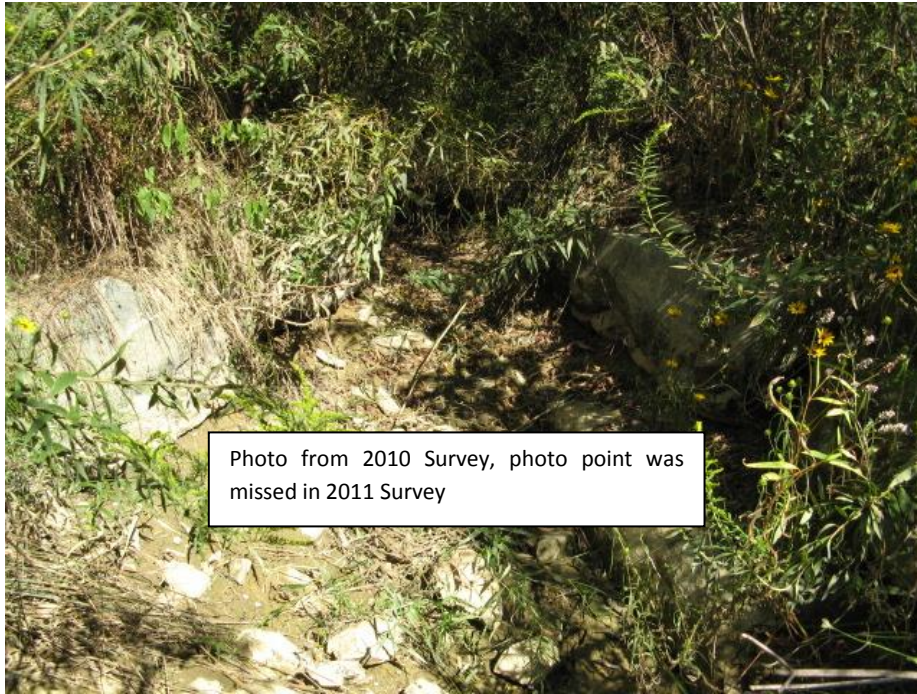
Photo Point 7

Photo from 2010 Survey, photo point was missed in 2011 Survey
