YEAR 3 (2017) MONITORING REPORT
ABBEY LAMM
STREAM AND WETLAND MITIGATION SITE
ALAMANCE COUNTY, NORTH CAROLINA
FULL DELIVERY CONTRACT NO. 5790

CAPE FEAR RIVER BASIN
CATALOGING UNIT 03030002

Data Collection – March-October 2017

January 2018

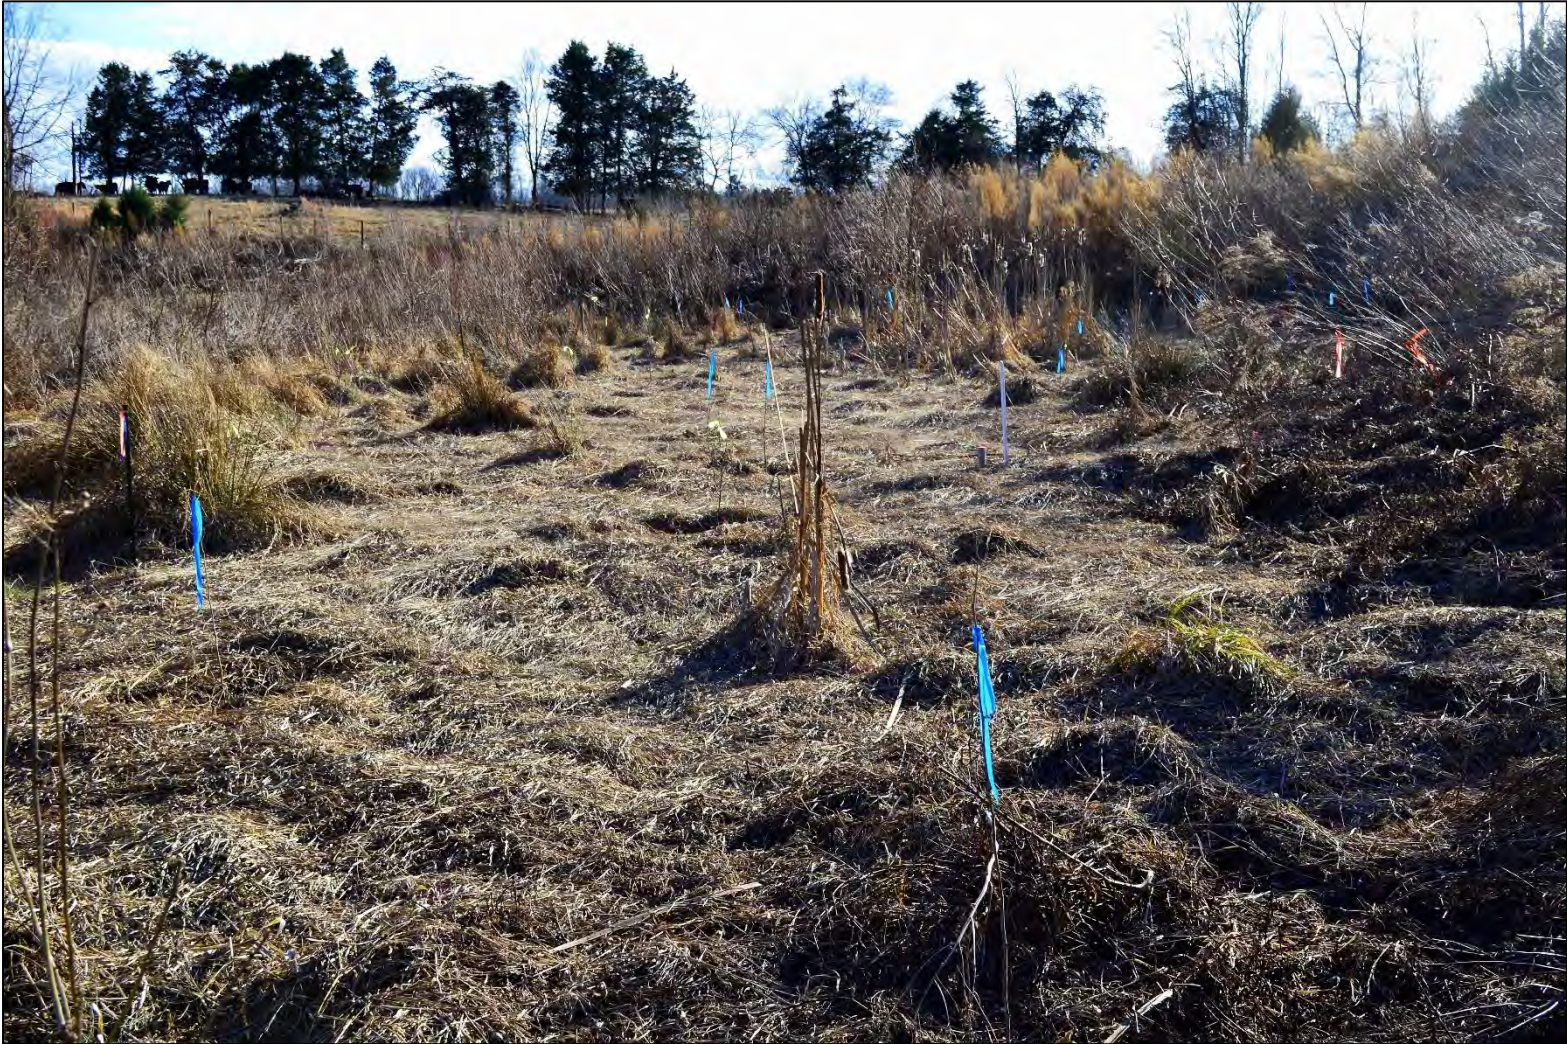
Photo 1: Looking S. along Replant Area -1

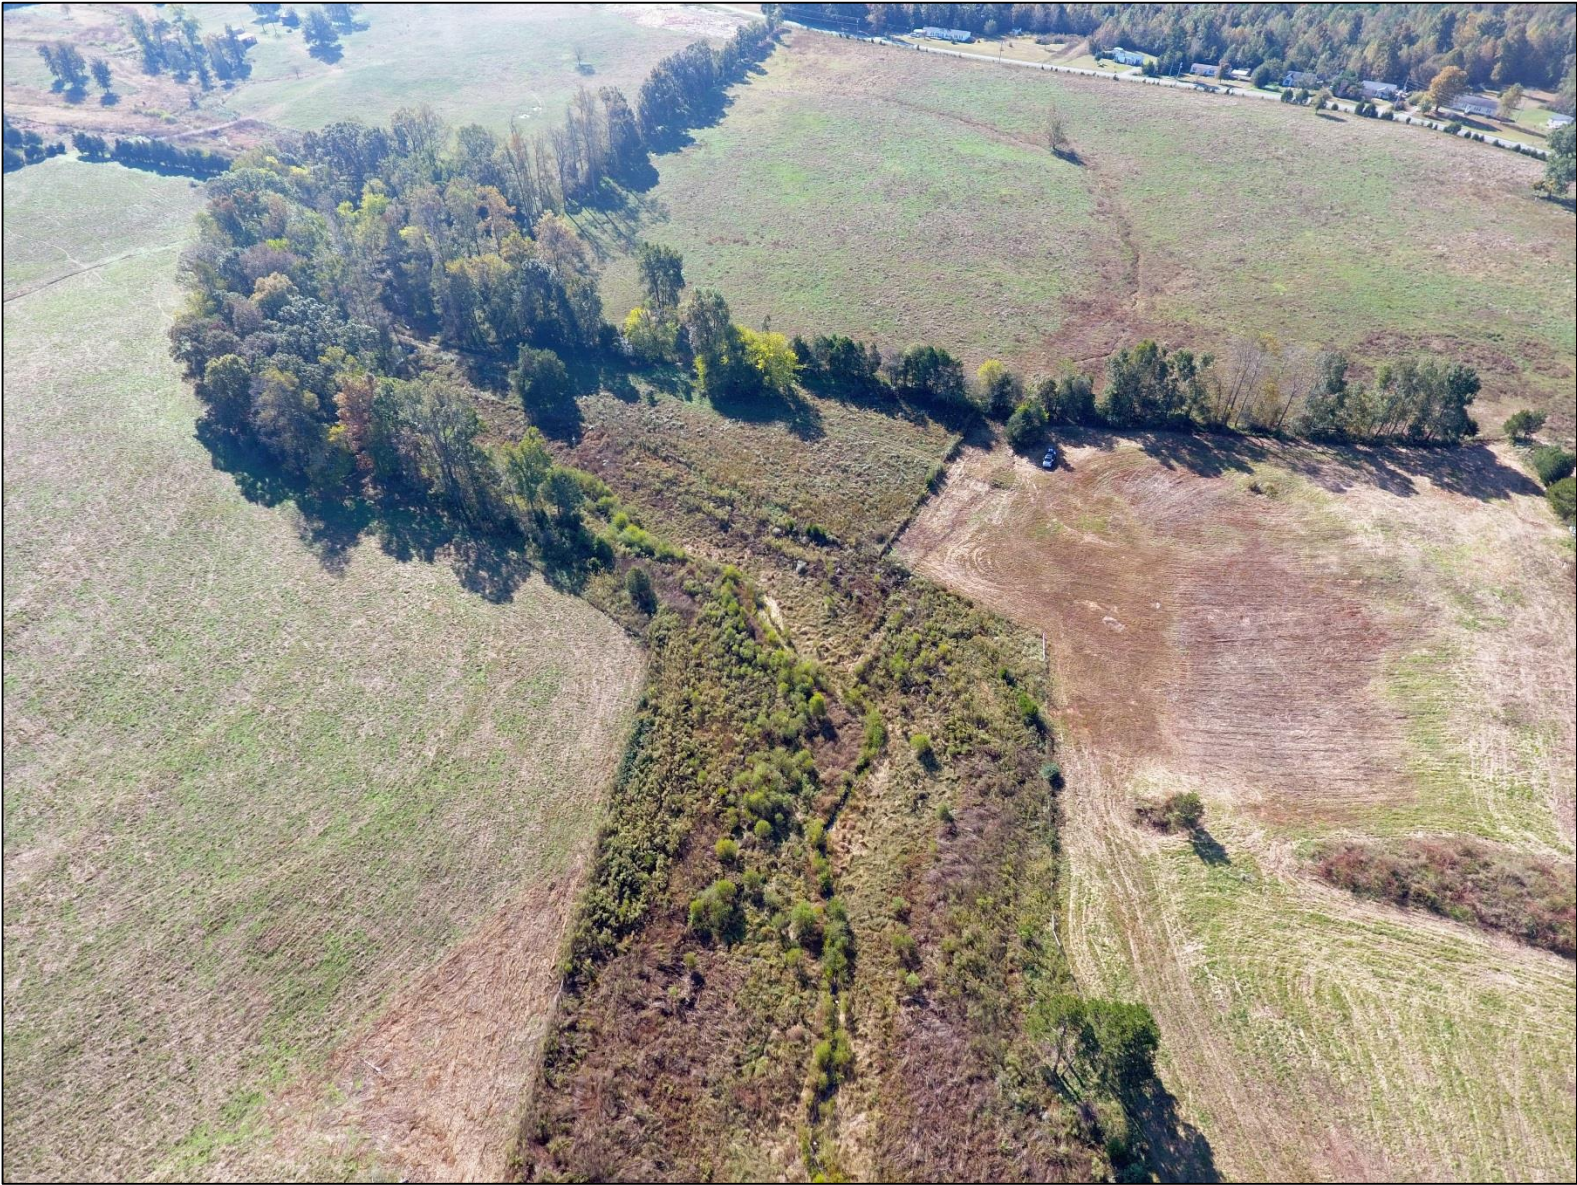
Photo 3: Downstream end of the Main Stem looking upstream into the old pond bed

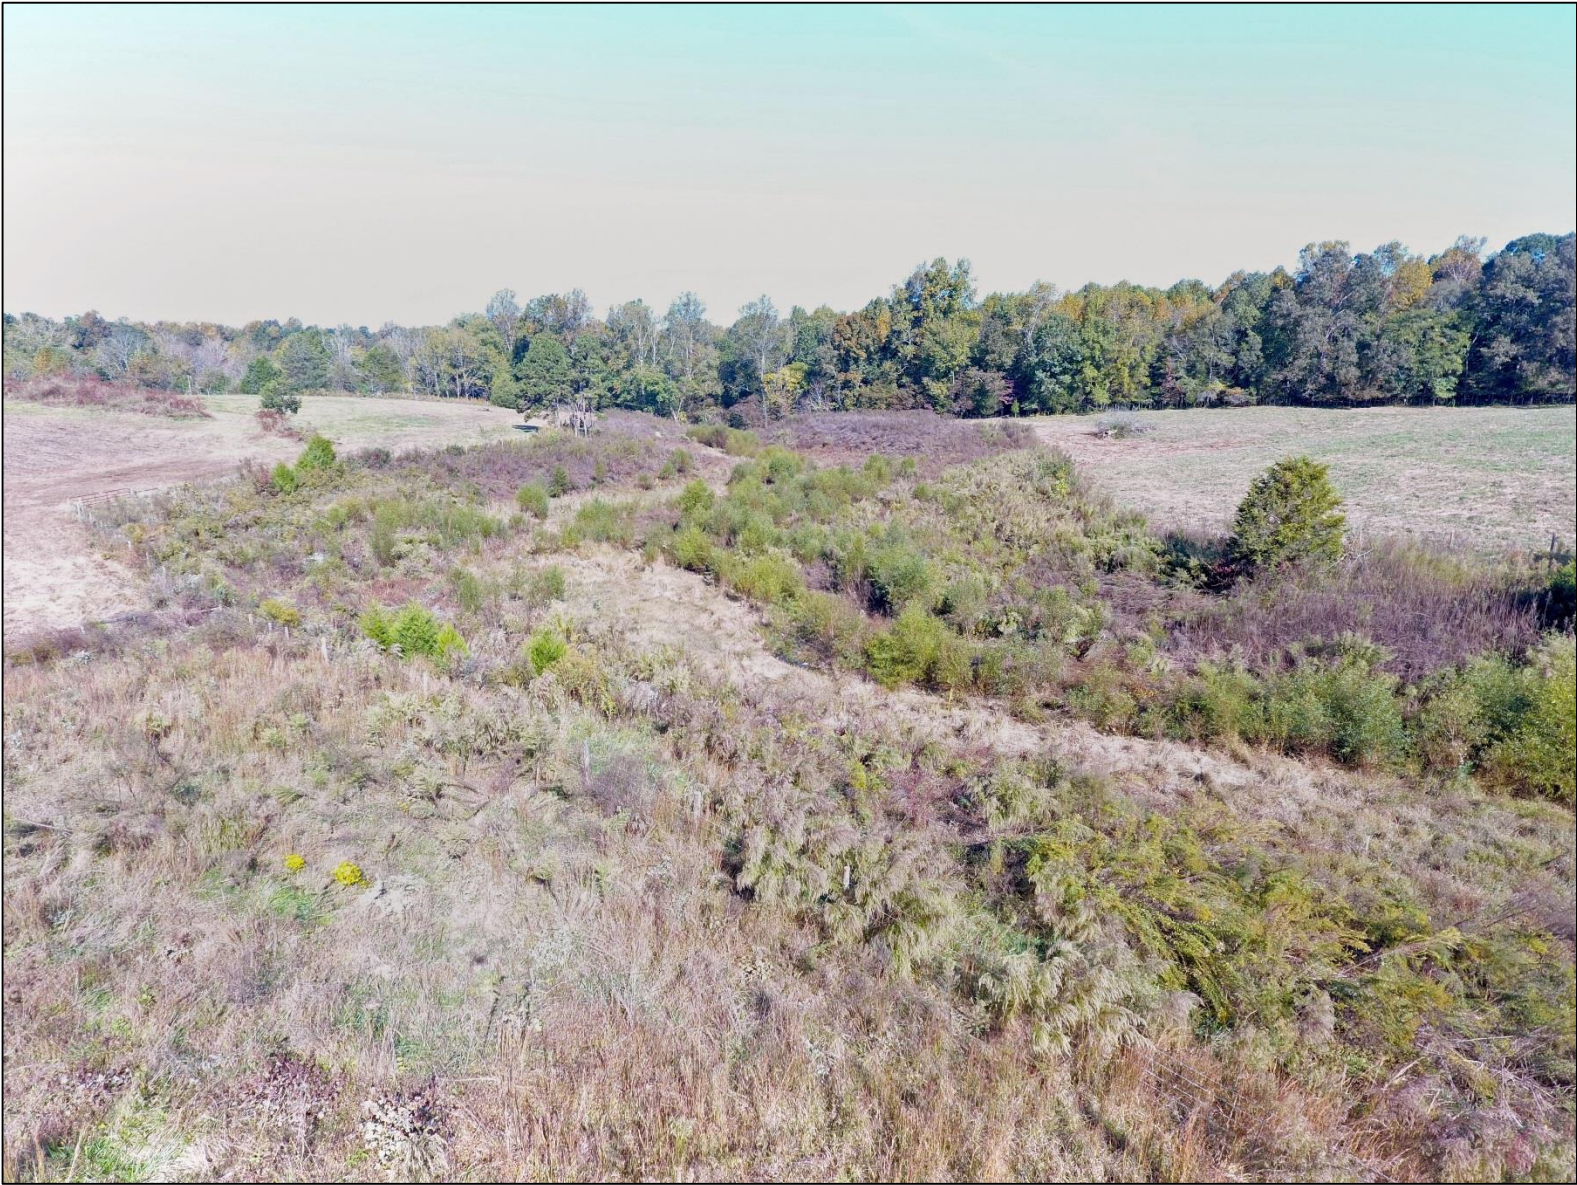
Photo 4: Upstream end of the old pond looking downstream

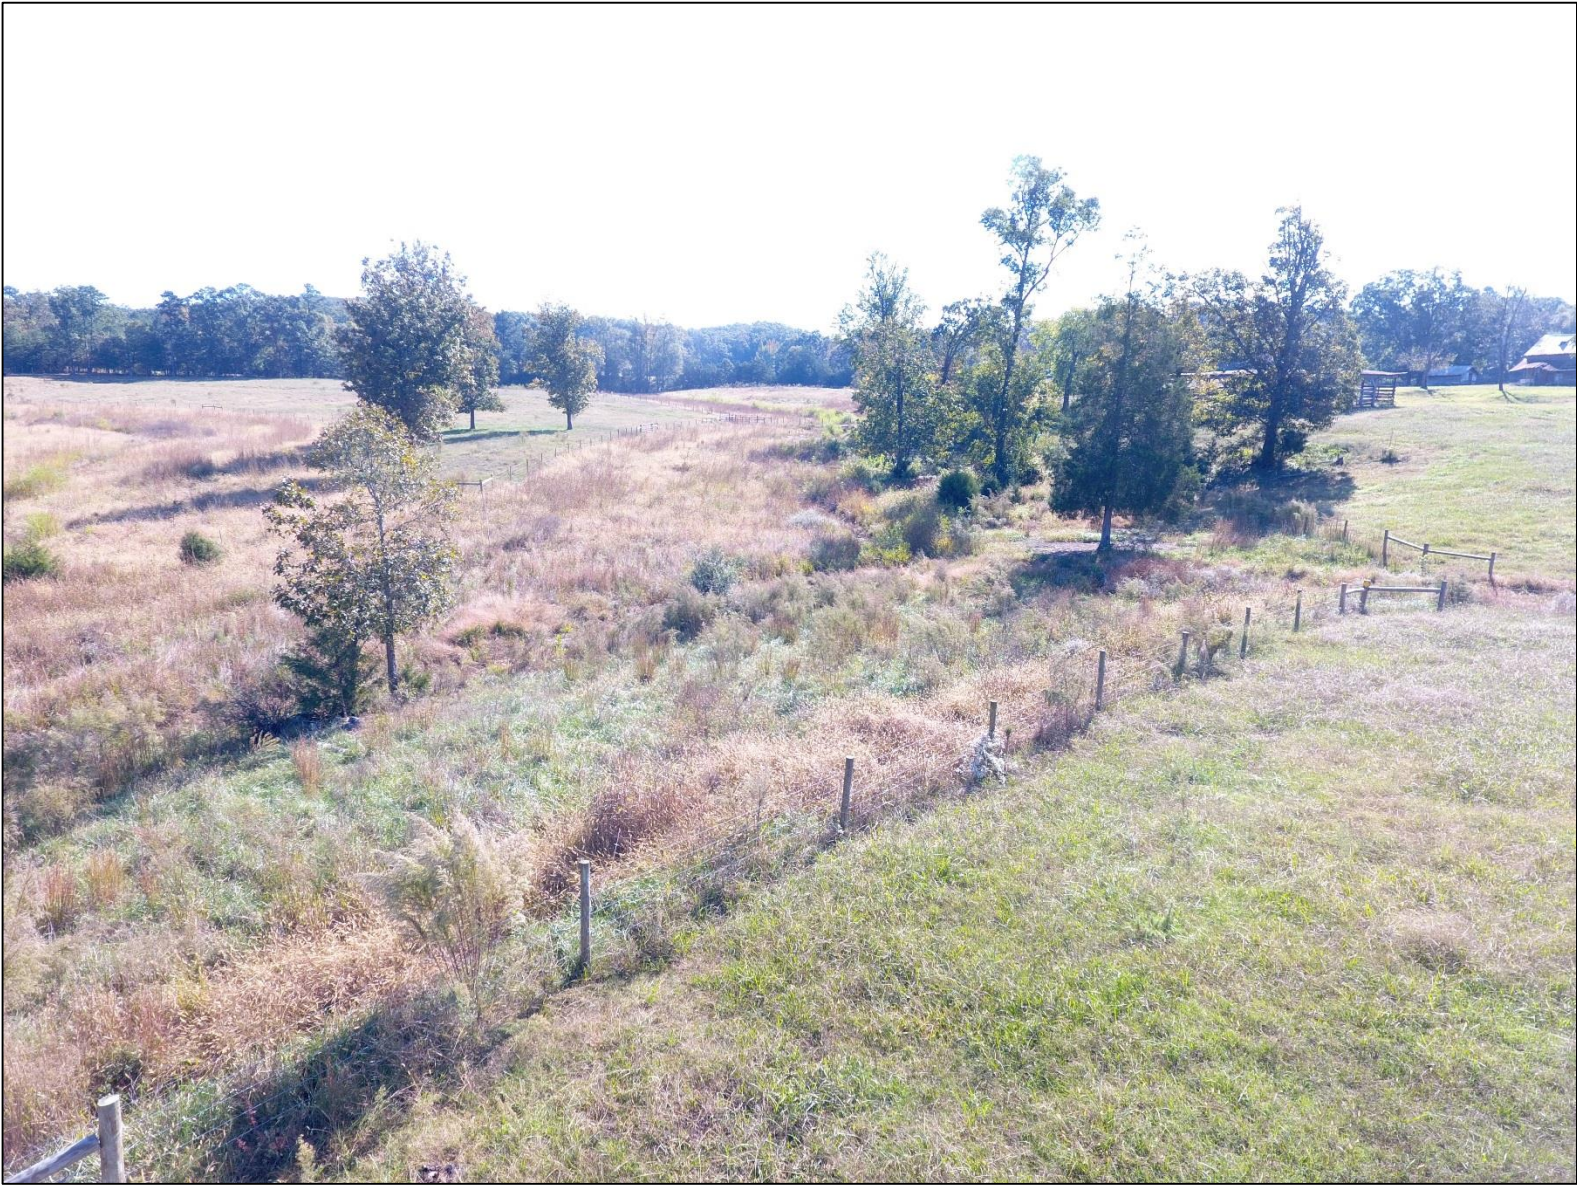
Photo 5: middle crossing looking upstream at the Main Stem and UT-3 on the left
