YEAR 5 (2019) MONITORING REPORT
ABBEY LAMM
STREAM AND WETLAND MITIGATION SITE
ALAMANCE COUNTY, NORTH CAROLINA
FULL DELIVERY CONTRACT No. 5790
DMS PROJECT No. 96311
NCDWR PROJECT No. 20140336
USACE ACTION ID No. SAW-2014-01710

CAPE FEAR RIVER BASIN
CATALOGING UNIT 03030002

Data Collection – March-November 2019

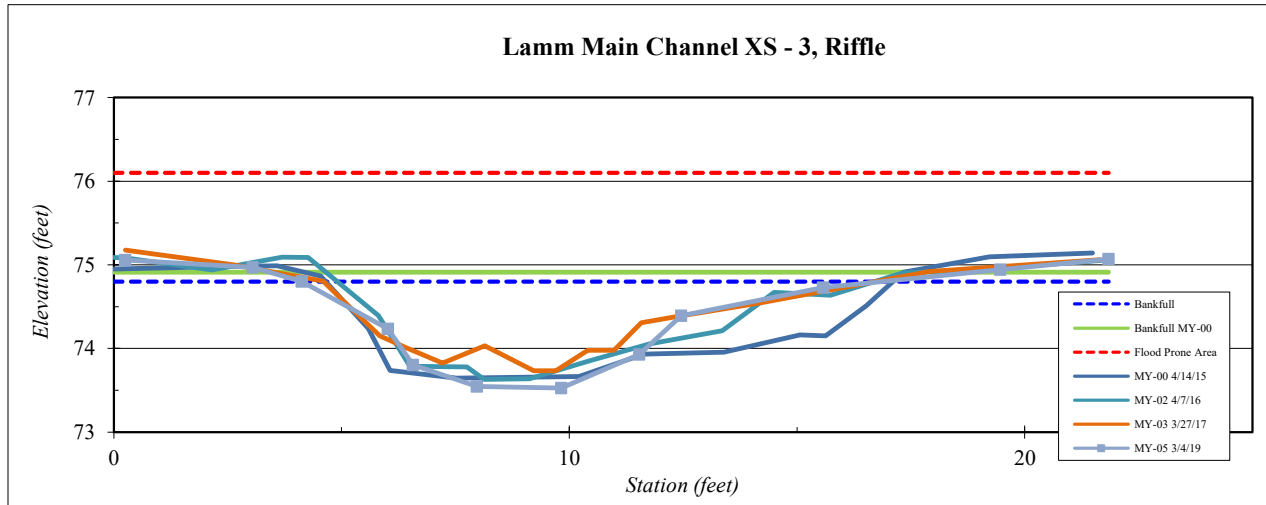
**MY0-3 BHR were calculated using DMS method of "Dmax year x /Dmax year 0". MY5-7 were calculated using DMS method of area best fit. Cross section not monitored during year 1 (2015) due to hornets nest at cross section location.

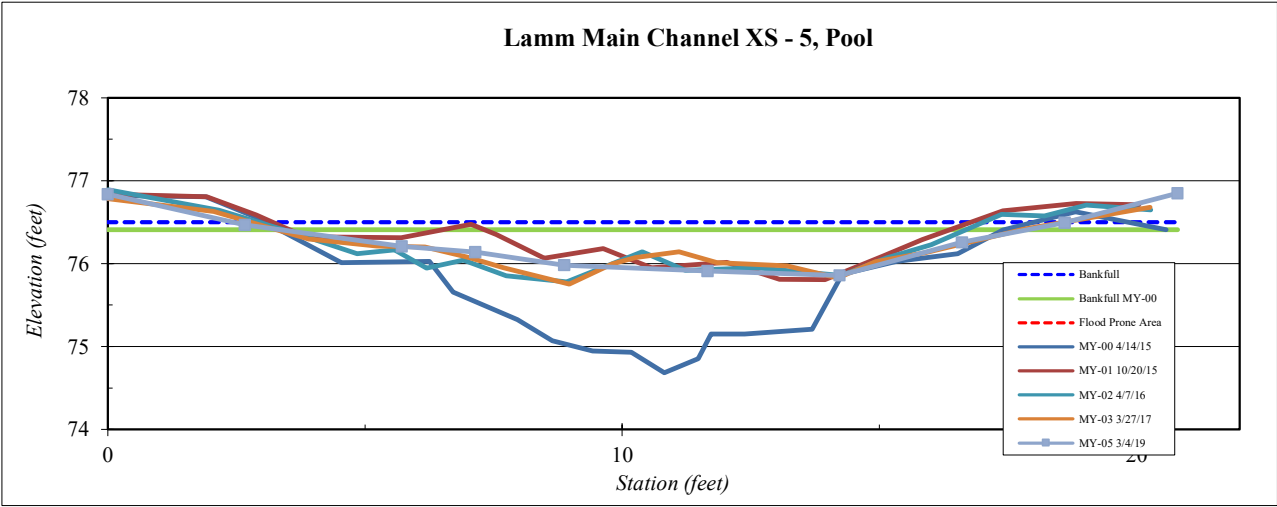
**MY0-3 BHR were calculated using DMS method of "Dmax year x /Dmax year 0". MY5-7 were calculated using DMS method of area best fit.
Sediment deposition in pool appears natural and is not expected to lead to instability.

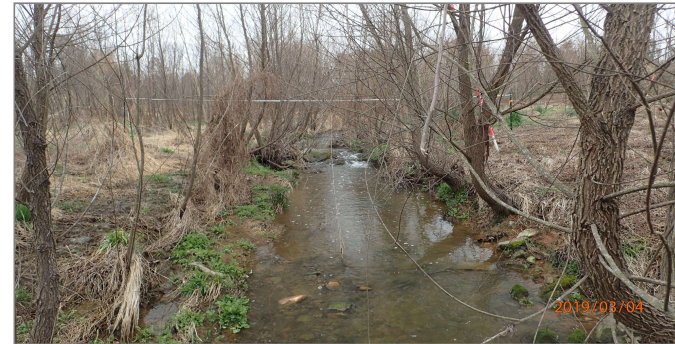
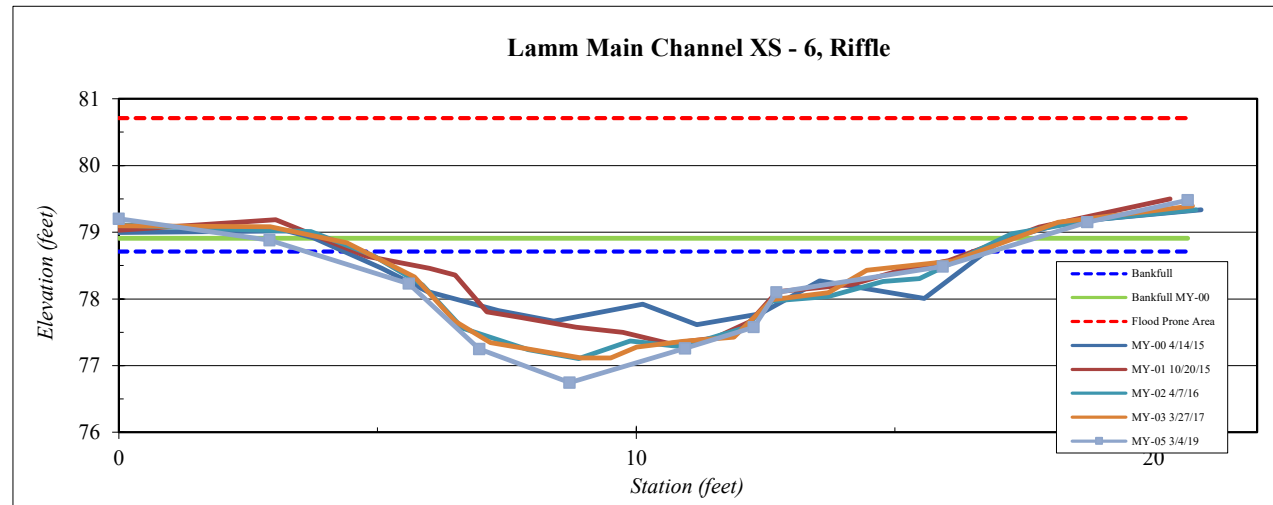
**MY0-3 BHR were calculated using DMS method of "Dmax year x /Dmax year 0". MY5-7 were calculated using DMS method of area best fit.
 Channel constructed in lake bed, with stabilization occurring in years 1 through 5 monitoring. No problems visible in this reach.

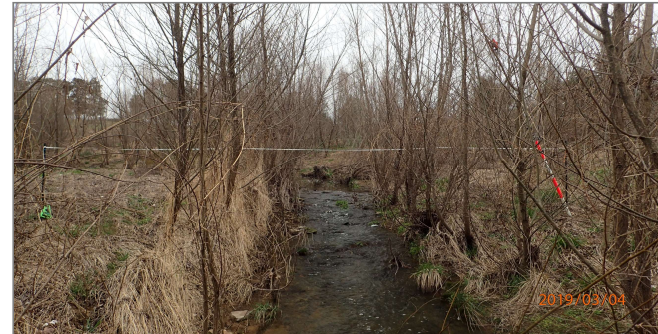
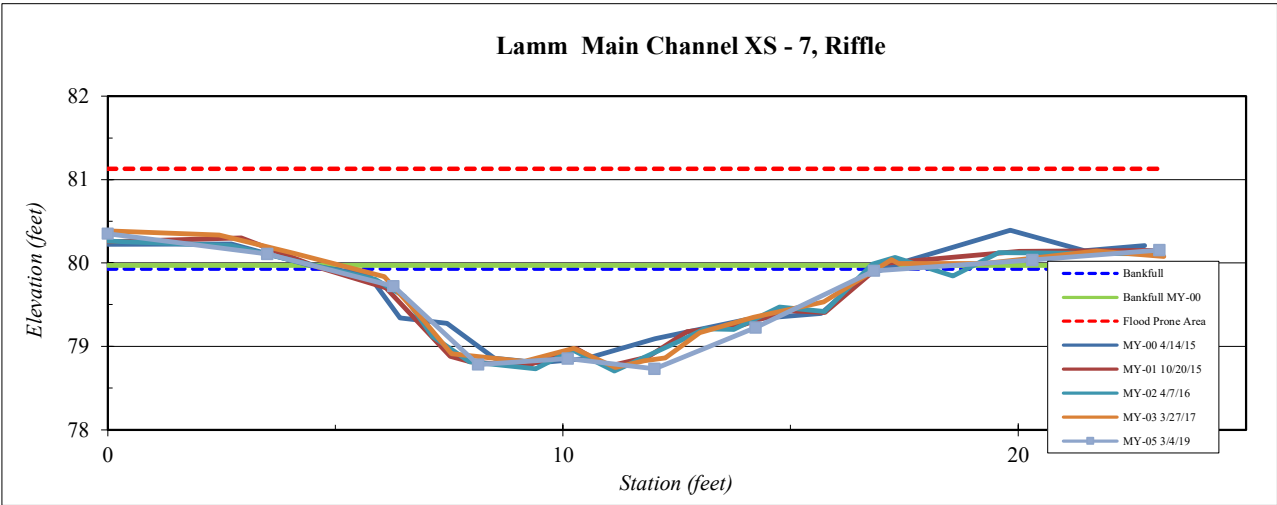
Site	Abbey Lamm
Watershed:	Cape Fear, 0303002
XS ID	Main Channel XS - 7, Riffle
Feature	Riffle
Date:	3/4/2019
Field Crew:	Perkinson, Radecki

**MY0-3 BHR were calculated using DMS method of "Dmax year x /Dmax year 0". MY5-7 were calculated using DMS method of area best fit.

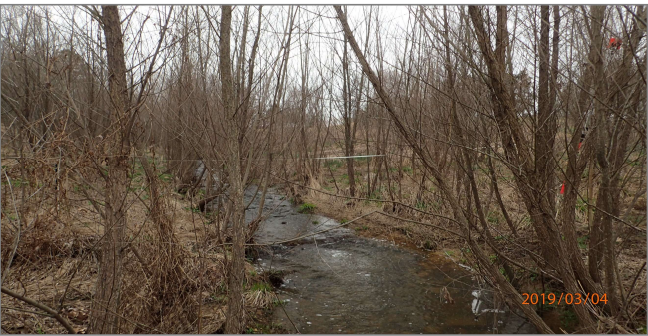
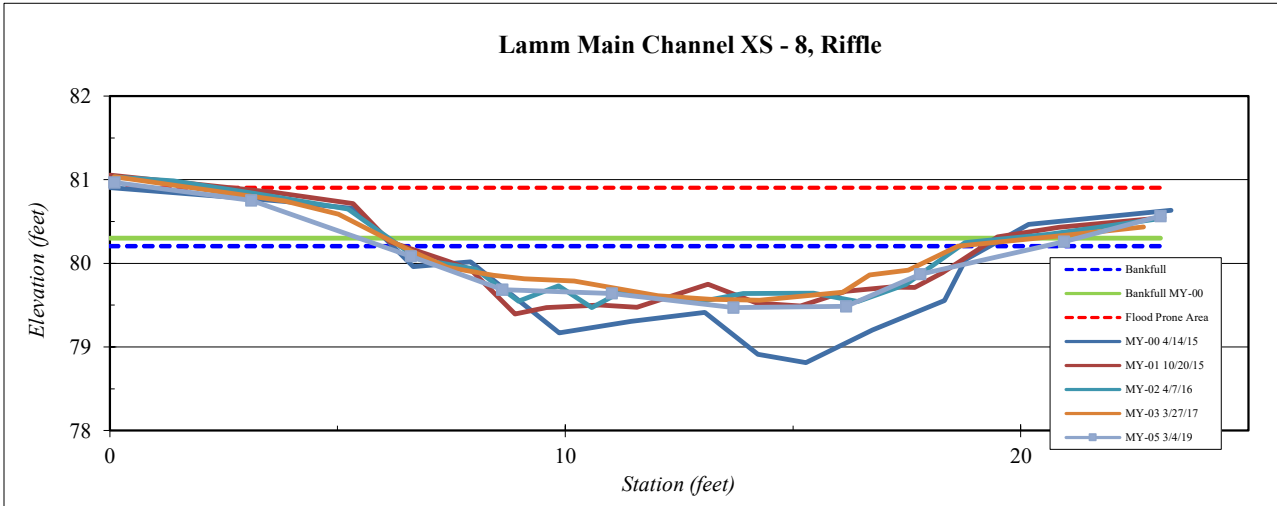
Site	Abbey Lamm
Watershed:	Cape Fear, 0303002
XS ID	Main Channel XS - 8, Riffle
Feature	Riffle
Date:	3/4/2019
Field Crew:	Perkinson, Radecki

Sediment transport appears to be natural and has stabilized during years 1 to 5 monitoring.

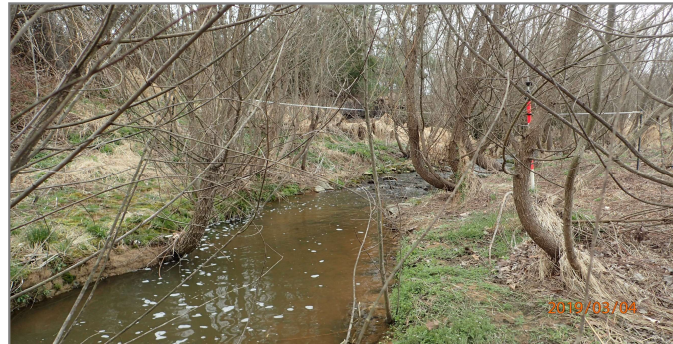
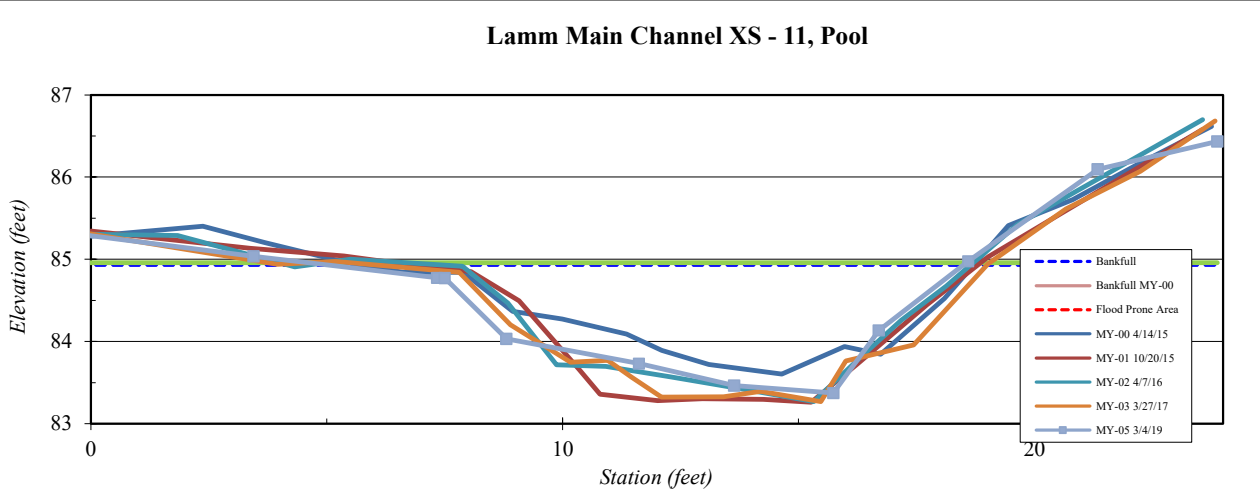
Site	Abbey Lamm
Watershed:	Cape Fear, 0303002
XS ID	Main Channel XS - 11, Pool
Feature	Pool
Date:	3/4/2019
Field Crew:	Perkinson, Radecki

**MY0-3 BHR were calculated using DMS method of "Dmax year x /Dmax year 0". MY5-7 were calculated using DMS method of area best fit.
Some downcutting occurred just after asbuilt but has stabilized during years 1 through 5.

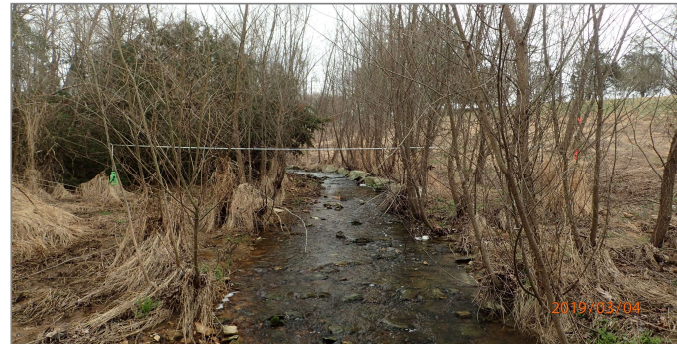
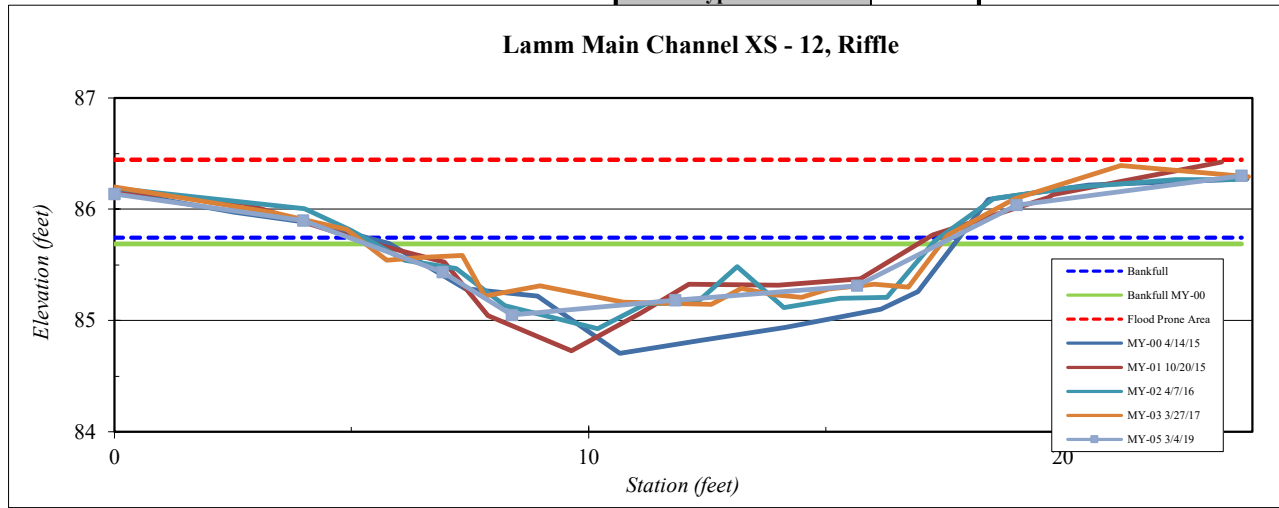
Site	Abbey Lamm
Watershed:	Cape Fear, 0303002
XS ID	Main Channel XS - 12, Riffle
Feature	Riffle
Date:	3/4/2019
Field Crew:	Perkinson, Radecki

**MY0-3 BHR were calculated using DMS method of "Dmax year x /Dmax year 0". MY5-7 were calculated using DMS method of area best fit.
Elevated BHR does not indicate instability along this reach.
Minor alterations in shallow channels may result in large discrepancies including elevated BHR.

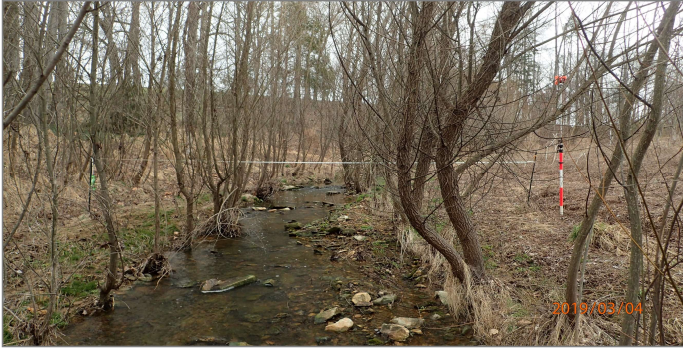
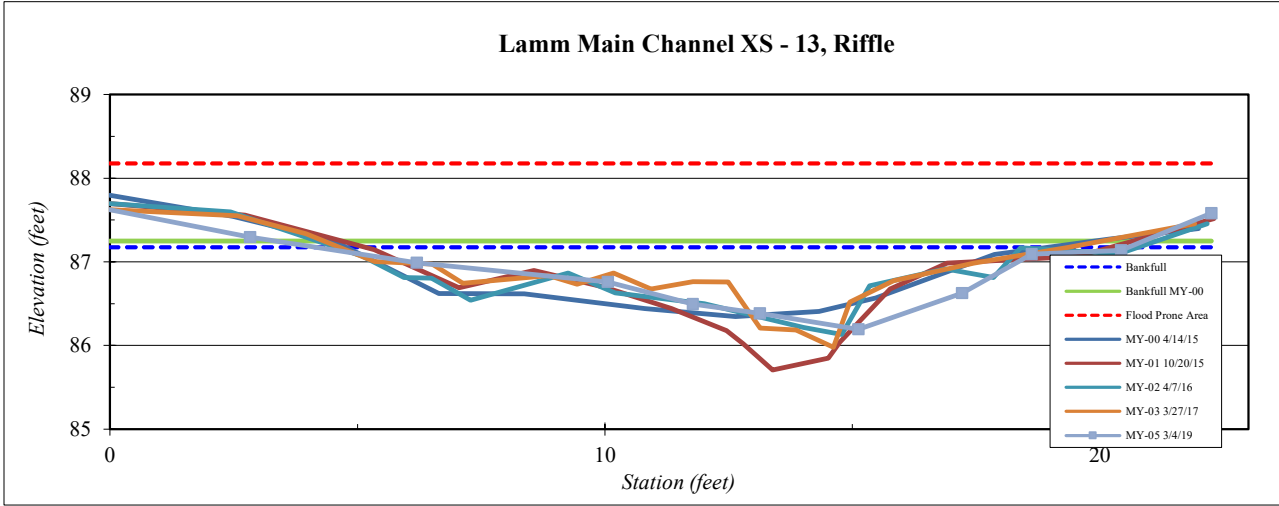
Site	Abbey Lamm
Watershed:	Cape Fear, 0303002
XS ID	Main Channel XS - 13, Riffle
Feature	Riffle
Date:	3/4/2019
Field Crew:	Perkinson, Radecki

**MY0-3 BHR were calculated using DMS method of "Dmax year x / Dmax year 0". MY5-7 were calculated using DMS method of area best fit.
Channel constructed in lake bed. Unconsolidated materials are forming a new channel within the constructed channel.
Depth decreased during MY-01-03 and is stabilizing.

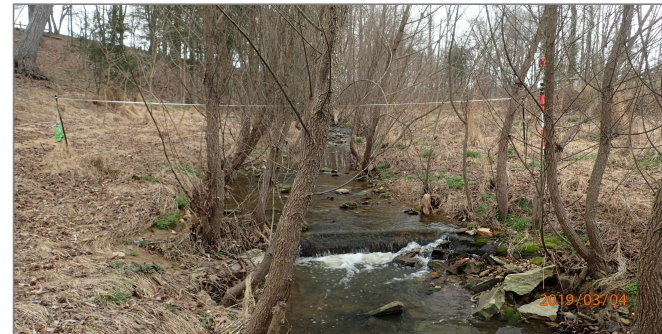
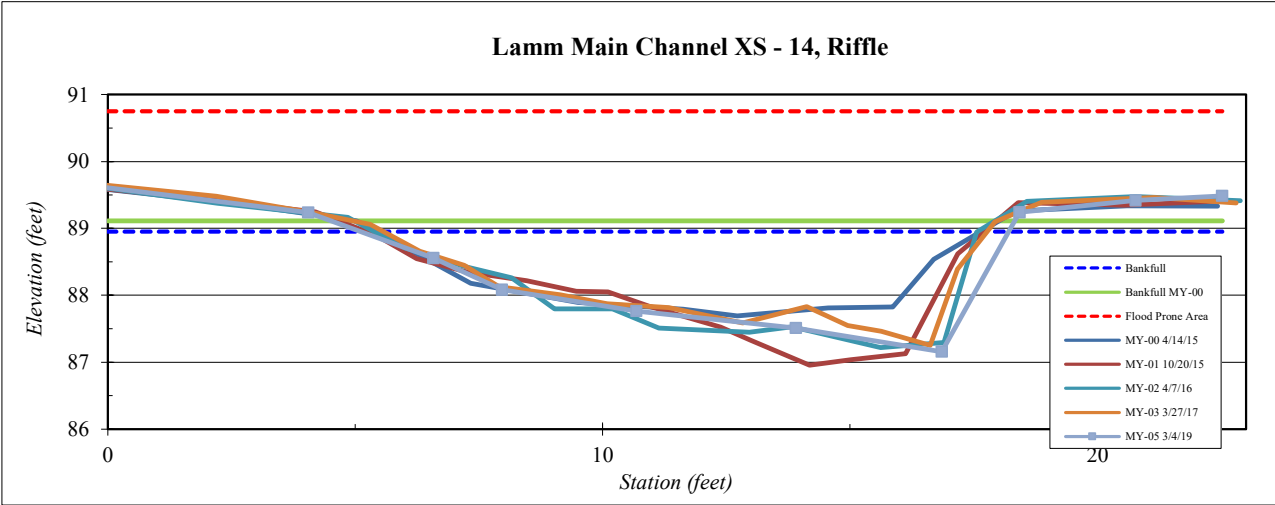
Site	Abbey Lamm
Watershed:	Cape Fear, 0303002
XS ID	Main Channel XS - 14, Riffle
Feature	Riffle
Date:	3/4/2019
Field Crew:	Perkinson, Radecki

**MY0-3 BHR were calculated using DMS method of "Dmax year x / Dmax year 0". MY5-7 were calculated using DMS method of area best fit.
 Channel constructed in lake bed. Unconsolidated materials are forming a new channel within the constructed channel.
 Depth is decreasing since MY-01 and is stabilizing in MY-02-05.

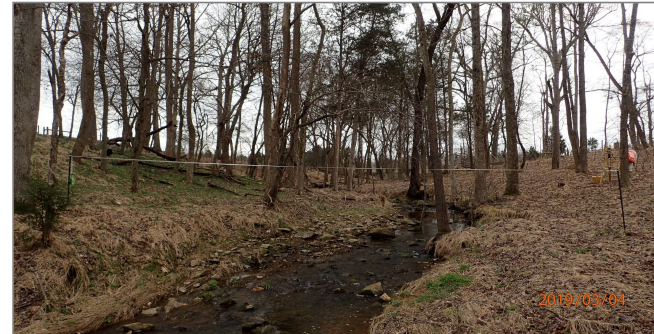
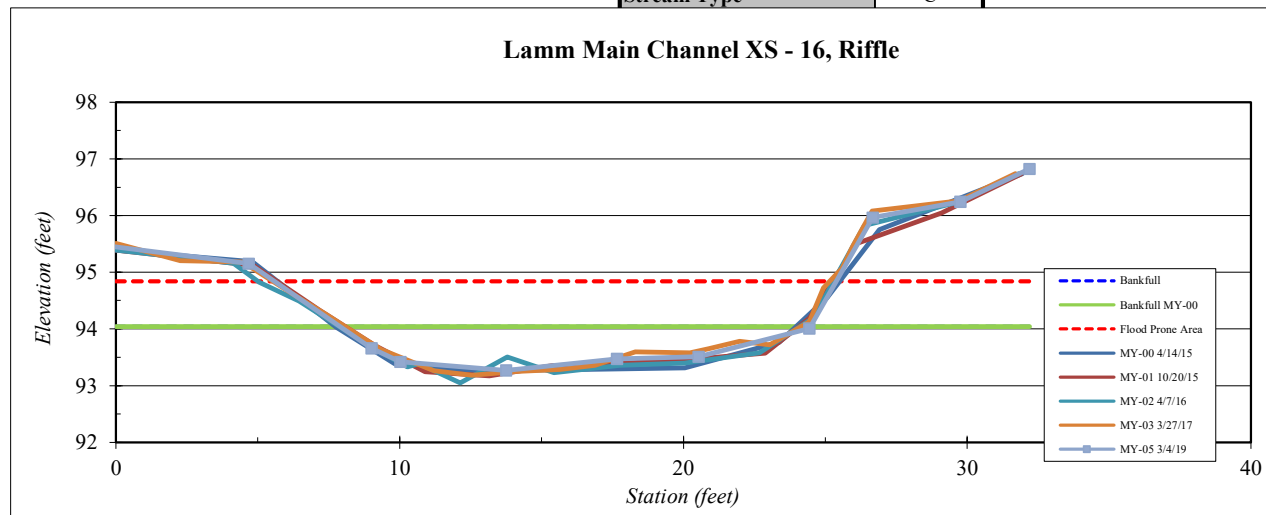
Site	Abbey Lamm
Watershed:	Cape Fear, 0303002
XS ID	Main Channel XS - 16, Riffle
Feature	Riffle
Date:	3/4/2019
Field Crew:	Perkinson, Radecki

Enhancement Level II Reach. BHR varies through this reach; however, the reach is stable.
 Minor alterations in shallow channels may result in large discrepancies including elevated BHR.

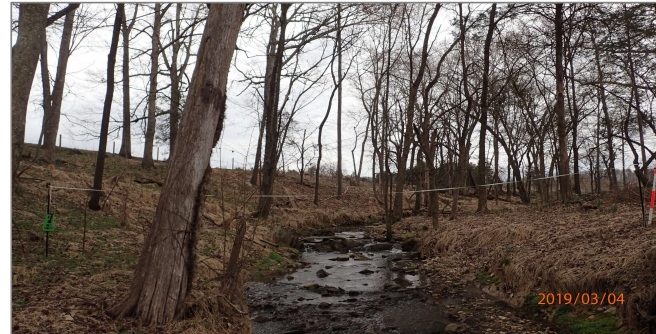
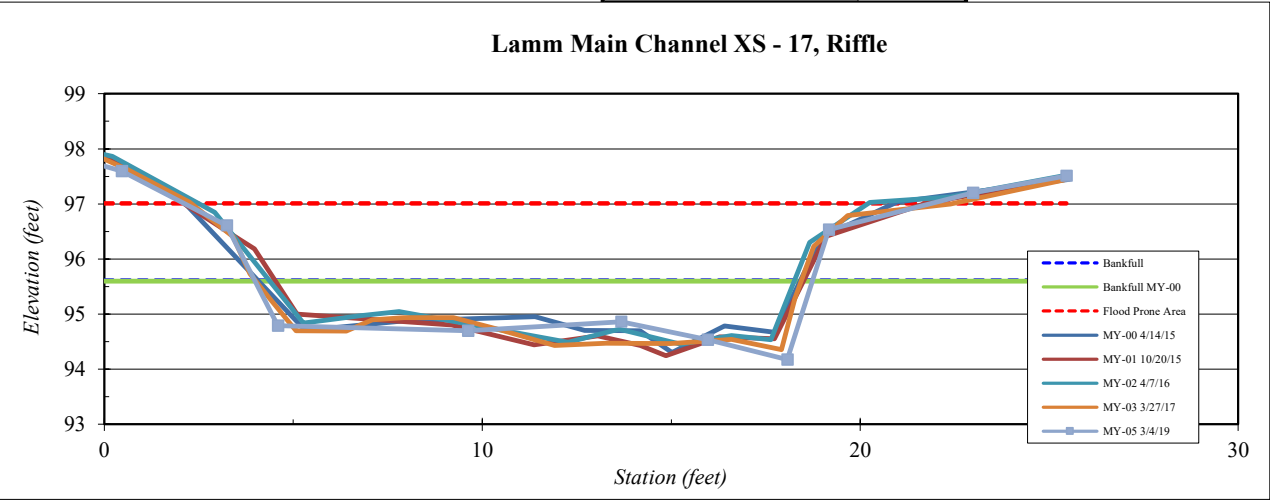
Site	Abbey Lamm
Watershed:	Cape Fear, 0303002
XS ID	Main Channel XS - 17, Riffle
Feature	Riffle
Date:	3/4/2019
Field Crew:	Perkinson, Radecki

****MY0-3 BHR were calculated using DMS method of "Dmax year x / Dmax year 0". MY5-7 were calculated using DMS method of area best fit. Enhancement Level II Reach. BHR varies through this reach; however, the reach is stable. Minor alterations in shallow channels may result in large discrepancies including elevated BHR.**

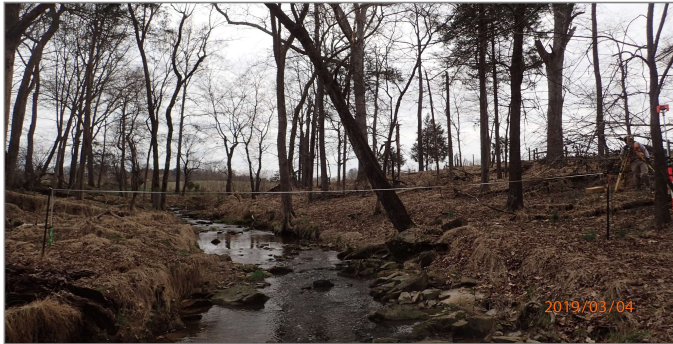
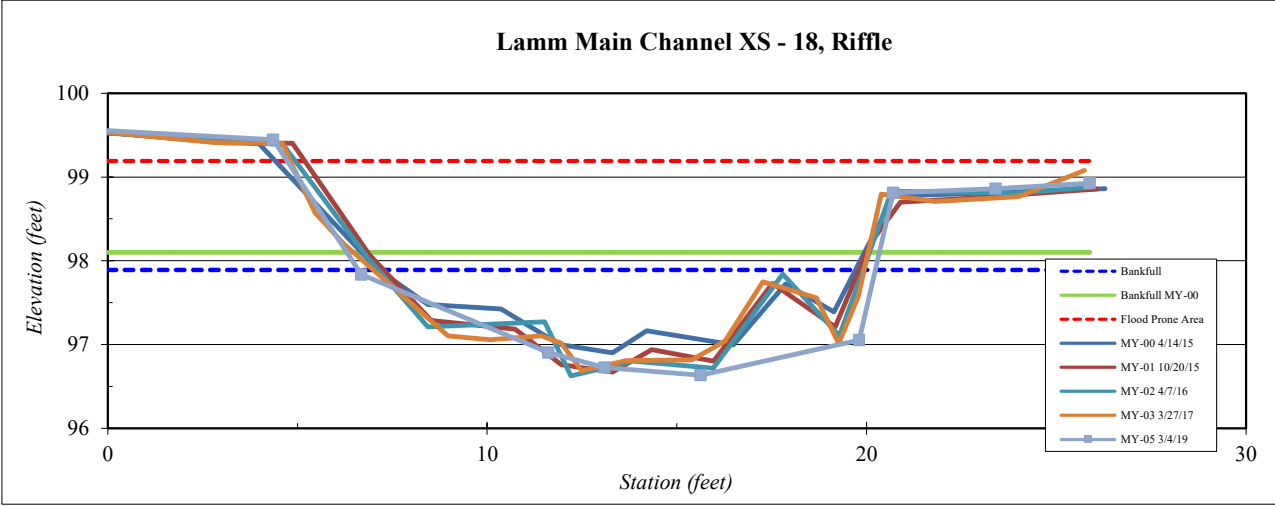
Site	Abbey Lamm
Watershed:	Cape Fear, 0303002
XS ID	Main Channel XS - 18, Riffle
Feature	Riffle
Date:	3/4/2019
Field Crew:	Perkinson, Radecki

Enhancement Level II Reach. BHR varies through this reach; however, the reach is stable.
Minor alterations in shallow channels may result in large discrepancies including elevated BHR.

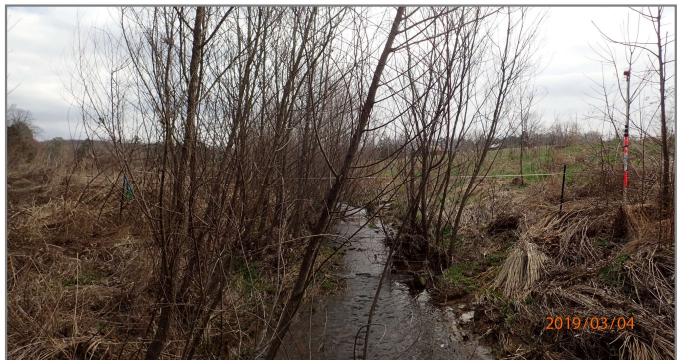
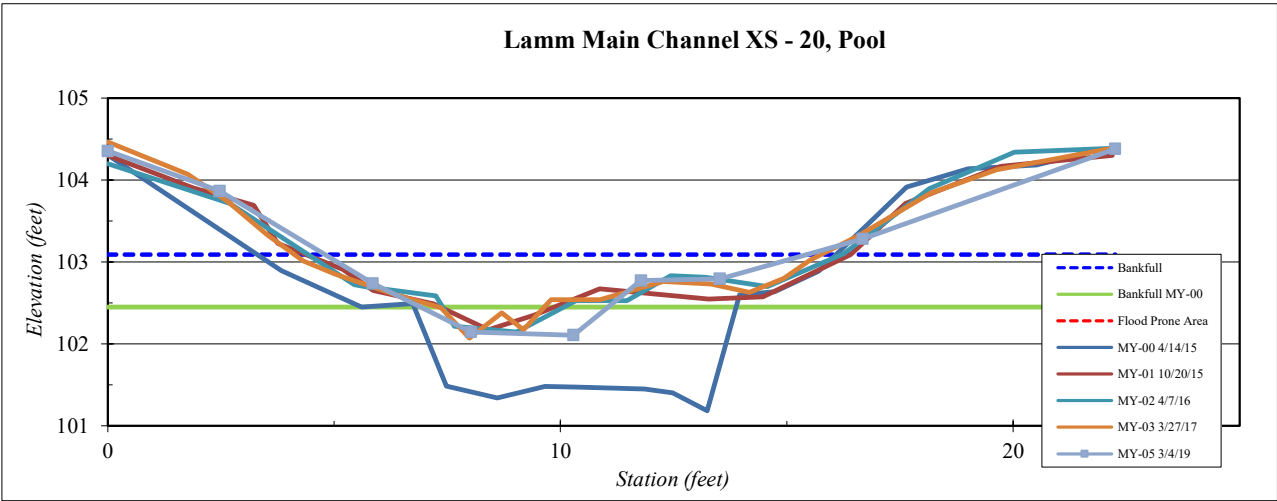
**MY0-3 BHR were calculated using DMS method of "Dmax year x /Dmax year 0". MY5-7 were calculated using DMS method of area best fit.
Sediment has aggraded behind a bedrock sill. Sediment has been stable MY-01 through MY-05.

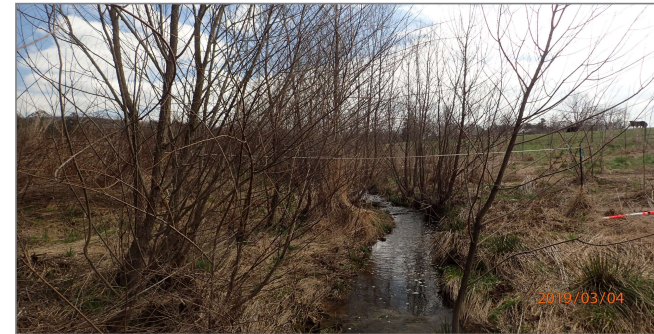
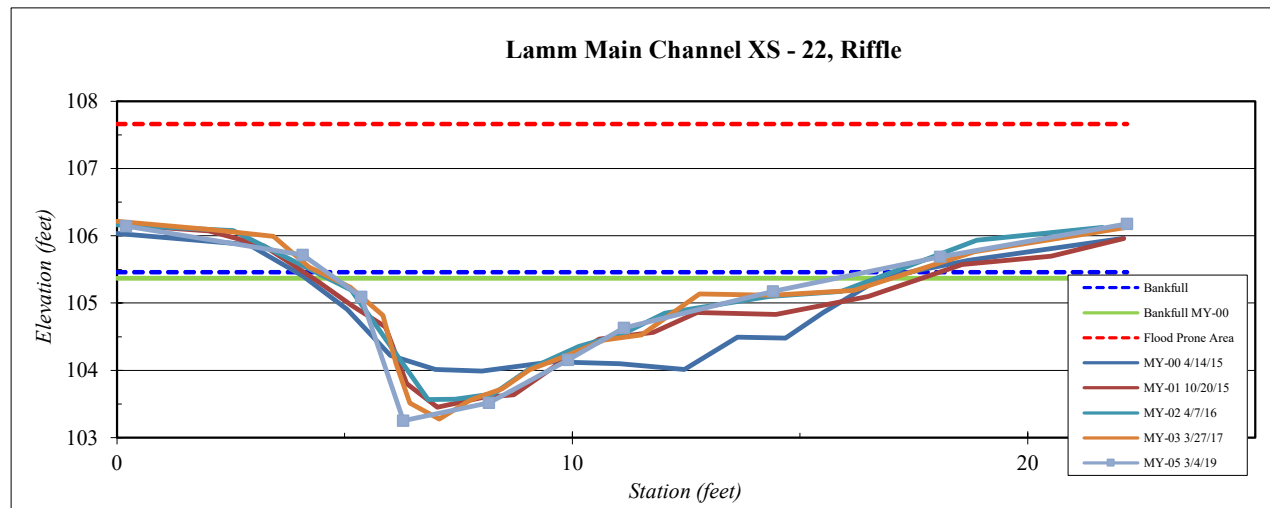
Site	Abbey Lamm
Watershed:	Cape Fear, 0303002
XS ID	Main Channel XS - 22, Riffle
Feature	Riffle
Date:	3/4/2019
Field Crew:	Perkinson, Radecki

Overall channel area has decreased. Sediment mobilization has resulted in minor downcutting, which has stabilized over the past 5 years. No problems are visible in this reach.

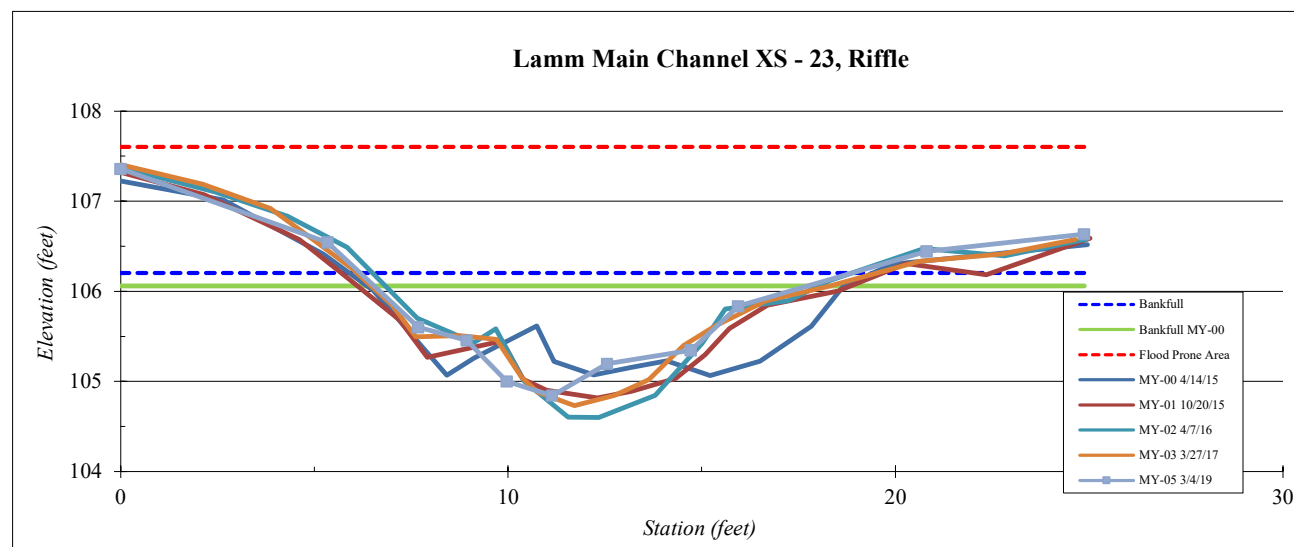
**MY0-3 BHR were calculated using DMS method of "Dmax year x /Dmax year 0". MY5-7 were calculated using DMS method of area best fit.

Overall channel area has remained constant. Sediment mobilization has resulted in minor downcutting, which has stabilized over the past 5 years. No problems are visible in this reach.

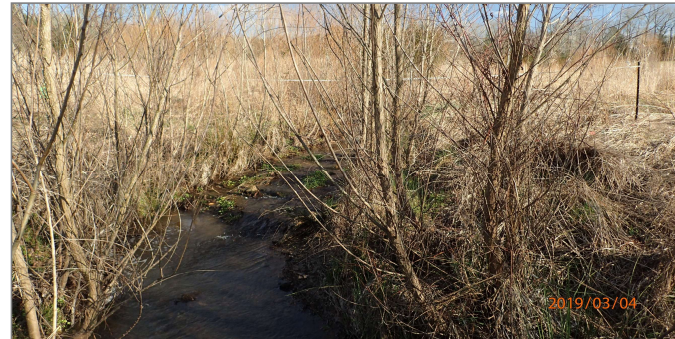
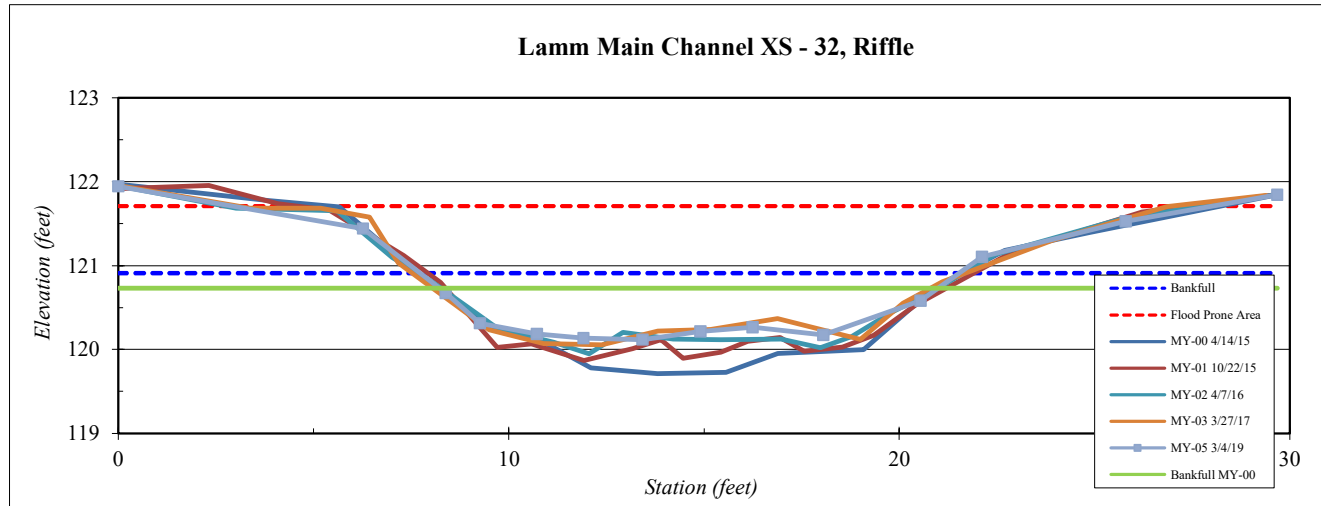
Site	Abbey Lamm
Watershed:	Cape Fear, 0303002
XS ID	Main Channel XS - 32, Riffle
Feature	Riffle
Date:	3/4/2019
Field Crew:	Perkinson, Radecki

**MY0-3 BHR were calculated using DMS method of "Dmax year x /Dmax year 0". MY5-7 were calculated using DMS method of area best fit. No problems have been noted in this reach. Minor alterations in shallow channels may result in large discrepancies including elevated BHR.

SUMMARY DATA	
Bankfull Elevation:	120.9
Bankfull Cross-Sectional Area:	8.2
Bankfull Width:	13.8
Flood Prone Area Elevation:	121.7
Flood Prone Width:	25.0
Max Depth at Bankfull:	0.8
Mean Depth at Bankfull:	0.6
W / D Ratio:	23.2
Entrenchment Ratio:	1.8
Bank Height Ratio:	1.3

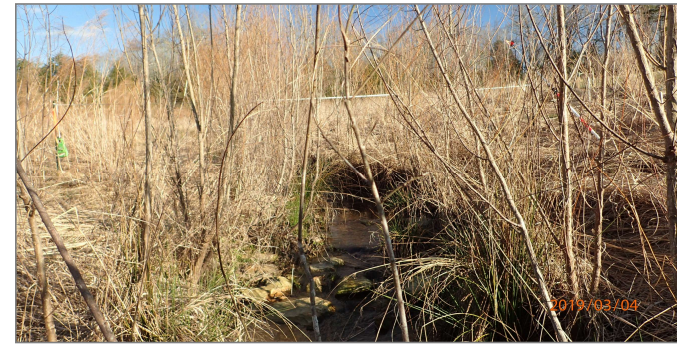
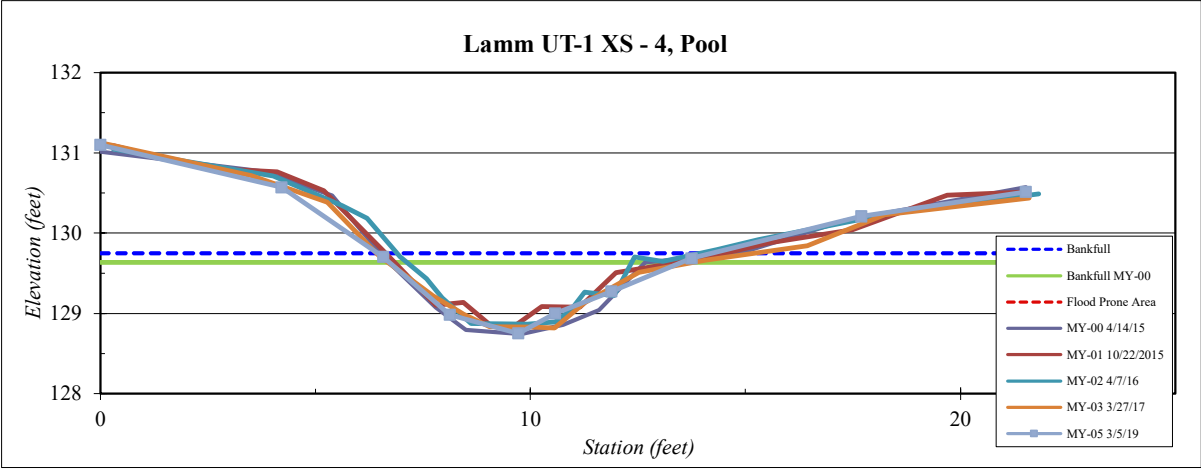
Site	Abbey Lamm
Watershed:	Cape Fear, 0303002
XS ID	UT 1 XS - 4, Pool
Feature	Pool
Date:	3/5/2019
Field Crew:	Perkinson, Radecki

**MY0-3 BHR were calculated using DMS method of "Dmax year x /Dmax year 0". MY5-7 were calculated using DMS method of area best fit.
Elevated BHR results from shallow channel depth. UT 1 appears stable throughout.

XS-4 was determined to be a pool during MY-05. It was labeled a pool during MY-0 but was mislabeled as a riffle during MY-01 through MY-03.

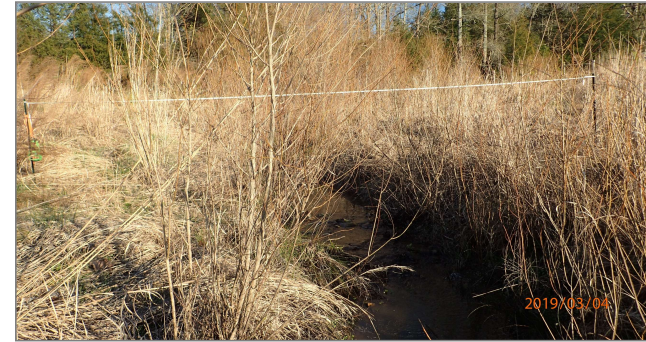
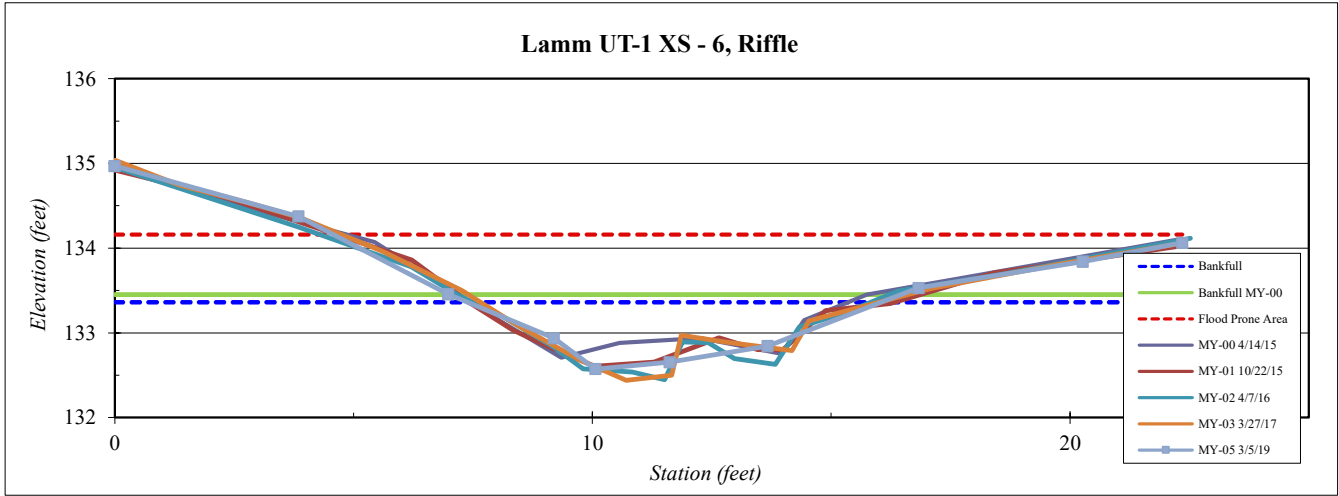
Site	Abbey Lamm
Watershed:	Cape Fear, 0303002
XS ID	UT 1 XS - 6, Riffle
Feature	Riffle
Date:	3/5/2019
Field Crew:	Perkinson, Radecki

Overall channel area has remained constant. Sediment mobilization has resulted in minor downcutting, which has stabilized over the past 5 years. No problems are visible in this reach.

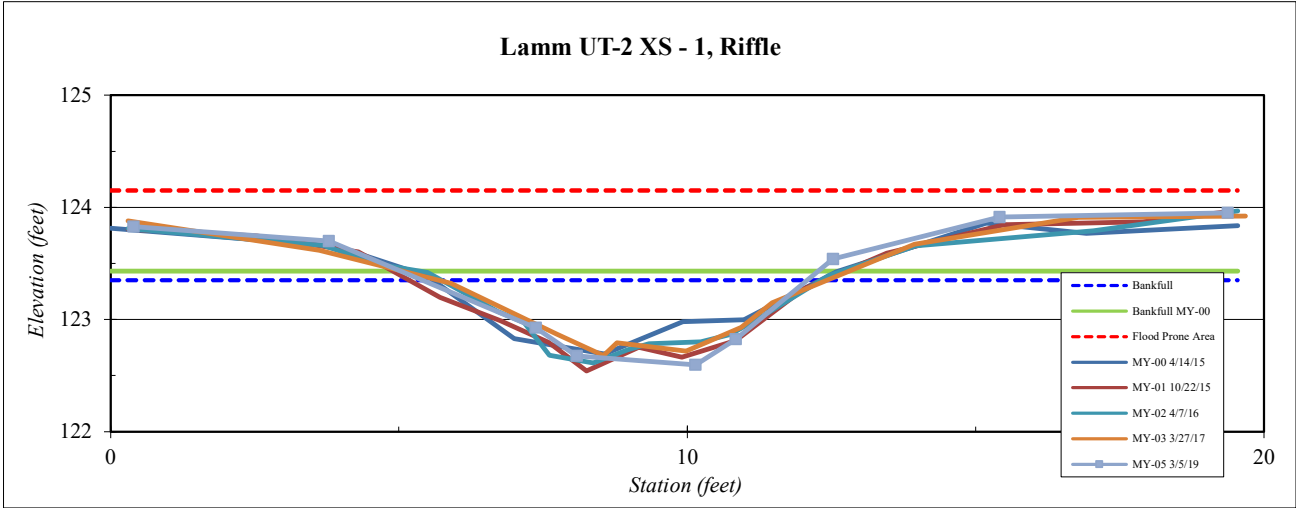
**MY0-3 BHR were calculated using DMS method of "Dmax year x /Dmax year 0". MY5-7 were calculated using DMS method of area best fit.
 No problems have been noted in this reach. Minor alterations in shallow channels may result in large discrepancies including elevated BHR.

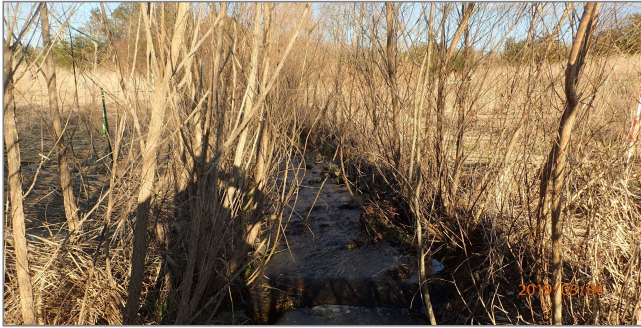
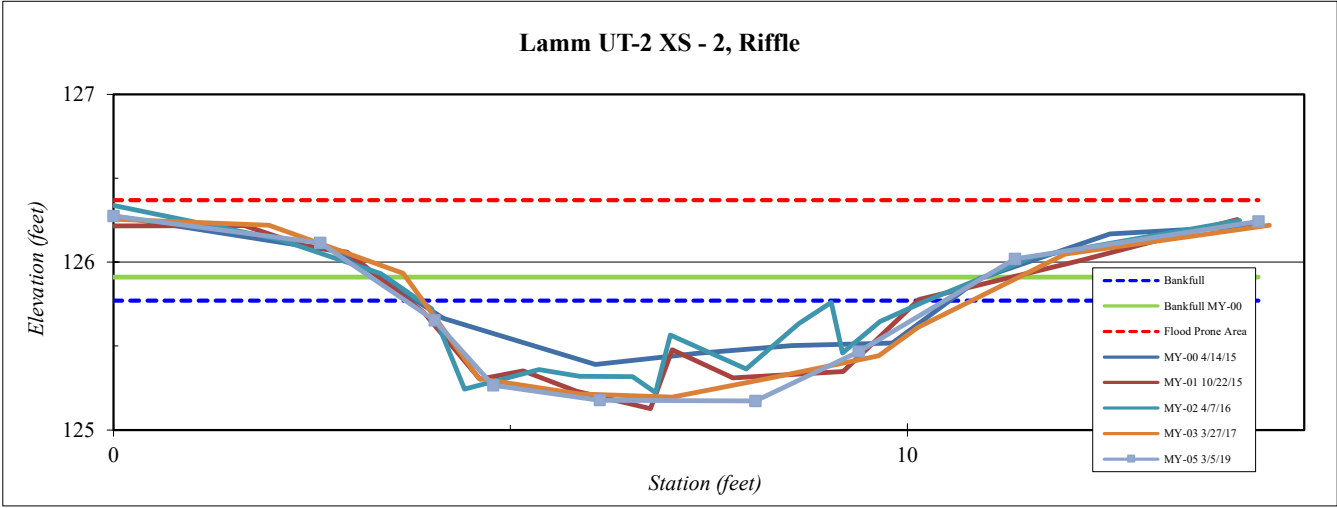
Site	Abbey Lamm
Watershed:	Cape Fear, 0303002
XS ID	UT 2 XS - 2, Riffle
Feature	Riffle
Date:	3/5/2019
Field Crew:	Perkinson, Radecki

**MY0-3 BHR were calculated using DMS method of "Dmax year x / Dmax year 0". MY5-7 were calculated using DMS method of area best fit. No problems have been noted in this reach. Minor alterations in shallow channels may result in large discrepancies including elevated BHR.

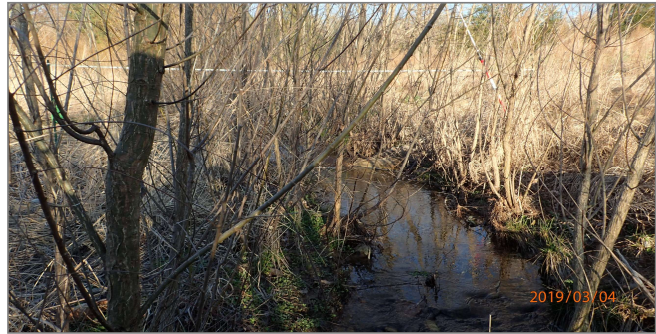
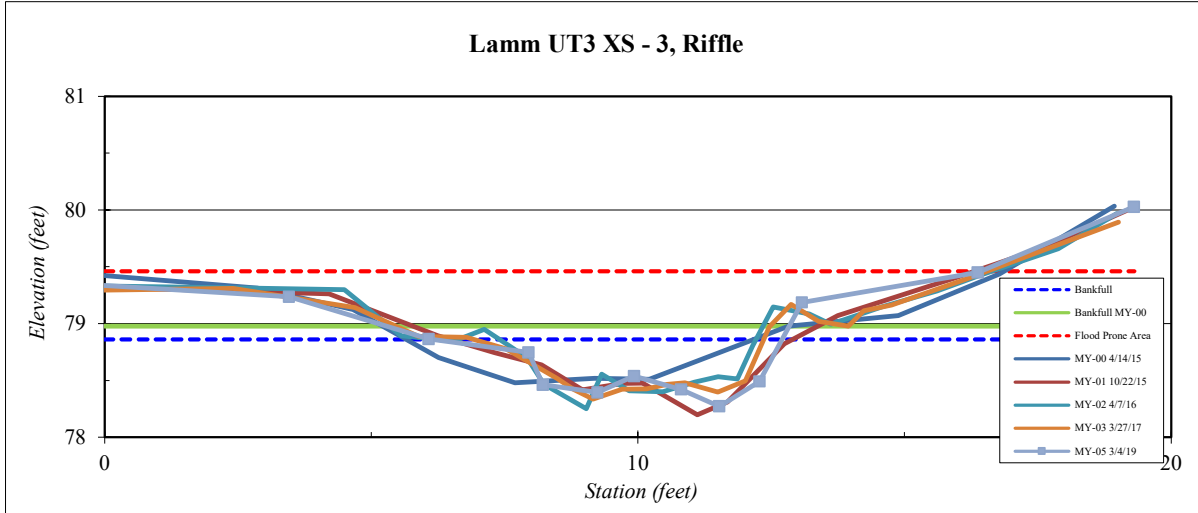
Site	Abbey Lamm
Watershed:	Cape Fear, 0303002
XS ID	UT 3 XS - 3, Riffle
Feature	Riffle
Date:	3/4/2019
Field Crew:	Perkinson, Radecki

****MY0-3 BHR were calculated using DMS method of "Dmax year x / Dmax year 0". MY5-7 were calculated using DMS method of area best fit. UT 3 has slight resorting of fill material in the channel; however, area has primarily remained constant and no significant erosion is apparent.**

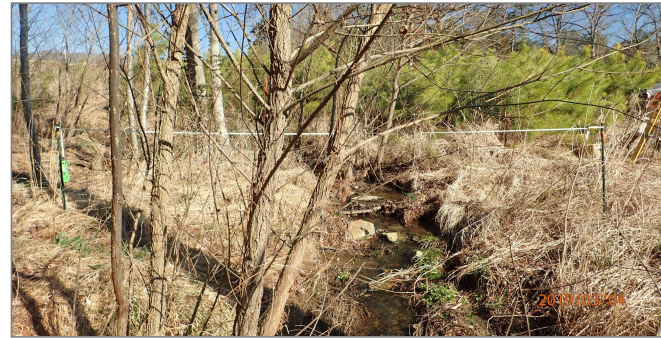
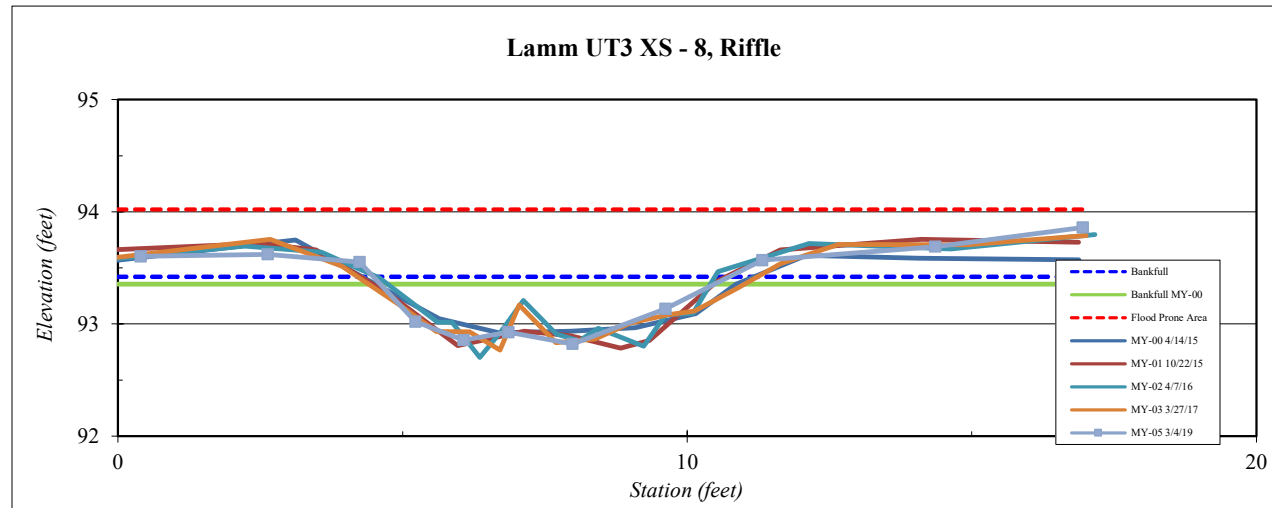
Site	Abbey Lamm
Watershed:	Cape Fear, 0303002
XS ID	UT 3 XS - 8, Riffle
Feature	Riffle
Date:	3/4/2019
Field Crew:	Perkinson, Radecki

**MY0-3 BHR were calculated using DMS method of "Dmax year x / Dmax year 0". MY5-7 were calculated using DMS method of area best fit.
 No problems have been noted in this reach. Minor alterations in shallow channels may result in large discrepancies including elevated BHR.

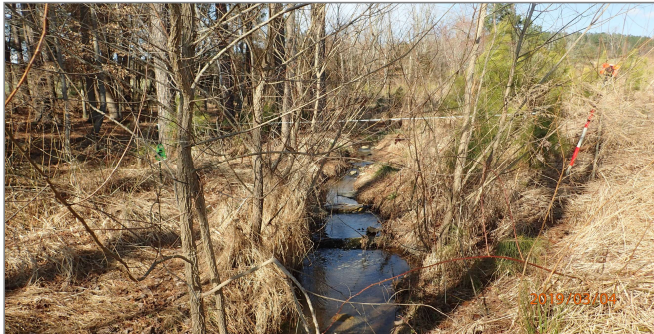
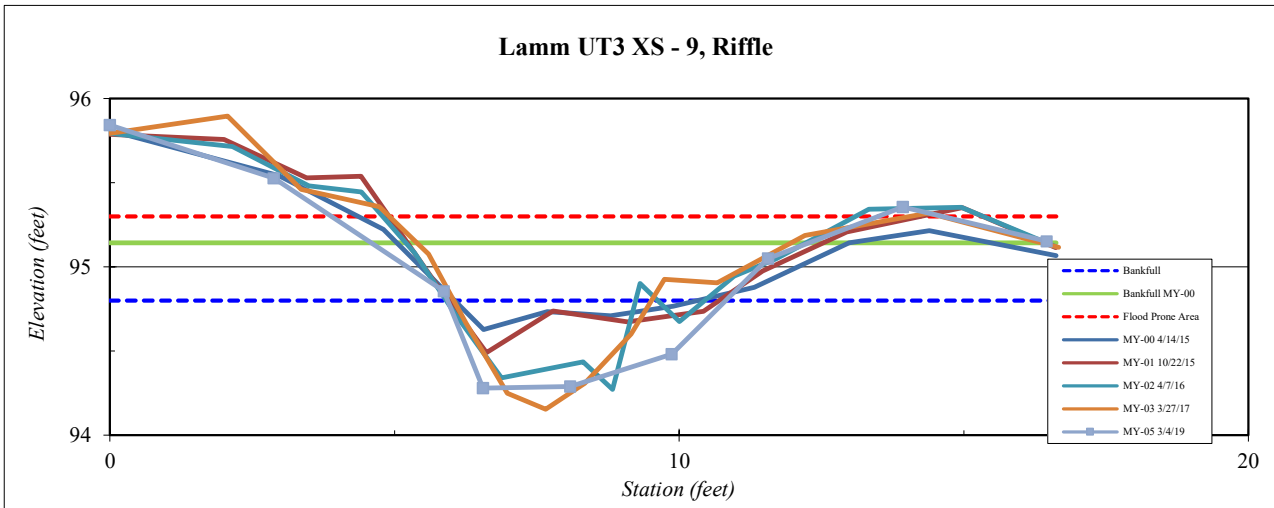
Site	Abbey Lamm
Watershed:	Cape Fear, 0303002
XS ID	UT 3 XS - 9, Riffle
Feature	Riffle
Date:	3/4/2019
Field Crew:	Perkinson, Radecki

**MY0-3 BHR were calculated using DMS method of "Dmax year x /Dmax year 0". MY5-7 were calculated using DMS method of area best fit.
 Sediment mobilization has resulted in minor downcutting, which has stabilized over the past 4 years. No problems are visible in this reach.

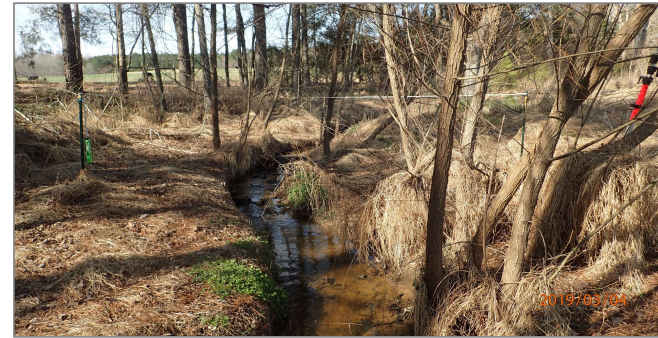
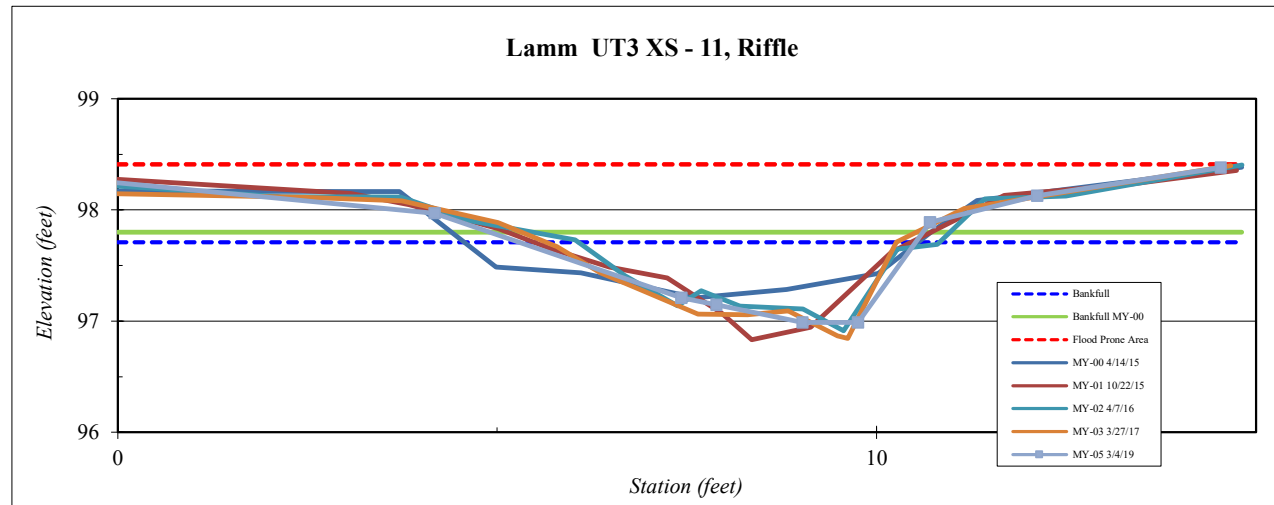
Site	Abbey Lamm
Watershed:	Cape Fear, 0303002
XS ID	UT 3 XS - 11, Riffle
Feature	Riffle
Date:	3/4/2019
Field Crew:	Perkinson, Radecki

**MY0-3 BHR were calculated using DMS method of "Dmax year x /Dmax year 0". MY5-7 were calculated using DMS method of area best fit.
 No problems have been noted in this reach. Minor alterations in shallow channels may result in large discrepancies including elevated BHR.

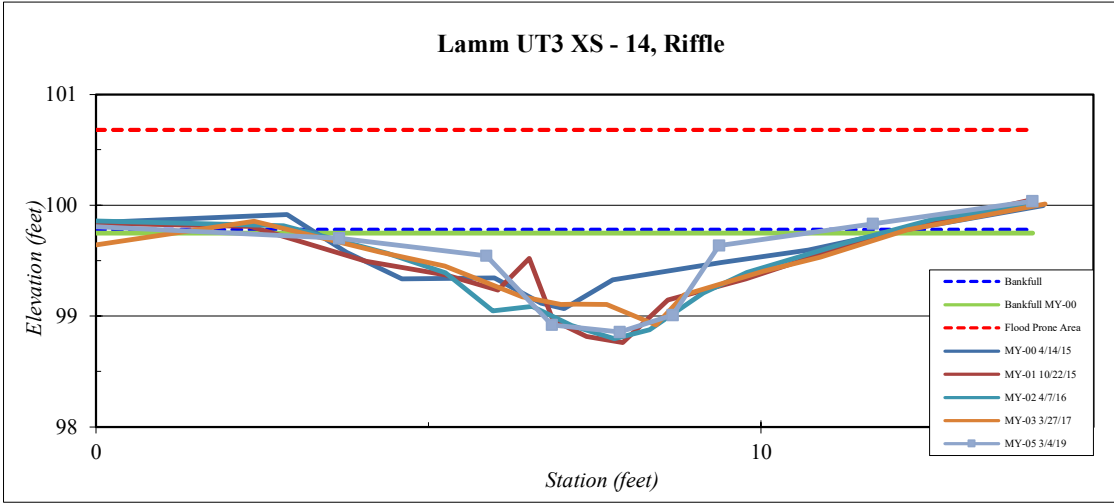
****MY0-3 BHR were calculated using DMS method of "Dmax year x /Dmax year 0". MY5-7 were calculated using DMS method of area best fit. No problems have been noted in this reach. Minor alterations in shallow channels may result in large discrepancies including elevated BHR.**
