YEAR 5 (2019) MONITORING REPORT
ABBEY LAMM
STREAM AND WETLAND MITIGATION SITE
ALAMANCE COUNTY, NORTH CAROLINA
FULL DELIVERY CONTRACT No. 5790
DMS PROJECT No. 96311
NCDWR PROJECT No. 20140336
USACE ACTION ID No. SAW-2014-01710

CAPE FEAR RIVER BASIN
CATALOGING UNIT 03030002

Data Collection – March-November 2019

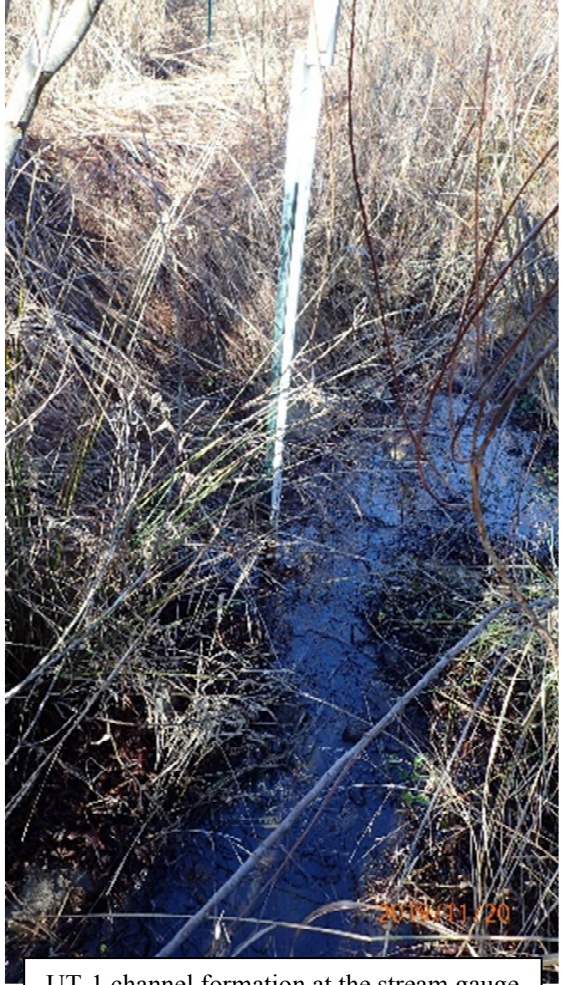
UT-1 channel formation at the stream gauge

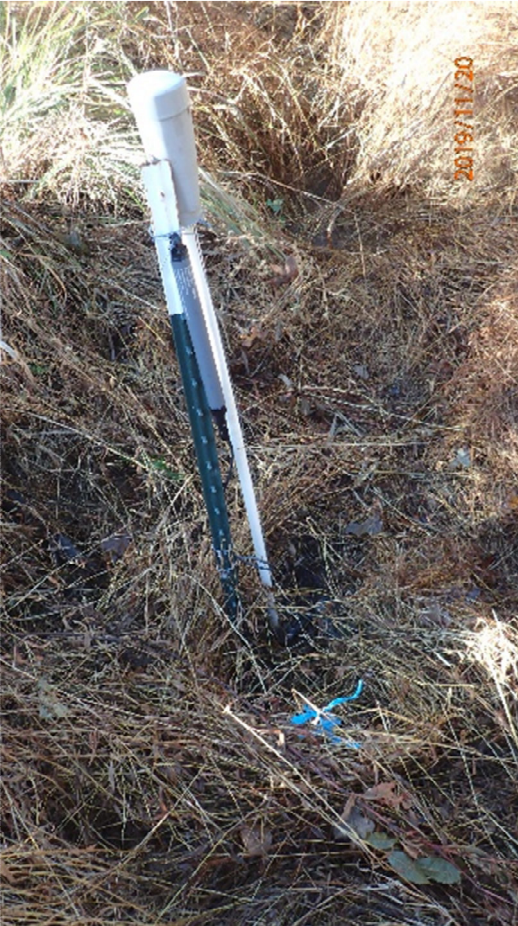
UT-3 channel formation at the stream gauge

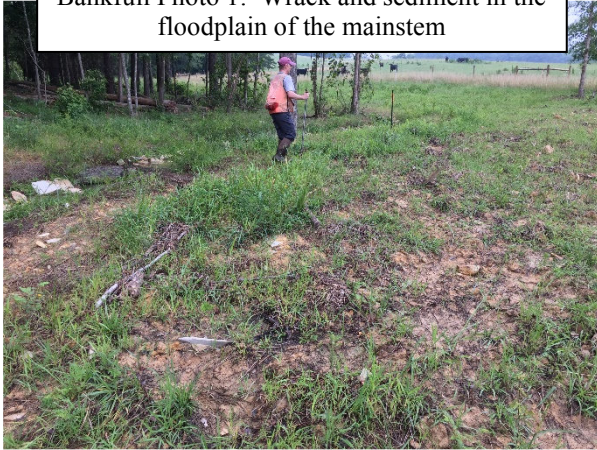
Bankfull Photo 1: Wrack and sediment in the floodplain of the mainstem

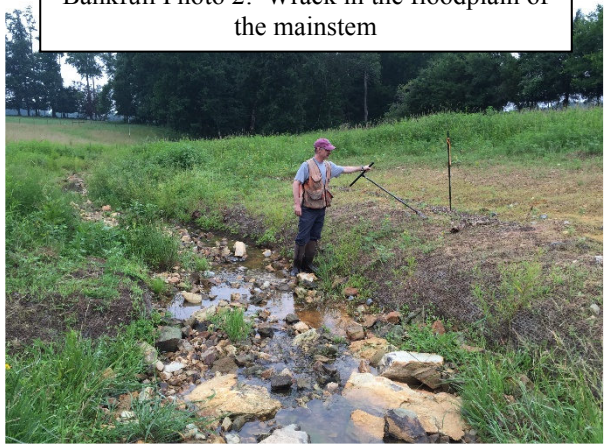
Bankfull Photo 2: Wrack in the floodplain of the mainstem

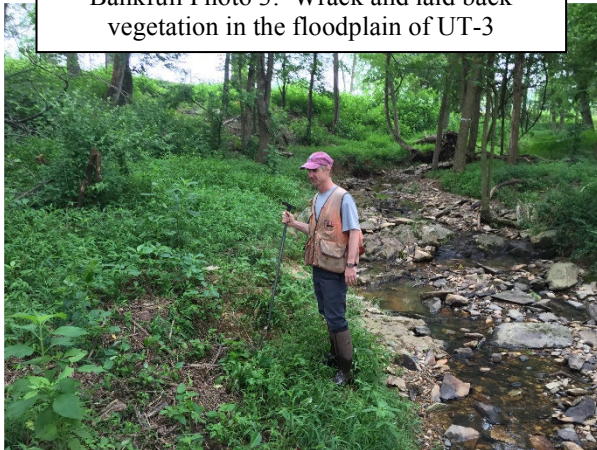
Bankfull Photo 3: Wrack and laid back vegetation in the floodplain of UT-3

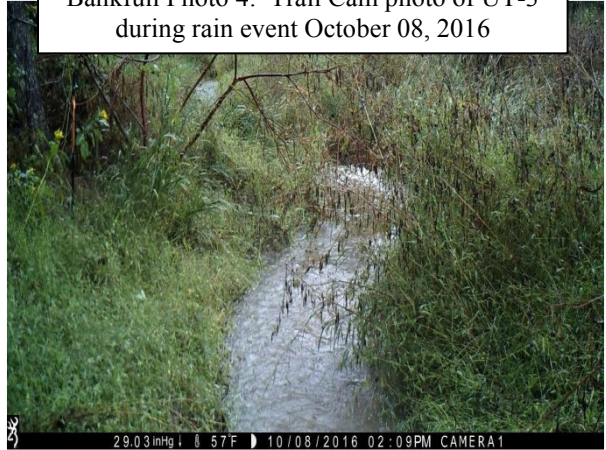
Bankfull Photo 4: Trail Cam photo of UT-3 during rain event October 08, 2016

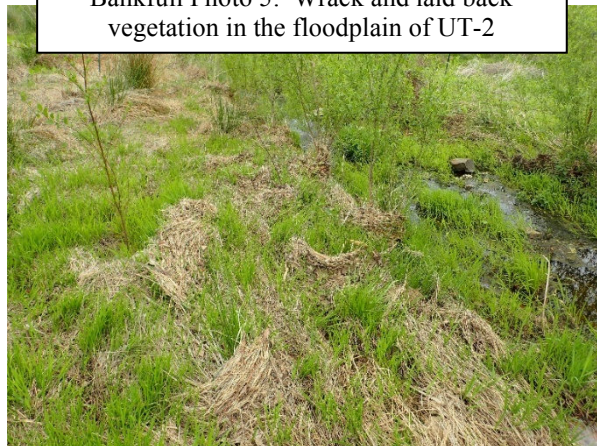
Bankfull Photo 5: Wrack and laid back vegetation in the floodplain of UT-2

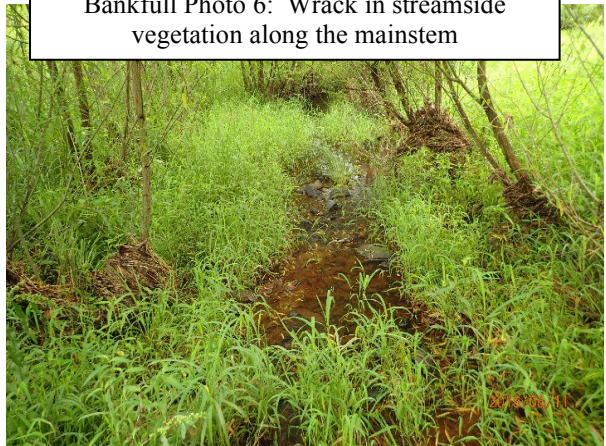
Bankfull Photo 6: Wrack in streamside vegetation along the mainstem

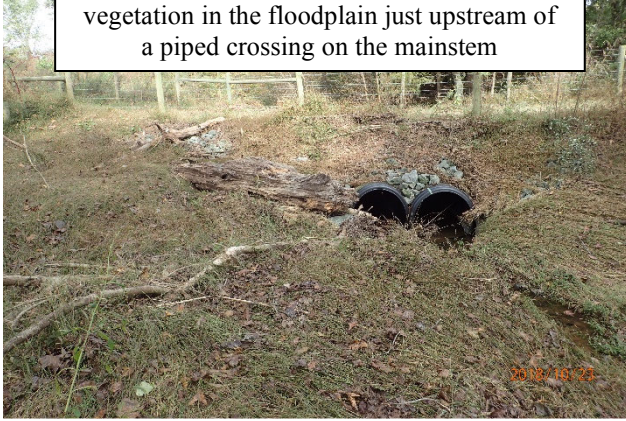
Bankfull Photo 7: Large wrack and laid back vegetation in the floodplain just upstream of a piped crossing on the mainstem

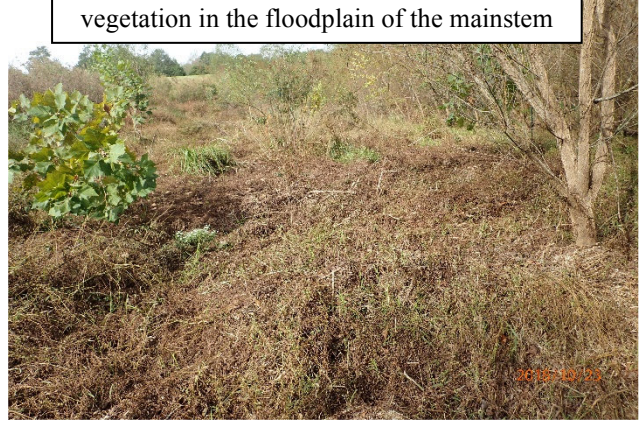
Bankfull Photo 8: Wrack and laid back vegetation in the floodplain of the mainstem

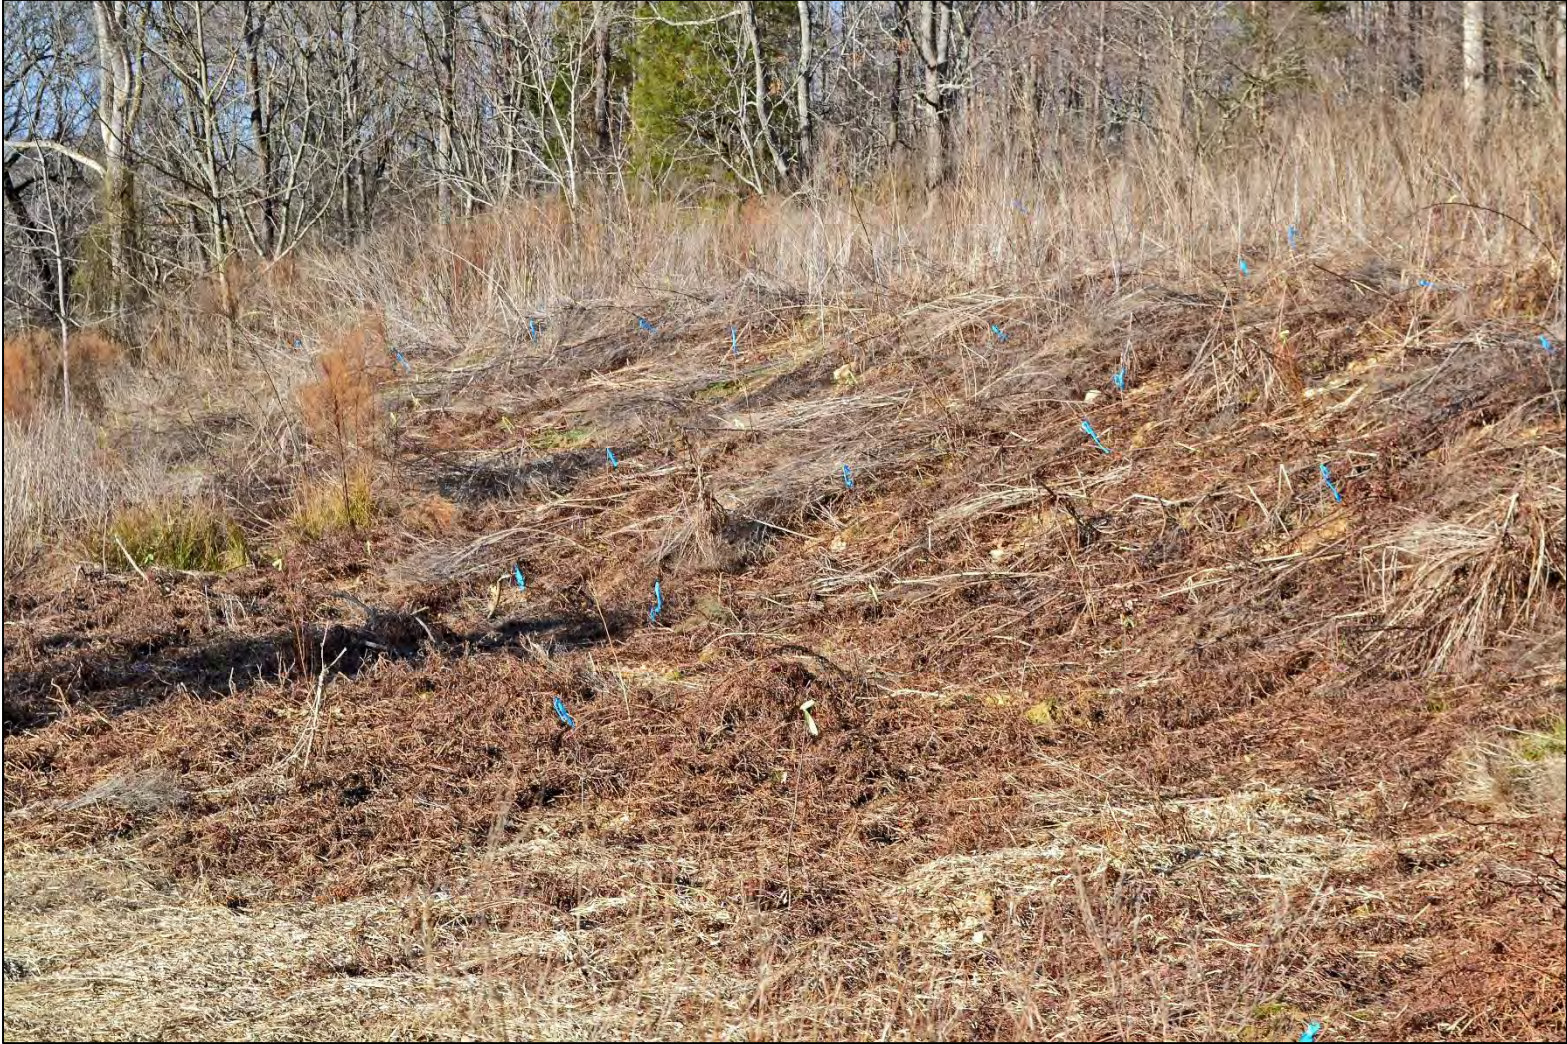
Photo 2: Looking N. in Replant Area 2, just N. of veg. plot 14

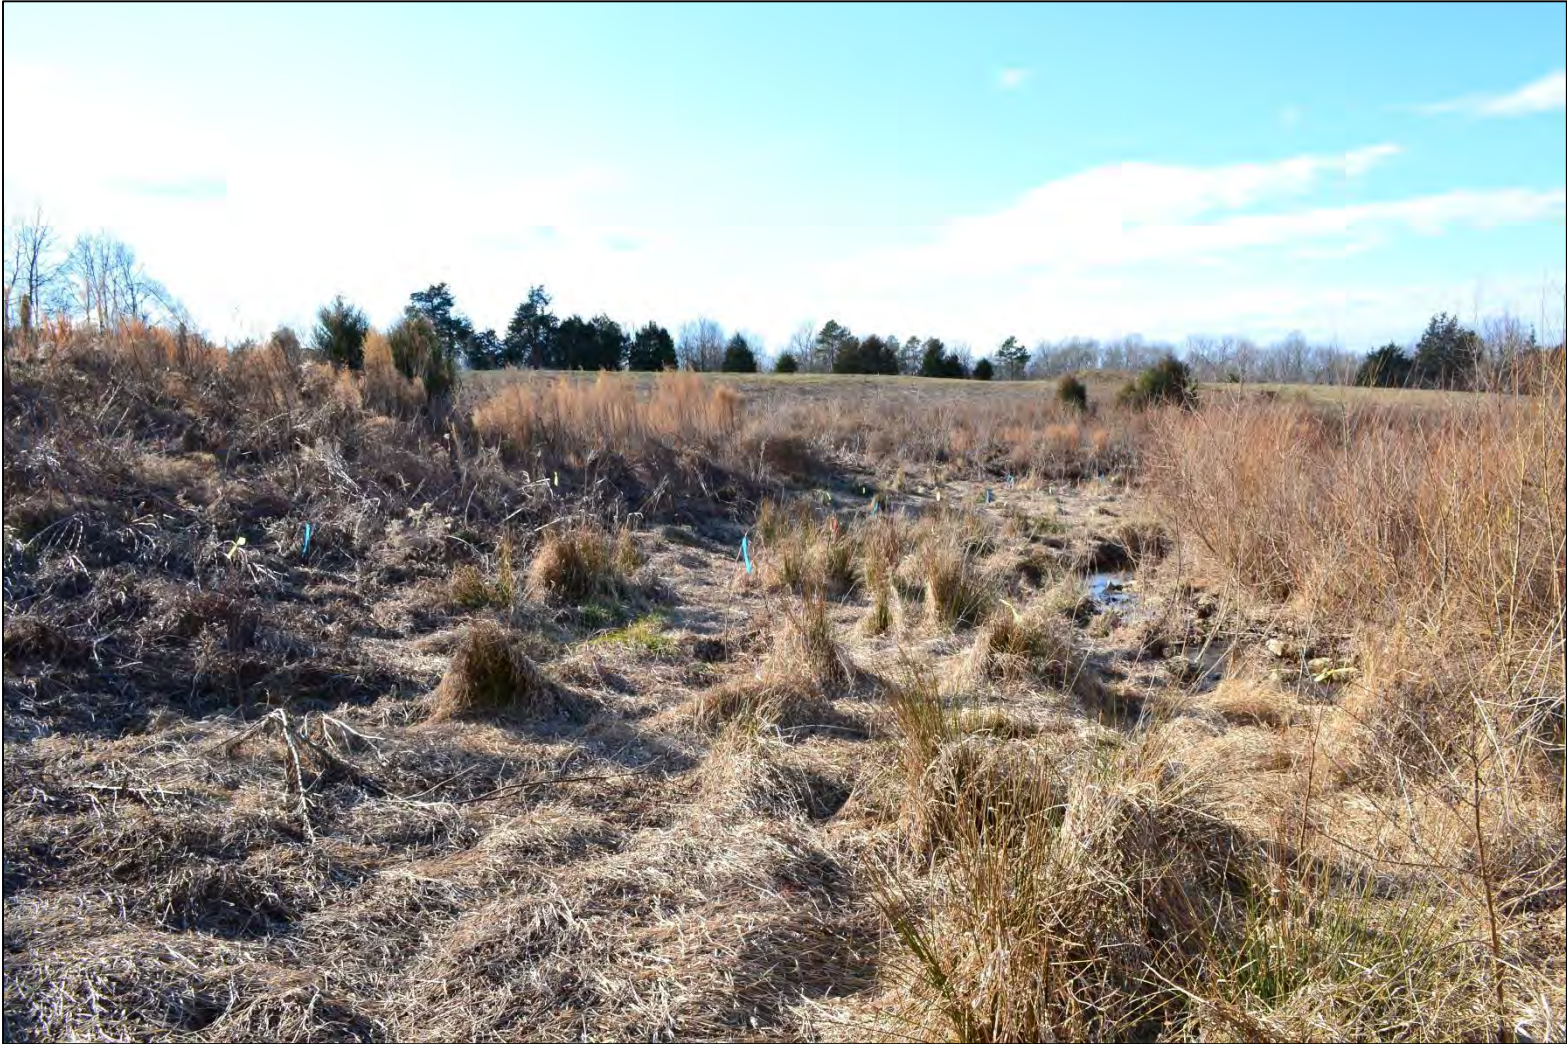
Photo 3: Looking W. in Replant Area 3, near veg. plot 13

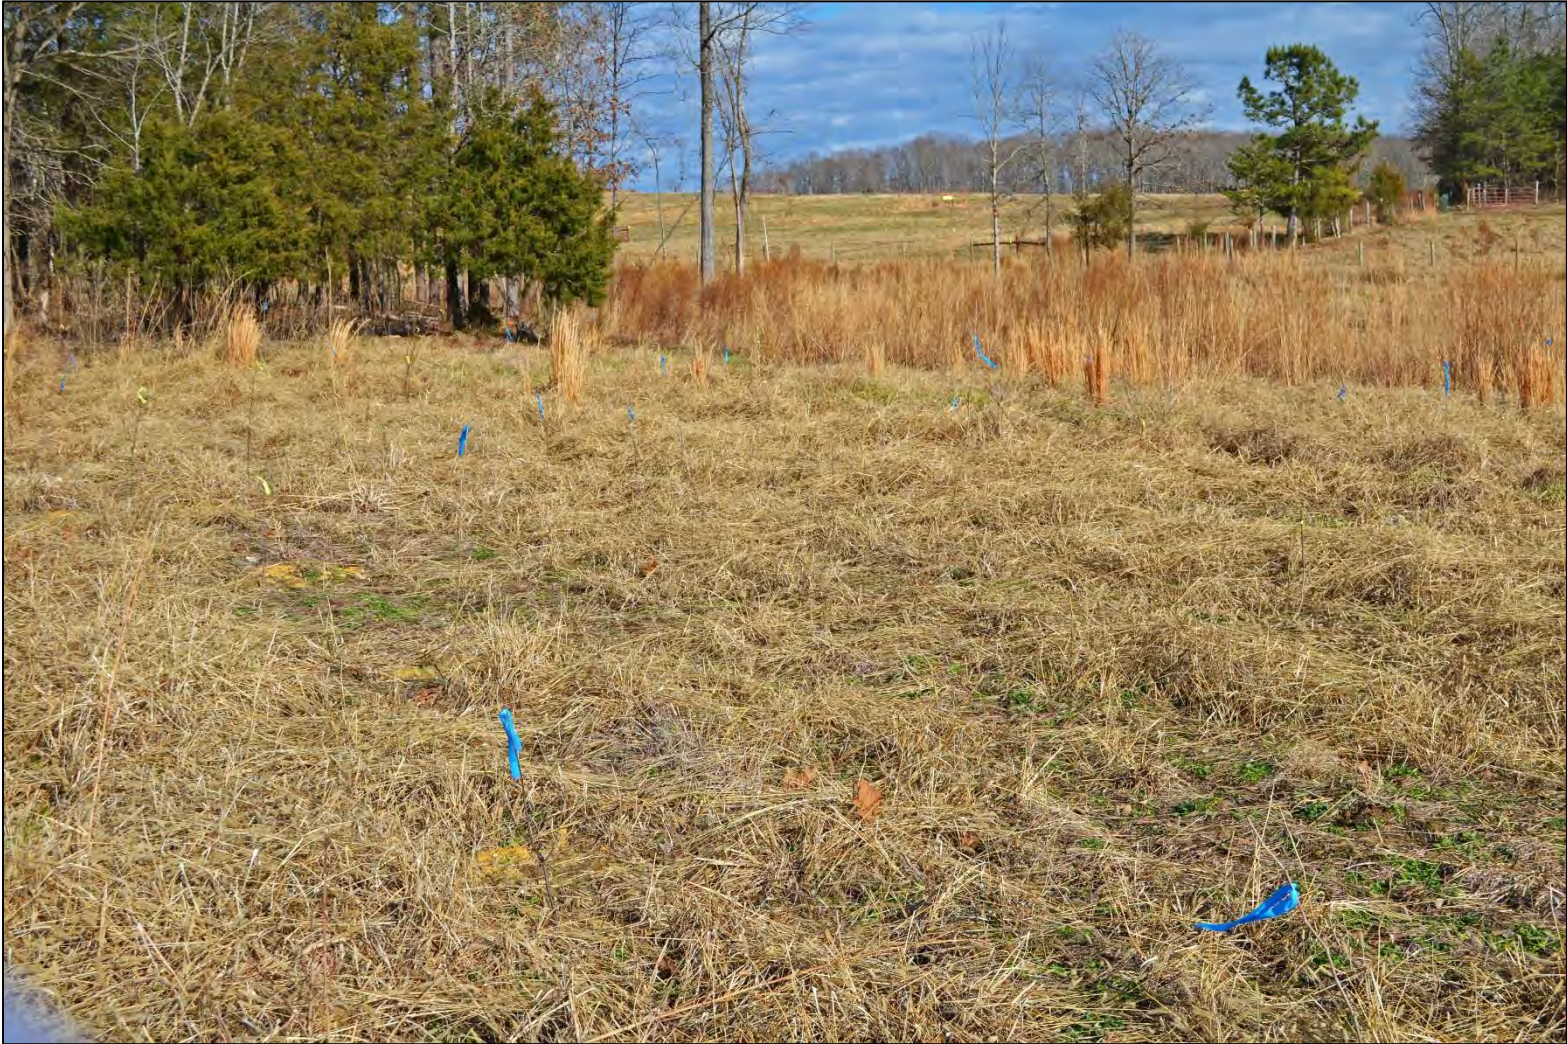
Photo 4: Looking NE. in Replant Area 5, near veg. plot 7

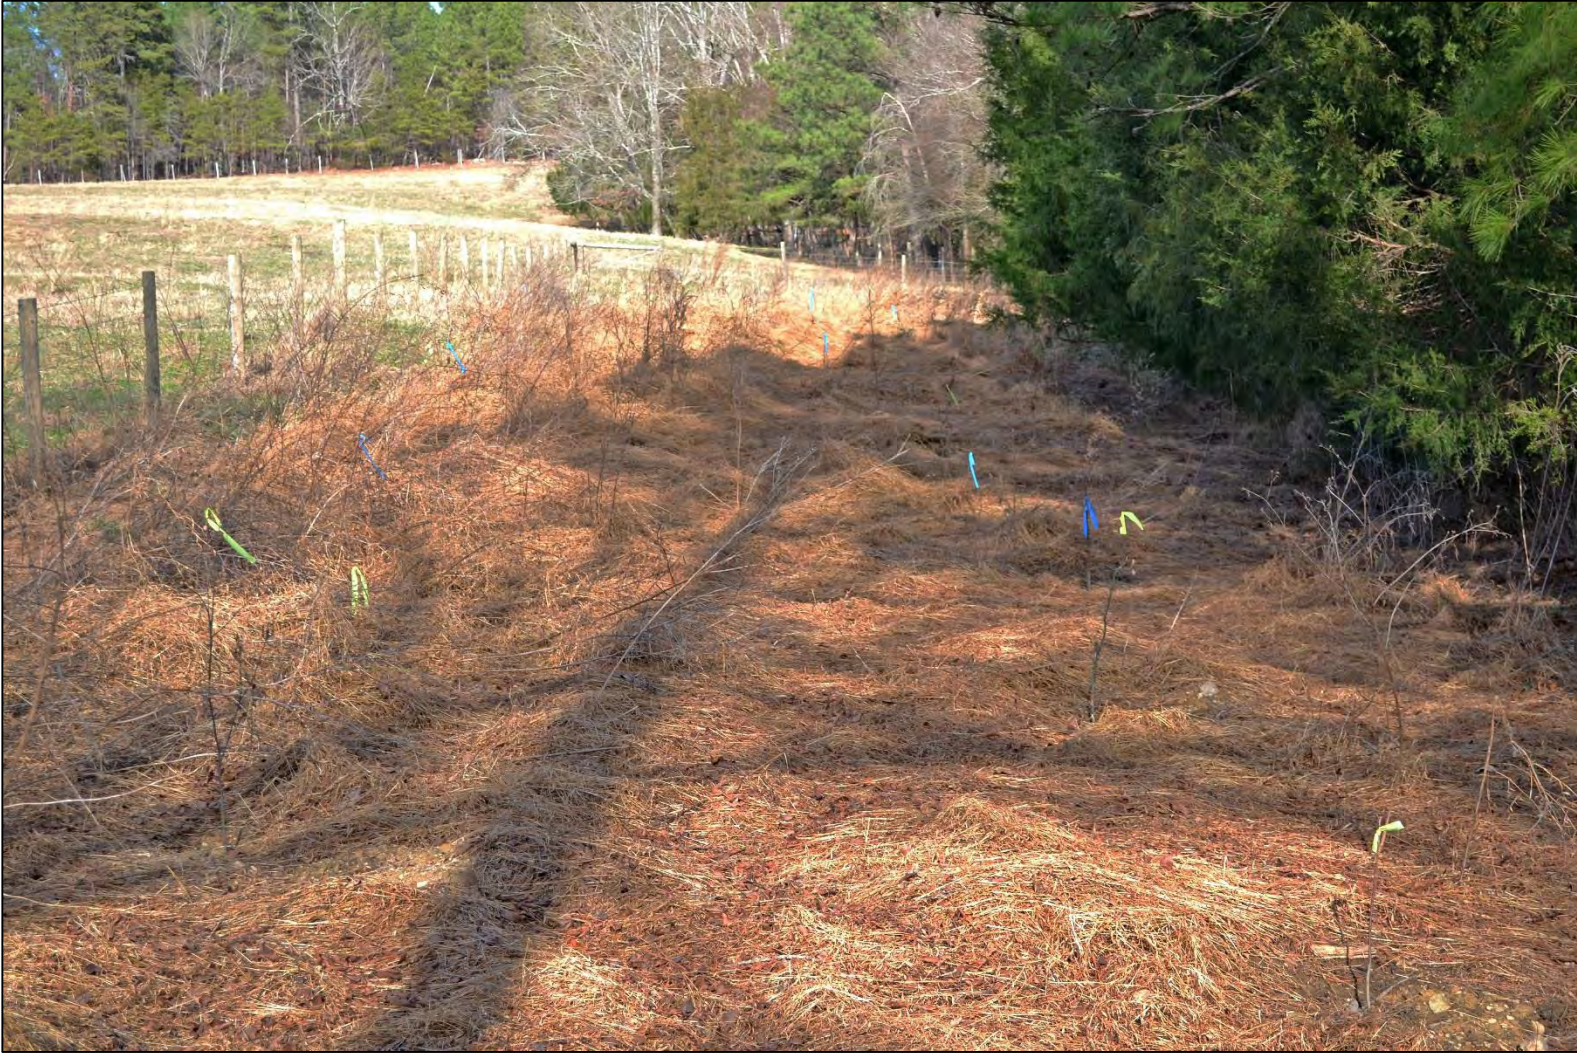
Photo 5: Looking N. in Replant Area 6.

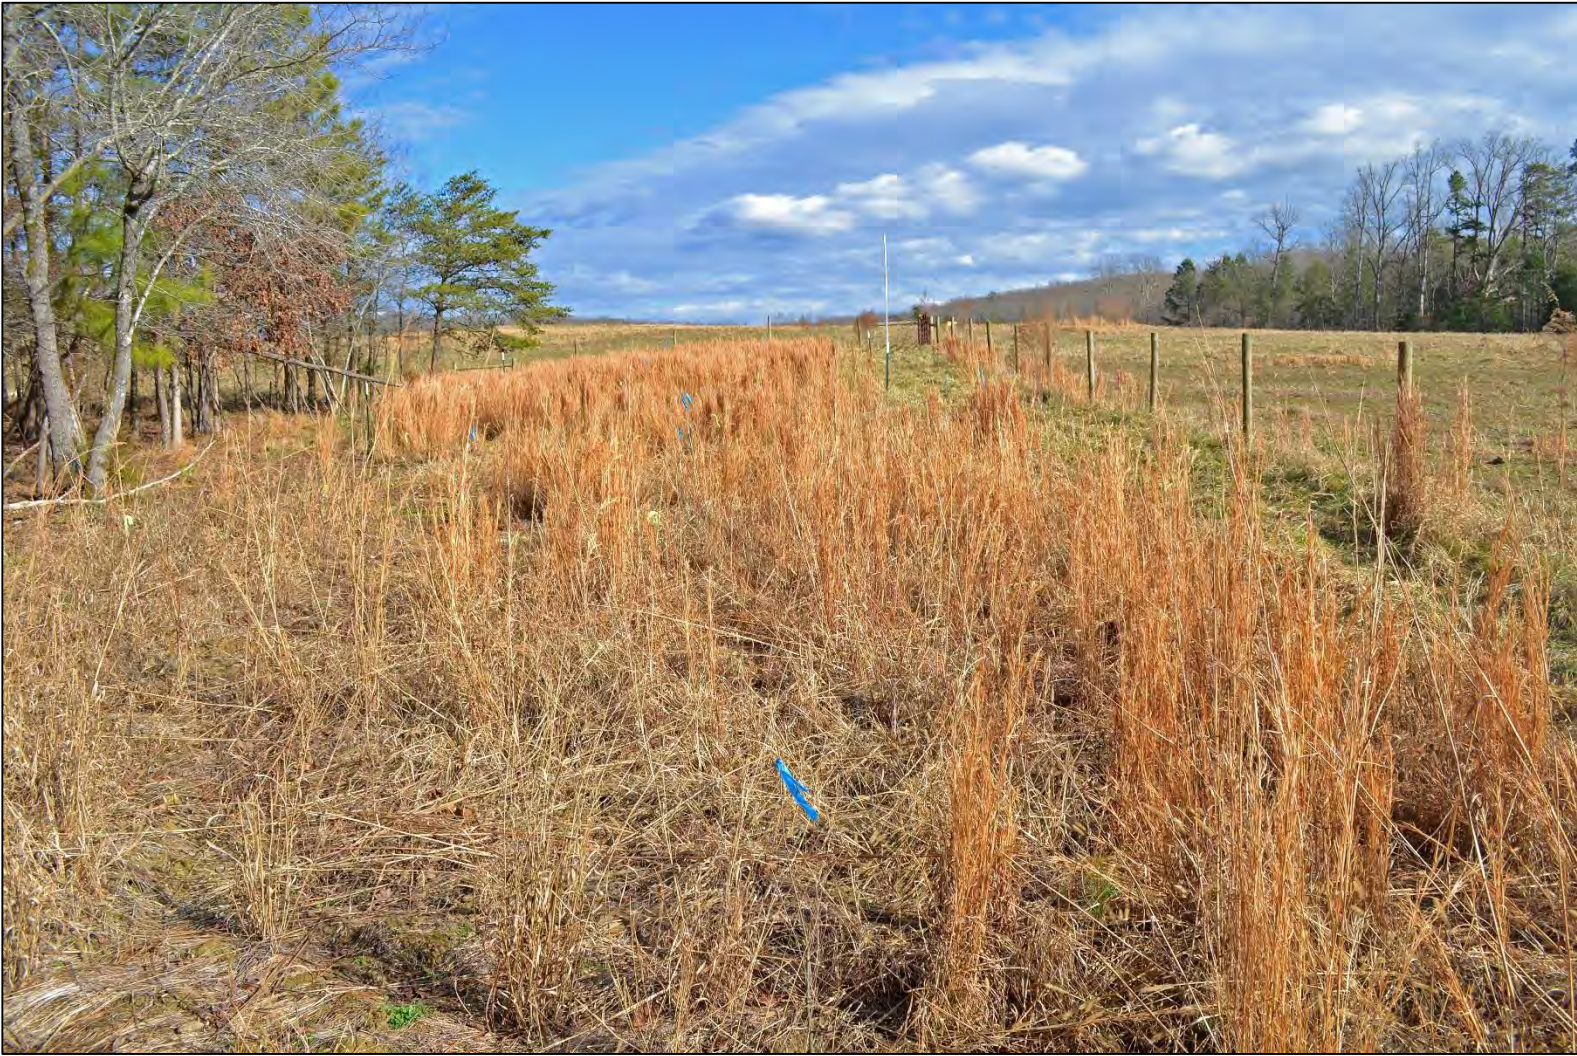
Photo 6: Looking N. in Replant Area 6, towards veg. plot 9.

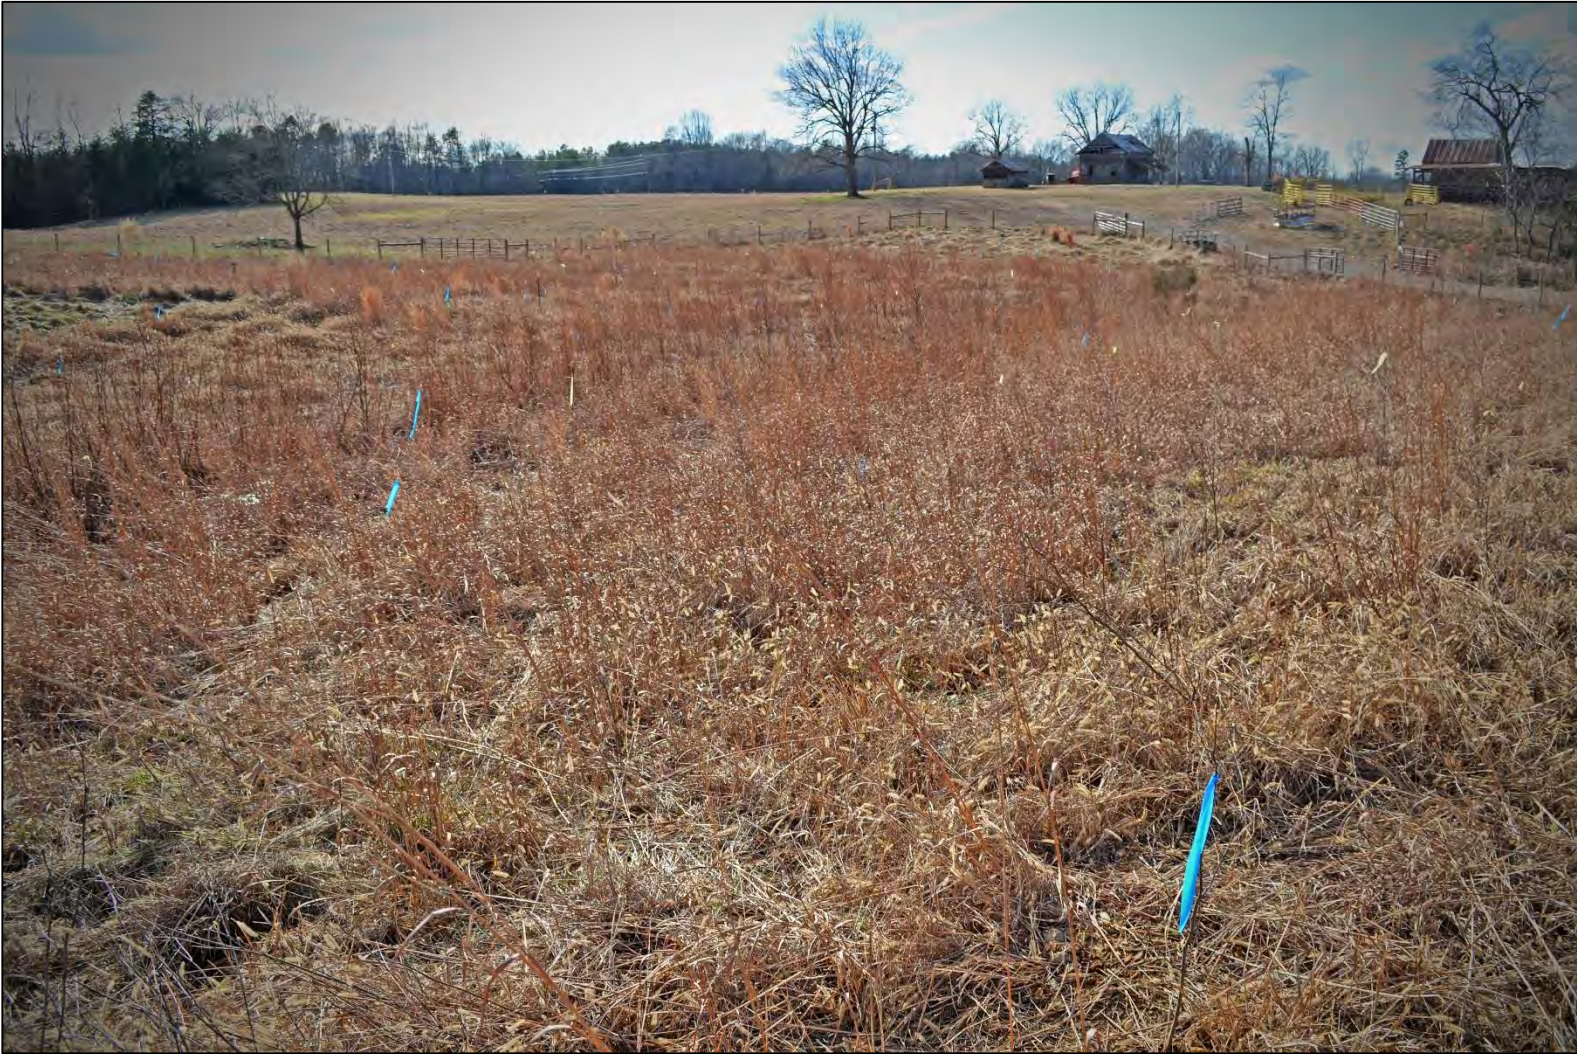
Photo 7: Looking SW. in Replant Area 8.

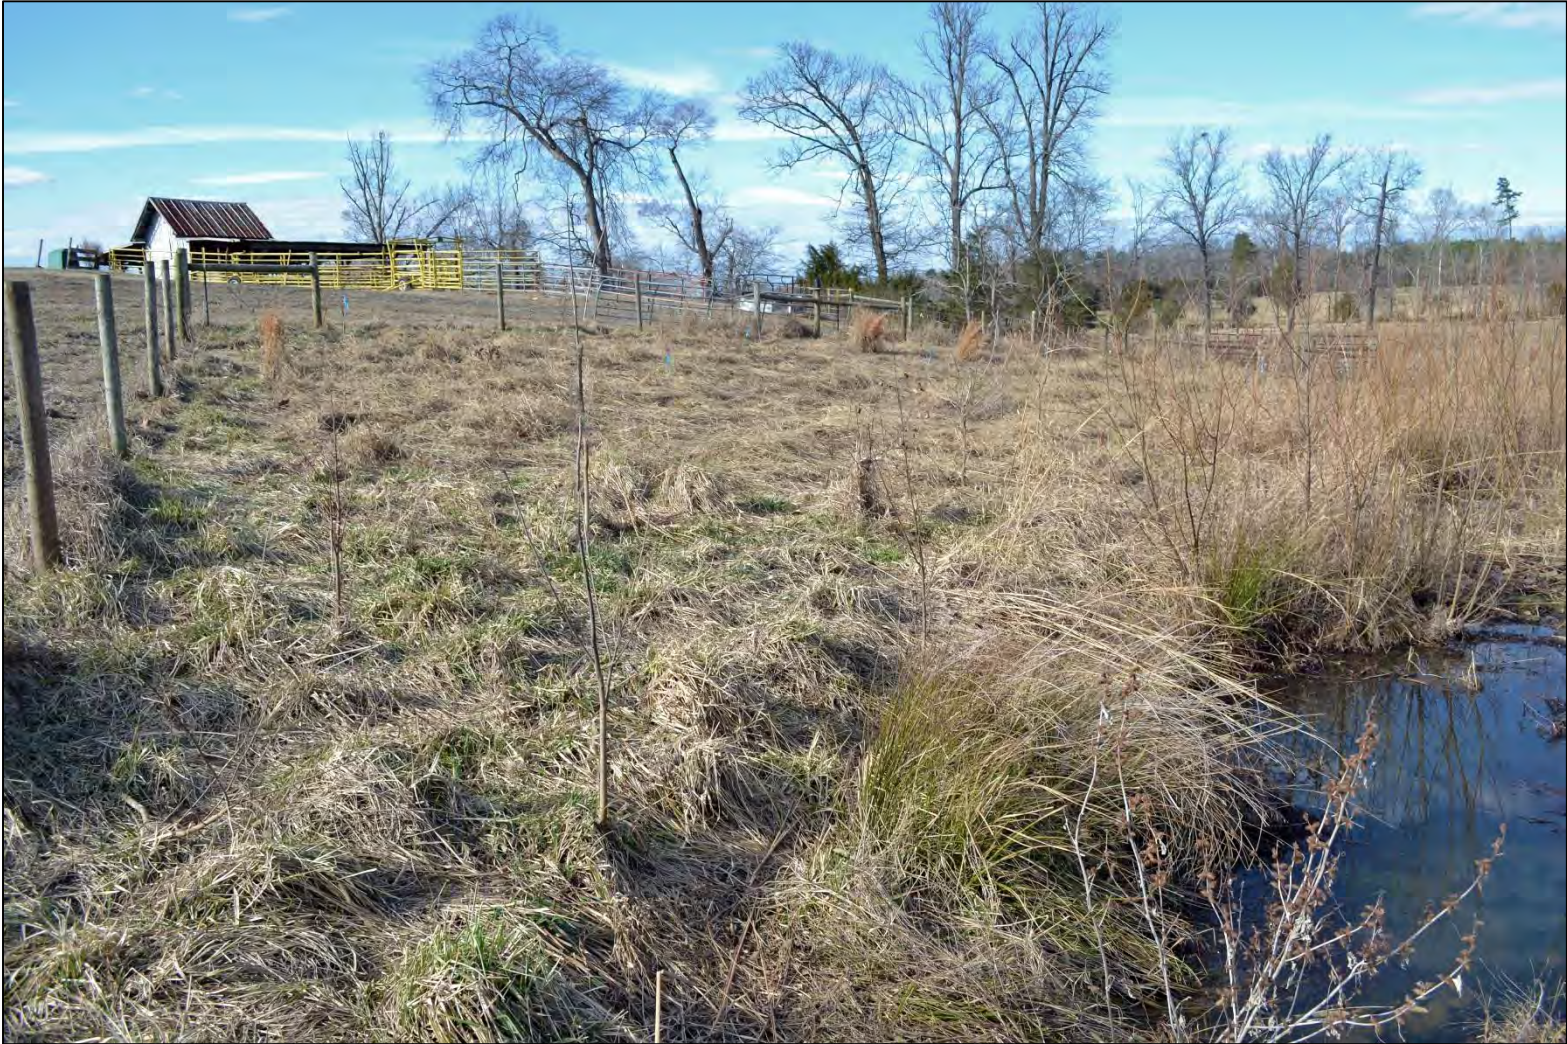
Photo 8: Looking NW. in Replant Area 10.
