YEAR 6 (2020) MONITORING REPORT
ABBEY LAMM
STREAM AND WETLAND MITIGATION SITE
ALAMANCE COUNTY, NORTH CAROLINA
FULL DELIVERY CONTRACT No. 5790
DMS PROJECT No. 96311
NCDWR PROJECT No. 20140336
USACE ACTION ID No. SAW-2014-01710

Abbey Lamm Year 6, 2020 Monitoring Summary

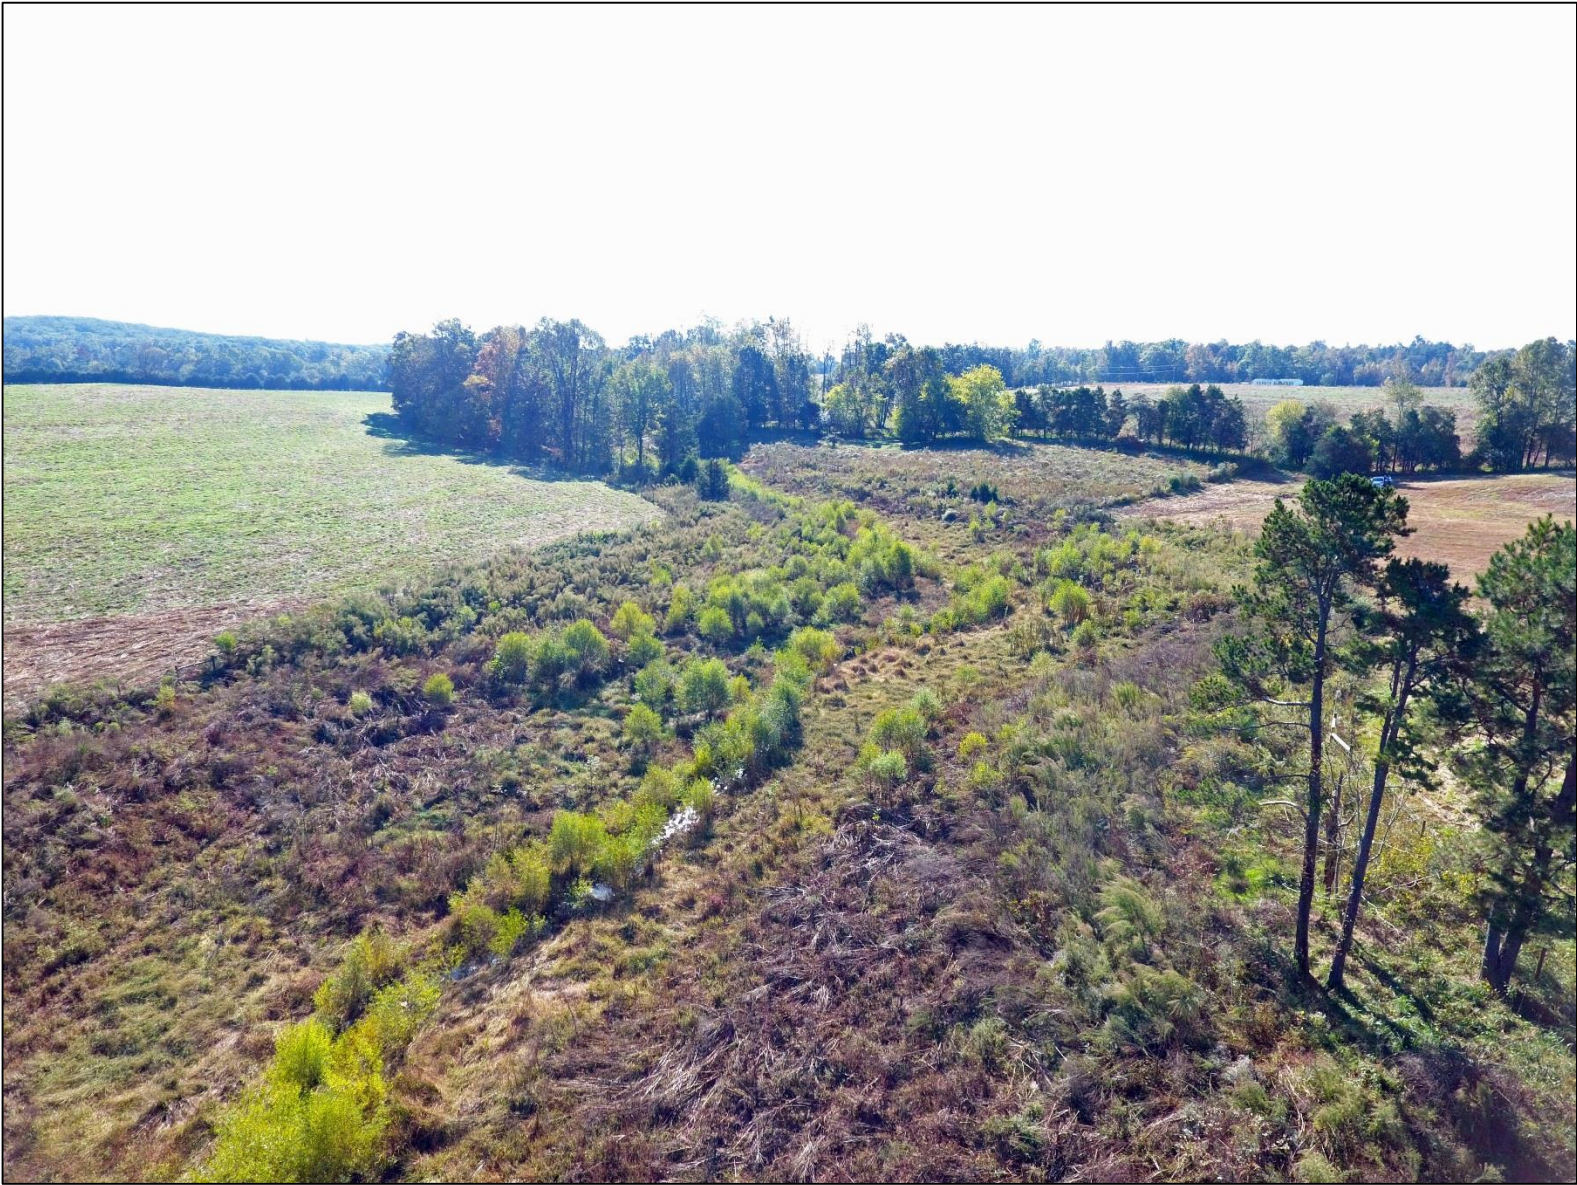
Photo 1: Downstream end of the Main Stem looking upstream into the old pond bed

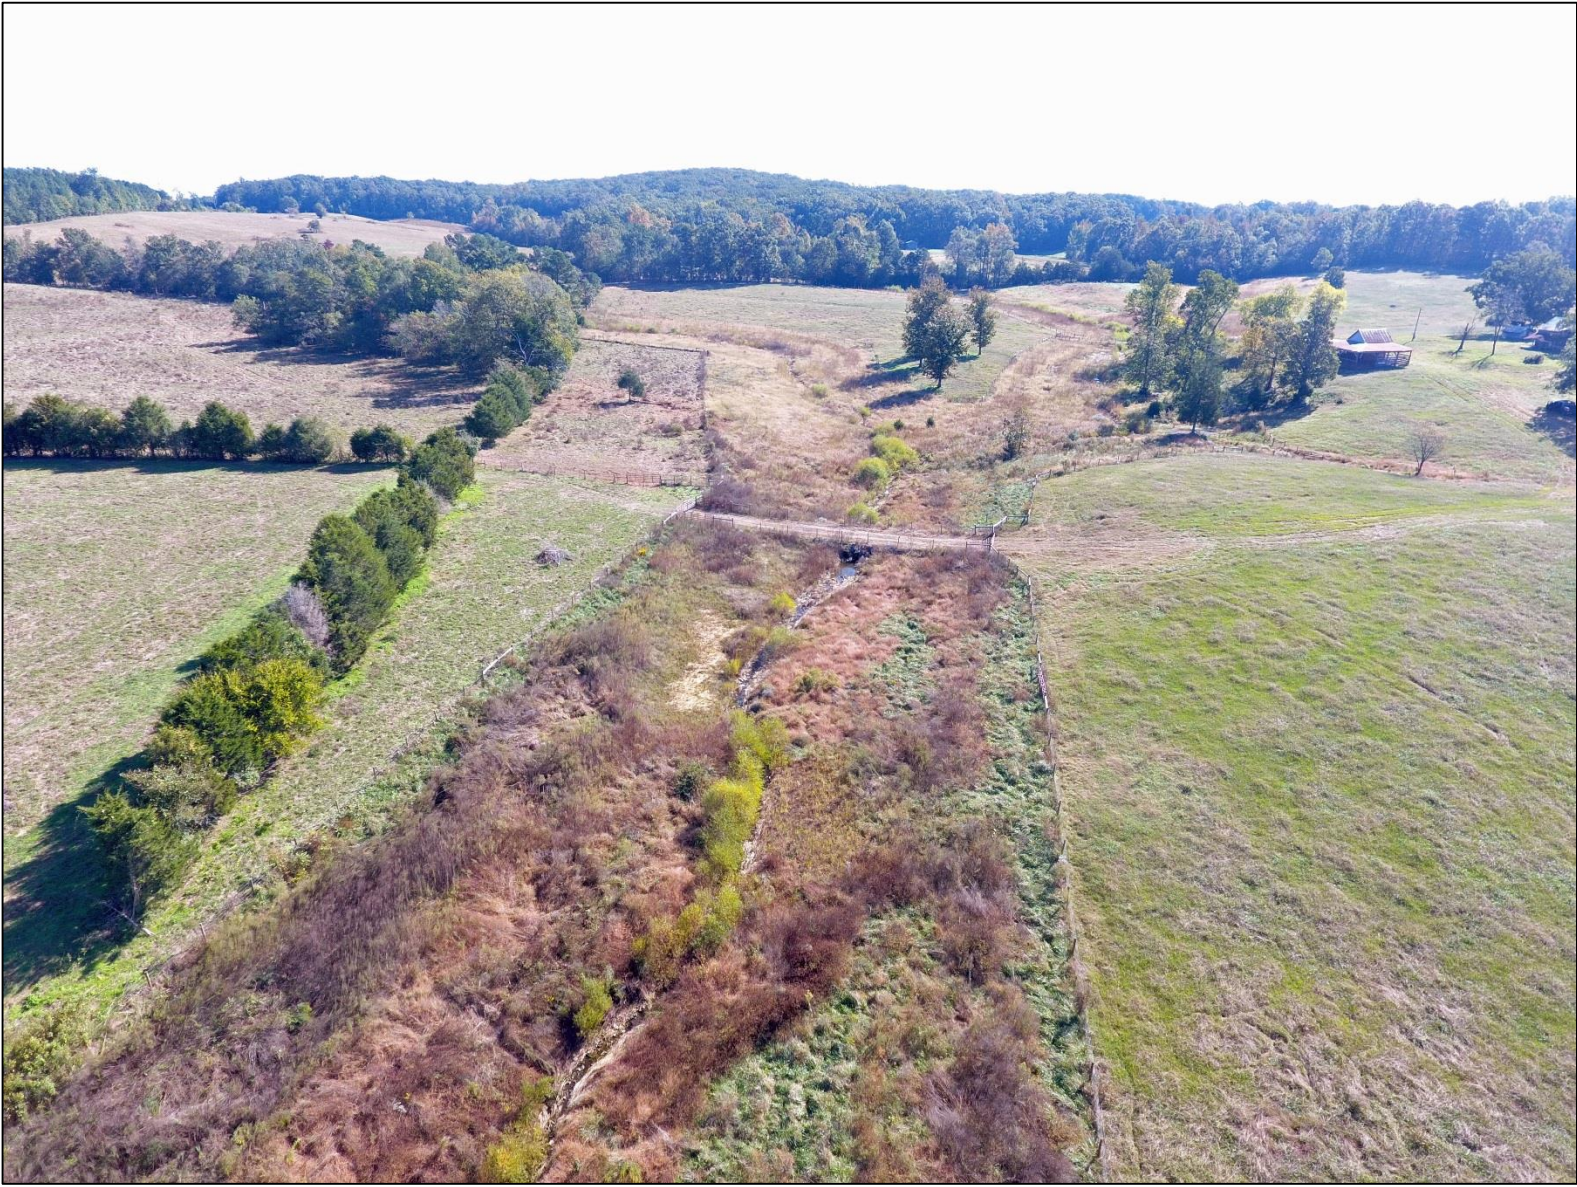
Photo 6: middle crossing looking upstream at the Main Stem and UT-3 on the left

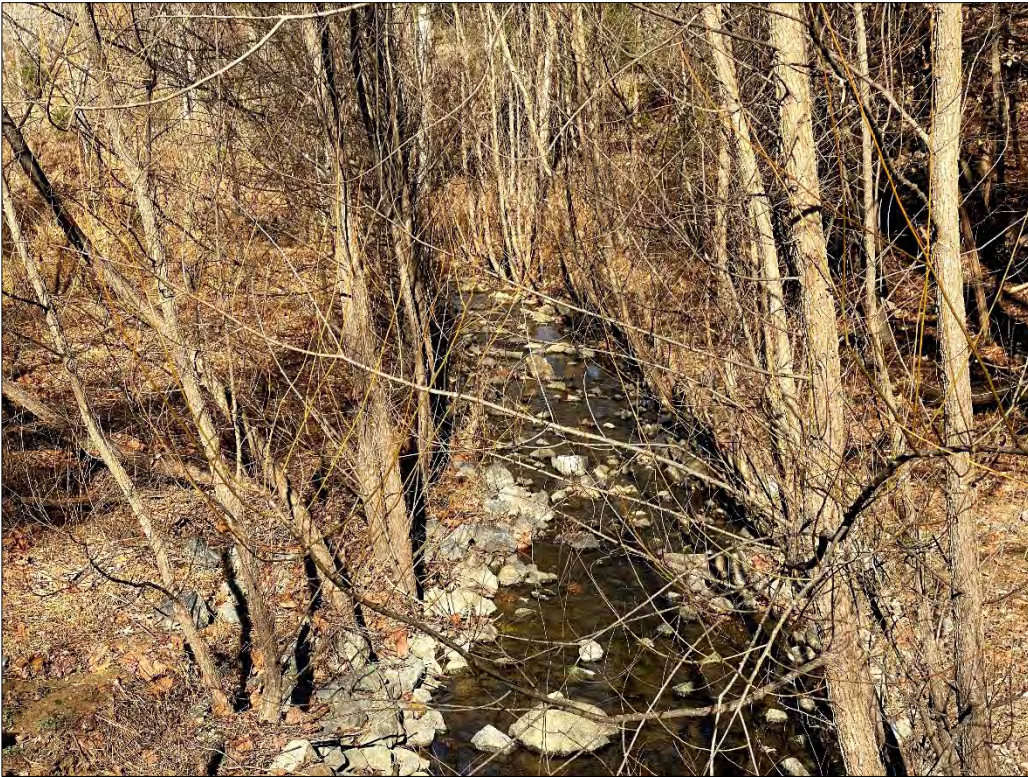
Mainstem Looking Downstream of the Most Downstream Crossing (Just Below XS 16)
