YEAR 1 MONITORING REPORT

ADKIN BRANCH STREAM RESTORATION PROJECT PHASE 1 – WASHINGTON AVE. TO LINCOLN ST.

Lenoir County, North Carolina

Project ID No. 050656101

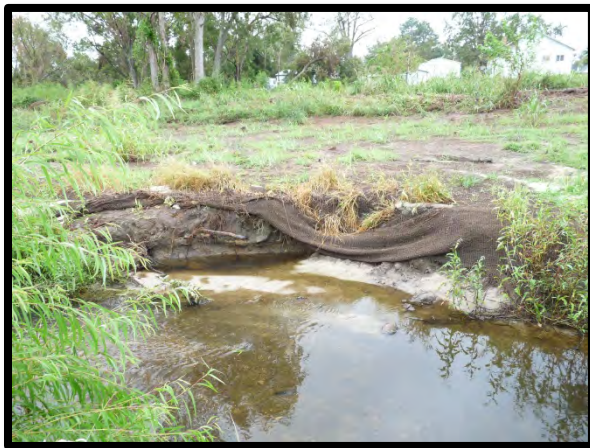
3.21 Severe bank erosion near 65+50

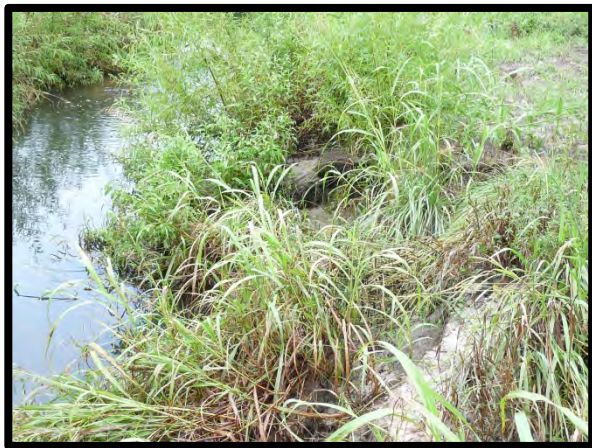
3.22 Moderate erosion near 71+50

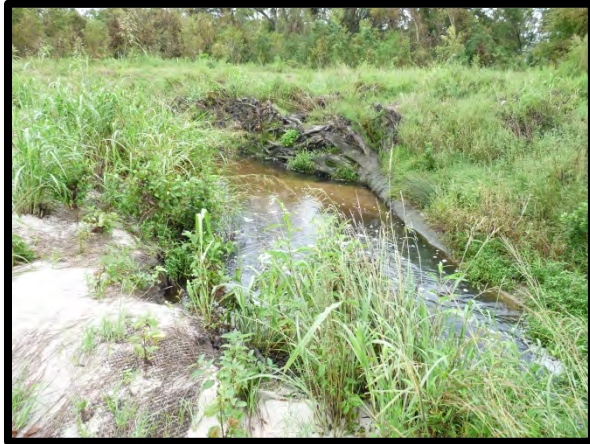
3.23 Minor erosion near 76+75

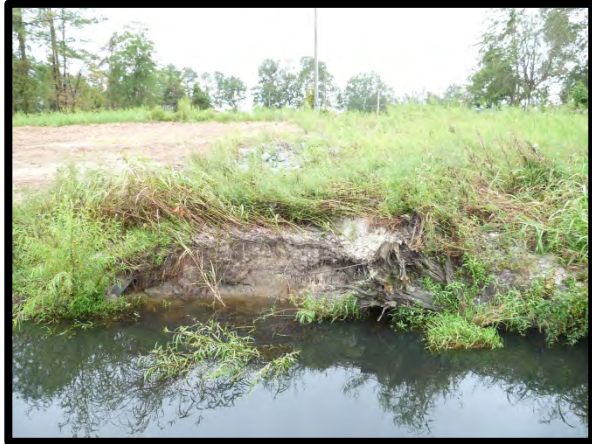
3.24 Moderate erosion near 81+10

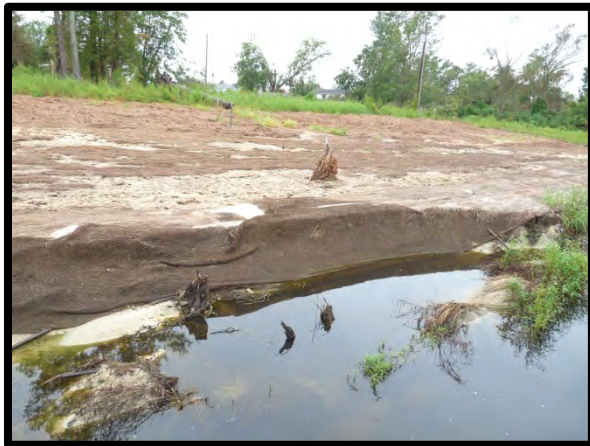
3.25 Severe erosion/bare benches near 83+00

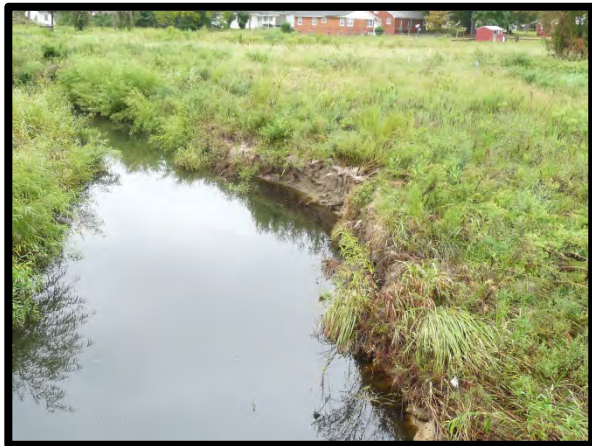
3.26 Moderate erosion near 83+50

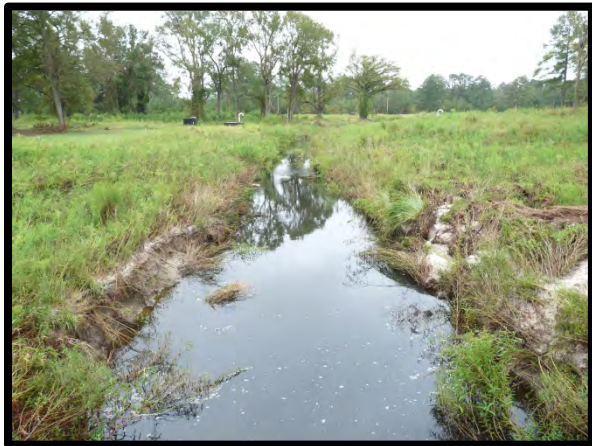
3.27 Moderate erosion near 84+25

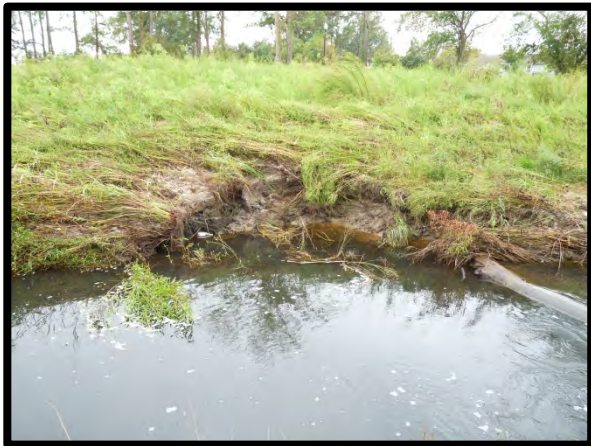
3.28 Moderate erosion near 85+80

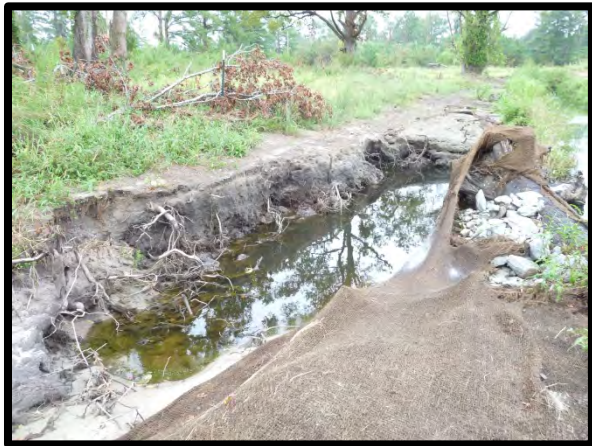
3.29 Severe erosion near 87+50

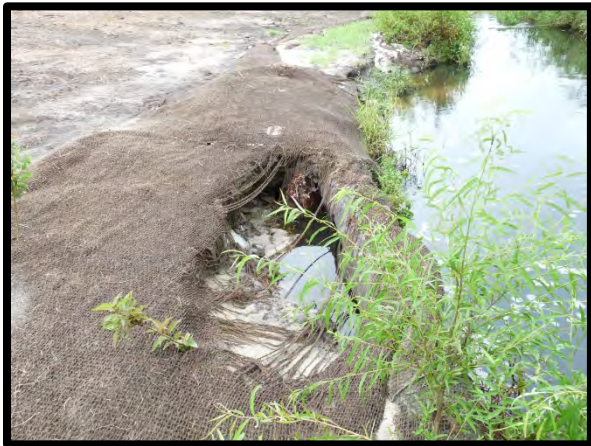
3.30 Moderate erosion near 91+50
