# ***YEAR 2 MONITORING REPORT***

## **ADKIN BRANCH STREAM RESTORATION PROJECT PHASE 1 – WASHINGTON AVE. TO LINCOLN ST.**

Lenoir County, North Carolina  
EEP IMS No. 7

Construction Completed: April 2011  
Morphology Data Collected: October/November 2012  
Vegetation Data Collected: August 2012  
Submitted: January 2013

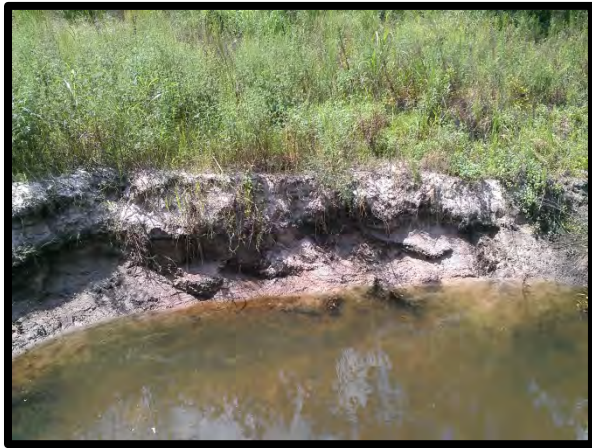
**3.21 Severe bank erosion near 65+35**

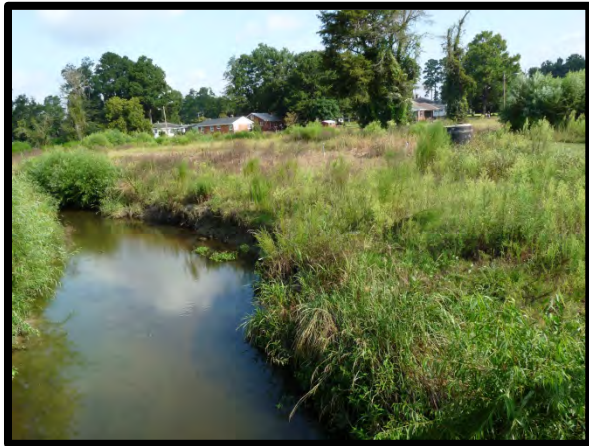
**3.23 Severe erosion upstream of pedestrian bridge (83+50)**

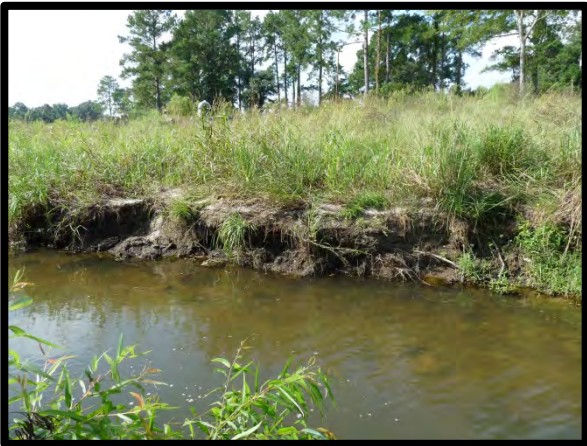
**3.24 Severe erosion near 86+70**

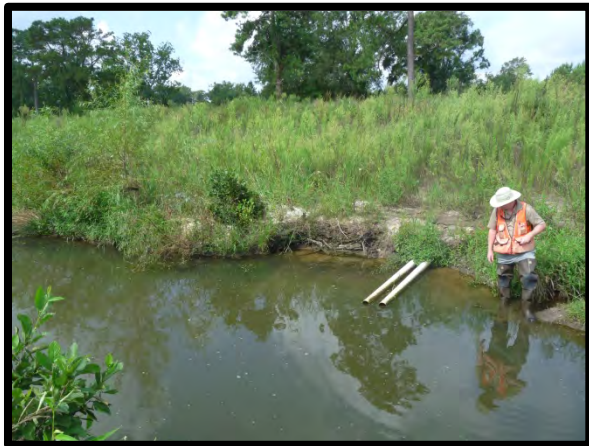
**3.25 Severe erosion near 92+50**

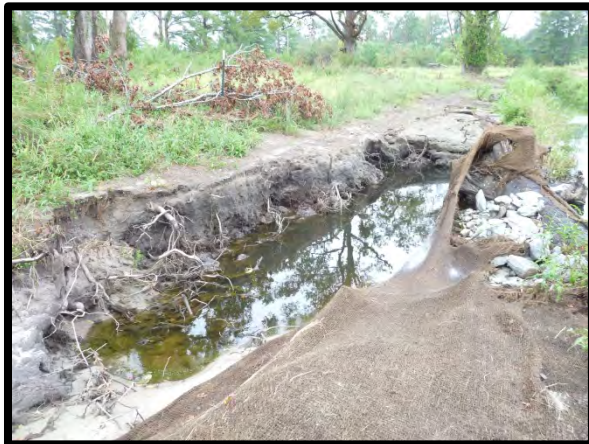
**3.29 Severe erosion around vane arm  
2011 (87+50)**

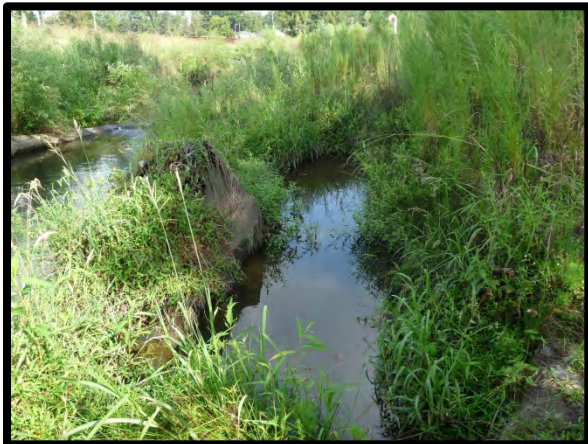
**3.30 Severe erosion around vane arm  
2012 (87+50)**
