# ***YEAR 4 MONITORING REPORT***

## **ADKIN BRANCH STREAM RESTORATION PROJECT PHASE 1 – WASHINGTON AVE. TO LINCOLN ST.**

Lenoir County, North Carolina  
EEP IMS No. 7

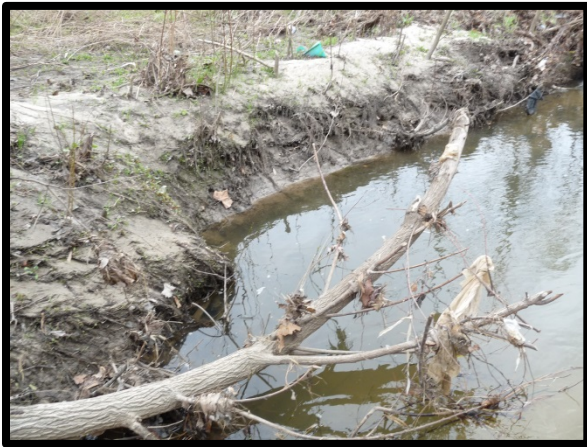
**3.21 Minor erosion near 45+00**

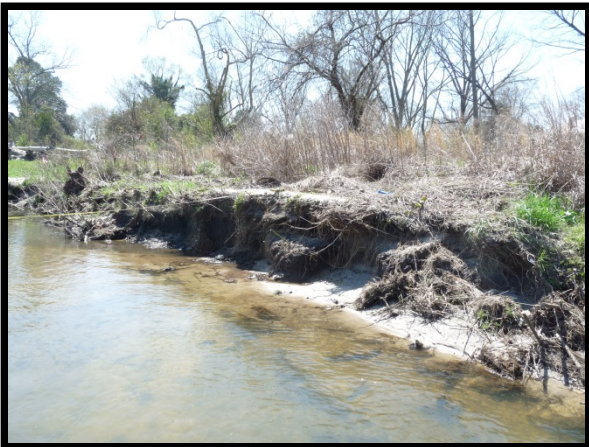
**3.28 Scouring at XS 9**

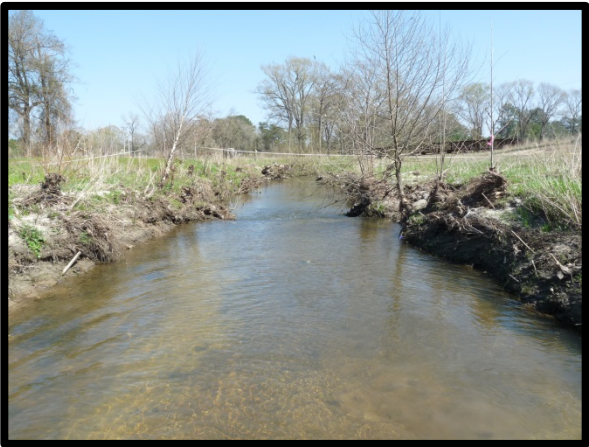
**3.30 Scouring at XS 11**
