YEAR 5 MONITORING REPORT

ADKIN BRANCH STREAM RESTORATION PROJECT PHASE 1 – WASHINGTON AVE. TO LINCOLN ST.

Lenoir County, North Carolina
DMS IMS No. 7

Submitted: December 2015

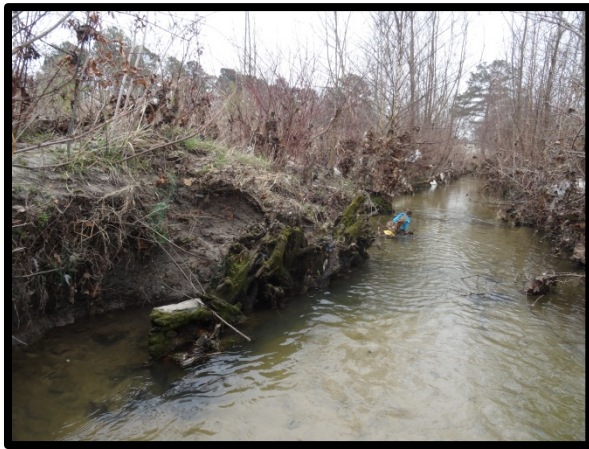
3.21 Minor erosion near 41+75

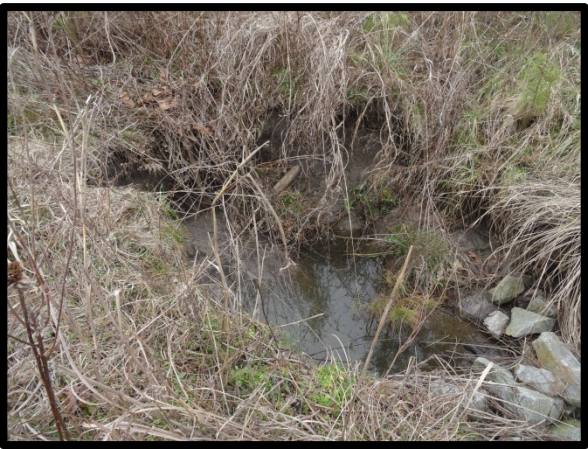
3.22 Scour in ditch off Elm Street near 44+50

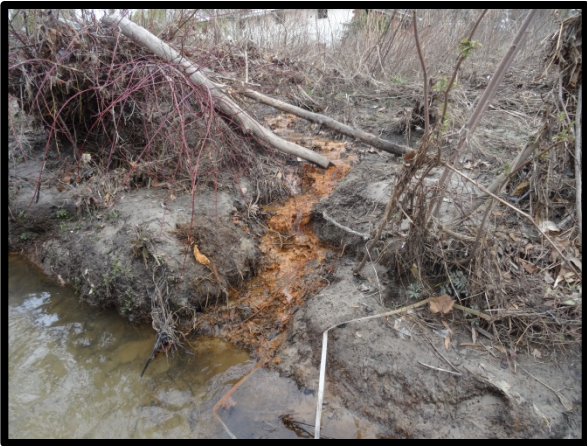
3.23 Minor erosion and thin grass near 46+10

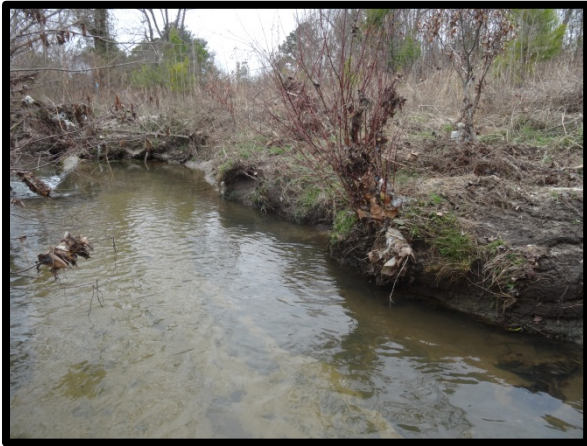
3.24 Overflow channel from drainage ditch off Sycamore Street near 47+30

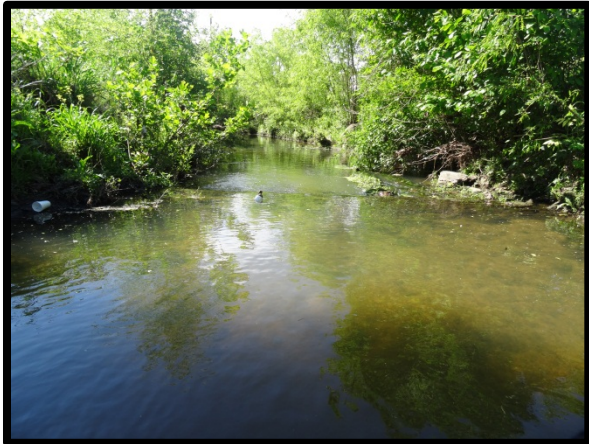
3.26 Hole near 56+40

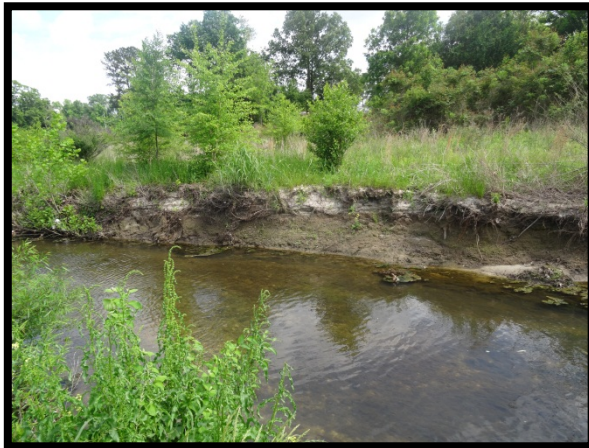
3.30 Re-vegetating bank near 63+50
