MONITORING YEAR 3 ANNUAL REPORT

AGONY ACRES MITIGATION SITE

Guilford County, NC

DMS Project Number 95716

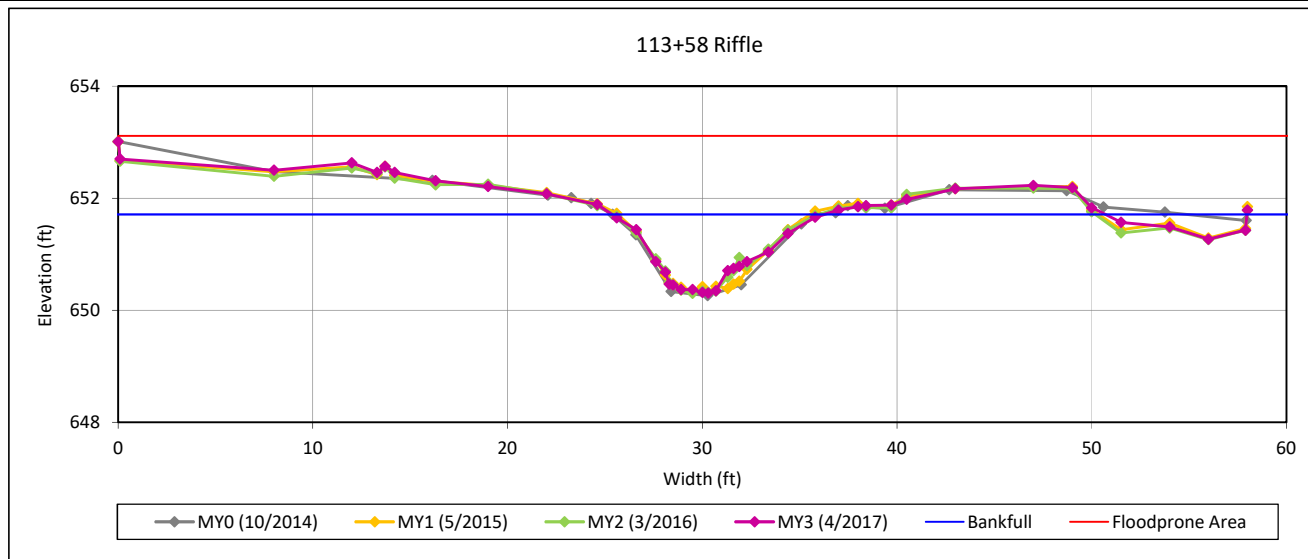
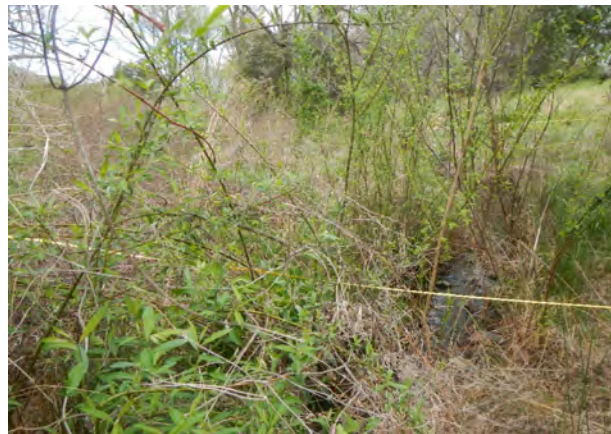
Cross Section 1-UT1 Reach 2

7.9	x-section area (ft.sq.)
10.9	width (ft)
0.7	mean depth (ft)
1.4	max depth (ft)
11.4	wetted parimeter (ft)
0.7	hyd radi (ft)
15.1	width-depth ratio
100.0	W flood prone area (ft)
9.2	entrenchment ratio
1.0	low bank height ratio

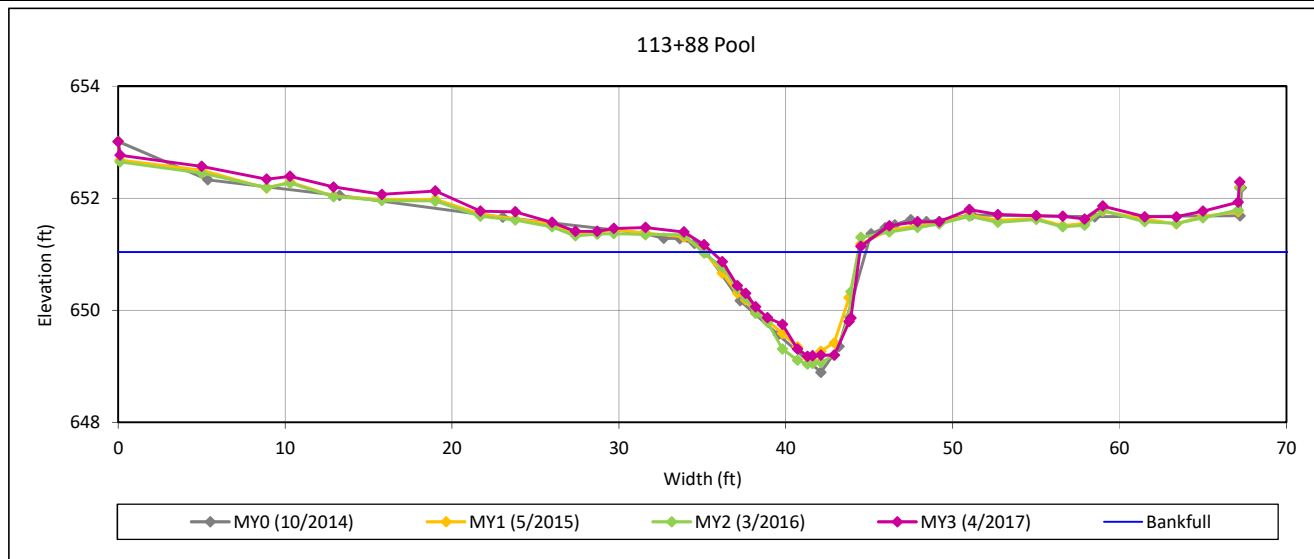
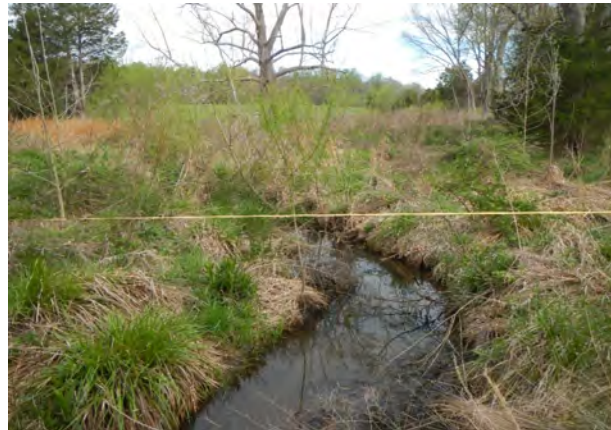
Cross Section 2-UT1 Reach 2

10.3	x-section area (ft.sq.)
8.9	width (ft)
1.2	mean depth (ft)
1.9	max depth (ft)
10.2	wetted parimeter (ft)
1.0	hyd radi (ft)
7.6	width-depth ratio

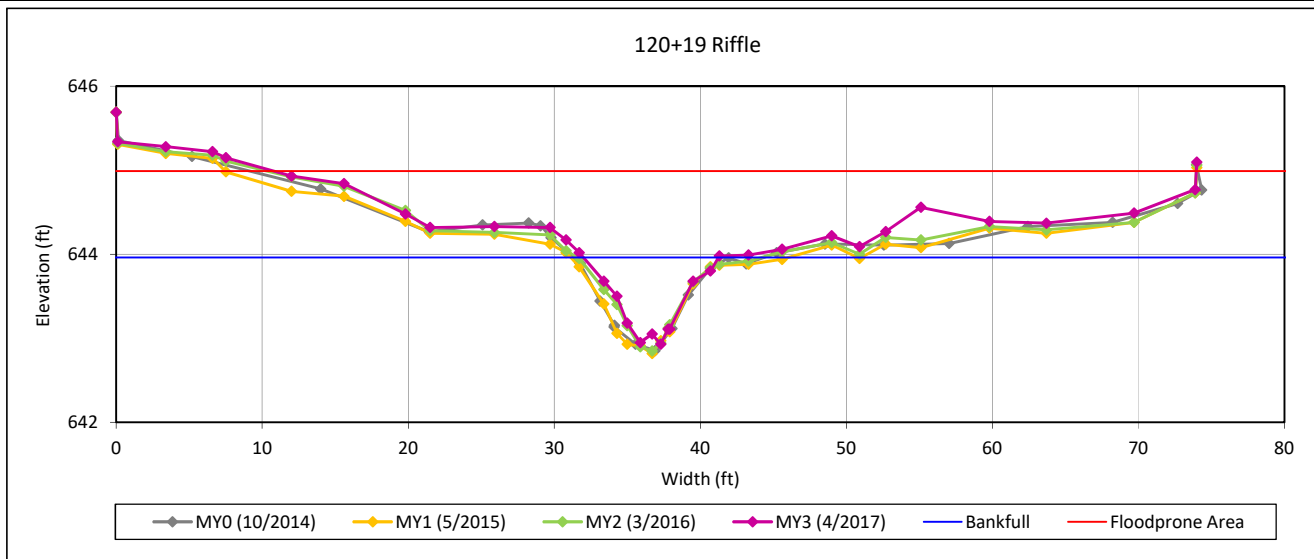
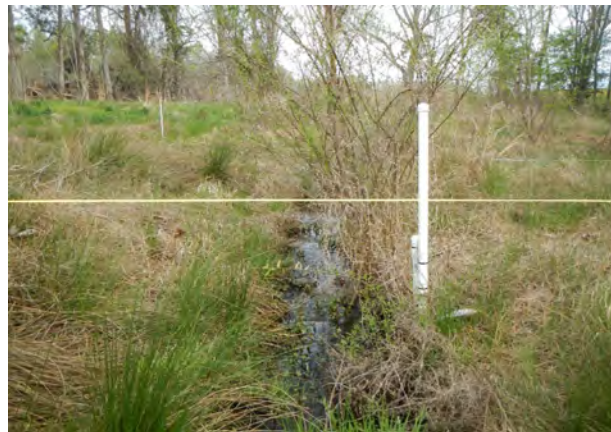
Cross Section 3-UT1 Reach 2

4.9	x-section area (ft.sq.)
9.2	width (ft)
0.5	mean depth (ft)
1.0	max depth (ft)
9.6	wetted parimeter (ft)
0.5	hyd radi (ft)
17.5	width-depth ratio
60.0	W flood prone area (ft)
6.5	entrenchment ratio
1.0	low bank height ratio

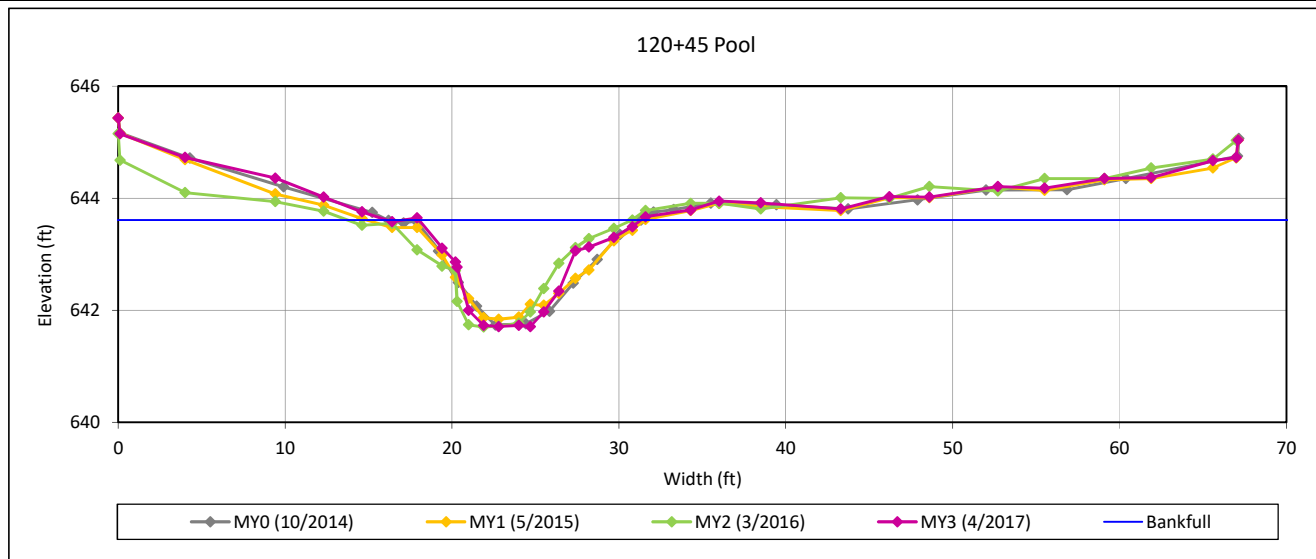
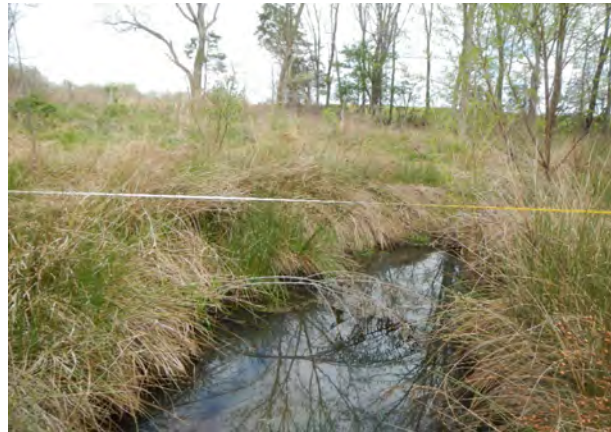
Cross Section 4-UT1 Reach 2

13.6	x-section area (ft.sq.)
13.3	width (ft)
1.0	mean depth (ft)
1.9	max depth (ft)
14.3	wetted parimeter (ft)
1.0	hyd radi (ft)
13.1	width-depth ratio

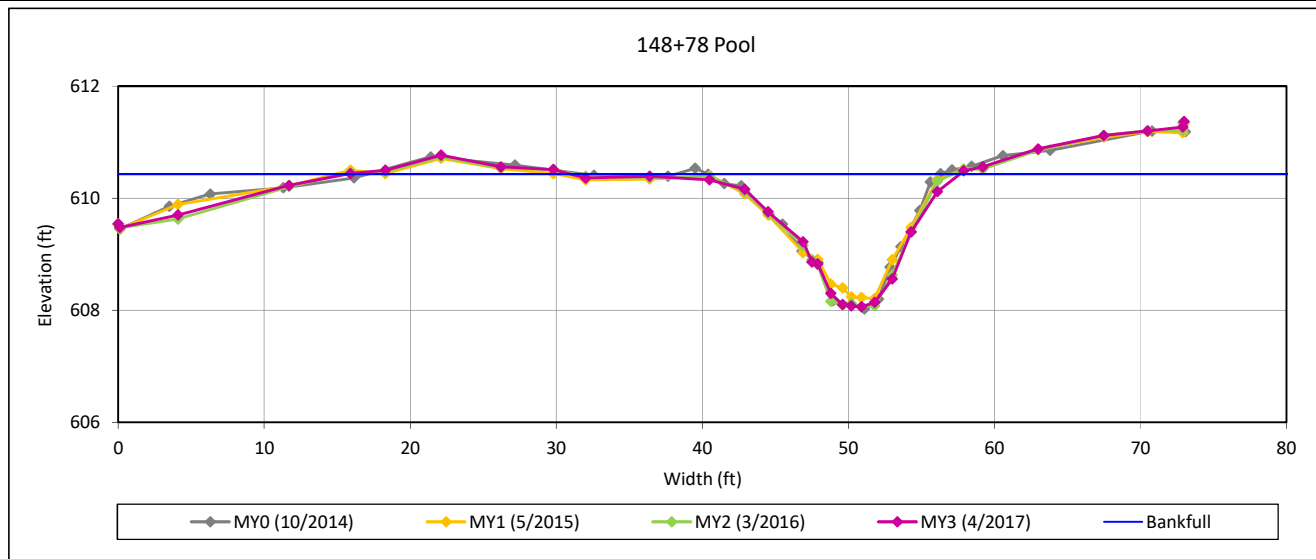
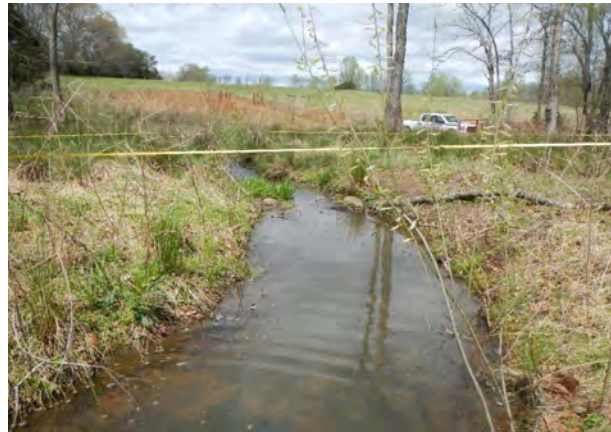
Cross Section 5-UT1 Reach 5

19.4	x-section area (ft.sq.)
17.1	width (ft)
1.1	mean depth (ft)
2.4	max depth (ft)
18.0	wetted parimeter (ft)
1.1	hyd radi (ft)
15.1	width-depth ratio

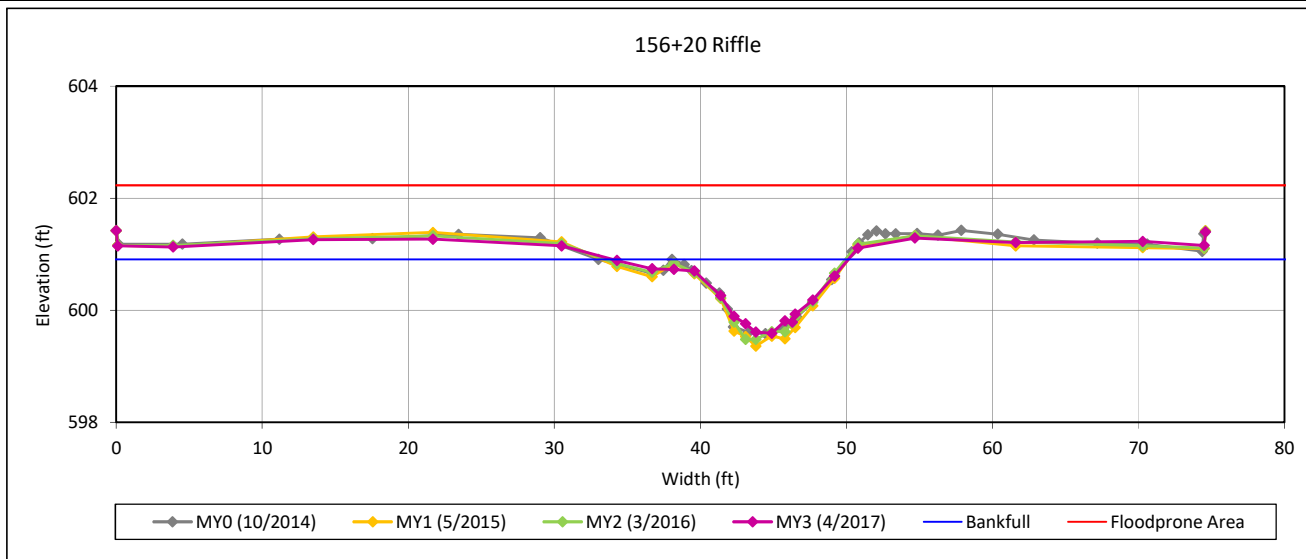
Cross Section 7-UT1 Reach 5

8.8	x-section area (ft.sq.)
12.0	width (ft)
0.7	mean depth (ft)
1.3	max depth (ft)
12.3	wetted parimeter (ft)
0.7	hyd radi (ft)
16.3	width-depth ratio
200.0	W flood prone area (ft)
16.7	entrenchment ratio
1.0	low bank height ratio
