# **MONITORING YEAR 5 ANNUAL REPORT**

## **AGONY ACRES MITIGATION SITE**

Guilford County, NC

DMS Project Number 95716

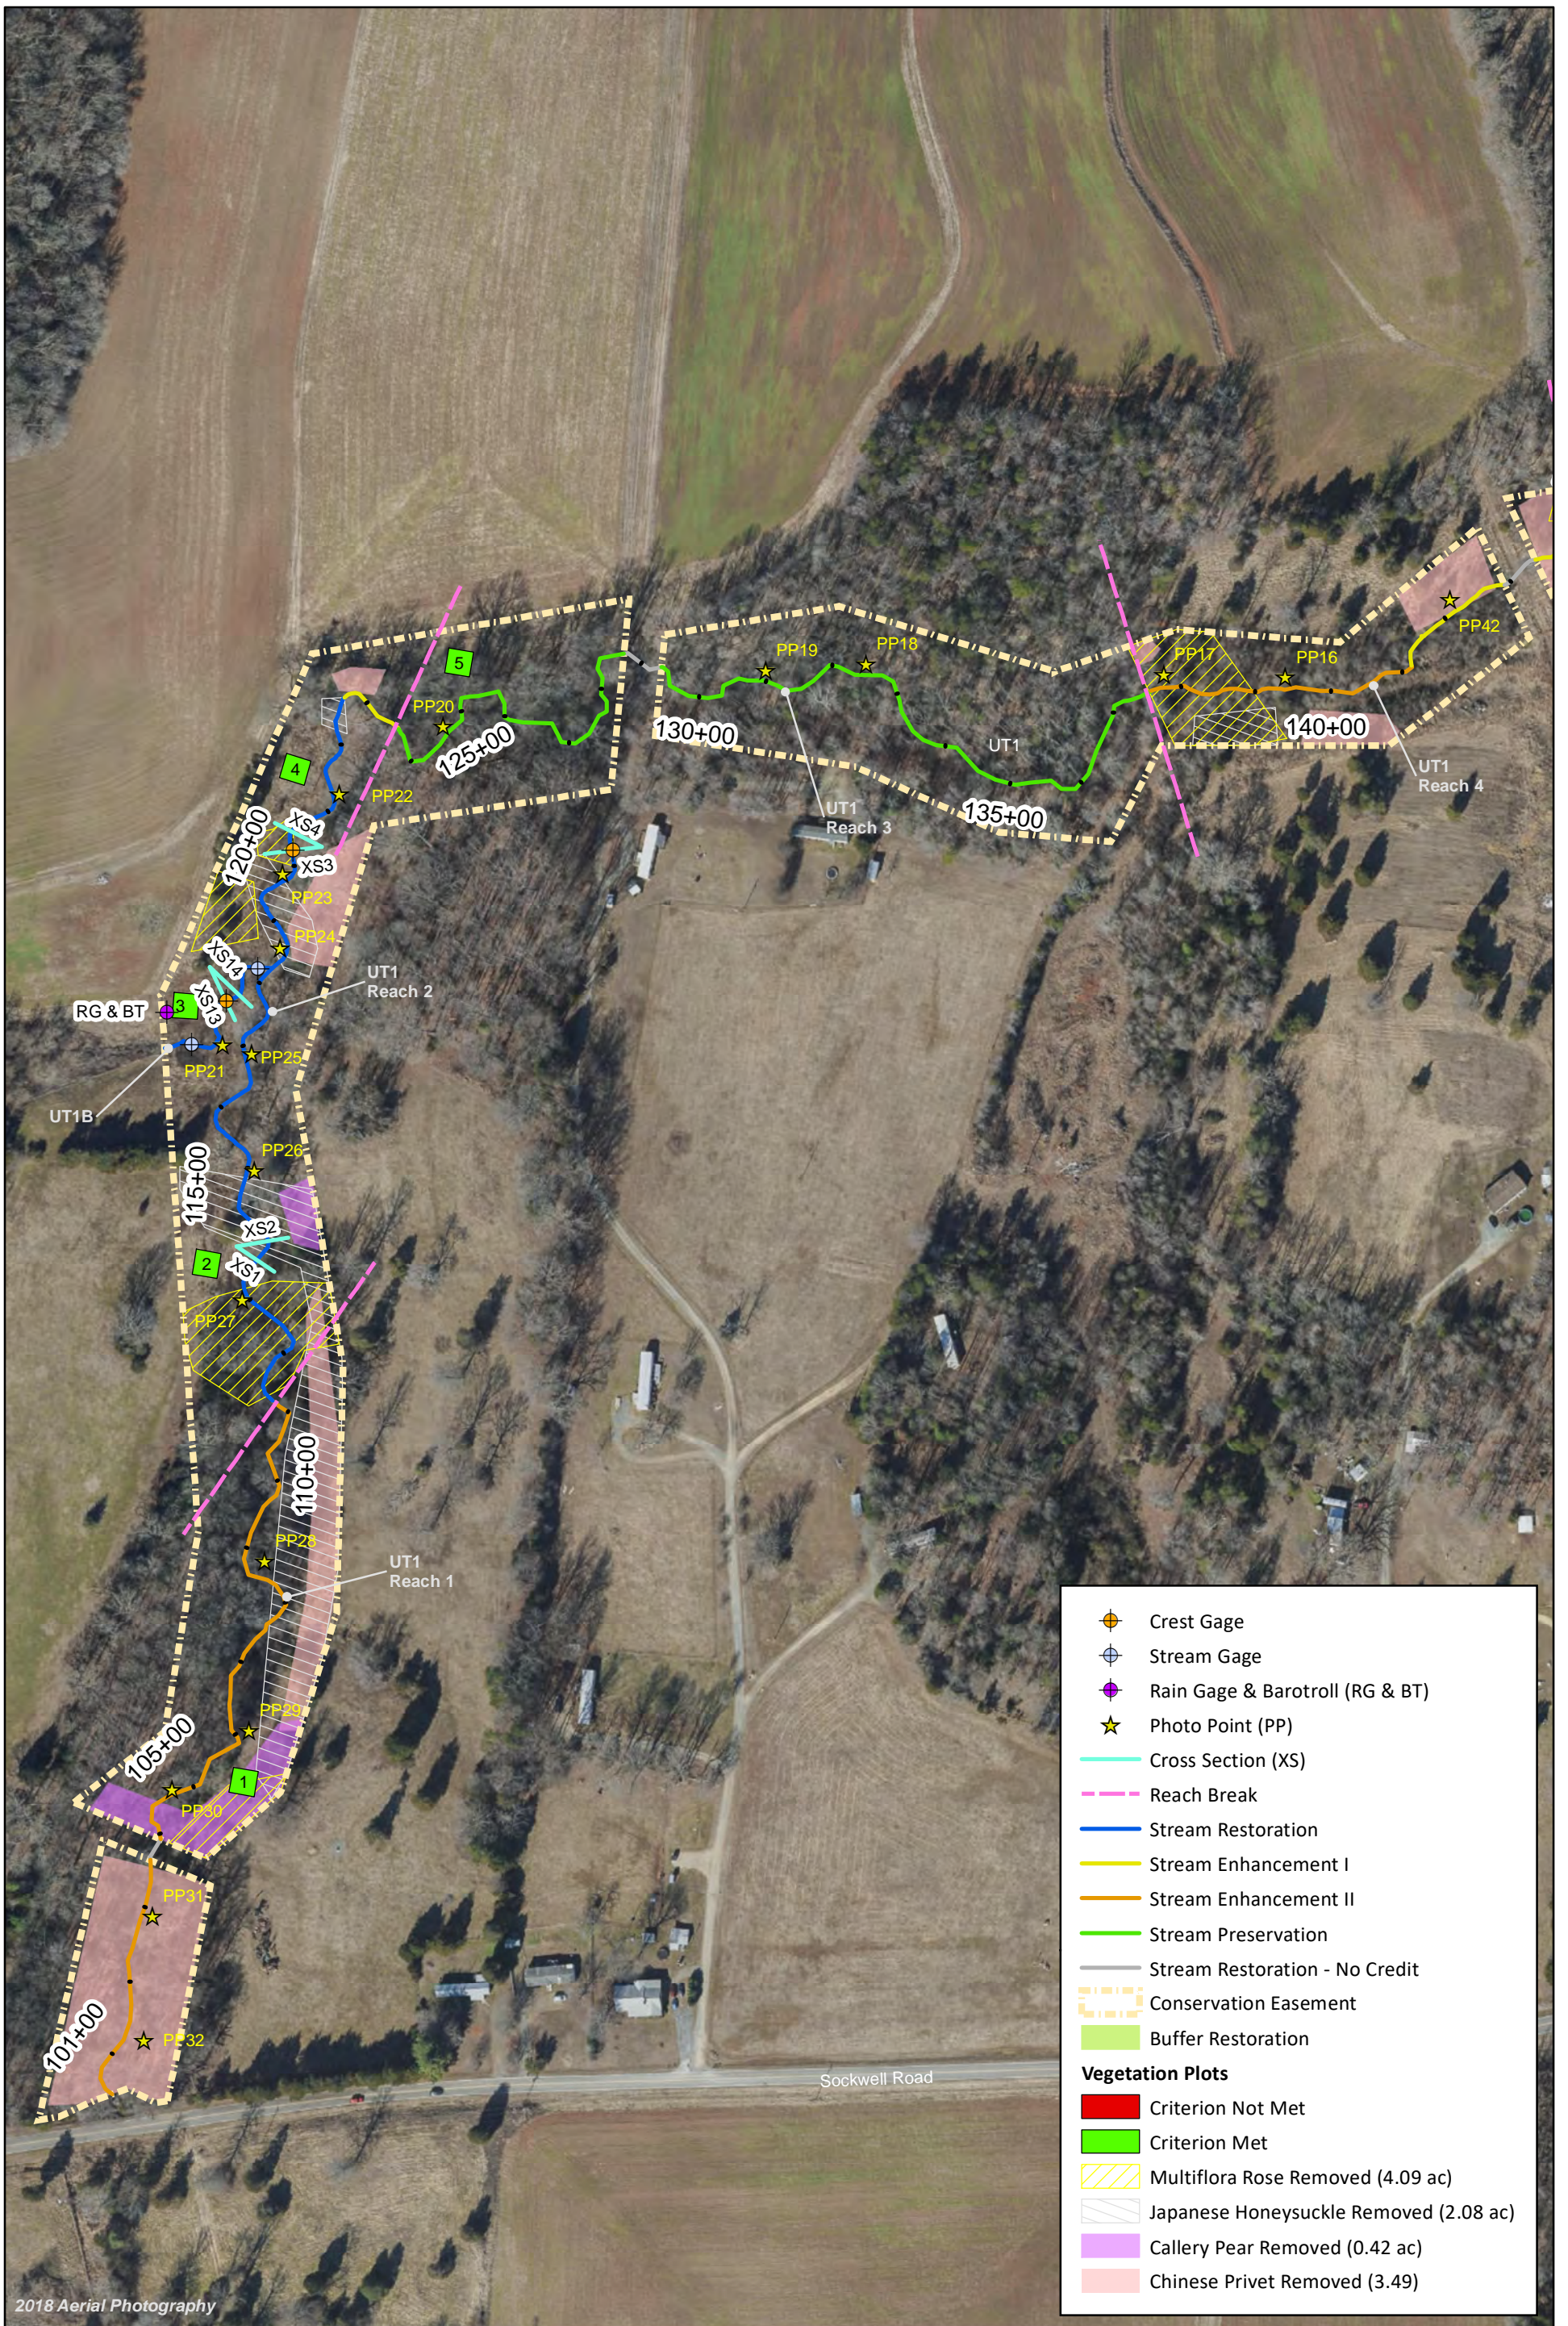
Figure 3.2. Integrated Current Condition Plan View  
 (Sheet 2 of 3)  
 Agony Acres Mitigation Site  
 DMS Project No. 95716  
 Monitoring Year 5 - 2019  
 Guilford County, NC

Beaver activity occurred on UT1 where it approaches the Reedy Fork floodplain (Figure 3.2). Beaver activity was identified in September and removal was completed in October. Minimal damage occurred to the stream channels and tree community.

Stream flow was recorded at five locations in UT1A during MY5, but there is no hydrology performance standard for this stream other than the bankfull flow requirement (Figure 3.2). Flow gages 1, 3, 4, and 5 indicate that UT1A had consistent flow from the beginning of the year through June. From June through the remainder of the 2019 monitoring year, UT1A had sporadic stream flow. Flow gage 2 recorded short interruptions to baseflow during July and August and a longer interruption to baseflow during September and October. Below normal rainfall was recorded during May, July, September, and October which likely contributed to these results (Appendix 5). Stream flow on UT1A will continue to be monitored through the duration of the monitoring period.

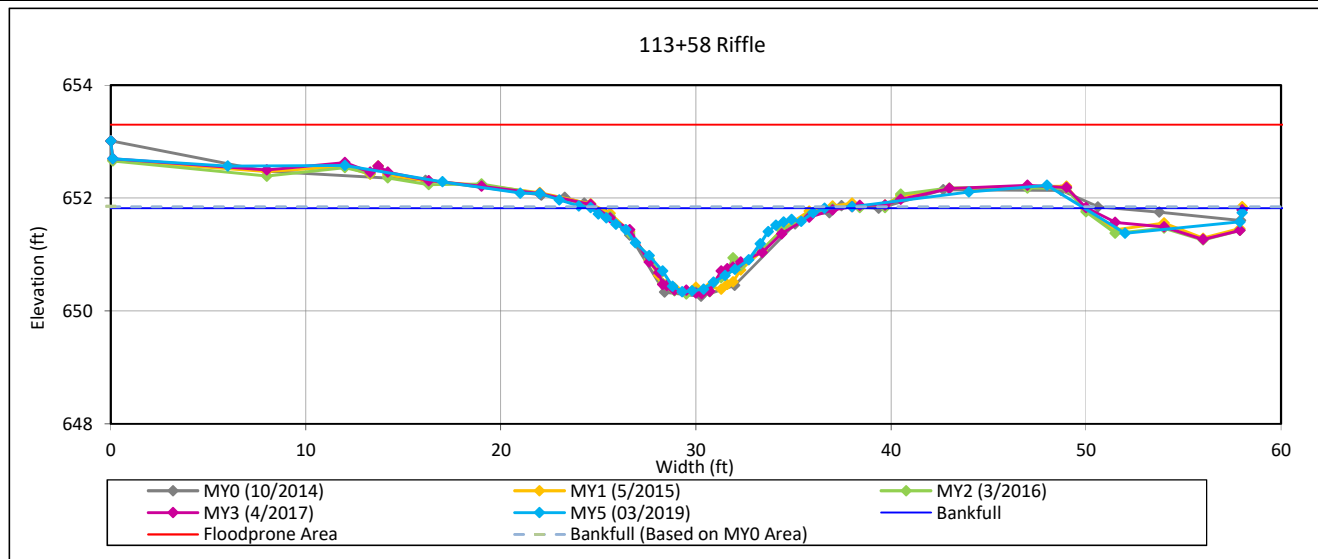
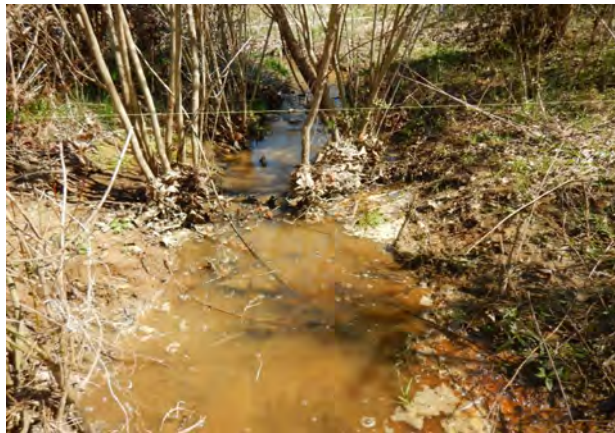
#### Cross Section 1-UT1 Reach 2

8.7	x-section area (ft.sq.)
12.0	width (ft)
0.7	mean depth (ft)
1.5	max depth (ft)
12.4	wetted perimeter (ft)
0.7	hyd radi (ft)
16.5	width-depth ratio
100.0	W flood prone area (ft)
8.4	entrenchment ratio
< 1.0	low bank height ratio

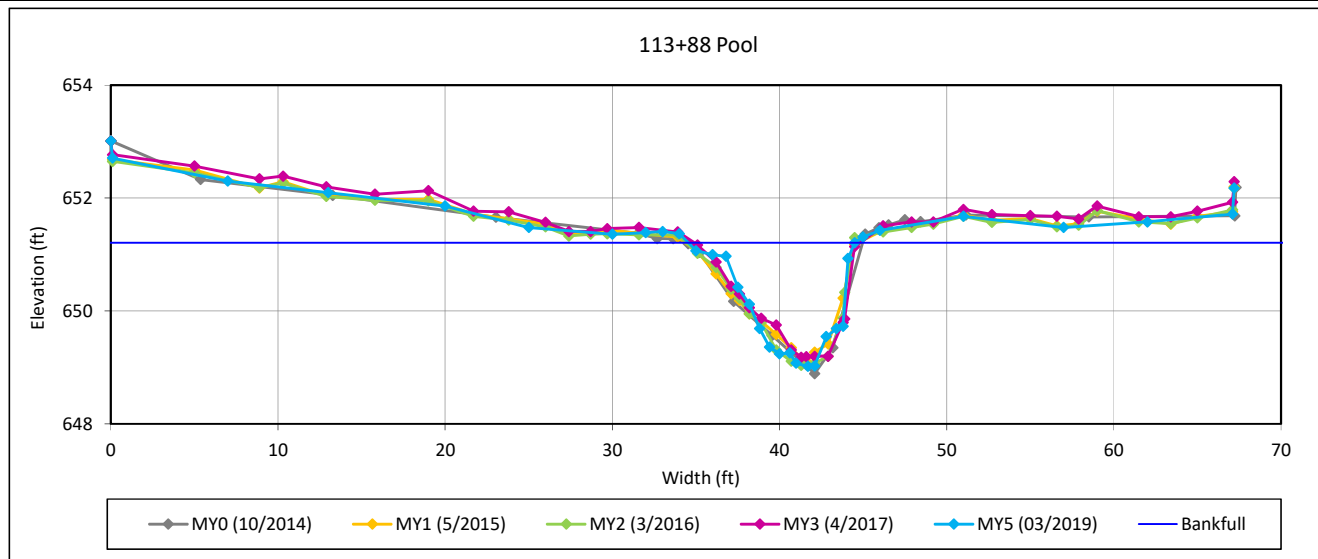
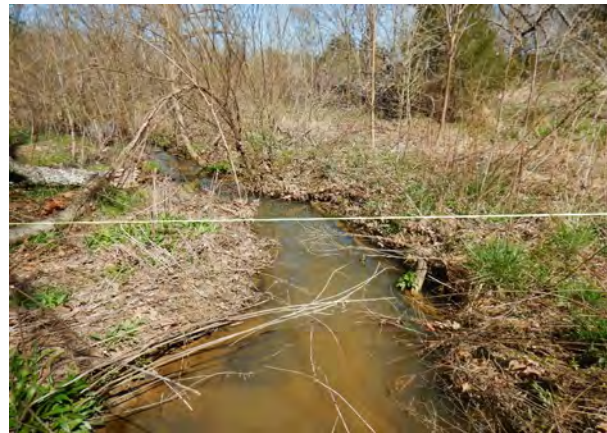
#### Cross Section 2-UT1 Reach 2

11.9	x-section area (ft.sq.)
10.0	width (ft)
1.2	mean depth (ft)
2.2	max depth (ft)
11.7	wetted parimeter (ft)
1.0	hyd radi (ft)
8.3	width-depth ratio

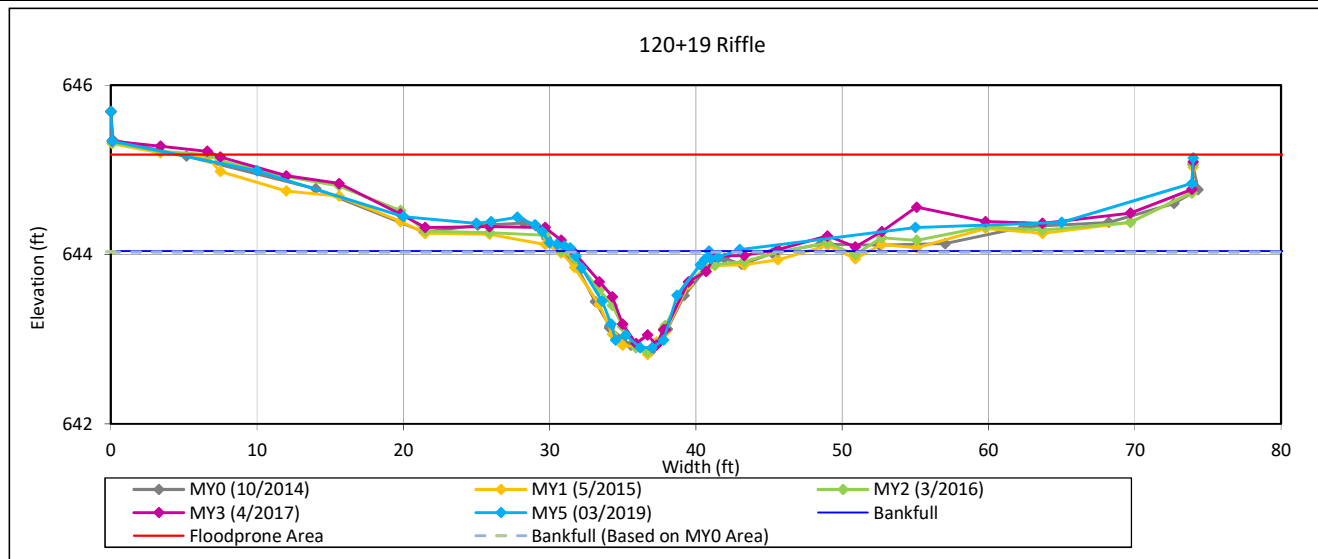
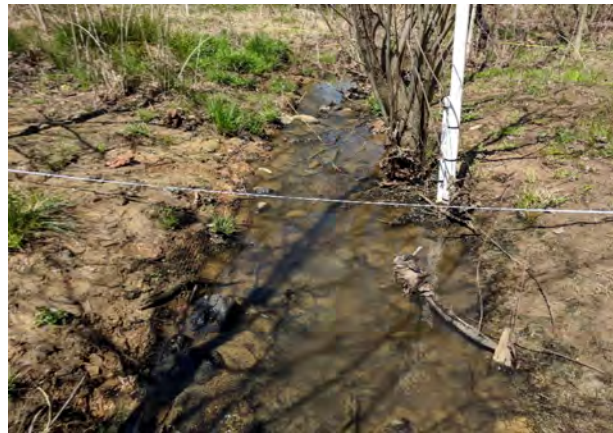
#### Cross Section 3-UT1 Reach 2

6.2	x-section area (ft.sq.)
9.7	width (ft)
0.6	mean depth (ft)
1.1	max depth (ft)
10.2	wetted parimeter (ft)
0.6	hyd radi (ft)
15.1	width-depth ratio
60.0	W flood prone area (ft)
6.2	entrenchment ratio
1.0	low bank height ratio

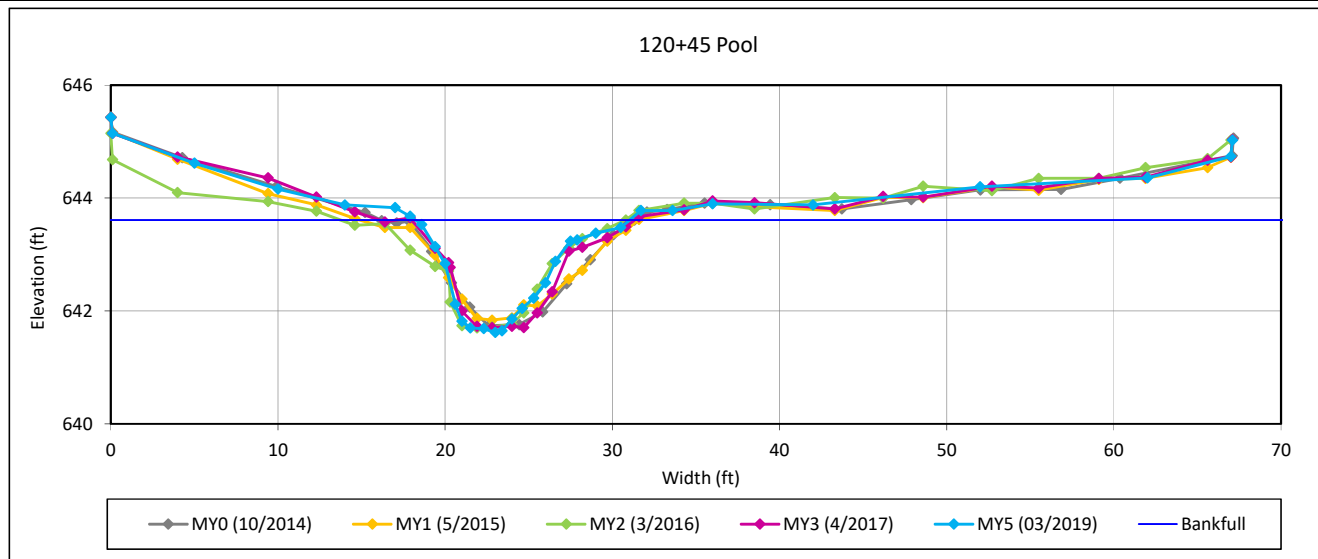
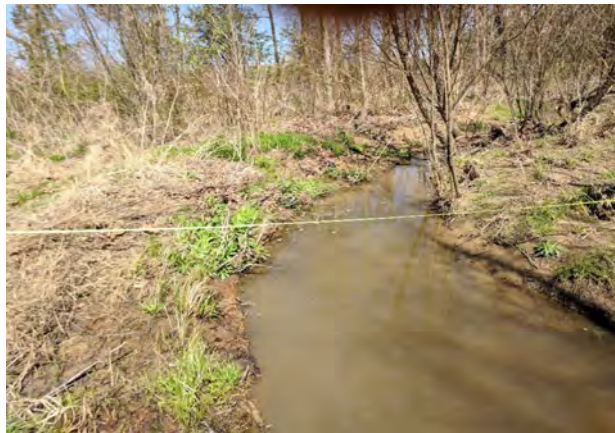
#### Cross Section 4-UT1 Reach 2

12.4	x-section area (ft.sq.)
12.8	width (ft)
1.0	mean depth (ft)
2.0	max depth (ft)
13.8	wetted parimeter (ft)
0.9	hyd radi (ft)
13.2	width-depth ratio

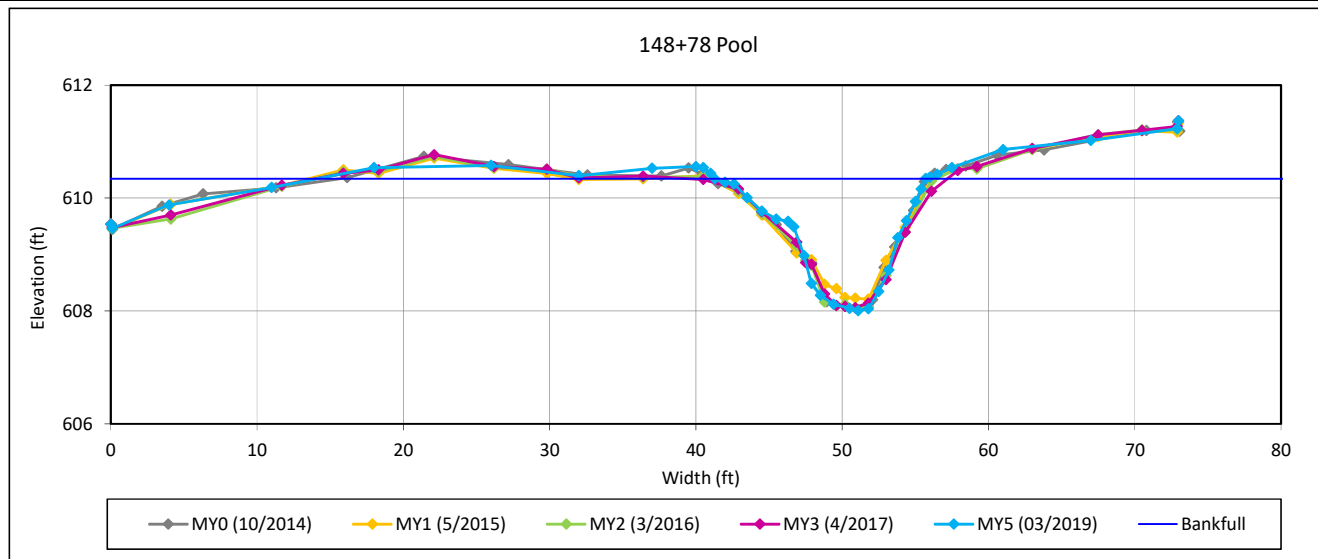
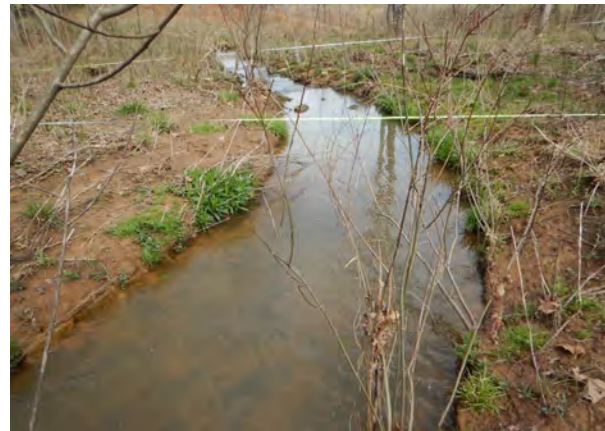
**Cross Section 5-UT1 Reach 5**

17.0	x-section area (ft.sq.)
14.4	width (ft)
1.2	mean depth (ft)
2.3	max depth (ft)
15.5	wetted parimeter (ft)
1.1	hyd radi (ft)
12.2	width-depth ratio

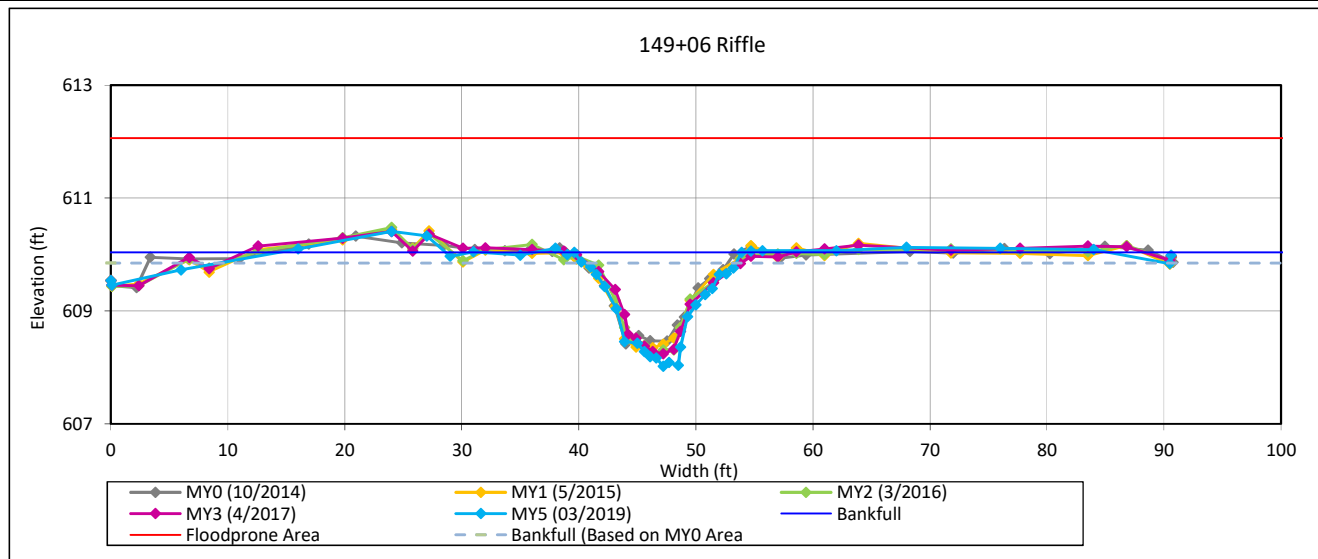
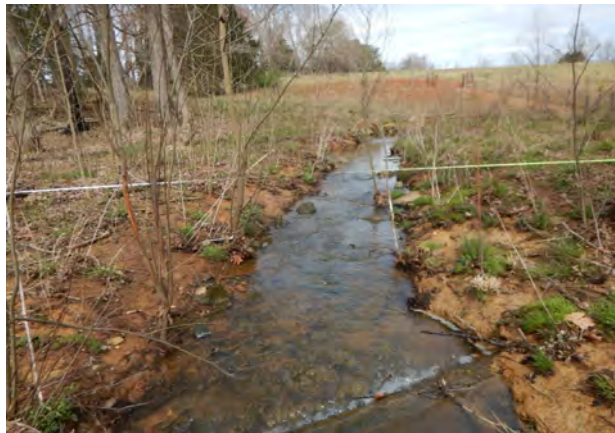
#### Cross Section 6-UT1 Reach 5

14.7	x-section area (ft.sq.)
15.3	width (ft)
1.0	mean depth (ft)
2.0	max depth (ft)
16.2	wetted perimeter (ft)
0.9	hyd radi (ft)
15.9	width-depth ratio
200.0	W flood prone area (ft)
13.1	entrenchment ratio
1.1	low bank height ratio
