MONITORING YEAR 6 ANNUAL REPORT

AGONY ACRES MITIGATION SITE

Guilford County, NC

DMS Project Number 95716

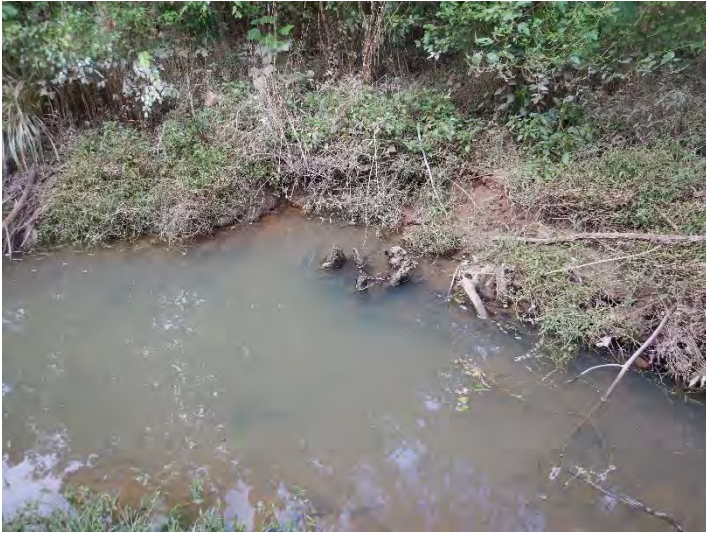
UT1 Bank erosion – (09/23/2020)

All areas of invasive vegetation are scheduled for treatment and removal in the spring of 2021. Repair of the perched culvert and piping log sills is expected during the winter of 2020. The localized area of bank erosion in lower UT1 reach 5 will be seeded and planted with live stakes during spring of 2021. This stabilization approach is intended to minimize impacts to existing vegetation.

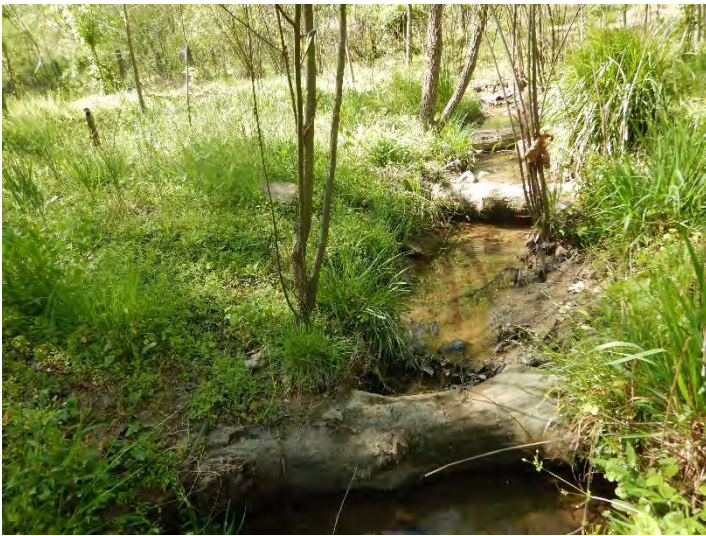
UT2 Piping Log Sills – (04/17/2020)
