MONITORING YEAR 3 ANNUAL REPORT

ALEXANDER FARM MITIGATION SITE

DMS Project No. 100048

Data Collection Period: January 2022 – November 2022

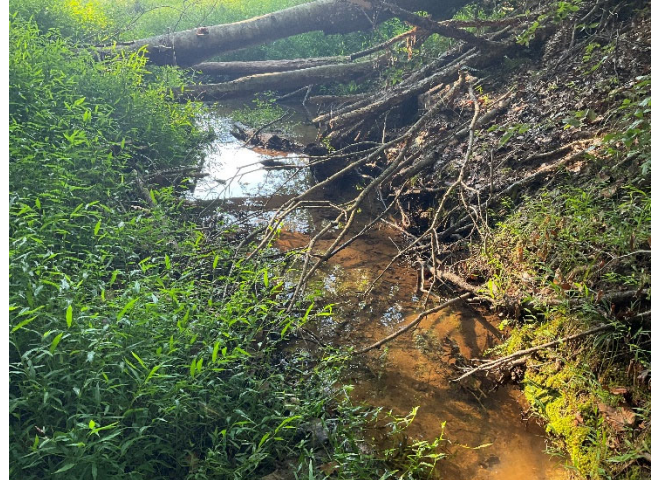
UT1 R4A (STA 139+00-139+75) – view downstream of aggradation area reported in MY2 (09/20/2022)

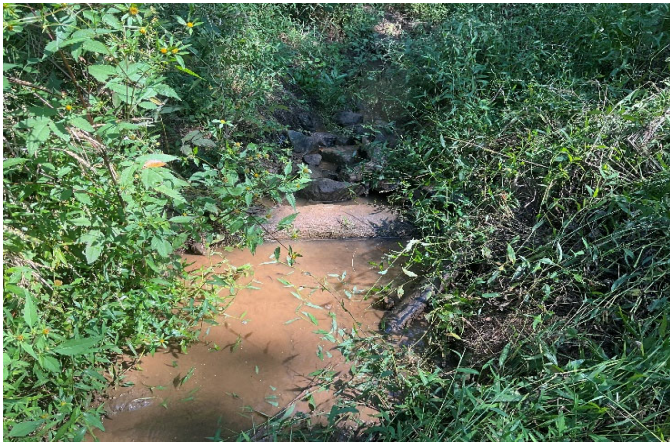
UT1 R4A (STA 139+00-139+75) – view downstream of channel after the sediment was flushed out of the system in MY3 (09/20/2022)

UT1 R1A Structure Piping (STA 104+00) – view upstream (09/20/2022)

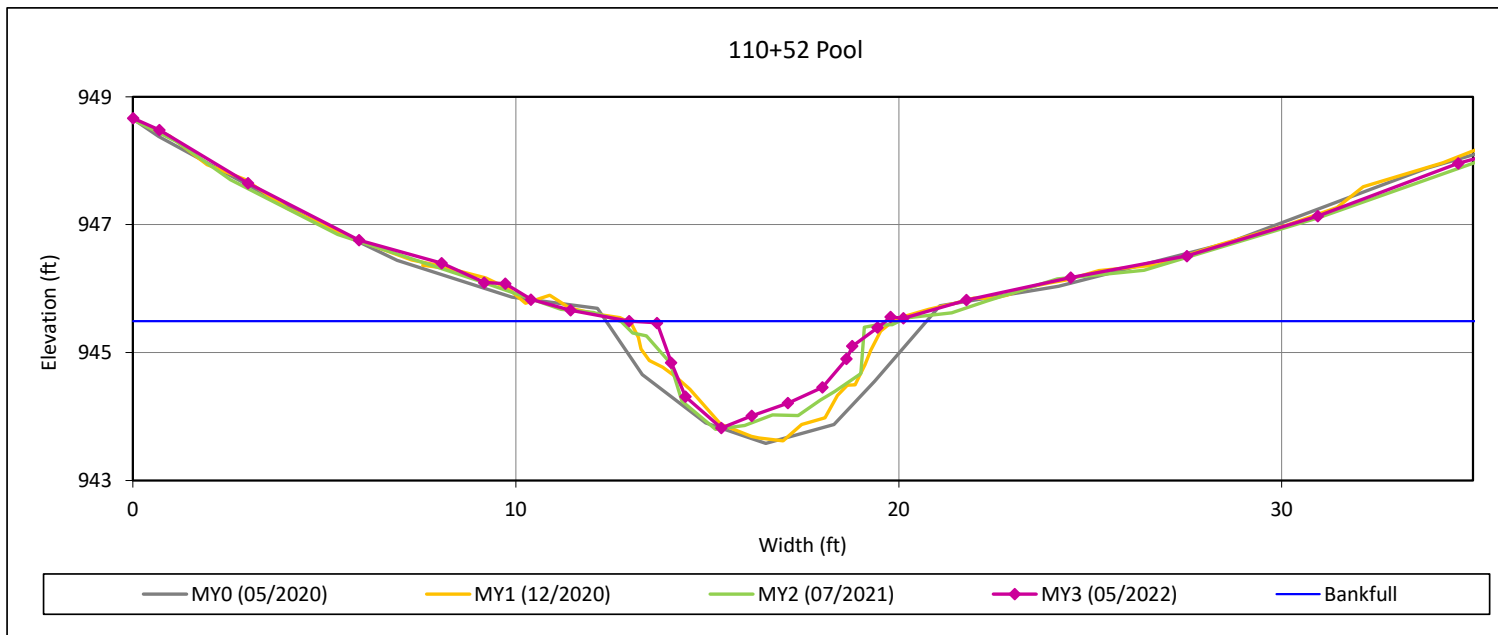
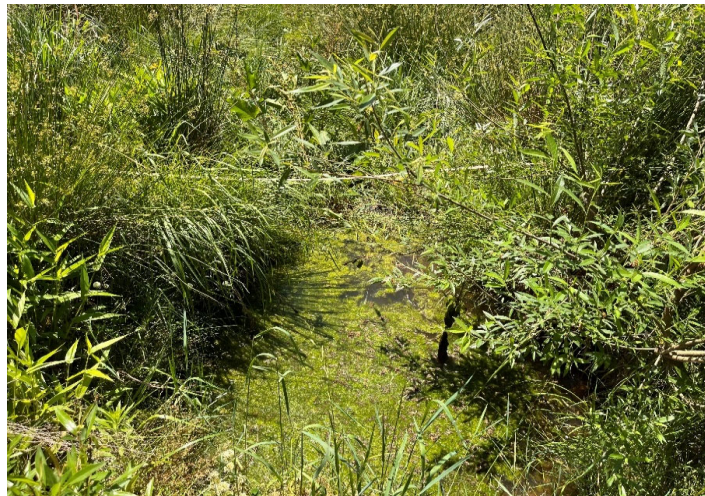
Cross-Section 3-UT1 Reach 1B

6.2	x-section area (ft.sq.)
6.7	width (ft)
0.9	mean depth (ft)
1.7	max depth (ft)
7.8	wetted perimeter (ft)
0.8	hydraulic radius (ft)
7.3	width-depth ratio

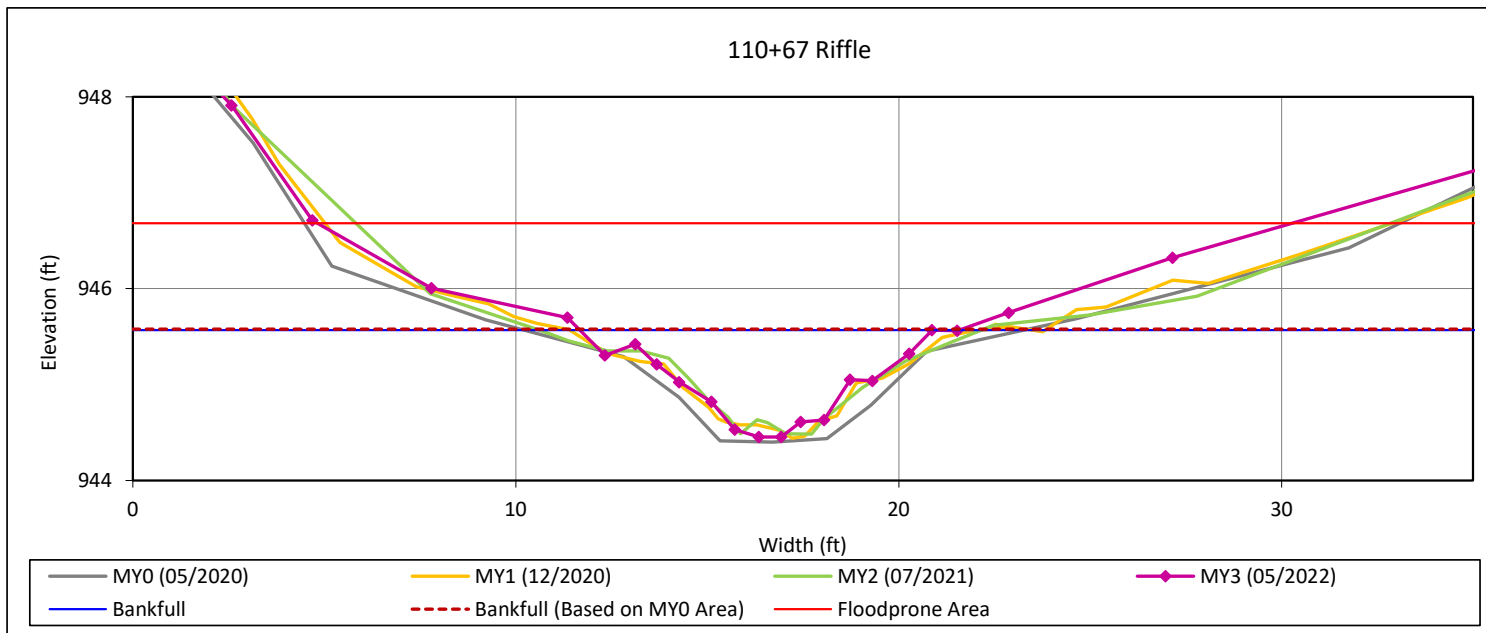
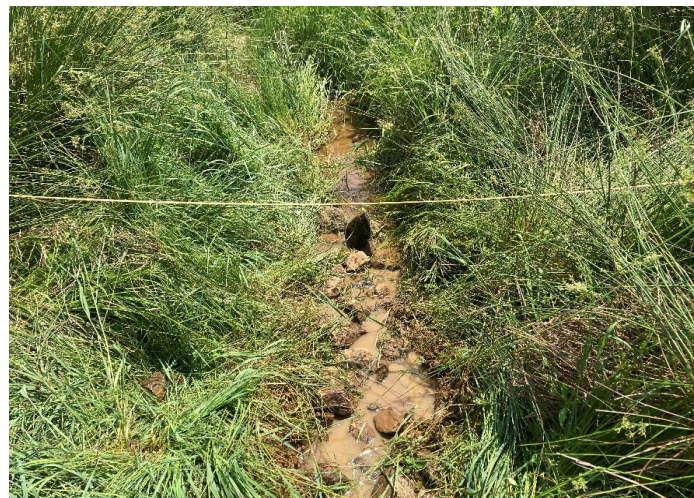
Cross-Section 4-UT1 Reach 1B

5.4	x-section area (ft.sq.)
9.2	width (ft)
0.6	mean depth (ft)
1.1	max depth (ft)
9.7	wetted perimeter (ft)
0.6	hydraulic radius (ft)
15.6	width-depth ratio
25.5	W flood prone area (ft)
2.8	entrenchment ratio
1.0	low bank height ratio

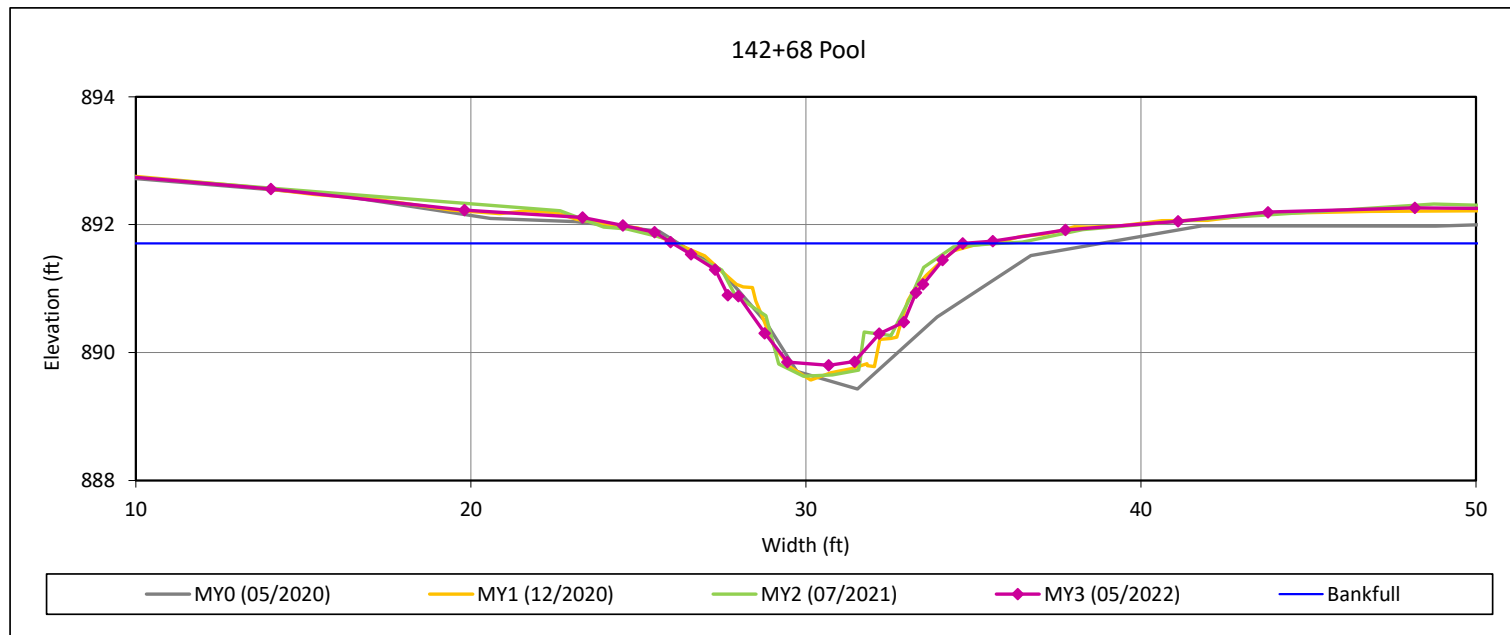
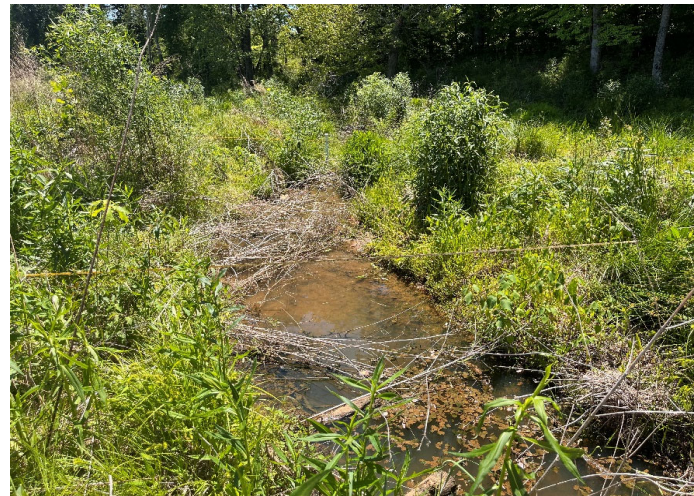
Cross-Section 5-UT1 Reach 4A

9.5	x-section area (ft.sq.)
8.6	width (ft)
1.1	mean depth (ft)
1.9	max depth (ft)
9.8	wetted perimeter (ft)
1.0	hydraulic radius (ft)
7.9	width-depth ratio

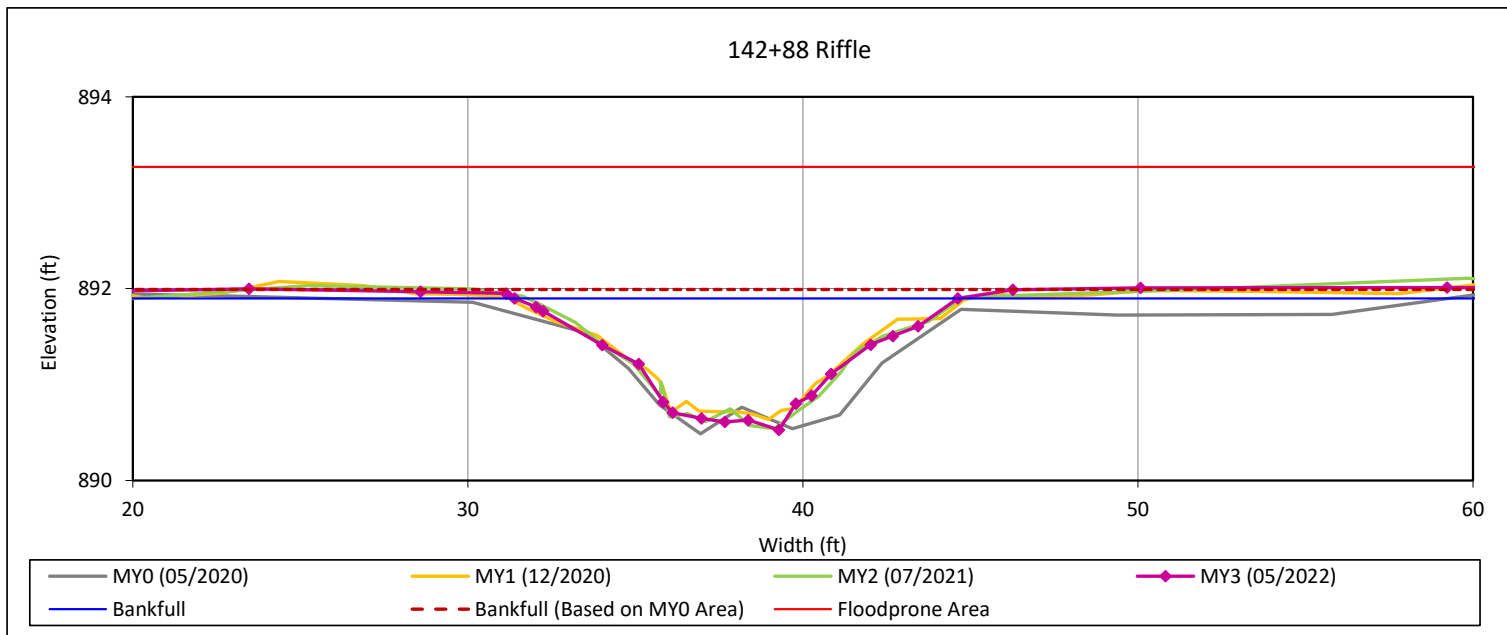
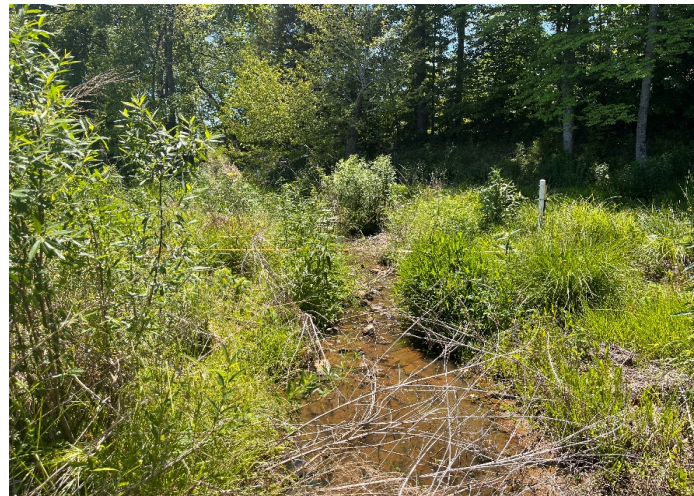
Cross-Section 6-UT1 Reach 4A

9.4	x-section area (ft.sq.)
13.2	width (ft)
0.7	mean depth (ft)
1.4	max depth (ft)
13.6	wetted perimeter (ft)
0.7	hydraulic radius (ft)
18.7	width-depth ratio
66.4	W flood prone area (ft)
5.0	entrenchment ratio
0.9	low bank height ratio

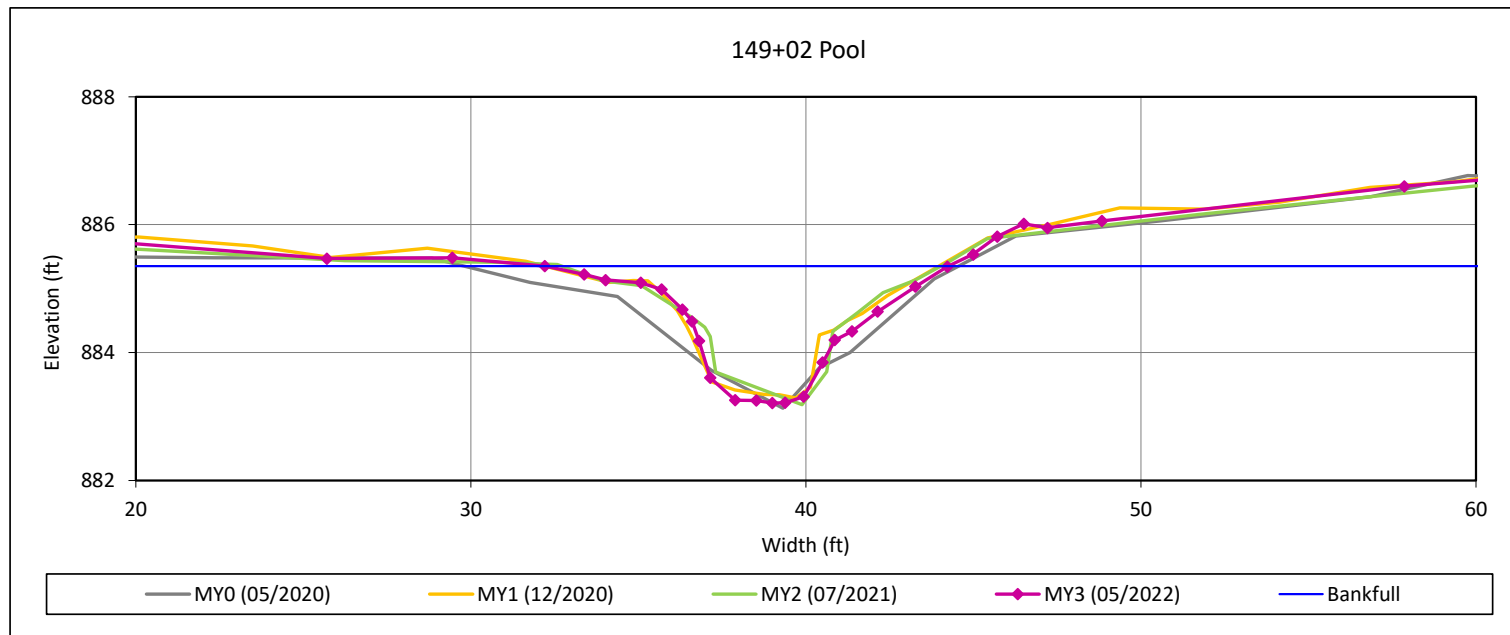
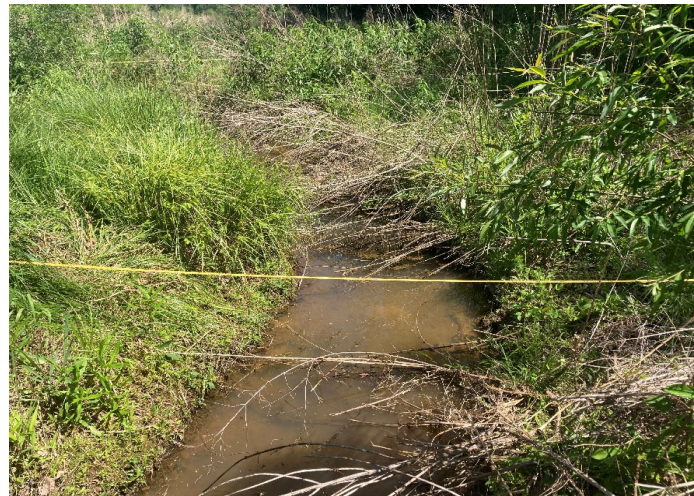
Cross-Section 7-UT1 Reach 4A

11.1	x-section area (ft.sq.)
12.1	width (ft)
0.9	mean depth (ft)
2.1	max depth (ft)
13.3	wetted perimeter (ft)
0.8	hydraulic radius (ft)
13.1	width-depth ratio

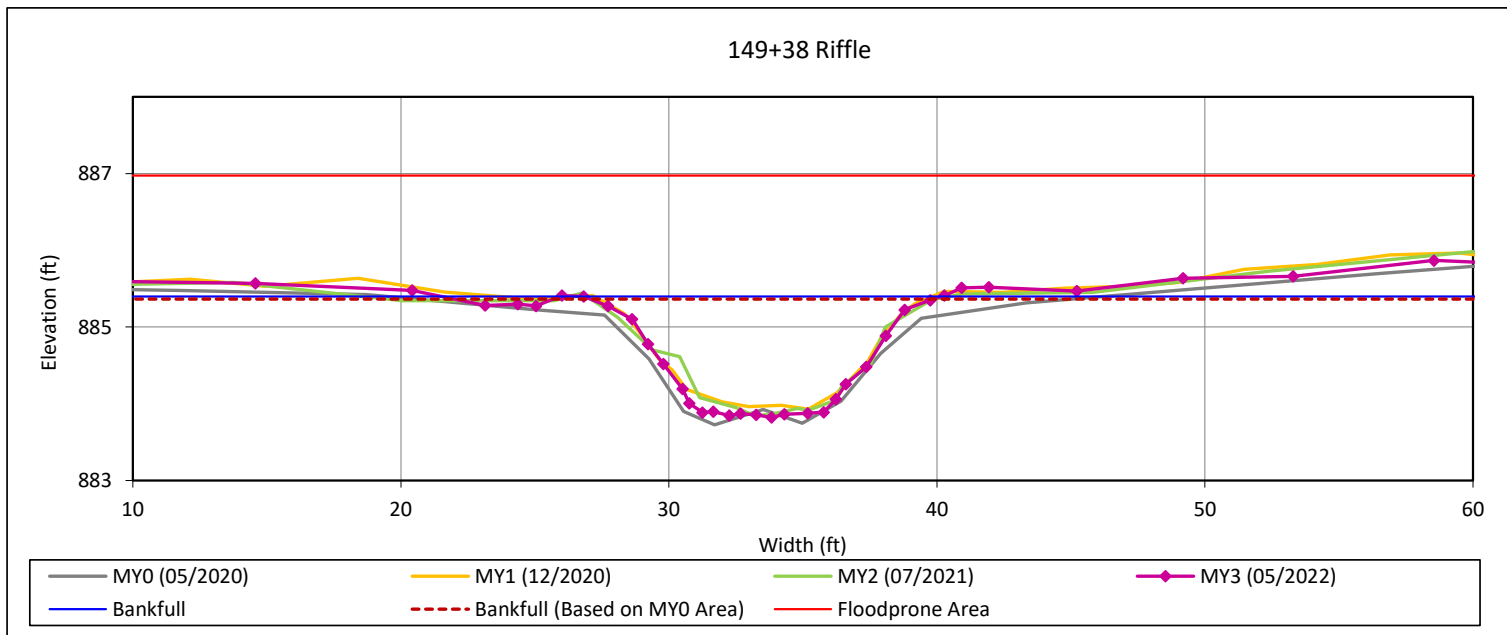
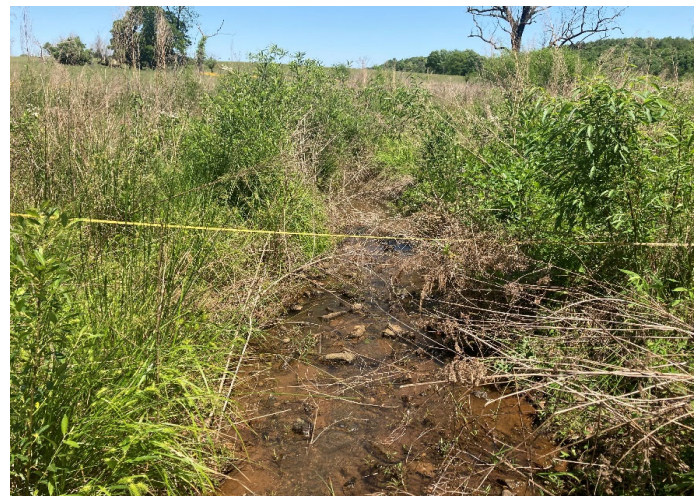
Cross-Section 8-UT1 Reach 4A

12.4	x-section area (ft.sq.)
12.9	width (ft)
1.0	mean depth (ft)
1.6	max depth (ft)
13.5	wetted perimeter (ft)
0.9	hydraulic radius (ft)
13.5	width-depth ratio
62.6	W flood prone area (ft)
4.8	entrenchment ratio
1.0	low bank height ratio

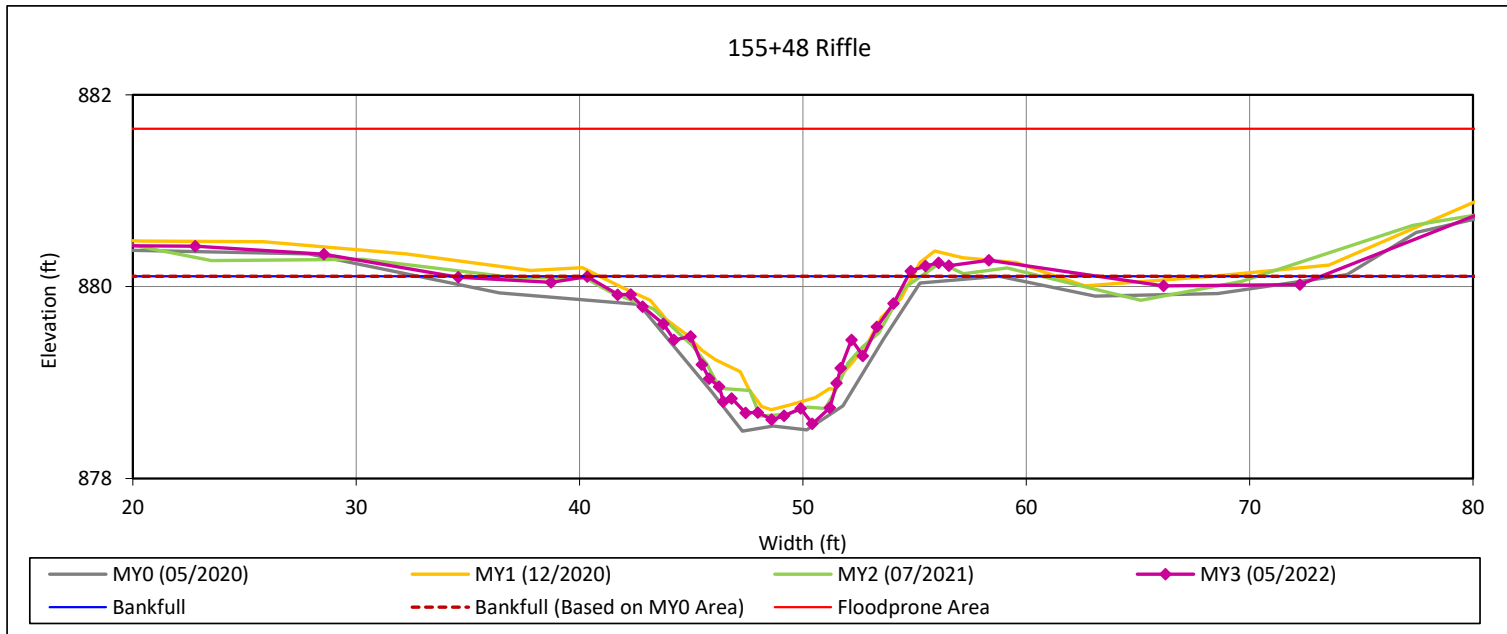
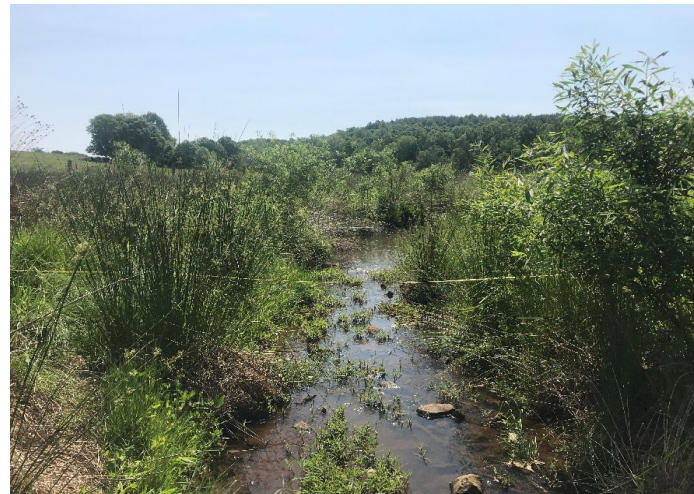
Cross-Section 9-UT1 Reach 4B

- 11.9 x-section area (ft.sq.)
- 14.4 width (ft)
- 0.8 mean depth (ft)
- 1.5 max depth (ft)
- 15.1 wetted perimeter (ft)
- 0.8 hydraulic radius (ft)
- 17.3 width-depth ratio
- 80.9 W flood prone area (ft)
- 5.6 entrenchment ratio
- 1.0 low bank height ratio

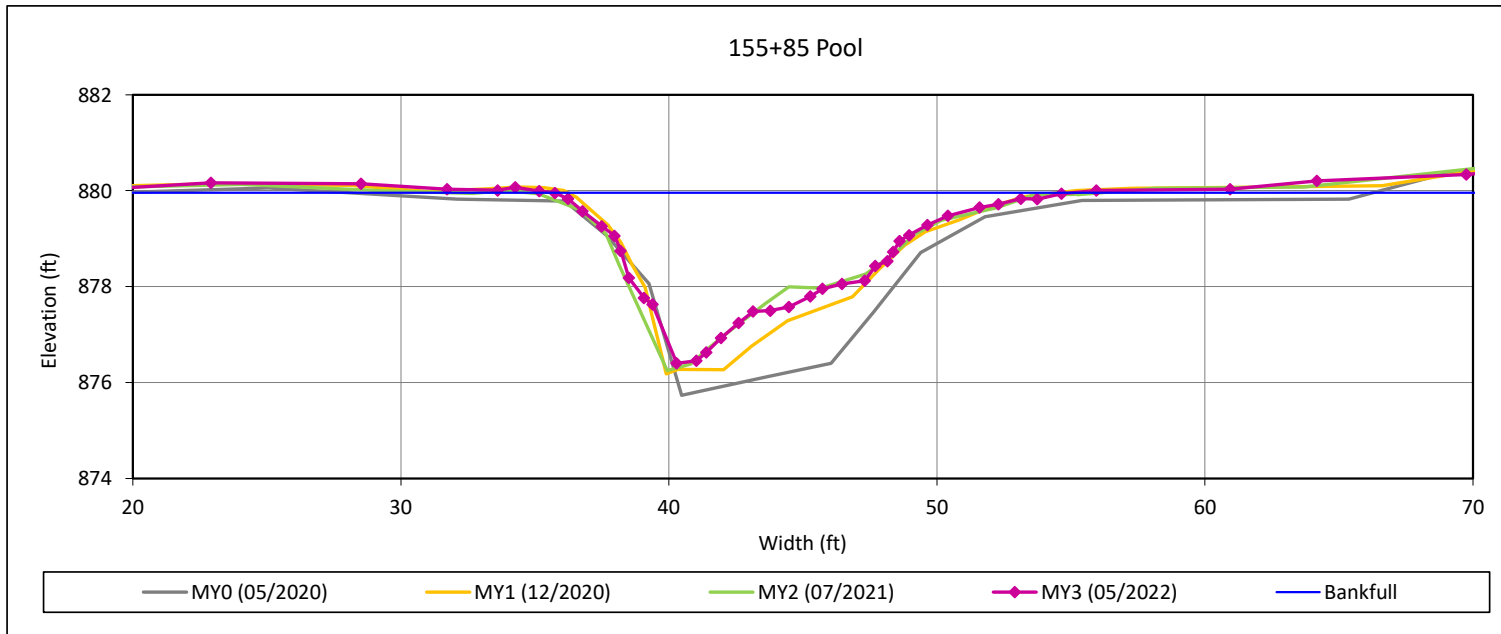
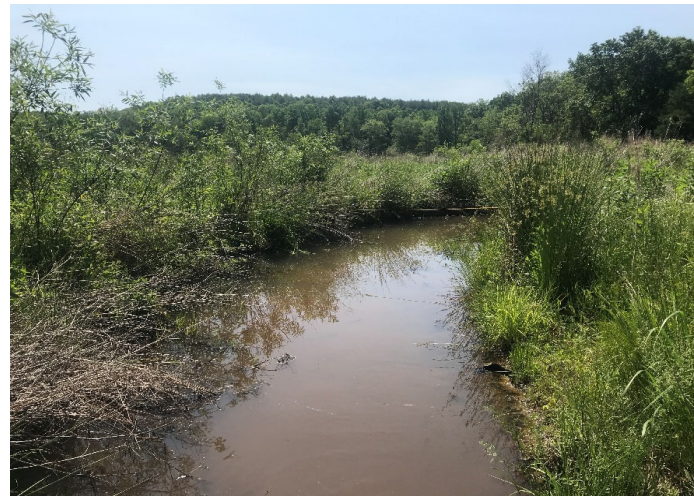
Cross-Section 10-UT1 Reach 4B

28.1	x-section area (ft.sq.)
18.9	width (ft)
1.5	mean depth (ft)
3.6	max depth (ft)
21.1	wetted perimeter (ft)
1.3	hydraulic radius (ft)
12.7	width-depth ratio

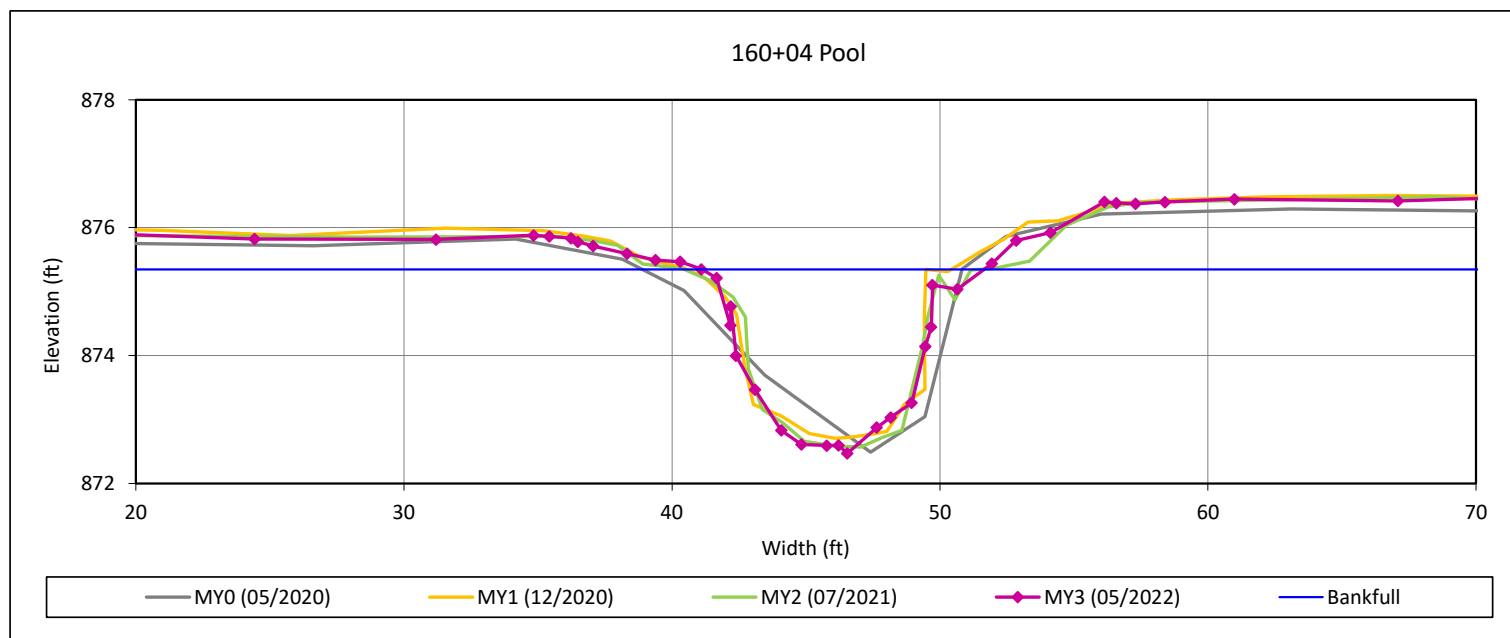
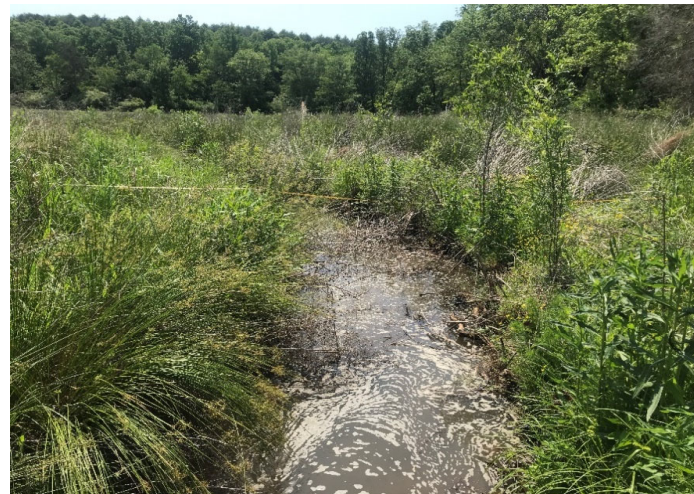
Cross-Section 11-UT1 Reach 4B

17.9	x-section area (ft.sq.)
10.6	width (ft)
1.7	mean depth (ft)
2.9	max depth (ft)
13.7	wetted perimeter (ft)
1.3	hydraulic radius (ft)
6.2	width-depth ratio

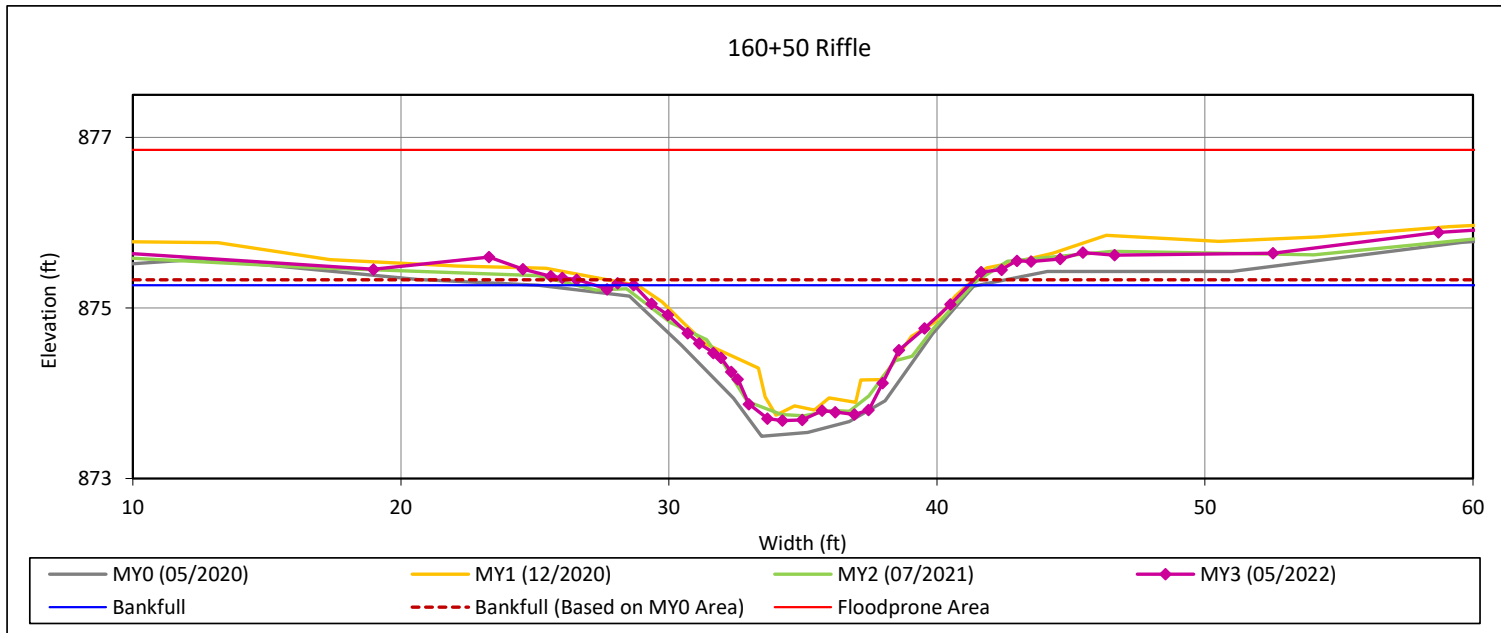
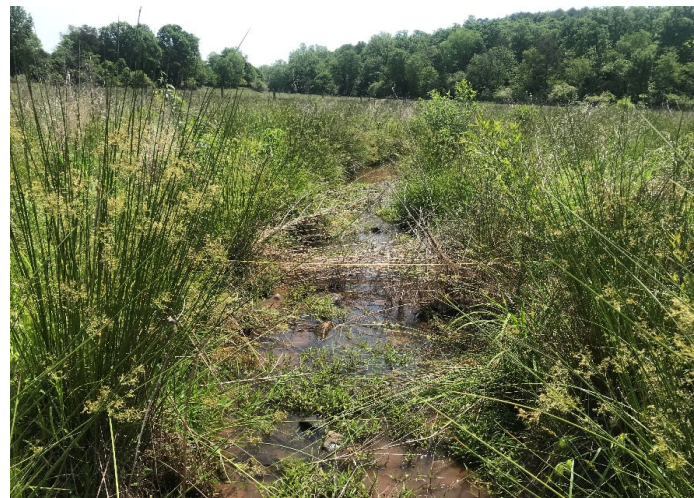
Cross-Section 12-UT1 Reach 4B

11.7	x-section area (ft.sq.)
12.5	width (ft)
0.9	mean depth (ft)
1.6	max depth (ft)
13.1	wetted perimeter (ft)
0.9	hydraulic radius (ft)
13.3	width-depth ratio
74.6	W flood prone area (ft)
6.0	entrenchment ratio
1.0	low bank height ratio

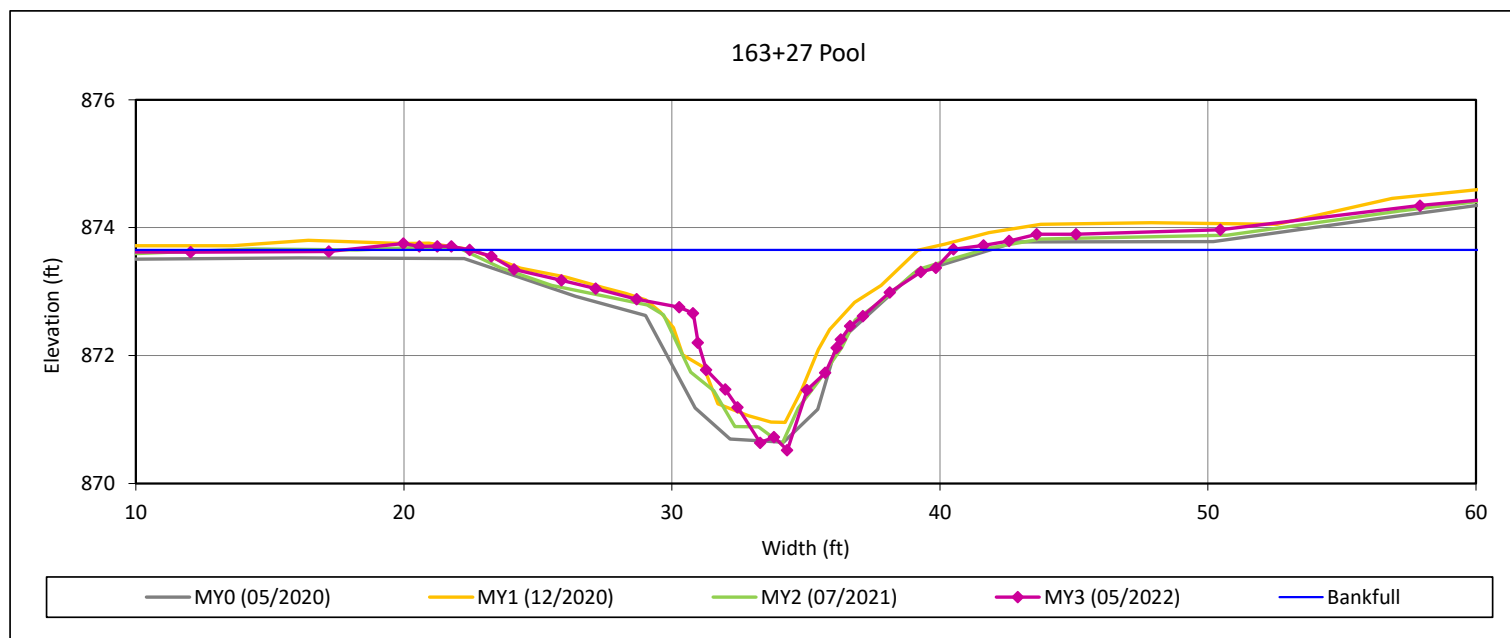
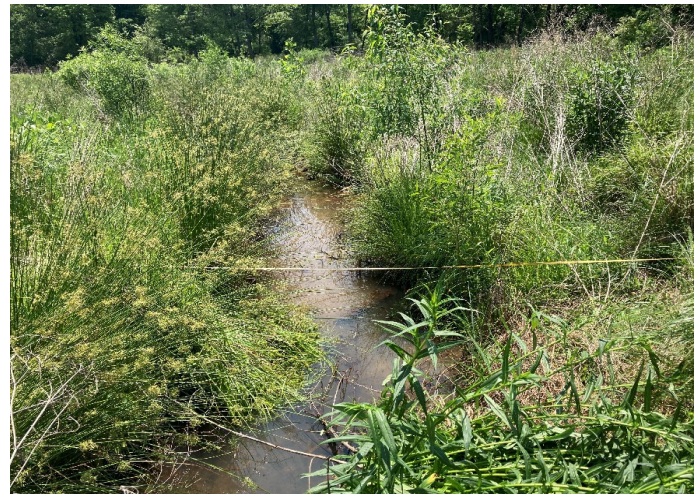
Cross-Section 13-UT1 Reach 4B

20.0	x-section area (ft.sq.)
18.0	width (ft)
1.1	mean depth (ft)
3.1	max depth (ft)
19.9	wetted perimeter (ft)
1.0	hydraulic radius (ft)
16.2	width-depth ratio

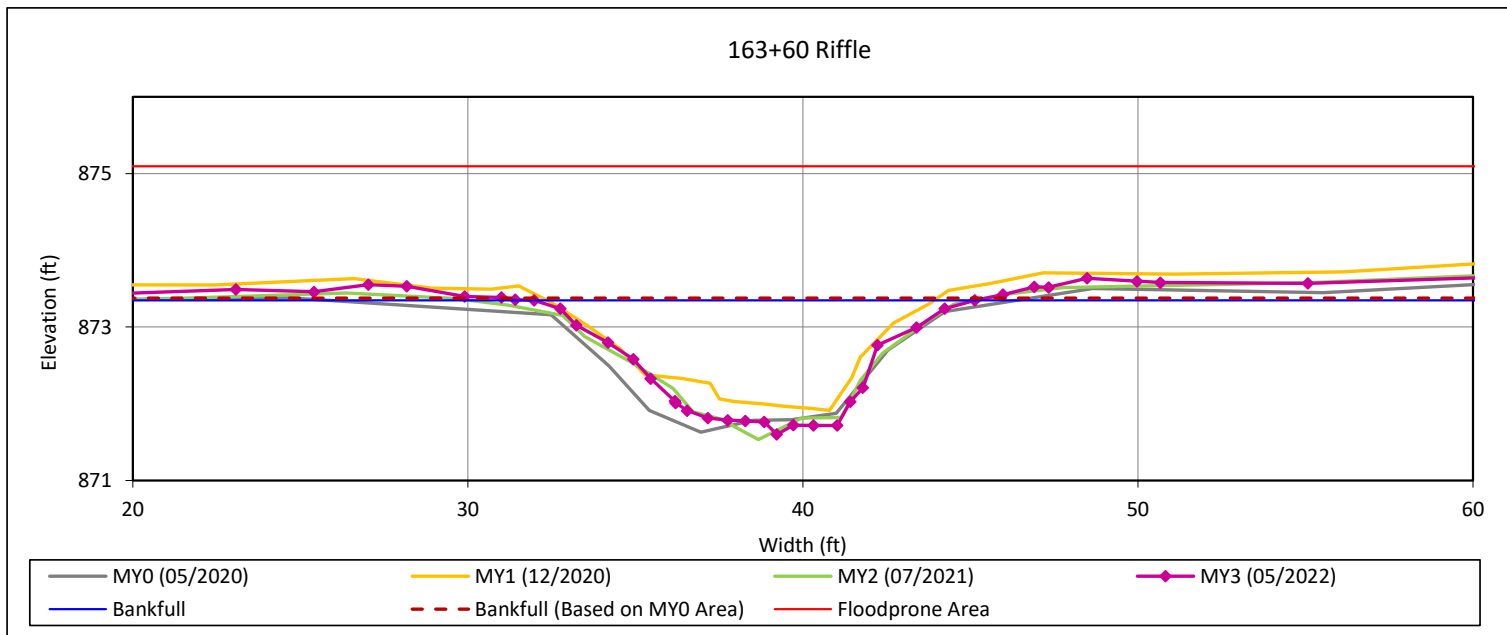
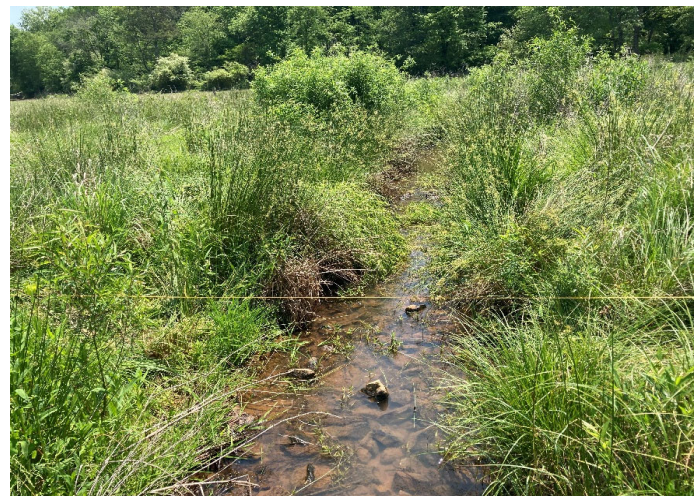
Cross-Section 14-UT1 Reach 4B

12.2	x-section area (ft.sq.)
13.2	width (ft)
0.9	mean depth (ft)
1.7	max depth (ft)
13.9	wetted perimeter (ft)
0.9	hydraulic radius (ft)
14.2	width-depth ratio
73.9	W flood prone area (ft)
5.6	entrenchment ratio
1.0	low bank height ratio
