MONITORING YEAR 4 ANNUAL REPORT

ALEXANDER FARM MITIGATION SITE

Alexander County, NC

DMS Project No. 100048

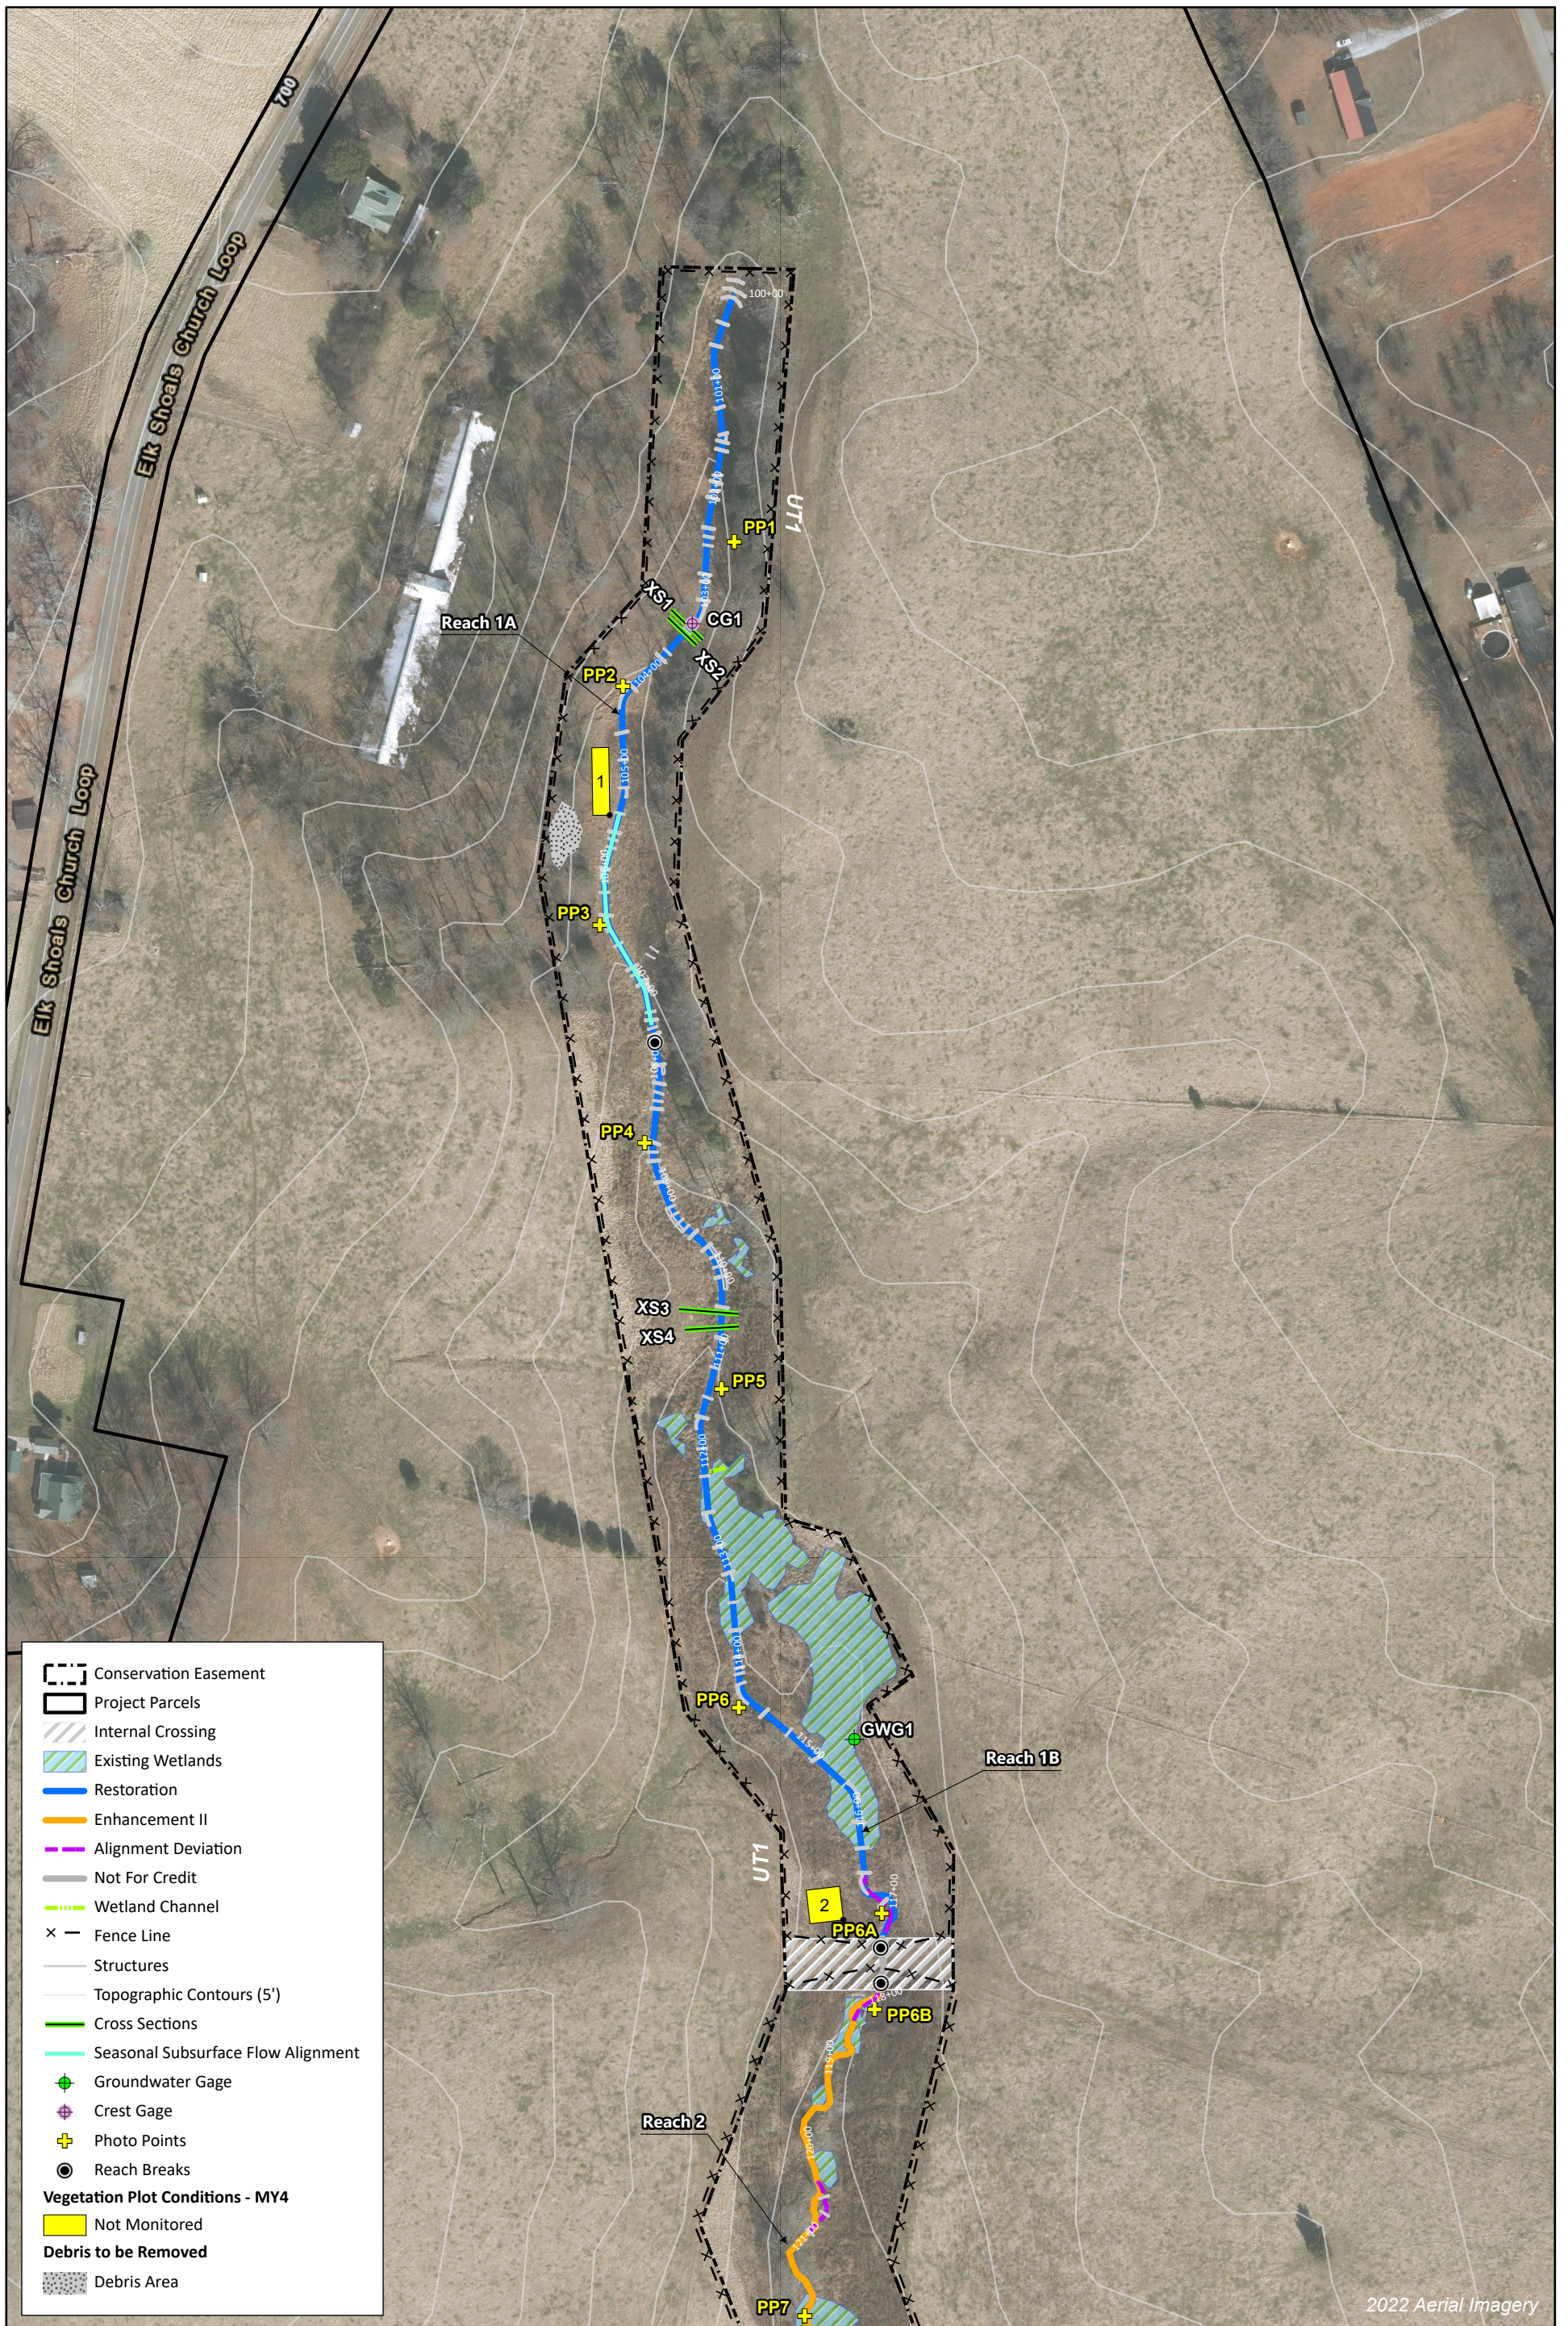
Figure 1a. Current Condition Plan View
 Alexander Farm Mitigation Site
 DMS Project No. 100048
 Monitoring Year 4 - 2023
 Alexander County, NC

DMS' comment: The subsurface stream flow repair area location (s) should be shown on Figure 1A; has the length of the affected area changed since 2022? Should this reach be reflected in the visual assessment table for reach 1A?

Wildlands' response: The subsurface stream flow area has now been added to Figure 1A. The polyline on the CCPV map shows the location of the subsurface flow that only occurs during very dry Site conditions, and its length is variable depending on the weather. Since the subsurface flow is not caused by a structural issue or stream bed aggradation or degradation, including the area on the visual assessment

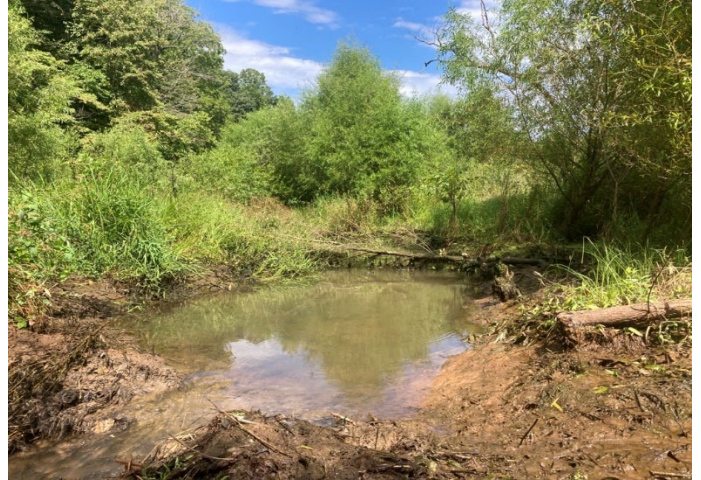
Beaver Dam – view upstream – UT1 R4B at STA 165+58
(05/10/2023)

Removed Beaver Dam – view upstream – UT1 R4B at STA 165+58
(08/15/2023)

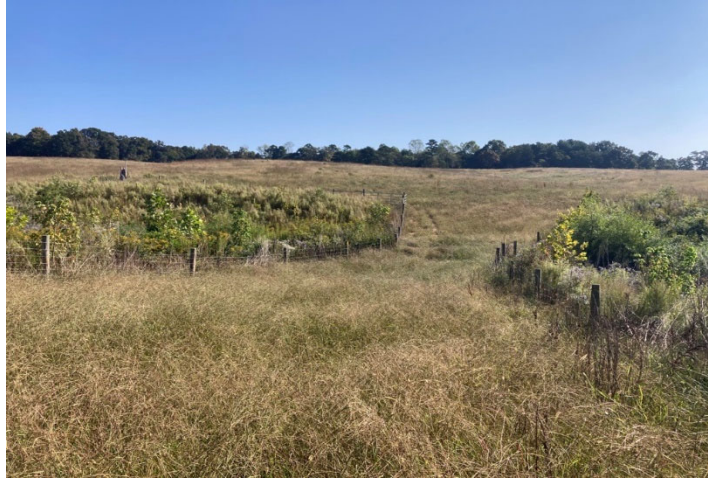
Vegetated Internal Crossing – view East – Between UT1 R1B & UT1 R2 (10/04/2023)

- Maintenance should be conducted within the internal crossing to stabilize the heavily impacted ground surface (see photos). Recommend cattle gates to reduce future impact.

Action Item: Maintenance should be conducted within the internal crossing to stabilize the heavily impacted ground surface (see photos). Recommend cattle gates to reduce future impact.
