FINAL
MONITORING REPORT (MY1)

ALLIANCE HEADWATERS MITIGATION SITE

Johnston County, North Carolina

Data Collection: January-November 2020
Submission: January 2021

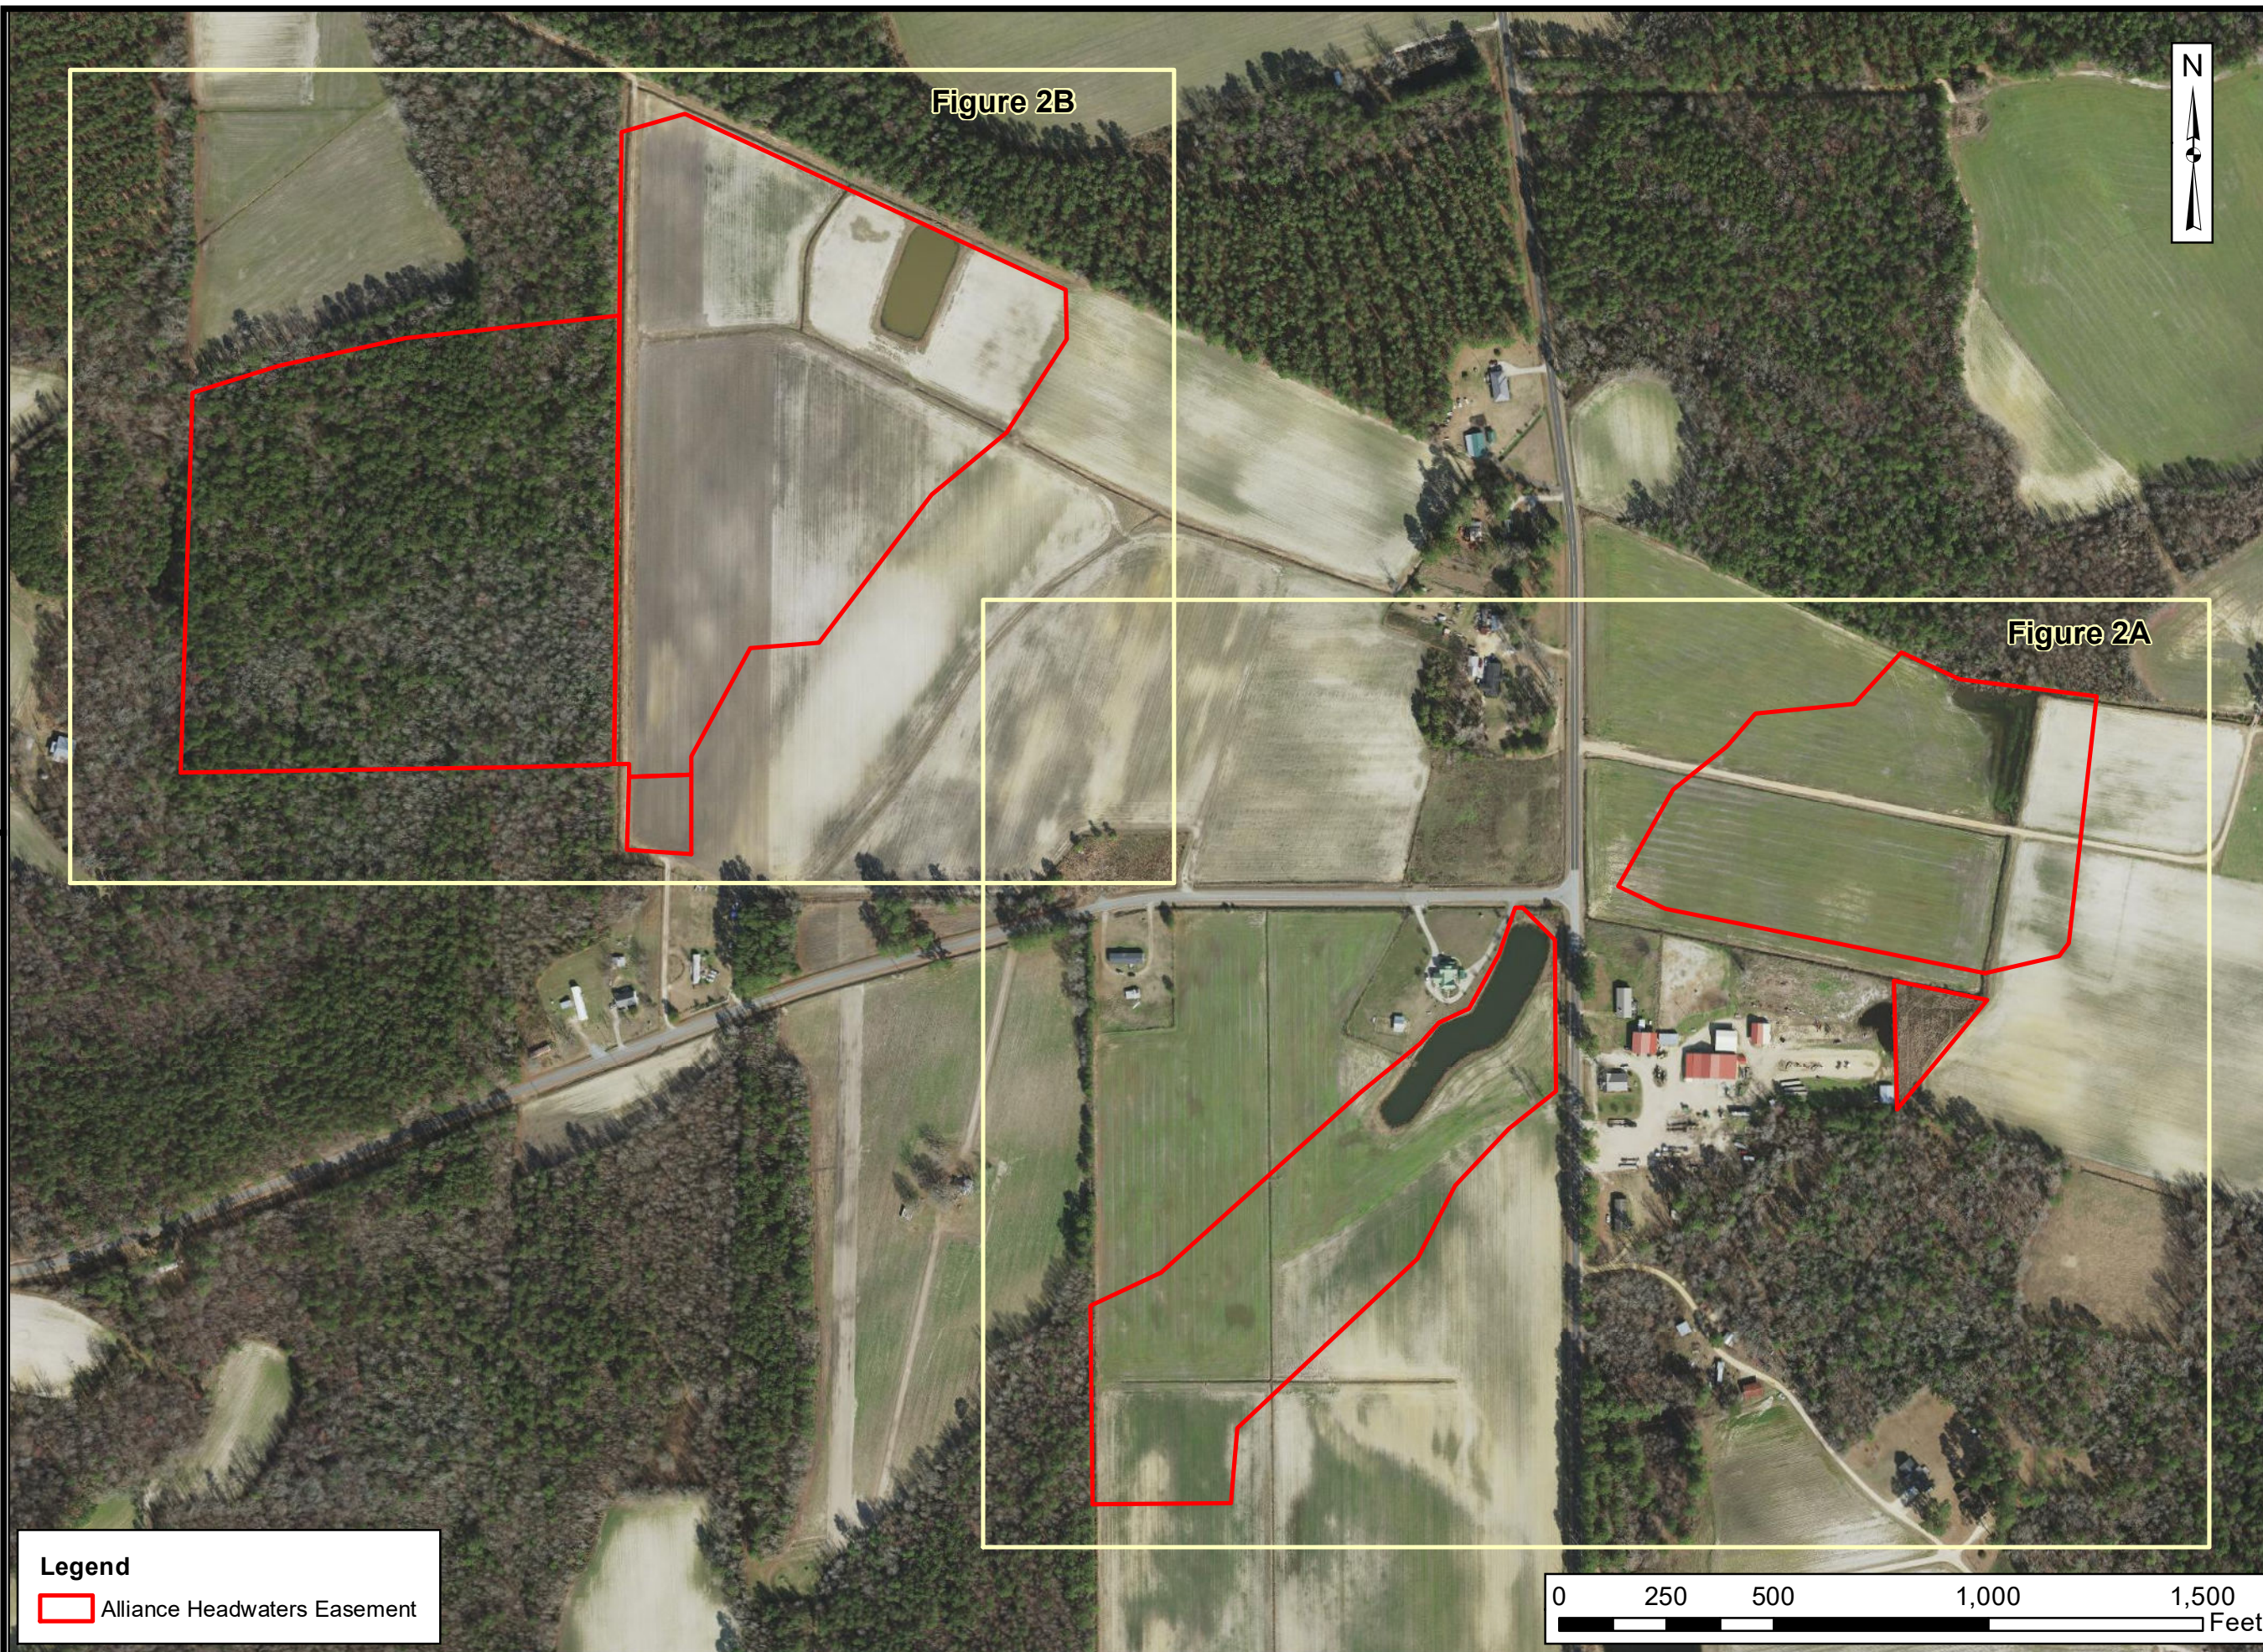
FIGURE
2A

3. Figure 1 Project Name is erroneous.
The Figure 1 Project name was updated.
4. Figure 2A Wetland Restoration acreage is erroneous (Should be approximately 9.5 acres instead of 30.24)
DMS feels it is prudent to show the site-wide wetland acreage and stream footage on Figures 2A and 2B to avoid confusion with site assets.

5. Figure 2A Wetland Creation (WC1) should be 0.54 acres instead of 1.44 acres
DMS feels it is prudent to show the site-wide wetland acreage and stream footage on Figures 2A and 2B to avoid confusion with site assets.

1. Please be sure to include the soil temperature probes on the CCPV for the monitoring reports.
The rain gauge and soil temperature probe were added to Figure 2A.
2. Will need to watch a few areas of wetland restoration given some of the grading, particularly upper UT1- R3, and other similar areas.
Understood
3. The drone footage was good. I would recommend next time to include the inset map for full flight after construction as well.
Understood
4. Some drone photos at the end of the document were good to see the tributaries coming out of the headwater wetland. Perhaps more of these in the future.
Additional photos were added to the Year 1 (2020) Monitoring Report. We will continue to supply photos with the annual monitoring report.

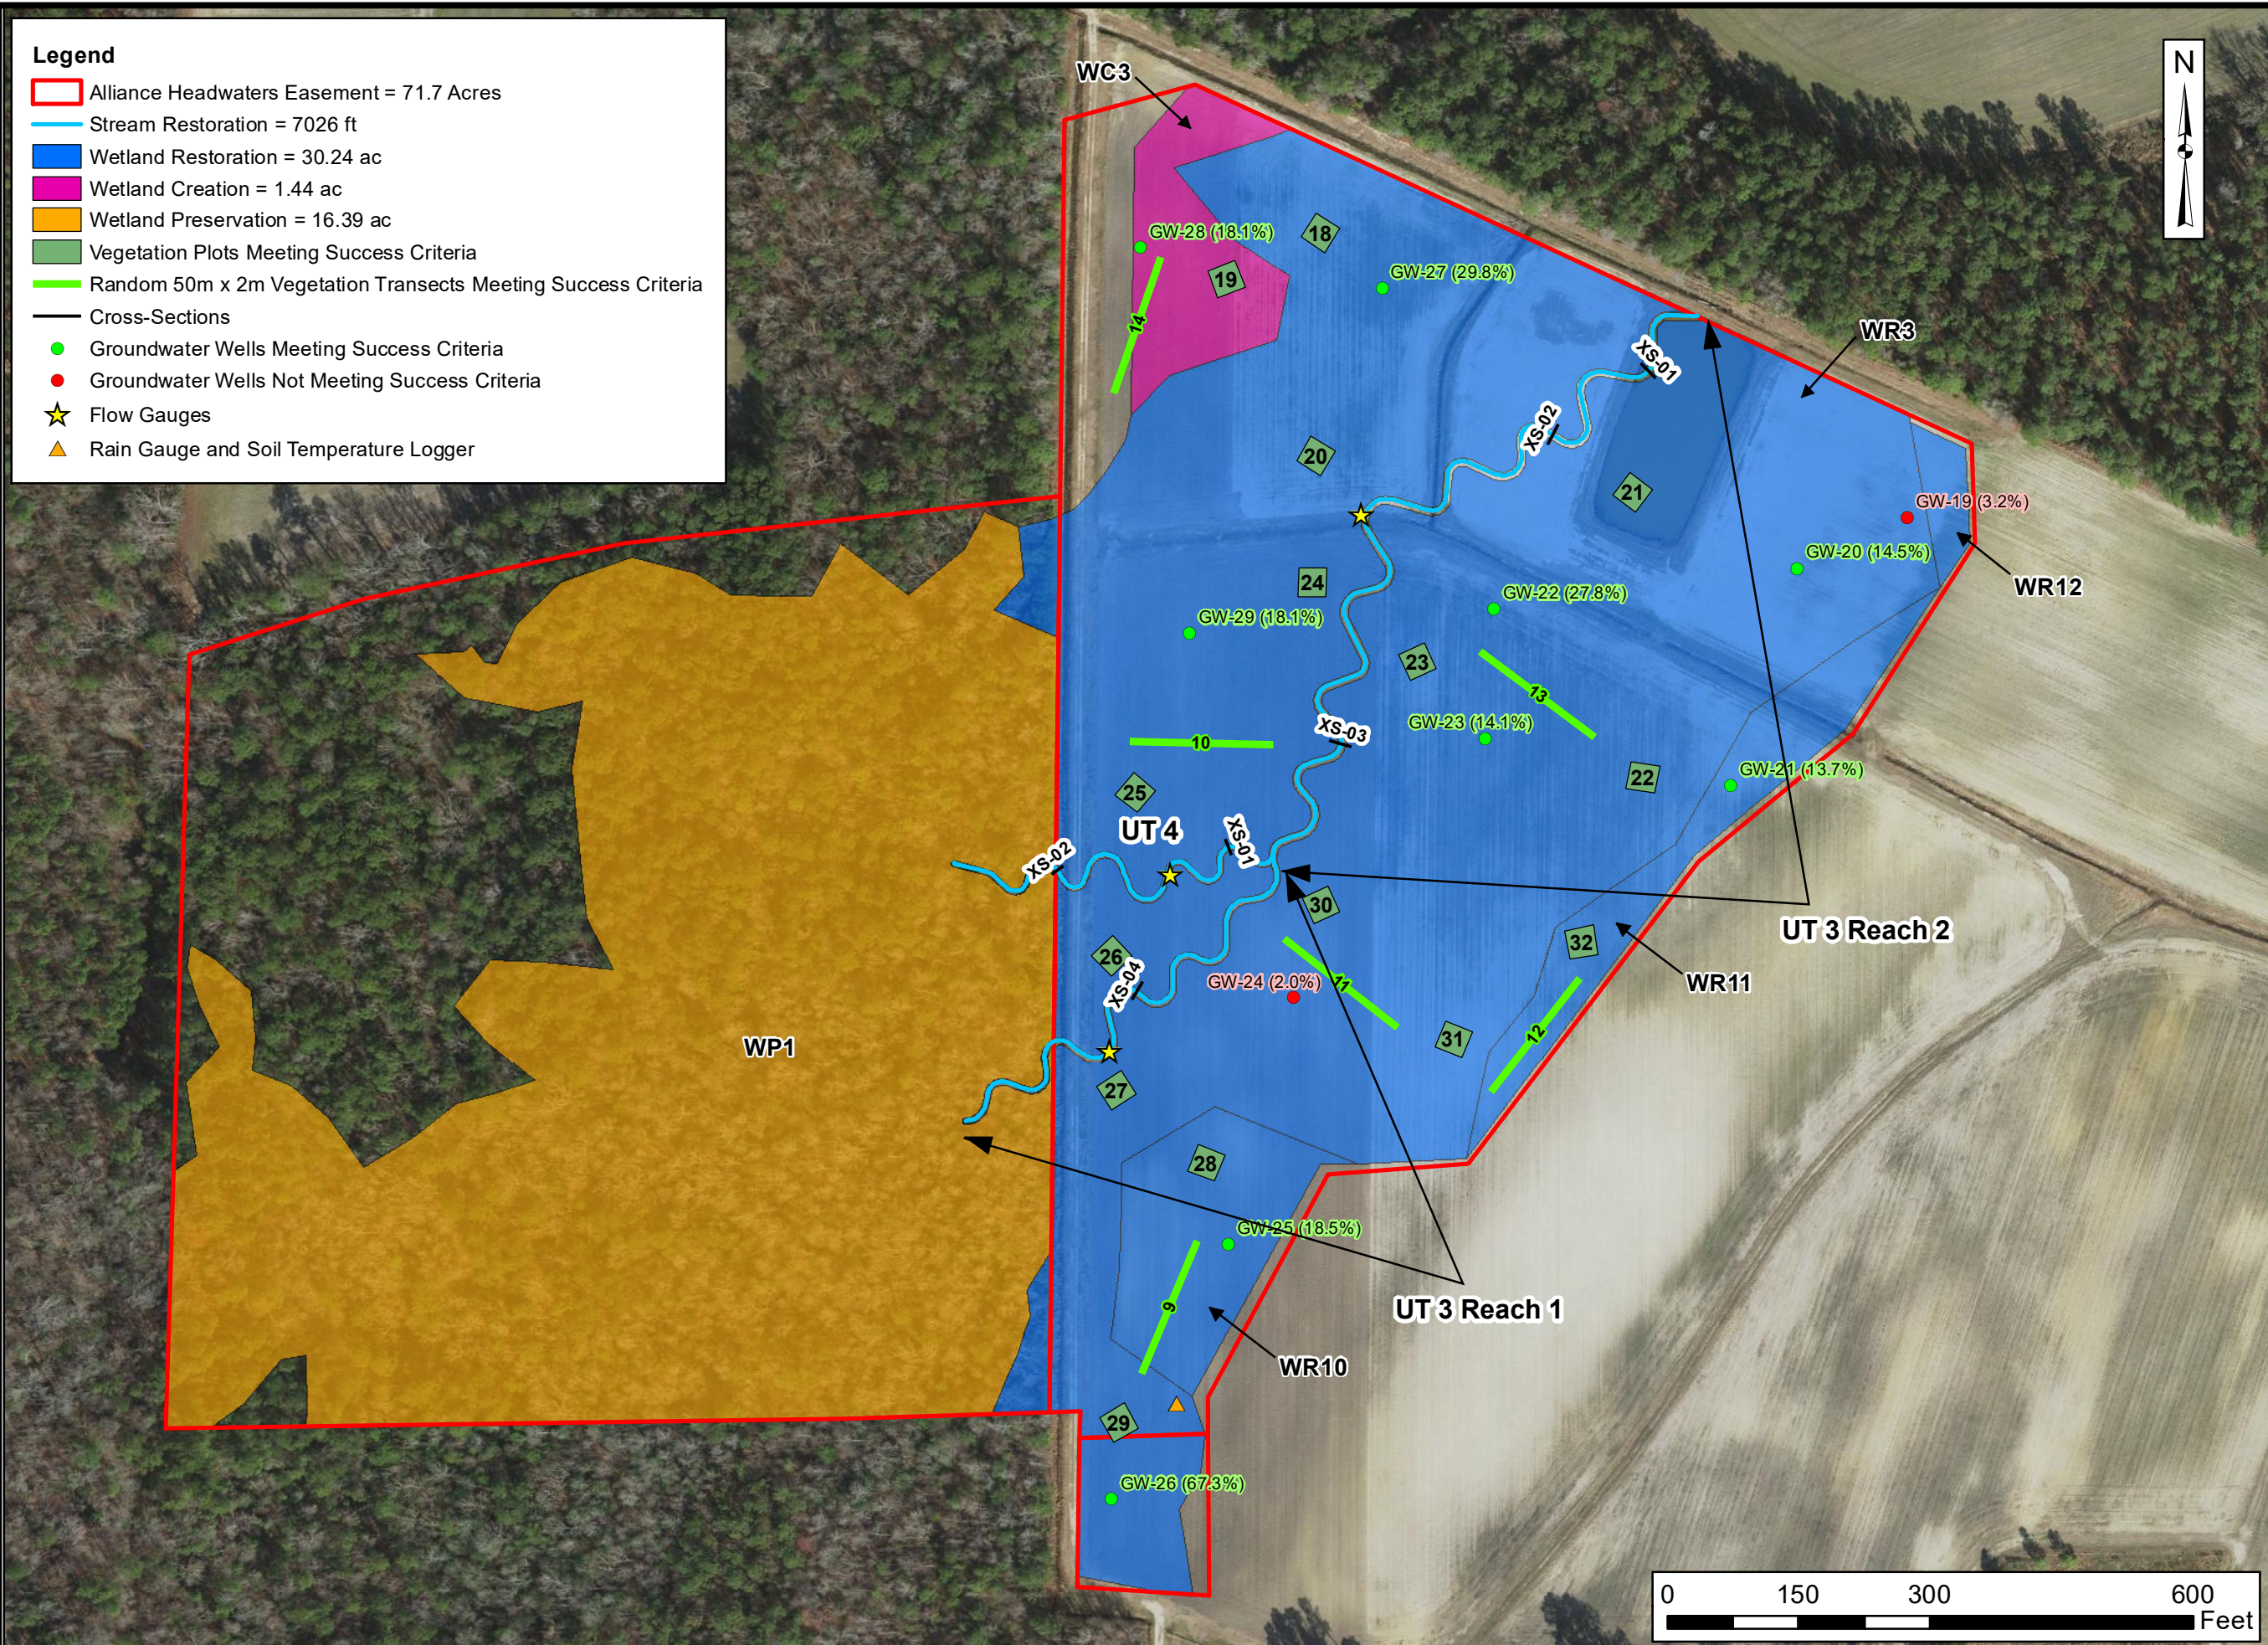
FIGURE
2B

6. Figure 2B Wetland Restoration acreage should be approximately 20.7 acres (30.24 listed)
DMS feels it is prudent to show the site-wide wetland acreage and stream footage on Figures 2A and 2B to avoid confusion with site assets.

7. Figure 2B Wetland Creation (WC3) should be 0.90 acres instead of 1.44 acres
DMS feels it is prudent to show the site-wide wetland acreage and stream footage on Figures 2A and 2B to avoid confusion with site assets.

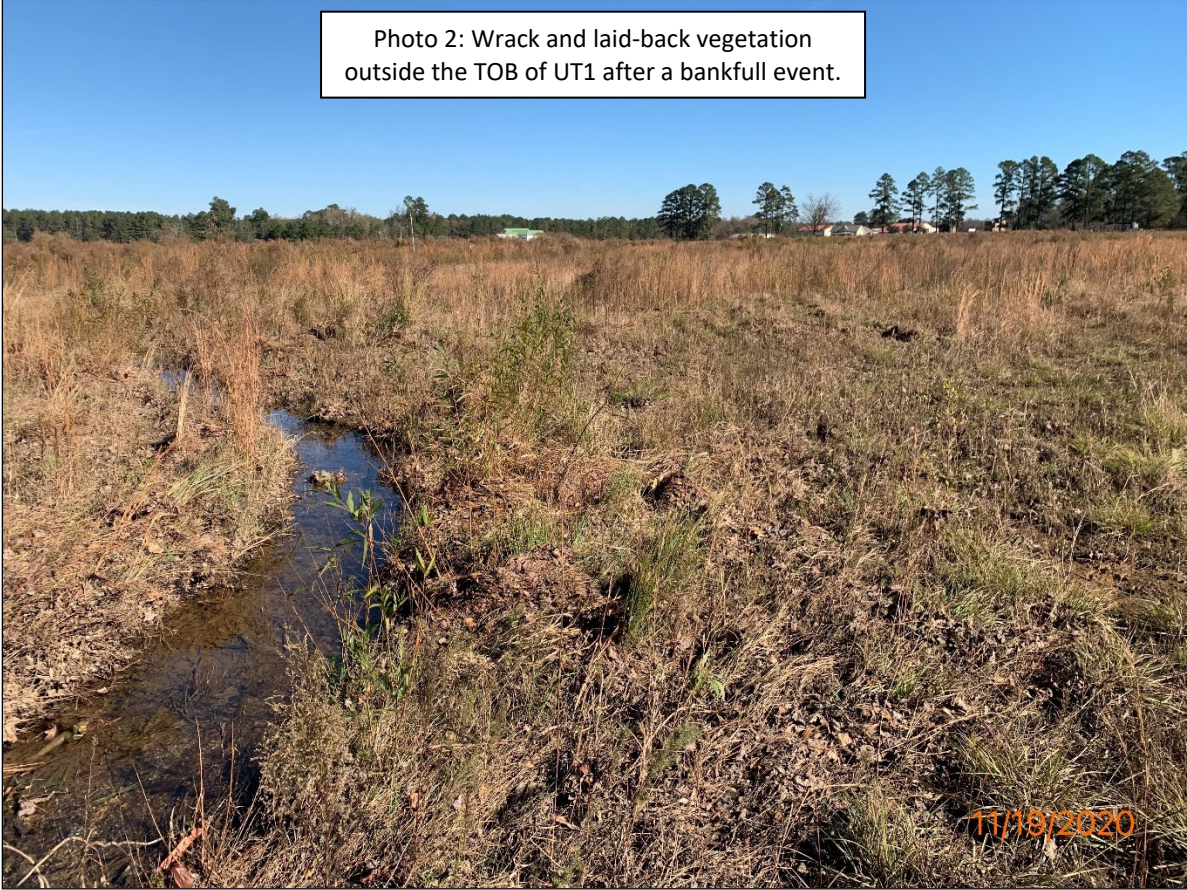
Photo 2: Wrack and laid-back vegetation outside the TOB of UT1 after a bankfull event.
