FINAL
MONITORING REPORT (MY3)

ALLIANCE HEADWATERS MITIGATION SITE

Johnston County, North Carolina

DMS ID No. 97086

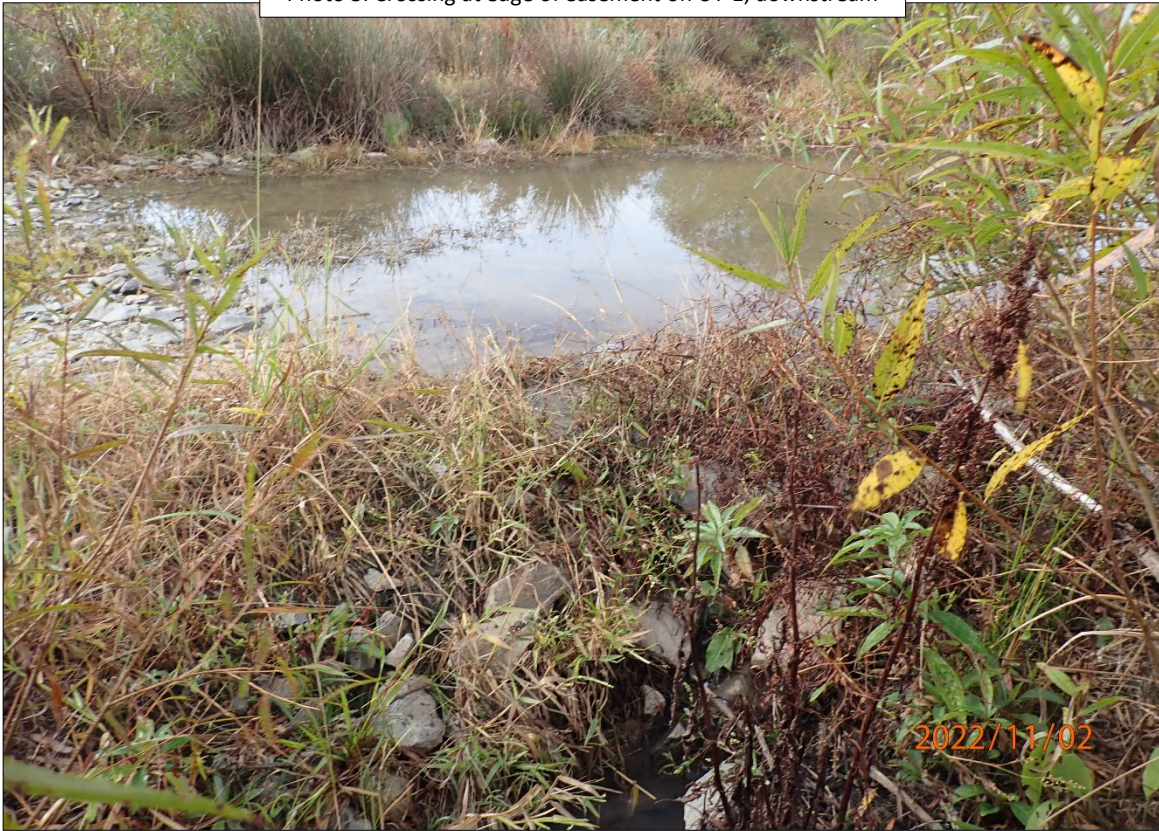
Photo 3: Crossing at edge of easement on UT-1, downstream
