Year 2 Monitoring Report

APPLE VALLEY PROJECT

NCDMS Project #100063 (Contract #7531)
USACE Action ID: SAW-2018-01150
DWR Project #20181028

Henderson County, North Carolina
French Broad River Basin
HUC 06010105

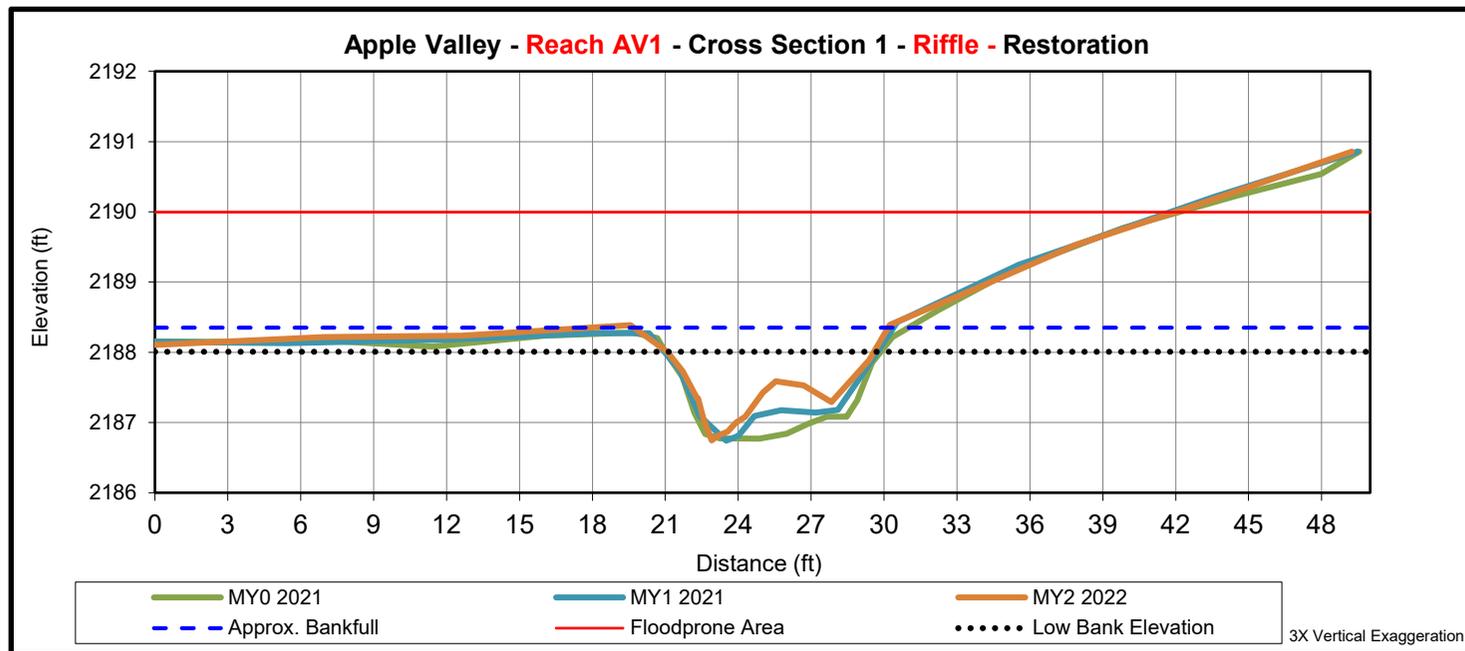
Cross Section 1 (Riffle)						
	MY0	MY1	MY2	MY3	MY5	MY7	MY+
Bankfull Elevation (ft) - Based on AB-XSA¹	2188.28	2188.4	2188.6				
Bankfull Width (ft) ¹	11.0	10.2	10.7				
Floodprone Width (ft) ¹	40.0	>42.8	>45.4				
Bankfull Max Depth (ft) ²	1.5	1.5	1.3				
Low Bank Elevation (ft)	2188.28	2188.3	2188.0				
Bankfull Cross Sectional Area (ft ²) ²	10.7	9.1	5.1				
Bankfull Entrenchment Ratio ¹	>3.6	>4.2	>4.3				
Bankfull Bank Height Ratio ¹	1.0	0.9	0.7

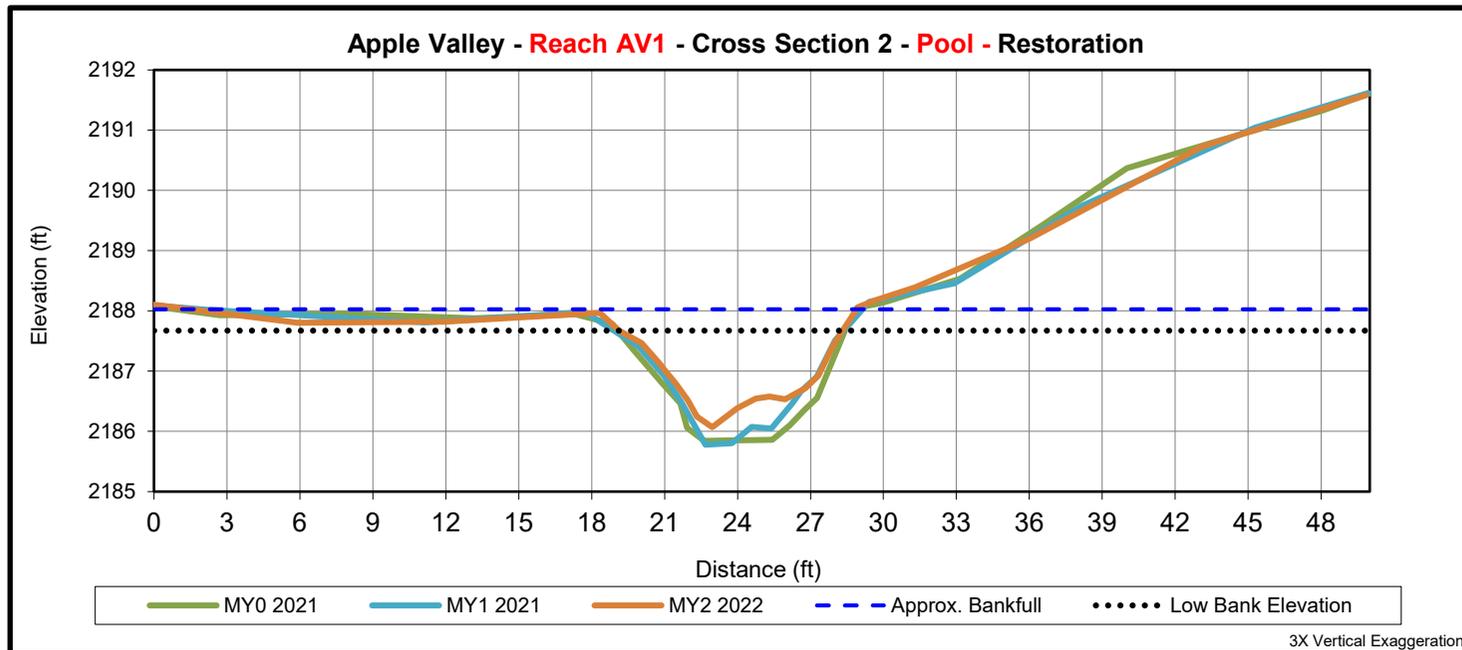
Cross Section 2 (Pool)						
	MY0	MY1	MY2	MY3	MY5	MY7	MY+
Bankfull Elevation (ft) - Based on AB-XSA¹	2187.95	2188.1	2188.0				
Bankfull Width (ft) ¹	-	-	-				
Floodprone Width (ft) ¹	-	-	-				
Bankfull Max Depth (ft) ²	2.1	1.2	1.6				
Low Bank Elevation (ft)	2187.95	2188.0	2187.7				
Bankfull Cross Sectional Area (ft ²) ²	14.4	13.4	8.2				
Bankfull Entrenchment Ratio ¹	-	-	-				
Bankfull Bank Height Ratio ¹	-	-	-

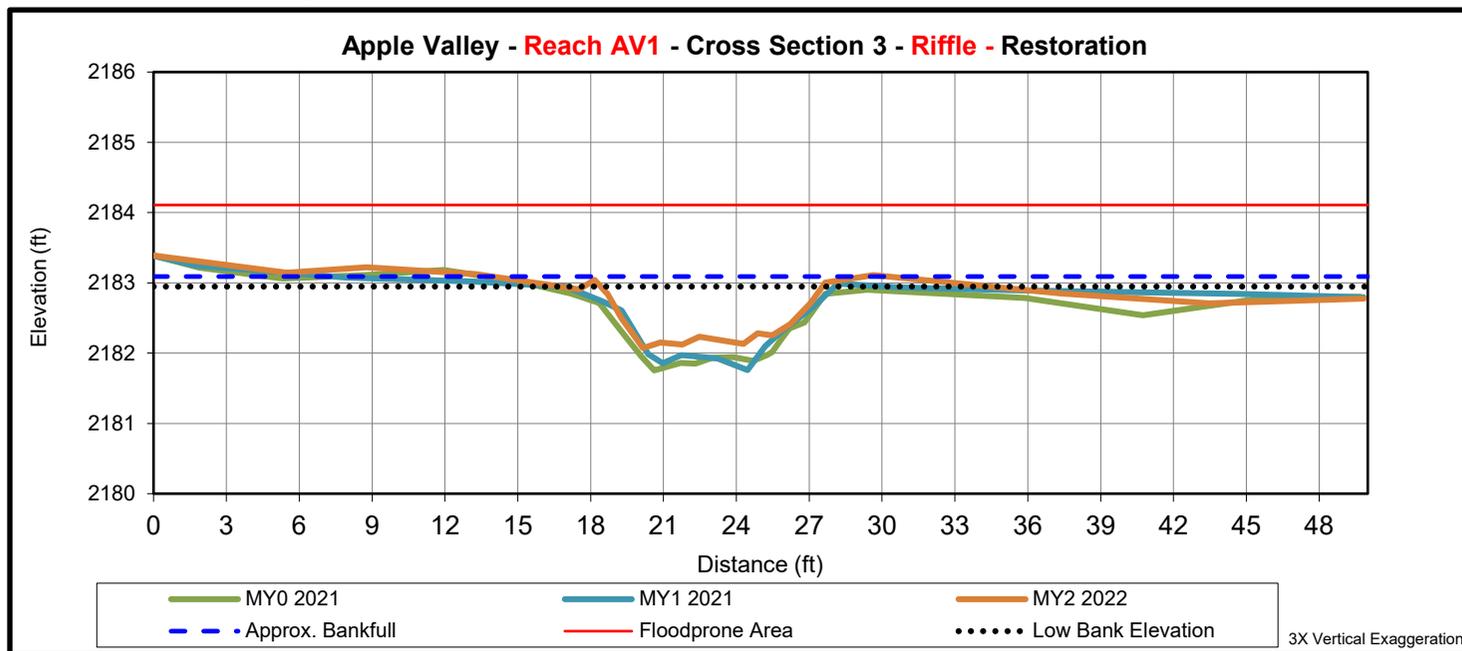
Cross Section 3 (Riffle)						
	MY0	MY1	MY2	MY3	MY5	MY7	MY+
Bankfull Elevation (ft) - Based on AB-XSA¹	2182.85	2182.9	2183.1				
Bankfull Width (ft) ¹	10.7	10.9	10.1				
Floodprone Width (ft) ¹	>49.7	>49.8	>49.8				
Bankfull Max Depth (ft) ²	1.1	1.2	0.8				
Low Bank Elevation (ft)	2182.85	2182.9	2182.9				
Bankfull Cross Sectional Area (ft ²) ²	7.1	7.3	5.3				
Bankfull Entrenchment Ratio ¹	>4.6	>4.6	>4.9				
Bankfull Bank Height Ratio ¹	1.0	1.0	0.8

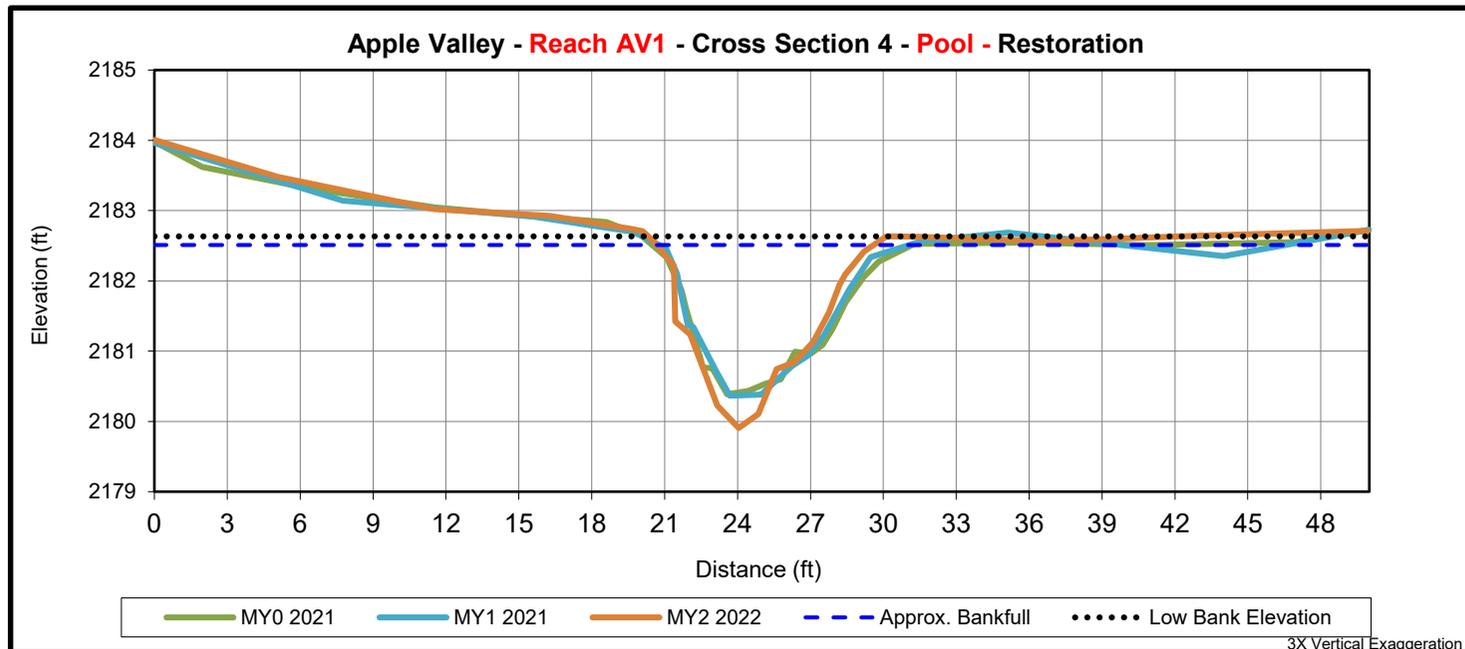
Cross Section 4 (Pool)						
	MY0	MY1	MY2	MY3	MY5	MY7	MY+
Bankfull Elevation (ft) - Based on AB-XSA¹	2182.53	2182.6	2182.5				
Bankfull Width (ft) ¹	-	-	8.9				
Floodprone Width (ft) ¹	-	-	-				
Bankfull Max Depth (ft) ²	2.1	2.1	2.7				
Low Bank Elevation (ft)	2182.53	2182.5	2182.6				
Bankfull Cross Sectional Area (ft ²) ²	12.5	11.4	13.6				
Bankfull Entrenchment Ratio ¹	-	-	-				
Bankfull Bank Height Ratio ¹	-	-	-

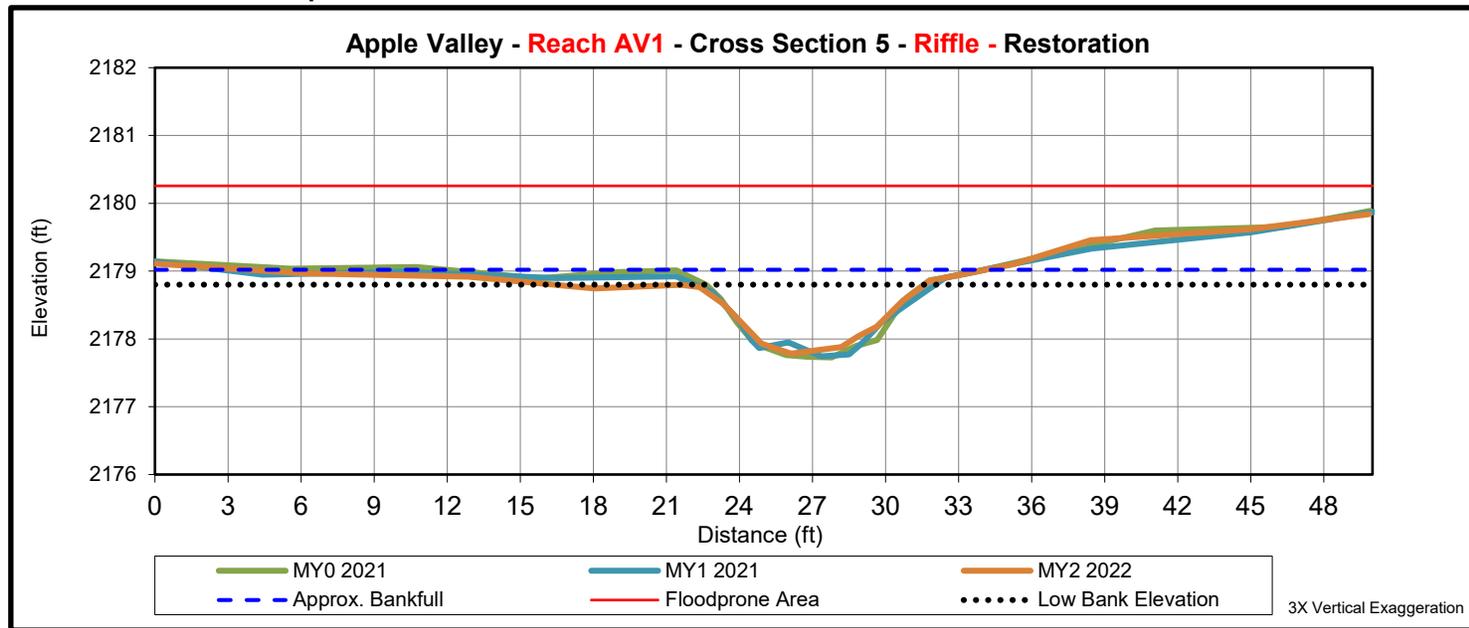
Cross Section 5 (Riffle)						
	MY0	MY1	MY2	MY3	MY5	MY7	MY+
Bankfull Elevation (ft) - Based on AB-XSA¹	2178.98	2179.0	2179.0				
Bankfull Width (ft) ¹	8.3	11.1	12.5				
Floodprone Width (ft) ¹	>49.9	>50.1	>49.9				
Bankfull Max Depth (ft) ²	1.3	1.2	1.0				
Low Bank Elevation (ft)	2178.98	2178.9	2178.8				
Bankfull Cross Sectional Area (ft ²) ²	8.3	7.3	5.9				
Bankfull Entrenchment Ratio ¹	>4.2	>4.5	>4.0				
Bankfull Bank Height Ratio ¹	1.0	0.9	0.8

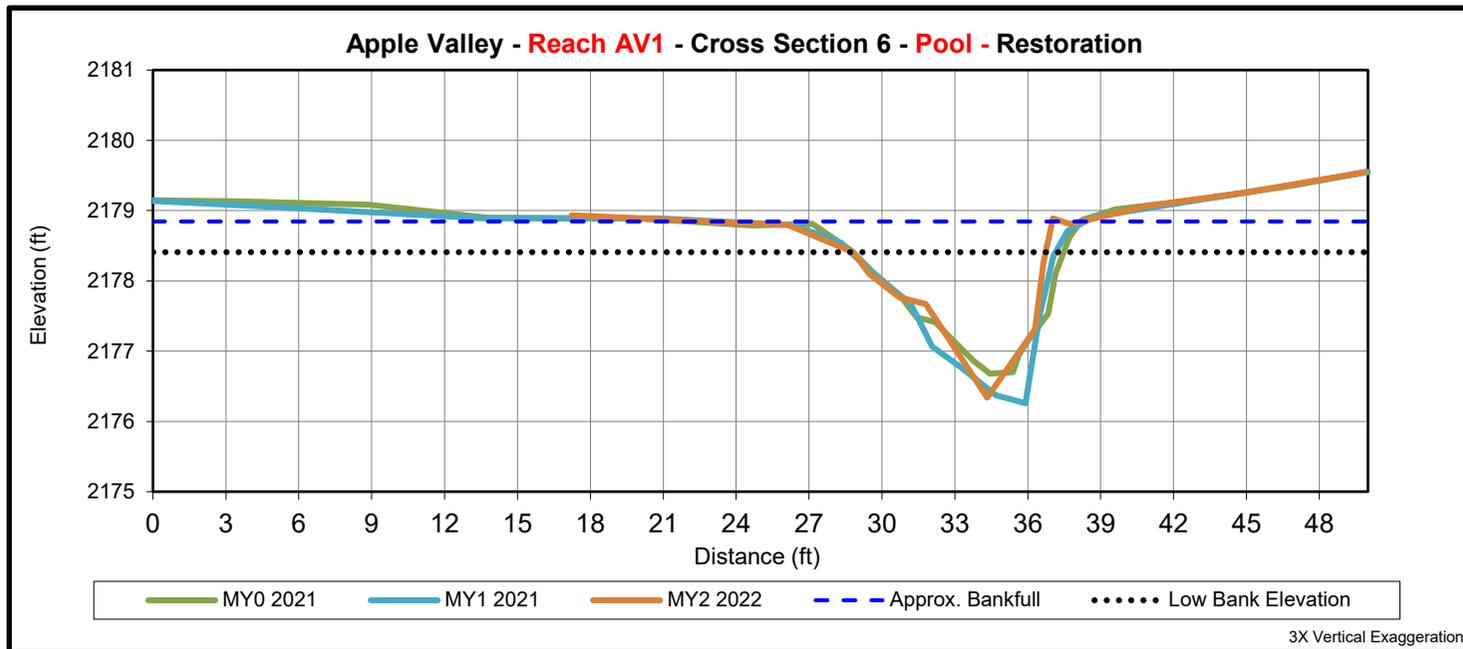
Cross Section 6 (Pool)						
	MY0	MY1	MY2	MY3	MY5	MY7	MY+
Bankfull Elevation (ft) - Based on AB-XSA¹	2178.81	2178.7	2178.8				
Bankfull Width (ft) ¹	-	-	14.8				
Floodprone Width (ft) ¹	-	-	-				
Bankfull Max Depth (ft) ²	2.1	2.5	2.1				
Low Bank Elevation (ft)	2178.81	2178.8	2178.4				
Bankfull Cross Sectional Area (ft ²) ²	12.6	13.7	8.3				
Bankfull Entrenchment Ratio ¹	-	-	-				
Bankfull Bank Height Ratio ¹	-	-	-

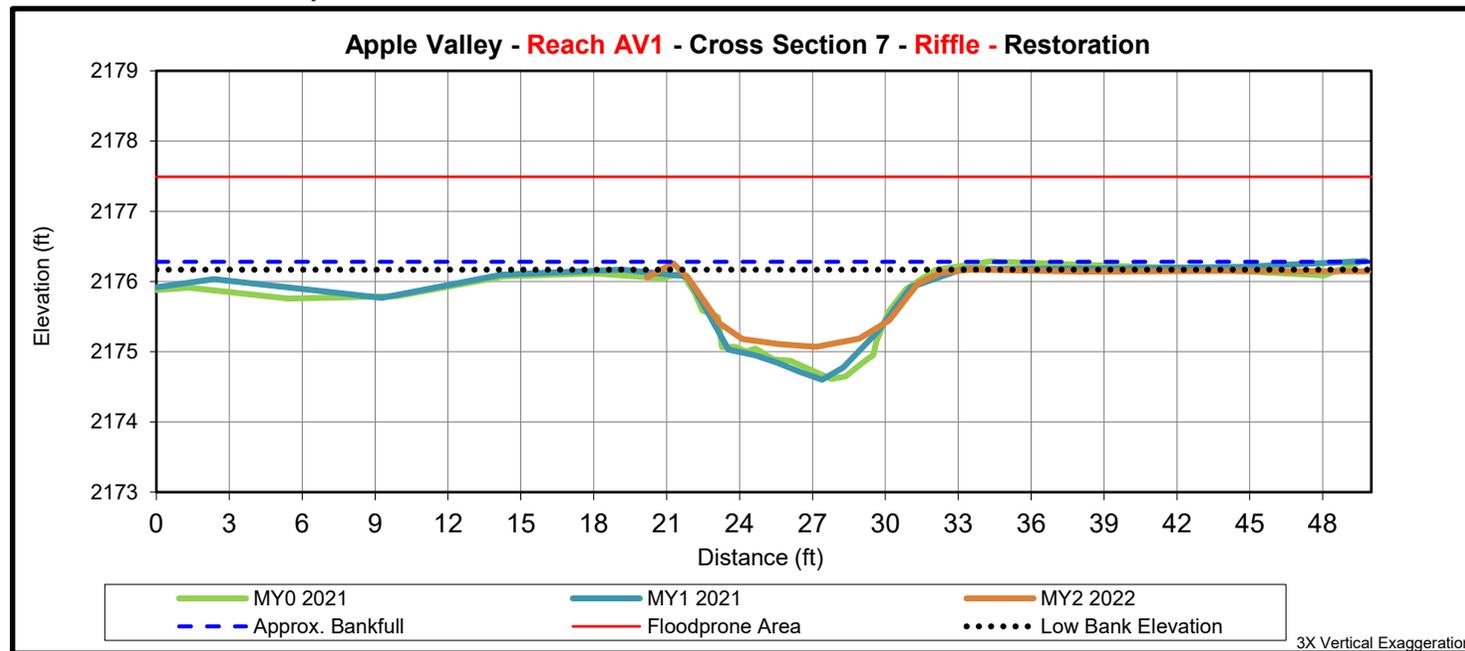
Cross Section 7 (Riffle)						
	MY0	MY1	MY2	MY3	MY5	MY7	MY+
Bankfull Elevation (ft) - Based on AB-XSA¹	2176.12	2176.1	2176.3				
Bankfull Width (ft) ¹	12.4	10.9	12.3				
Floodprone Width (ft) ¹	>49.6	>49.8	>49.9				
Bankfull Max Depth (ft) ²	1.5	1.5	1.1				
Low Bank Elevation (ft)	2176.12	2176.1	2176.2				
Bankfull Cross Sectional Area (ft ²) ²	9.6	9.1	8.2				
Bankfull Entrenchment Ratio ¹	>4.0	>4.6	>4.1				
Bankfull Bank Height Ratio ¹	1.0	1.0	0.9

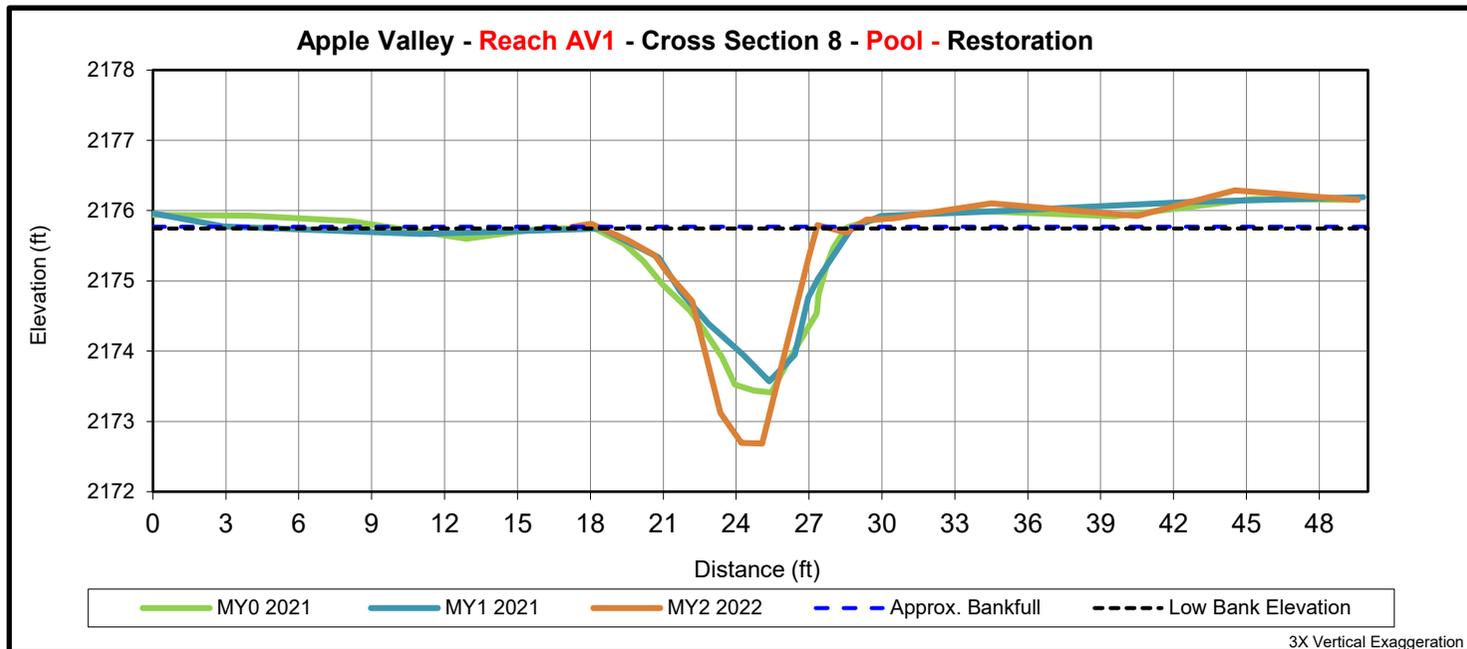
Cross Section 8 (Pool)						
	MY0	MY1	MY2	MY3	MY5	MY7	MY+
Bankfull Elevation (ft) - Based on AB-XSA¹	2175.74	2175.9	2175.8				
Bankfull Width (ft) ¹	-	-	10.0				
Floodprone Width (ft) ¹	-	-	-				
Bankfull Max Depth (ft) ²	2.3	2.2	3.1				
Low Bank Elevation (ft)	2175.74	2175.7	2175.8				
Bankfull Cross Sectional Area (ft ²) ²	12.3	10.4	12.7				
Bankfull Entrenchment Ratio ¹	-	-	-				
Bankfull Bank Height Ratio ¹	-	-	-

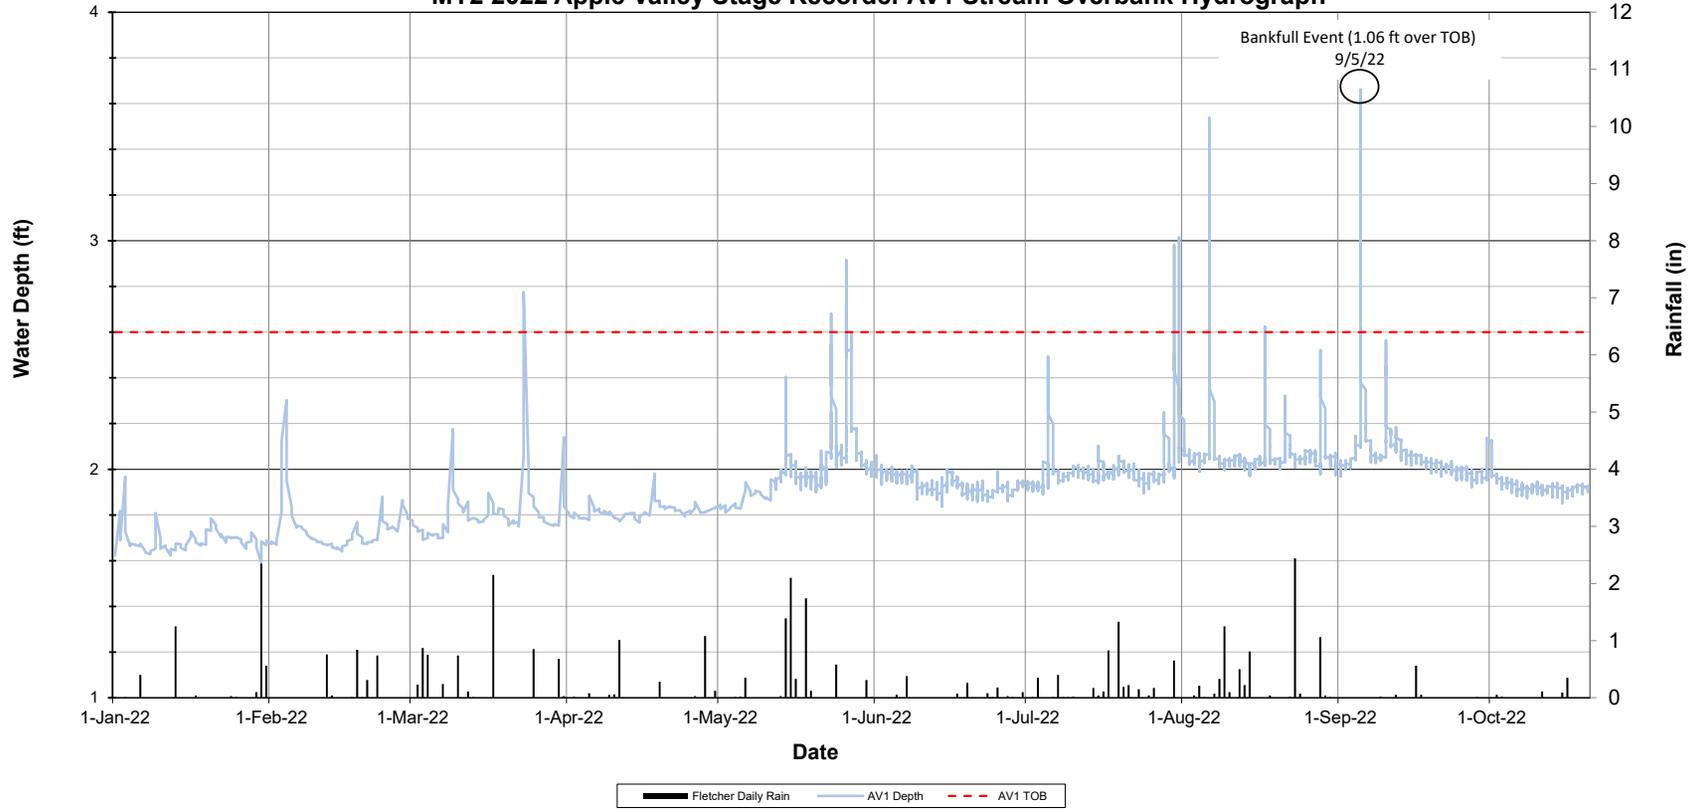
MY2 2022 Apple Valley Stage Recorder AV1 Stream Overbank Hydrograph

One stage recorder was installed on January 20, 2021, along AV1; however, the automatic recording pressure transducers (HOBO device) was originally programmed to collect readings twice a day, as opposed to once every hour—the correct interval. The original HOBO was replaced with a new one, reading at the proper intervals, on May 11, 2022. It is in place to document bankfull events throughout each monitoring year. The stage recorder on AV1 recorded six bankfull events during MY2, with the highest reading on September 5, 2022, reading a maximum bankfull height of 1.061 feet above the top of bank. The gauge location can be found on **Figure 2** and photos are in **Appendix B**.

*The stage recorder malfunctioned in 2021, and was replaced May 2022
