**Armstrong Property Wetland and Stream Mitigation Project
Hyde County, NC**

**2008 Annual Monitoring Report
Year 1**

**NCEEP Project Number D06012-A
Tar-Pamlico River Basin**

Date: December, 2008

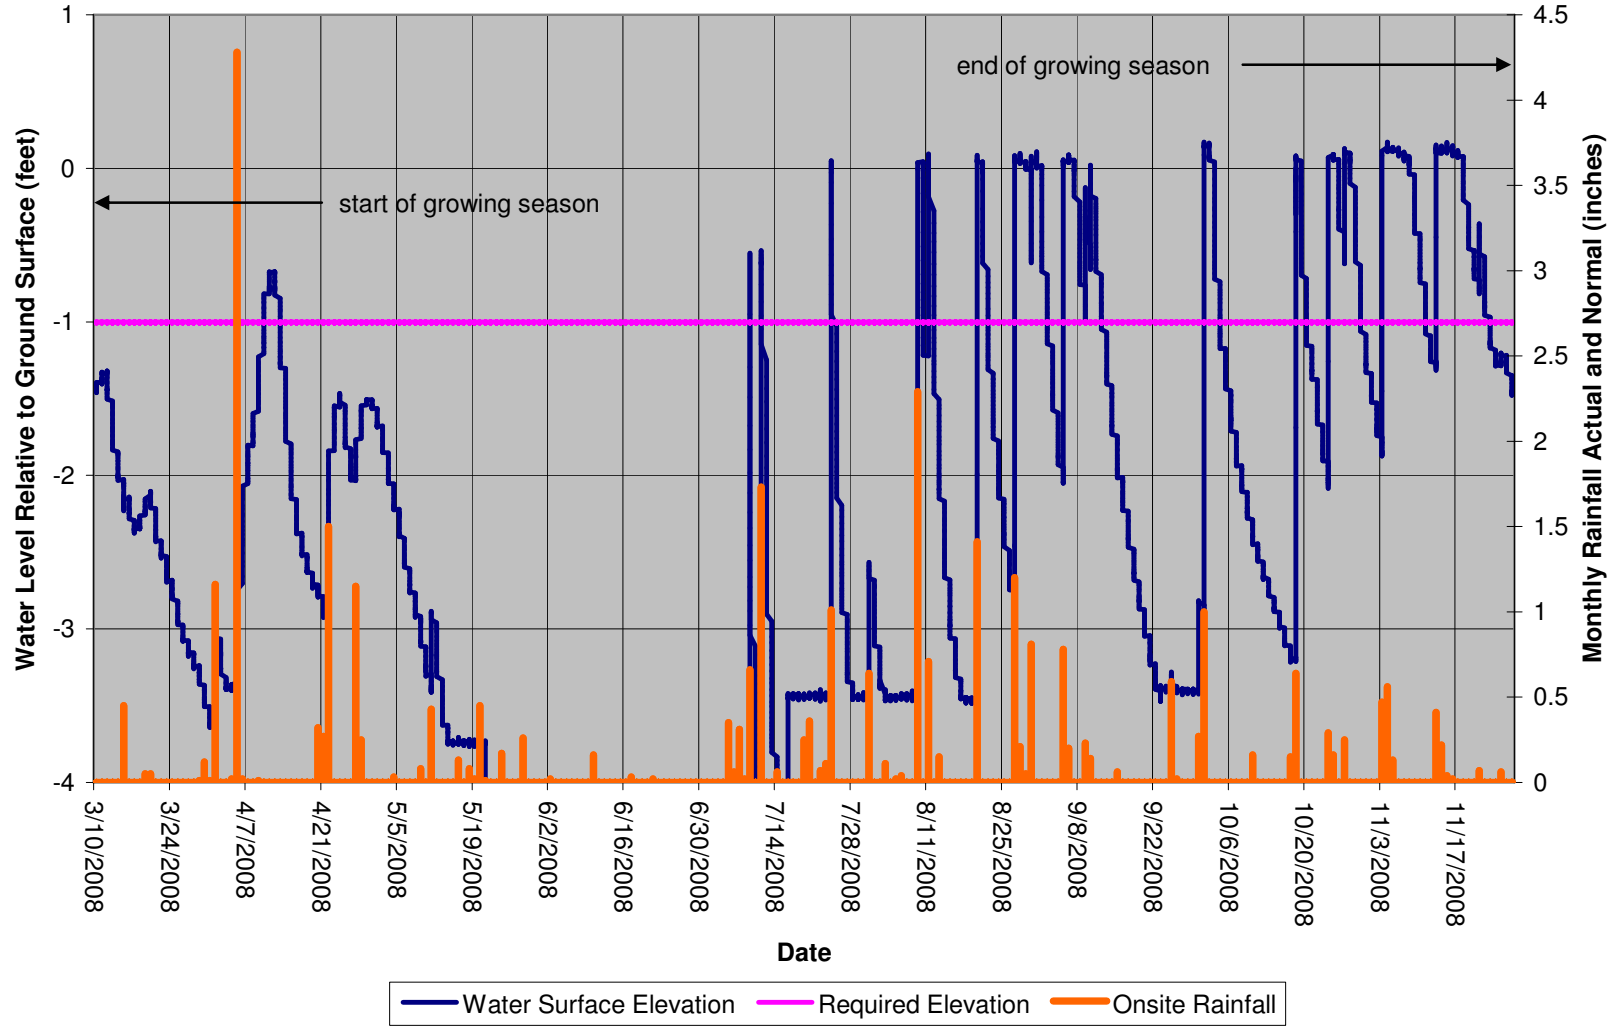
Armstrong Monitoring Gauge #3 (1272305)

The water levels in riverine wetland Gauges 3 and 5 corroborate the flow in that they maintain above-ground water levels for various lengths of time until runoff gradually depletes their excess water into the swamp run. The change in water level shown in Gauge 5, which is nearest the outfall is well correlated to that in Run Gauge 2 which is also nearest the outfall end. Run Gauge 1, which is farthest from the outfall, mirrors the trend measured at Run Gauge 2 indicating

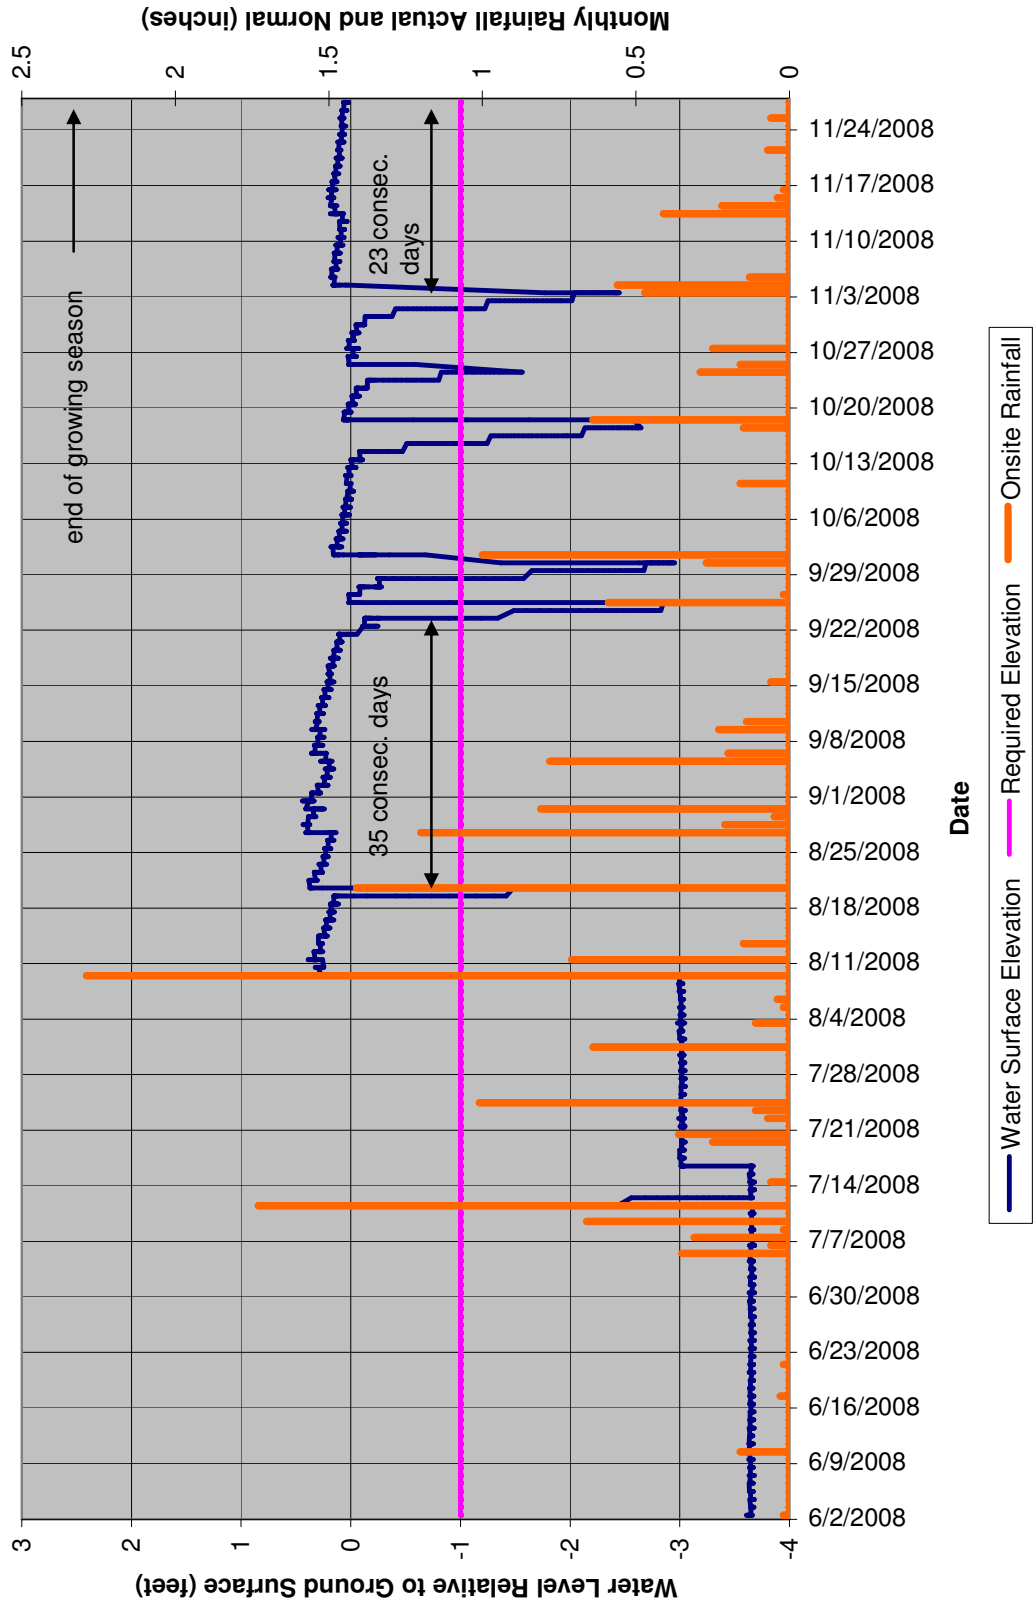
Armstrong Run Monitoring Gauge #1 (1272317)

Refer to Figures F1 and F2 for the following discussion of evidence of flow within the swamp run. Figure F1 compares the water level in the two run gauges to the water level in two gauges adjacent to and closest to the swamp run (gauges 3 and 5). A period of rainfall between August 9 and September 4 resulted in flow on-site that was visually confirmed. Events A, B and C in Figure F1 are separate rainfall events that caused flooding and flow in the riverine wetland areas, subsequent drainage into the swamp run, and flow downstream thru the downvalley terminus of the project.

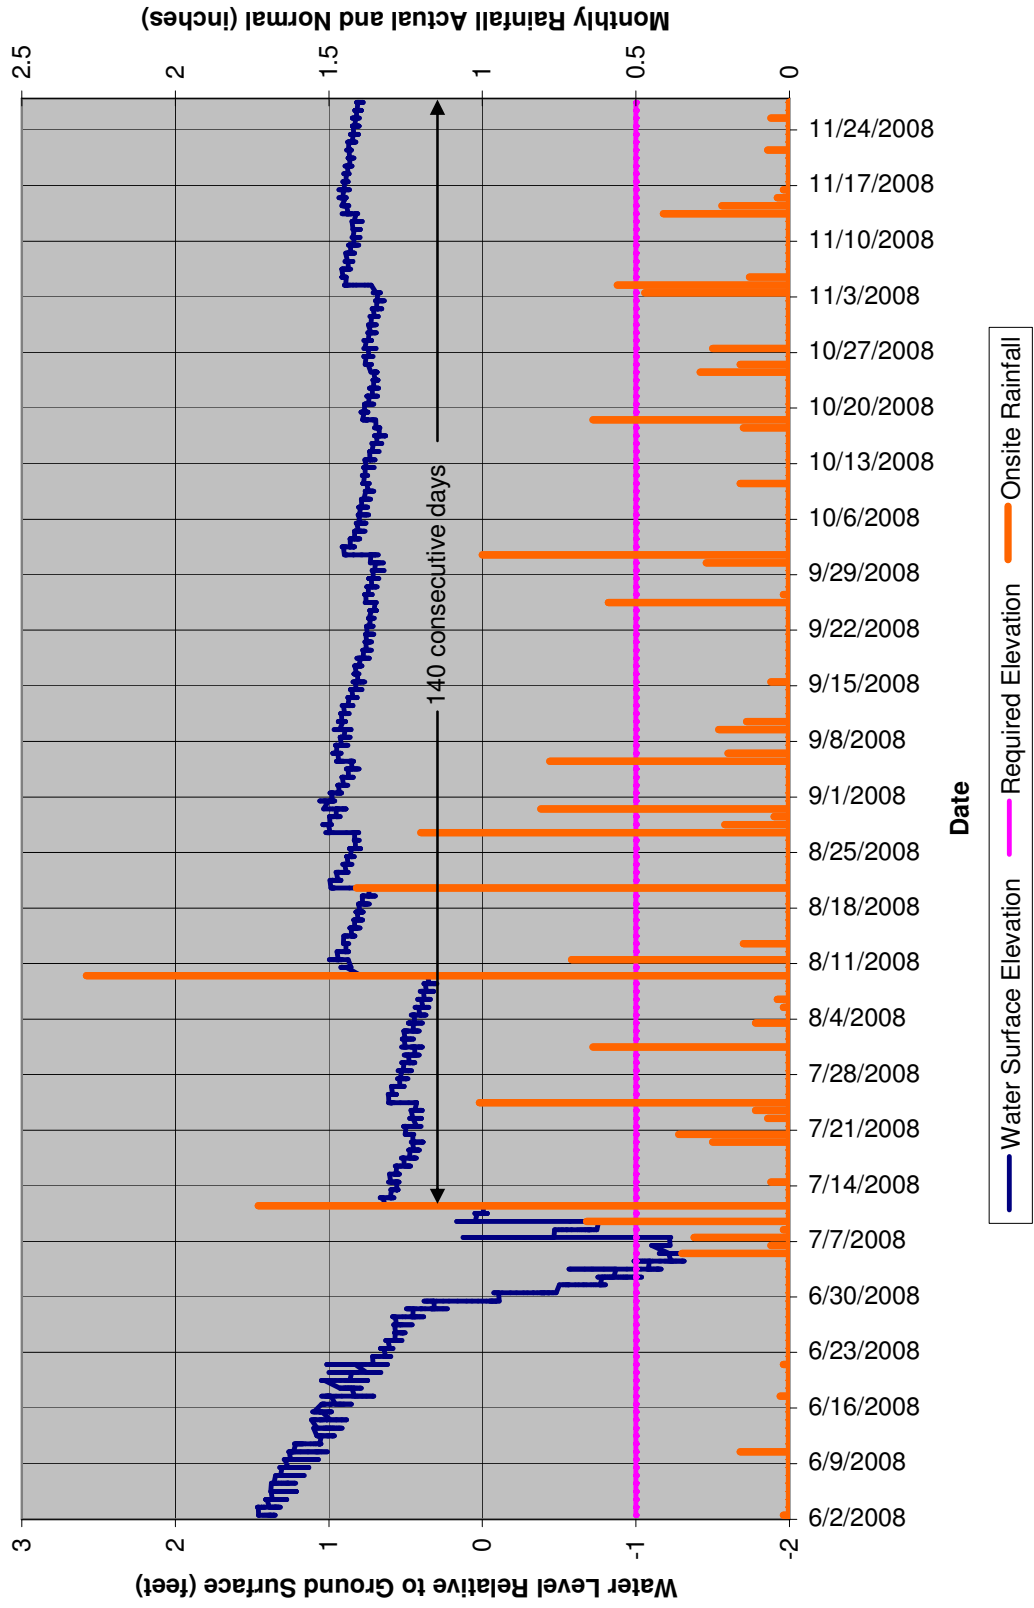
Armstrong Run Monitoring Gauge #2 (1272318)

Of particular note is the area near the outfall end of the project, the area in close proximity to Run Gauge 2. This area captured and held water for a sufficient length of time and at a sufficient depth as to support vertebrate aquatic life. During the monitoring data collection effort in September 2008, the presence of turtles and small fish were observed in the swamp run which
