**Armstrong Property Wetland and Stream Mitigation Project
Hyde County, NC**

**2009 Annual Monitoring Report
Year 2**

**NCEEP Project Number D06012-A
Tar-Pamlico River Basin**

Date: January, 2010

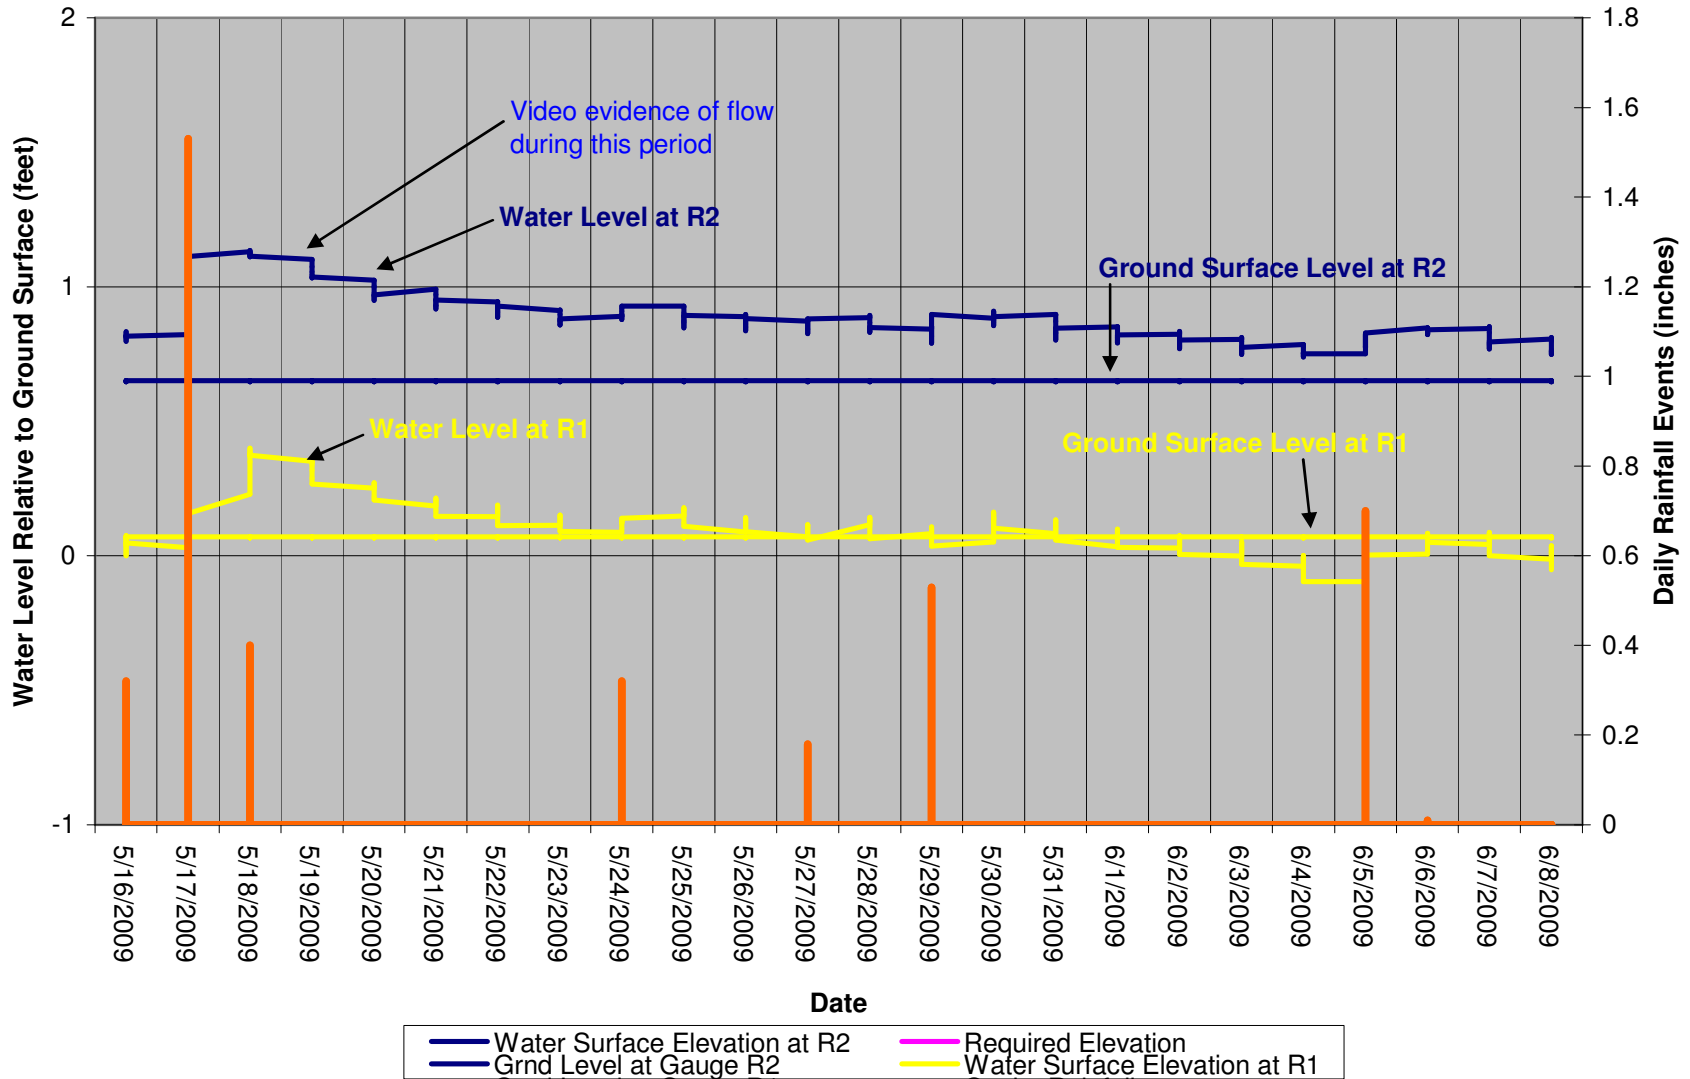
**Figure F1.
Armstrong Run Monitoring Gauges 1 and 2 (R1 and R2)
Correlated to Video Evidence of Flow Across Site**

Onsite flow is occurring, but due to the limited changes in elevation across the length of the project, it lacks sufficient velocity and is impeded to such an extent by volunteer herbaceous vegetation, dominated by cattails (*Typha latifolia*), as to be nearly immeasurable at any location other than in close proximity to the outfall pipe. But the data captured by the gauges and substantiated by visual (and photographic) confirmation does show water movement from the riverine wetland areas toward the swamp run during periods of sufficient rainfall. In addition, photographic evidence shows that on at least one occasion, overbank flow from the swamp run inundated the riverine wetland area, indicating that the system as a whole is functioning as anticipated.

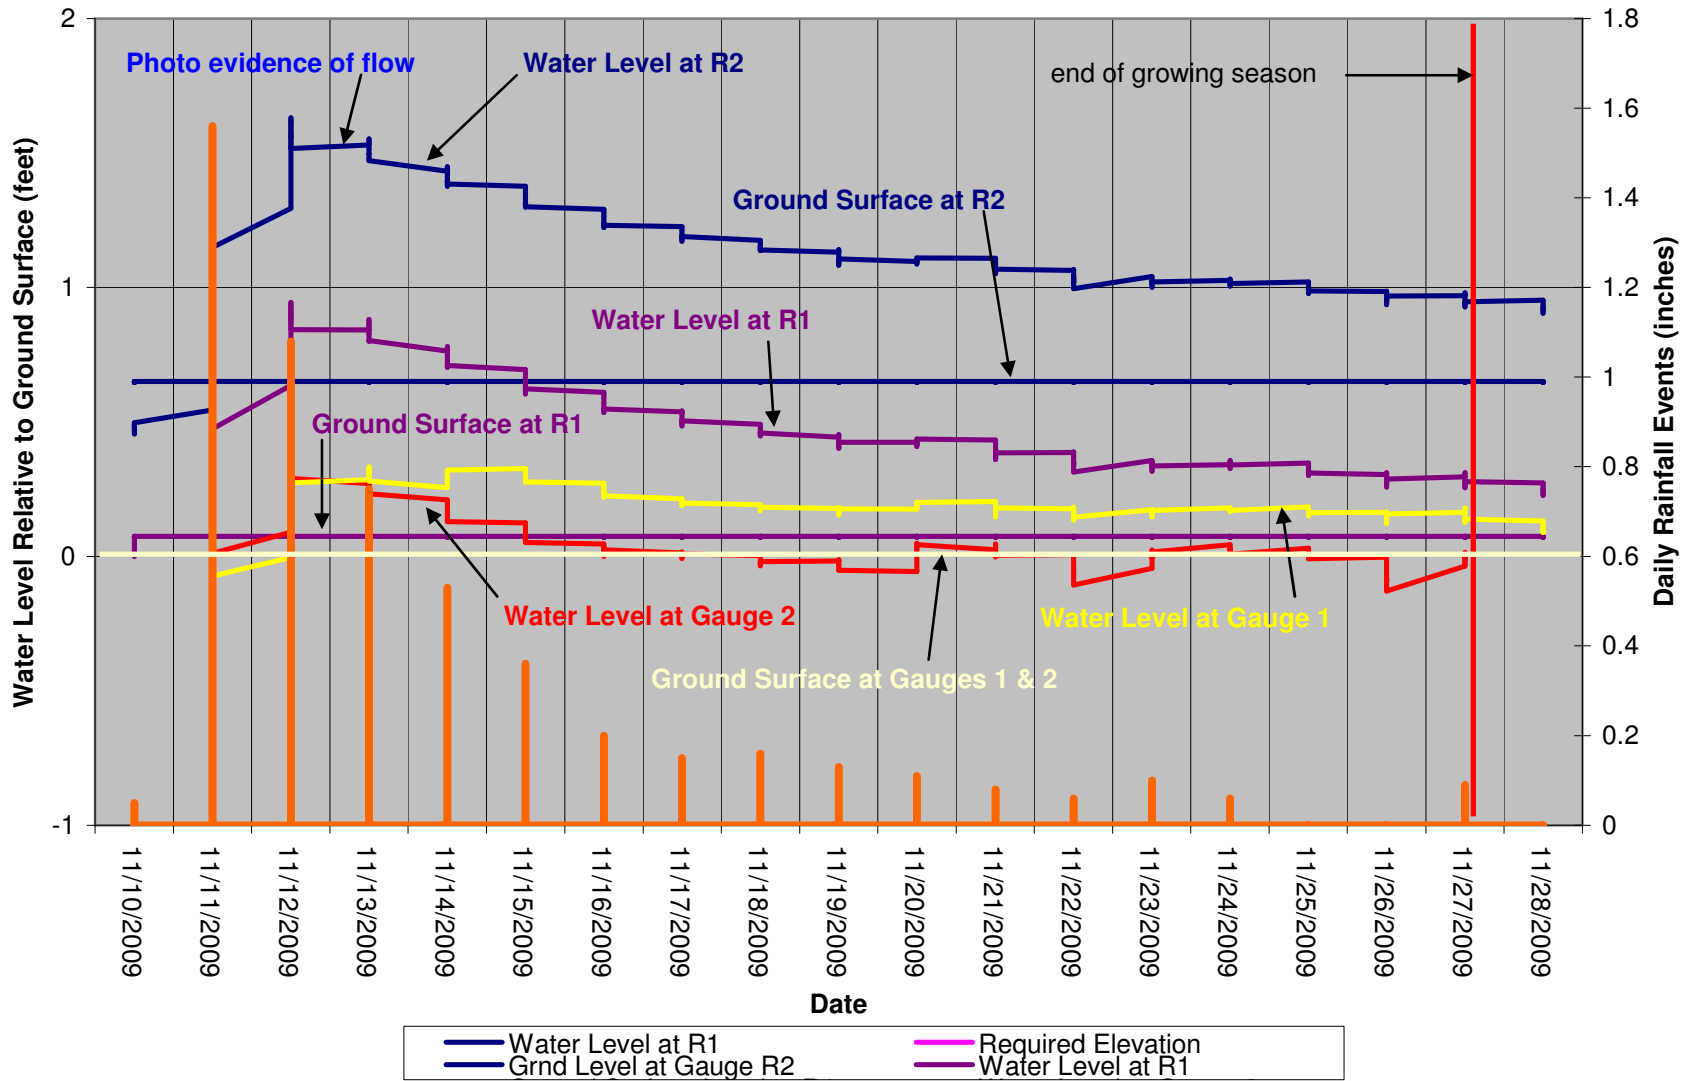
Figure F2.
Photo Evidence of Flow Correlated to
Gauges 1, 2, R1 and R2

Two separate flow events were photographically documented during the 2009 growing season. The data from the water level monitoring gauges coincides with and confirms the flow of water through and off the site via the outlet pipe. Heavy rainfall in November caused over bank flooding on the project to the extent that nearly the entire site was under water for a brief period.

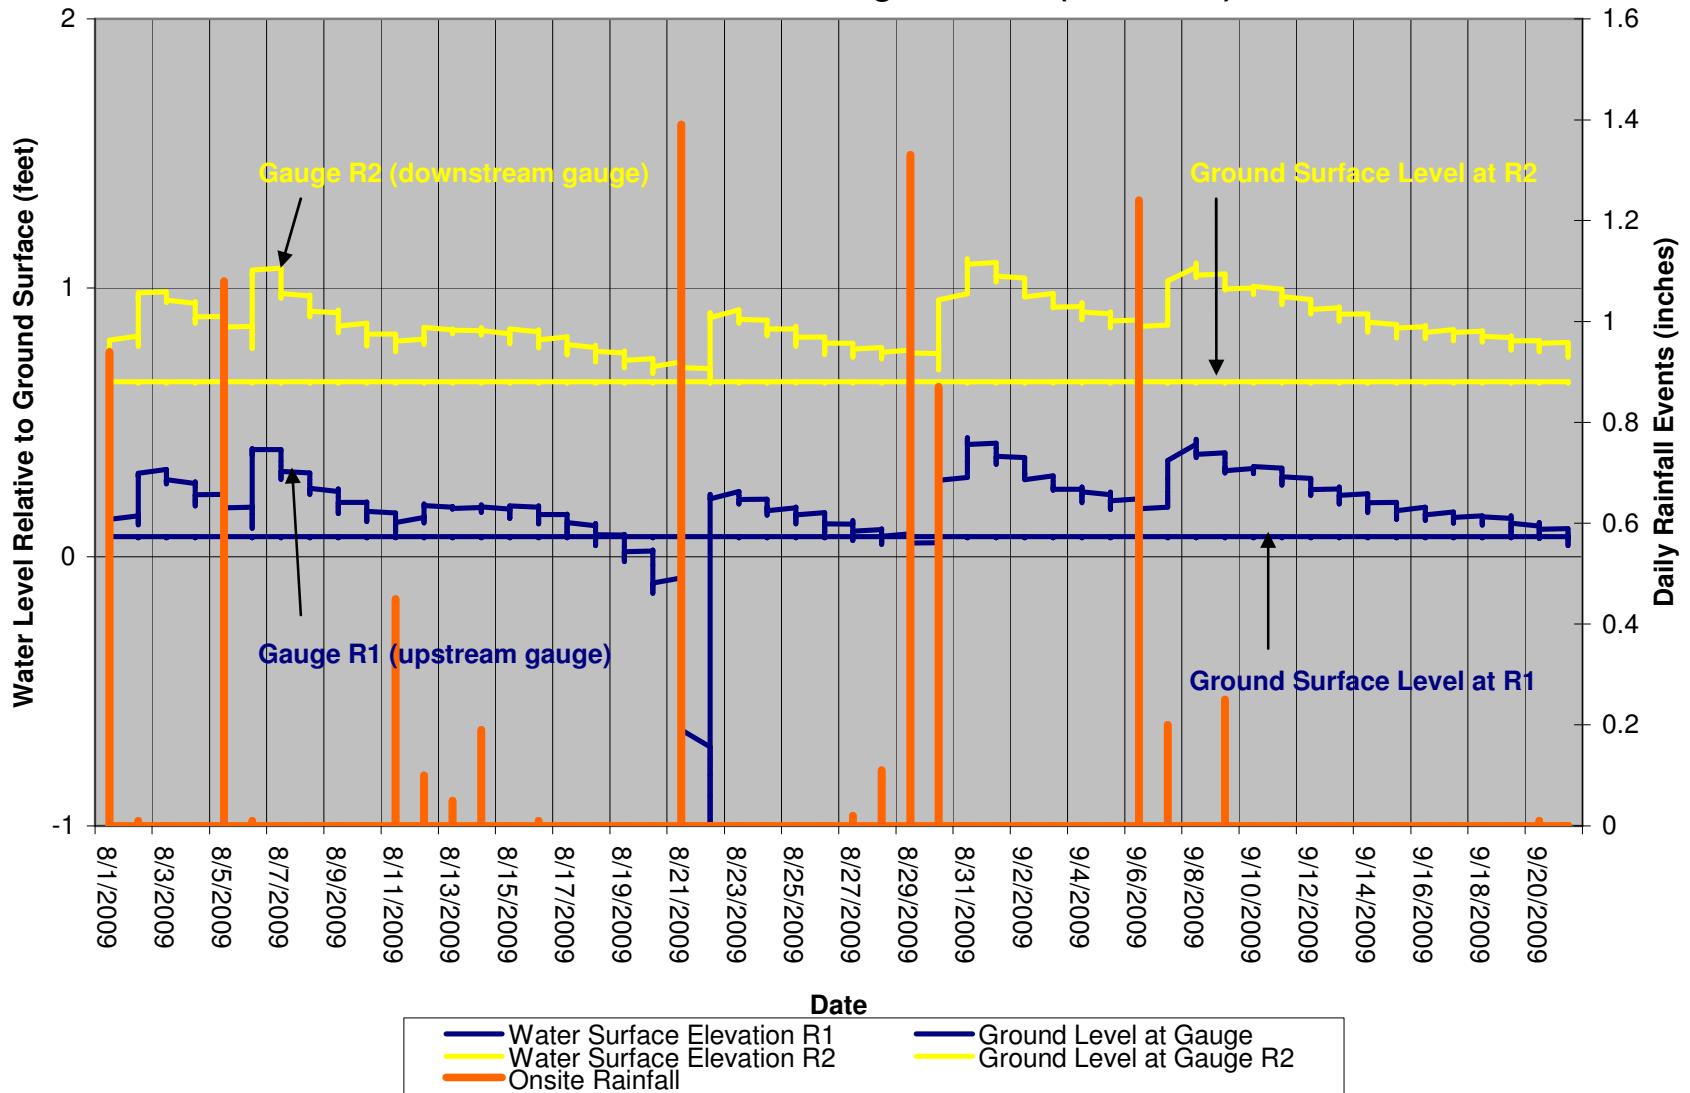
Figure F3.
4 Separate Flow Events During August and September
as Recorded at Run Gauges 1 and 2 (R1 and R2)

Figure F3 illustrates the same flow pattern in the swamp run gauges during four separate rainfall events when one-day precipitation totaled an inch or more. Each of these events caused exactly the same pattern of water rise and fall that were visually confirmed and photographed. From those visual confirmations, it can be extrapolated that flow occurred each of the four times during the period from August 1 through September 21.
