**Armstrong Property Wetland and Stream Mitigation Project
Hyde County, NC**

**2010 Annual Monitoring Report
Year 3**

**NCEEP Project Number D06012-A
Tar-Pamlico River Basin**

Date: November, 2010

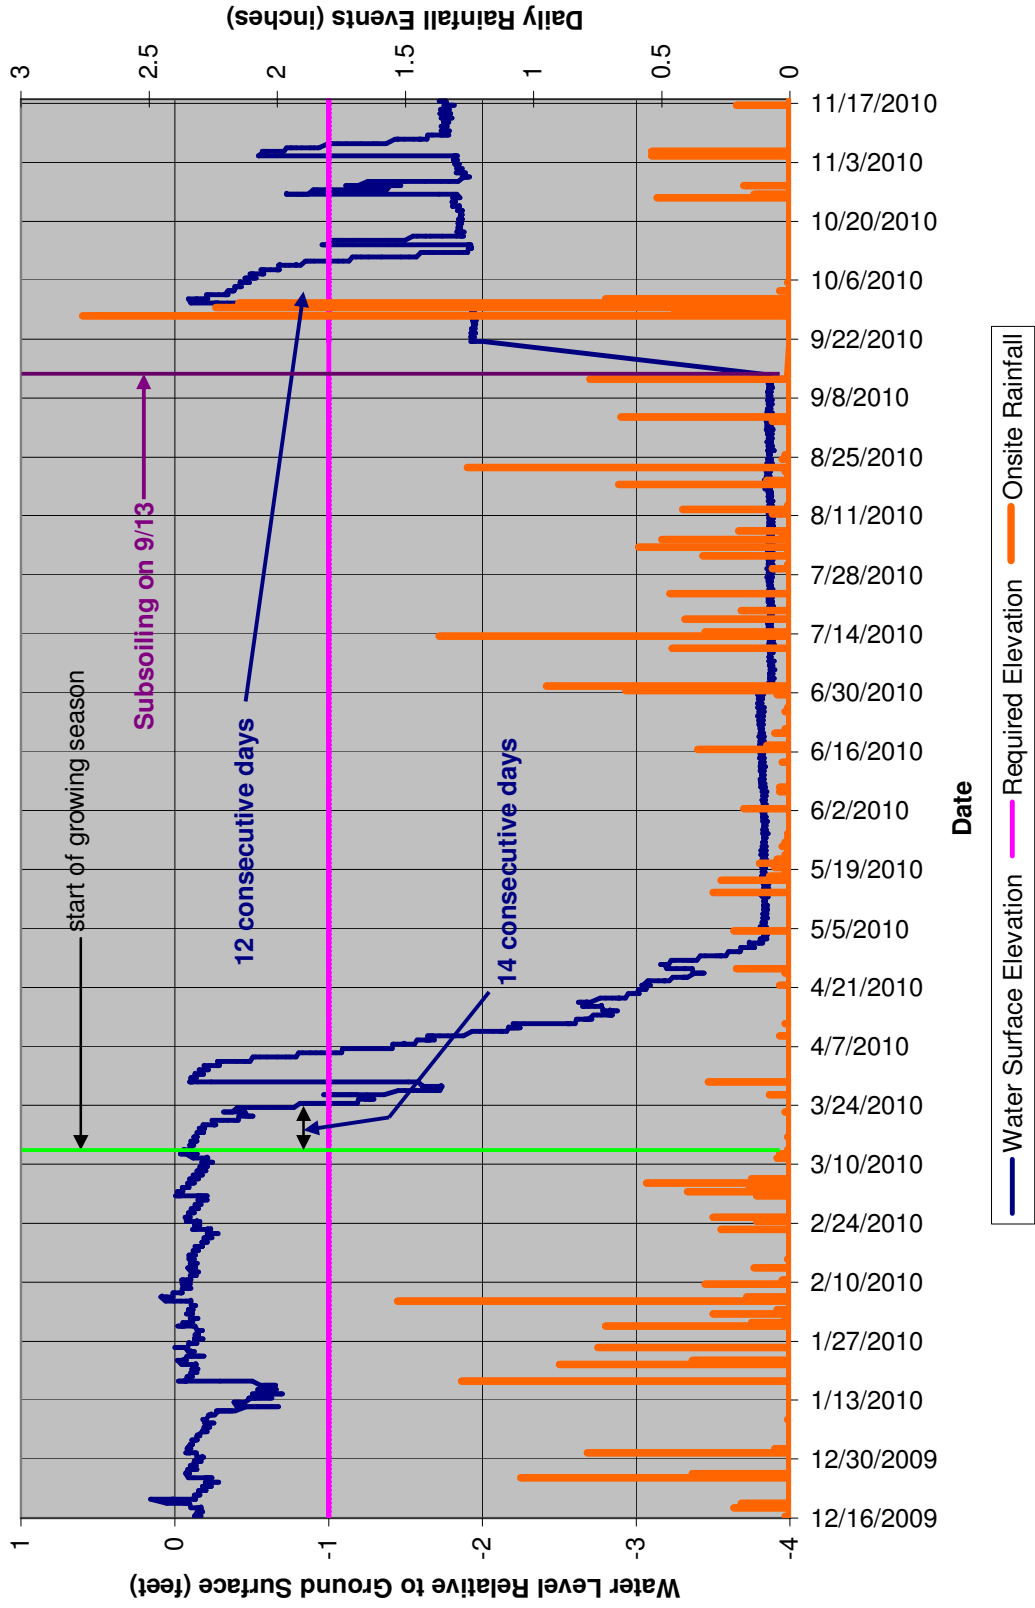
Armstrong Monitoring Gauge #1 (1126654)

Table C-1															
Longest Consecutive Successful Hydrologic Period in Days and Success at 5% and 8% of Growing Season															
Gauge	Year 1			Year 2			Current Year			Year 4			Year 5		
	Days	5%	8%	Days	5%	8%	Days	5%	8%	Days	5%	8%	Days	5%	8%
1	9	N	N	19	Y	N	14	Y	N						
2	4	N	N	17	Y	N	9	N	N						
3	12	N	N	17	Y	N	13	Y	N						
4	8	N	N	13	Y	N	30	Y	Y						
5	18	Y	N	27	Y	Y	51	Y	Y						
6 (Ref)	100	Y	Y	98	Y	Y	99	Y	Y						
7 (Ref)	14	N	N	17	Y	N	28	Y	Y						
Run 1	35	Y	Y	124	Y	Y	49	Y	Y						
Run 2	140	Y	Y	261	Y	Y	92	Y	Y
