**Armstrong Property Wetland and Stream Mitigation Project  
Hyde County, NC**

**2011 Annual Monitoring Report  
Year 4**

**NCEEP Project Number D06012-A  
Tar-Pamlico River Basin**

Date: December, 2011

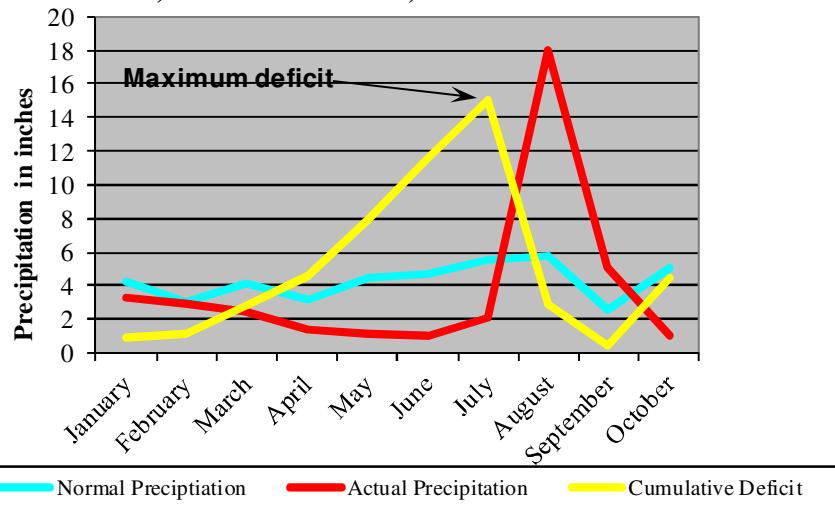
**2011 Reference Precipitation**  
Jan. 1, 2011 thru Oct. 31, 2011: 4.45 inch deficit

Through July, 2011, the project site suffered from a cumulative rainfall deficit of 15.08". The ten inches of rain produced by Hurricane Irene in late August were not enough to eliminate the total deficit and as of the end of October, the cumulative deficit was still 4.45". The project suffered a similar problem in 2010 when the cumulative deficit through the month of August was 14.17" and ended the growing season in November at 11.23". Despite the severely droughty conditions, Gauges 1-4 showed their best hydroperiods during the early part of the growing season, a characteristic mirrored by the reference gauge #7. This trend would suggest properly performing hydrology during times of adequate rainfall.

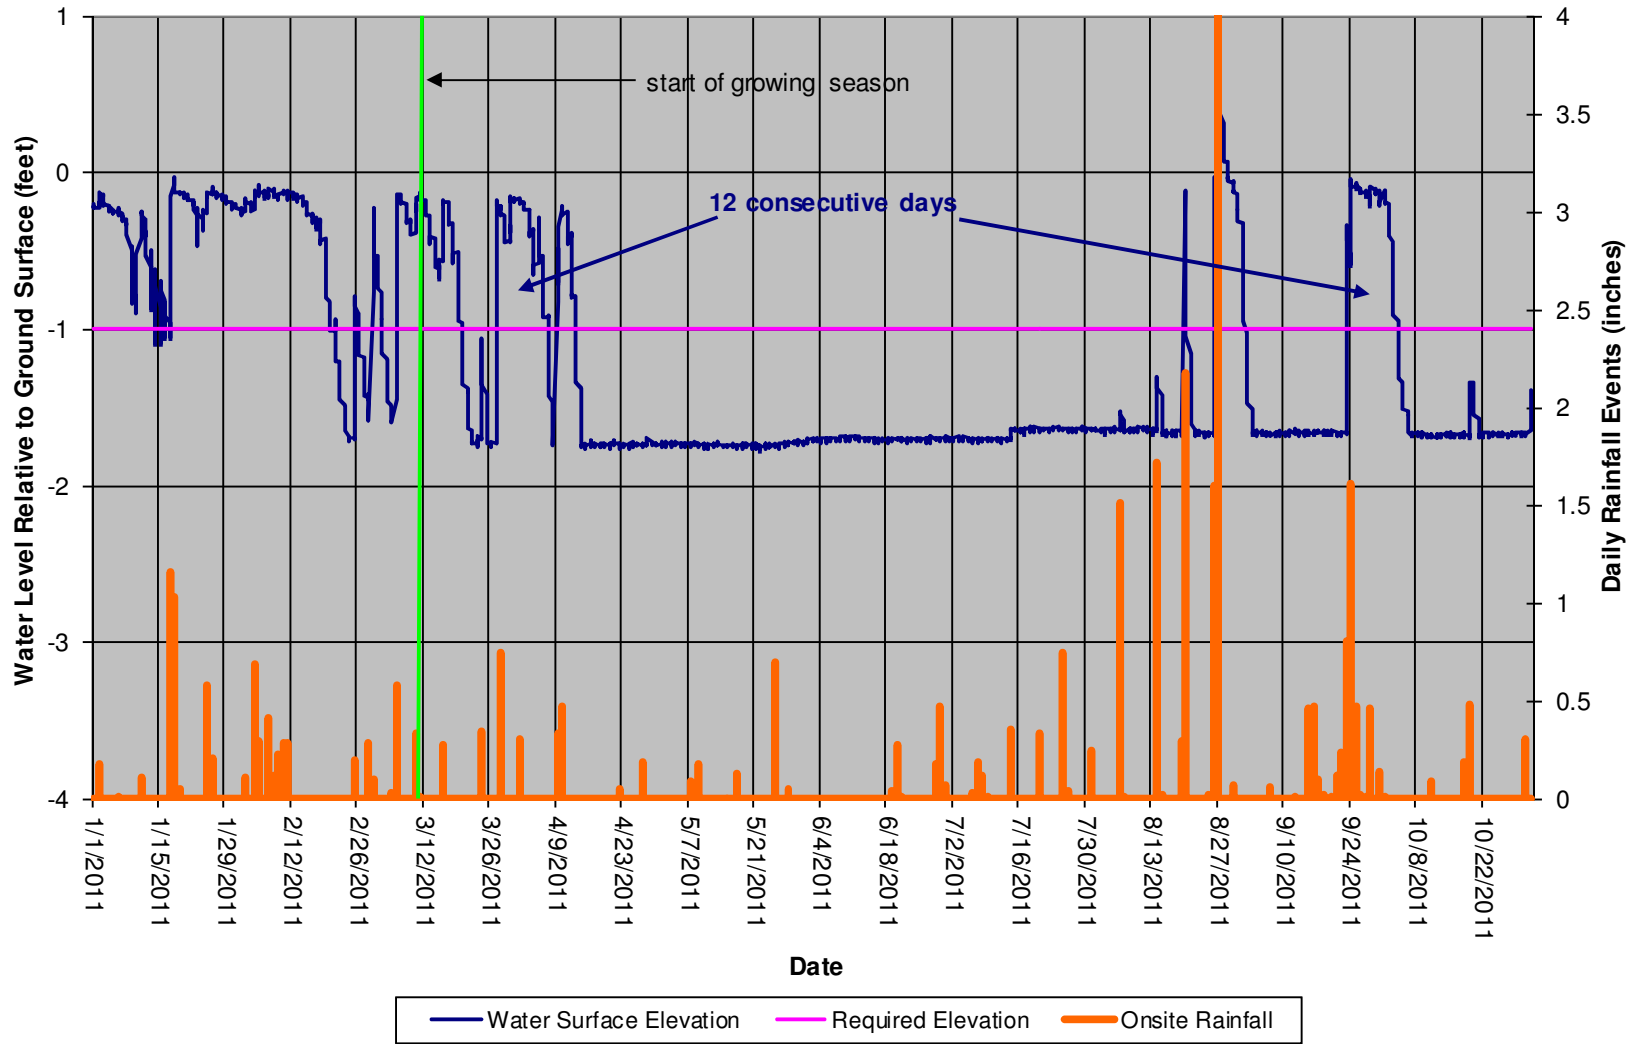
### Armstrong Monitoring Gauge #2 (1272306)

Of particular importance is the fact that from May 15 through August 18, Run Gauge 2 showed no standing water at all for the first time since the project was completed. A similar pattern occurs for Reference Gauge 6. The data, taken in their entirety, do not indicate a lack of wetland hydrology. Rather, they show the effects of inadequate rainfall. 2008 was the first year of monitoring and since its completion the project has been under moderate to severe rainfall drought. The hydrologic success of the project depends entirely on rainfall.
