YEAR 2 (2017) MONITORING REPORT
AYCOCK SPRINGS
STREAM AND WETLAND MITIGATION SITE
ALAMANCE COUNTY, NORTH CAROLINA
DMS PROJECT NO. 96312
FULL DELIVERY CONTRACT NO. 5791

CAPE FEAR RIVER BASIN
CATALOGING UNIT 03030002

Data Collection – May-October 2017

January 2018

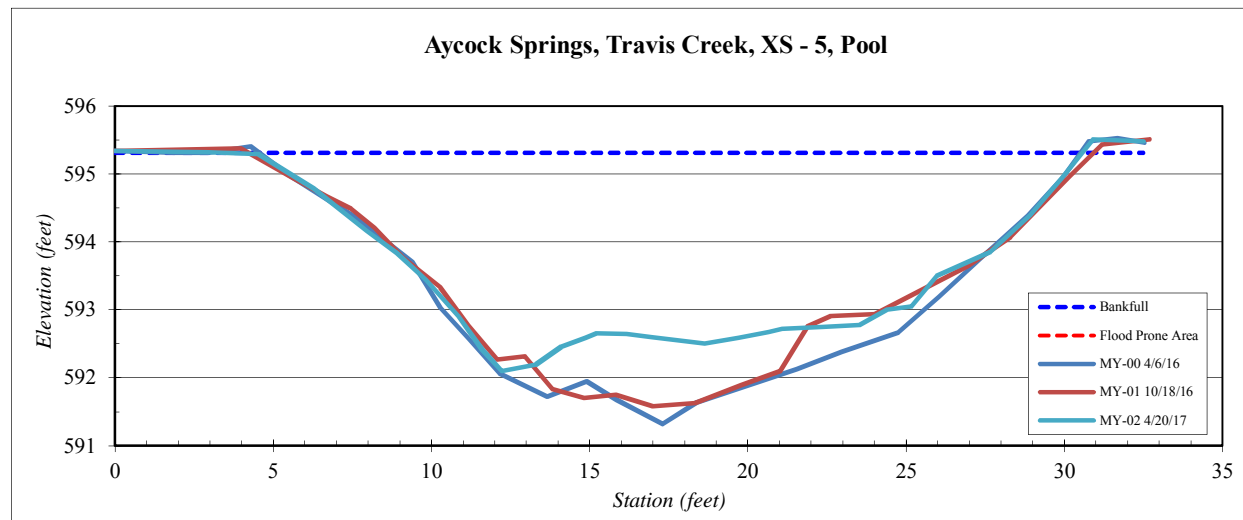
Site	Aycock Springs
Watershed:	Cape Fear, 0303002
XS ID	Travis Creek, XS - 5, Pool
Feature	Pool
Date:	4/20/2017
Field Crew:	Perkinson, Keith

Note: Sediment Deposition in pool appears natural and is not expected to lead to instability.

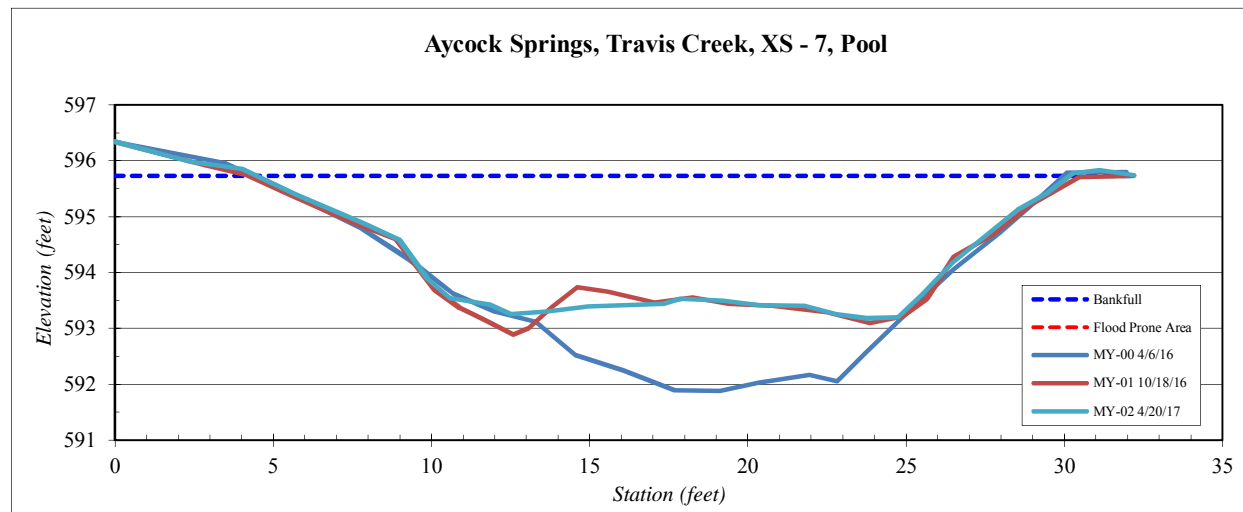
Site	Aycock Springs
Watershed:	Cape Fear, 0303002
XS ID	Travis Creek, XS - 7, Pool
Feature	Pool
Date:	4/20/2017
Field Crew:	Perkinson, Keith

Note: Sediment Deposition in pool appears natural and is not expected to lead to instability.

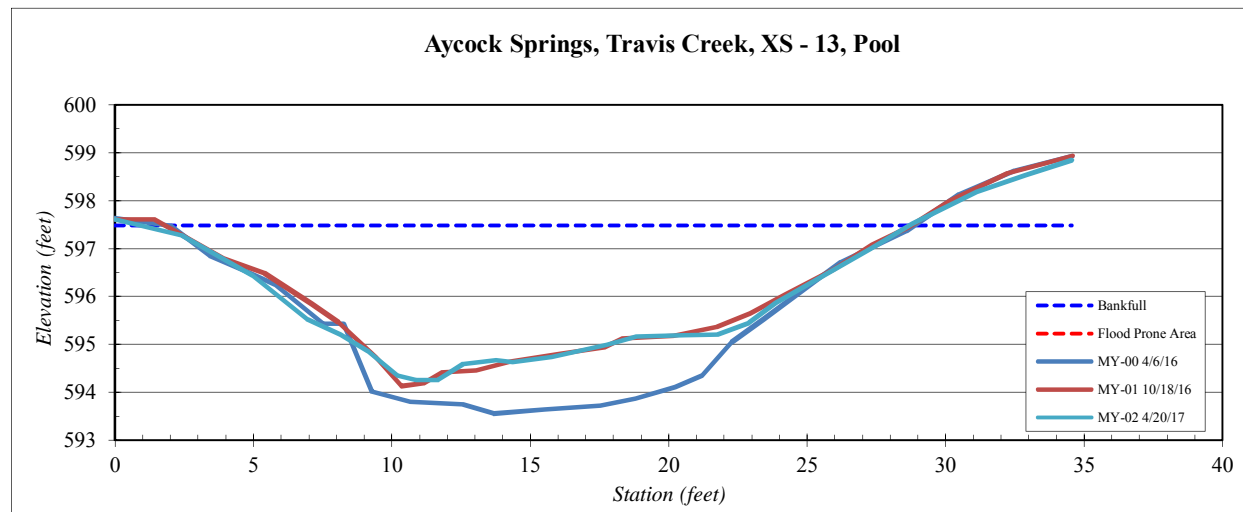
Site	Aycock Springs
Watershed:	Cape Fear, 0303002
XS ID	Travis Creek, XS - 13, Pool
Feature	Pool
Date:	4/20/2017
Field Crew:	Perkinson, Keith

Note: Sediment Deposition in pool appears natural and is not expected to lead to instability.

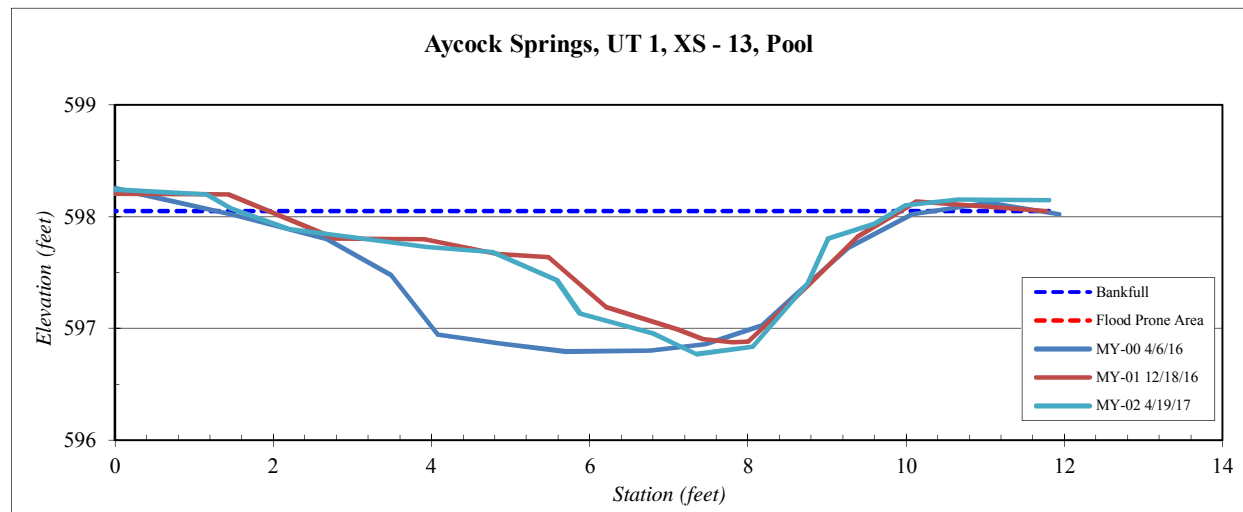
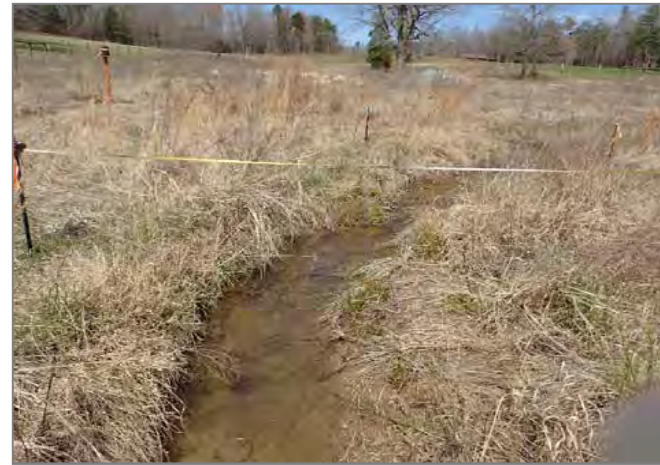
Site	Aycock Springs
Watershed:	Cape Fear, 0303002
XS ID	UT 1, XS - 13, Pool
Feature	Pool
Date:	4/19/2017
Field Crew:	Perkinson, Keith

Note: Point bar development appears stable after years 1 and 2 monitoring.

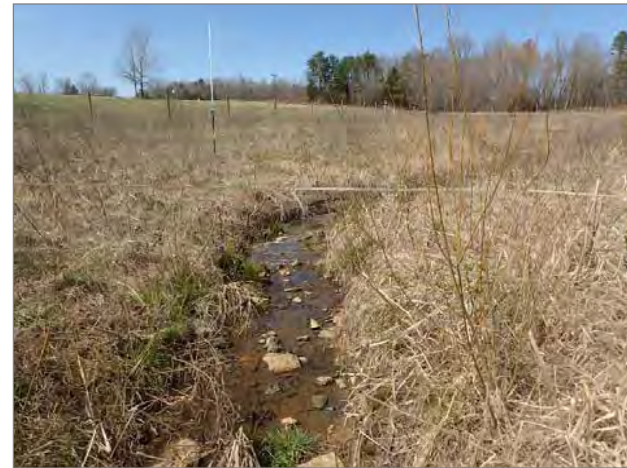
Note: No problems have been noted in this reach. Elevated BHR results from shallow channel depth.

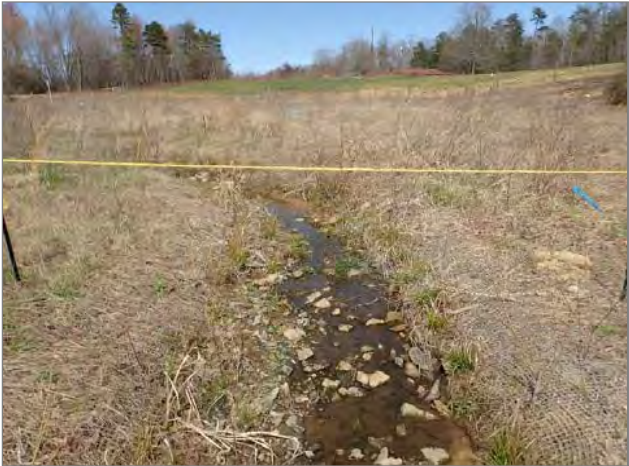
Note: No problems have been noted in this reach. Elevated BHR results from shallow channel depth.

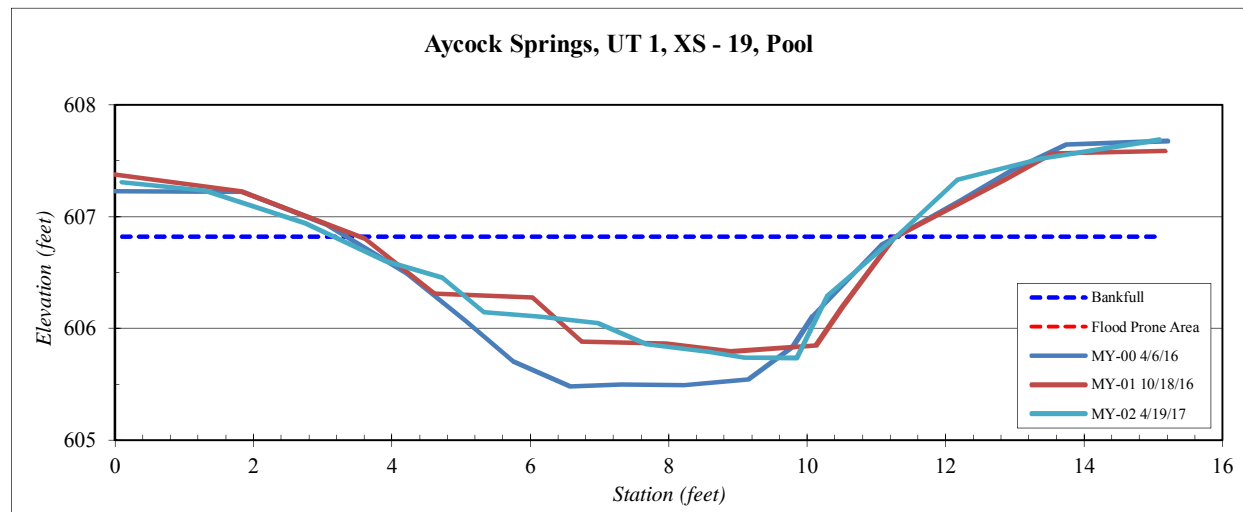
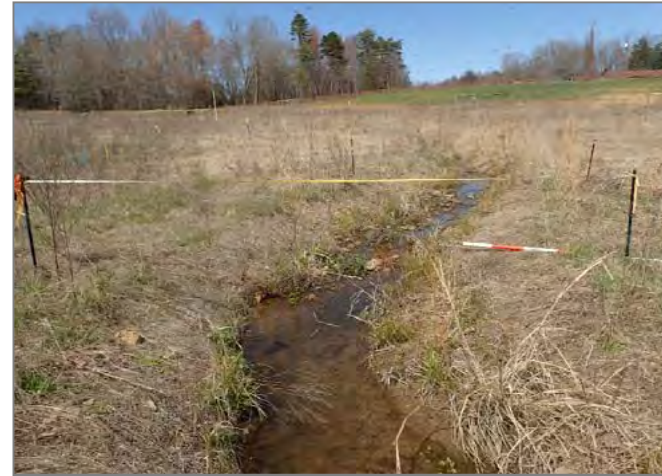
Site	Aycock Springs
Watershed:	Cape Fear, 0303002
XS ID	UT 1, XS - 19, Pool
Feature	Pool
Date:	4/19/2017
Field Crew:	Perkinson, Keith

Note: Point bar development appears stable after years 1 and 2 monitoring.

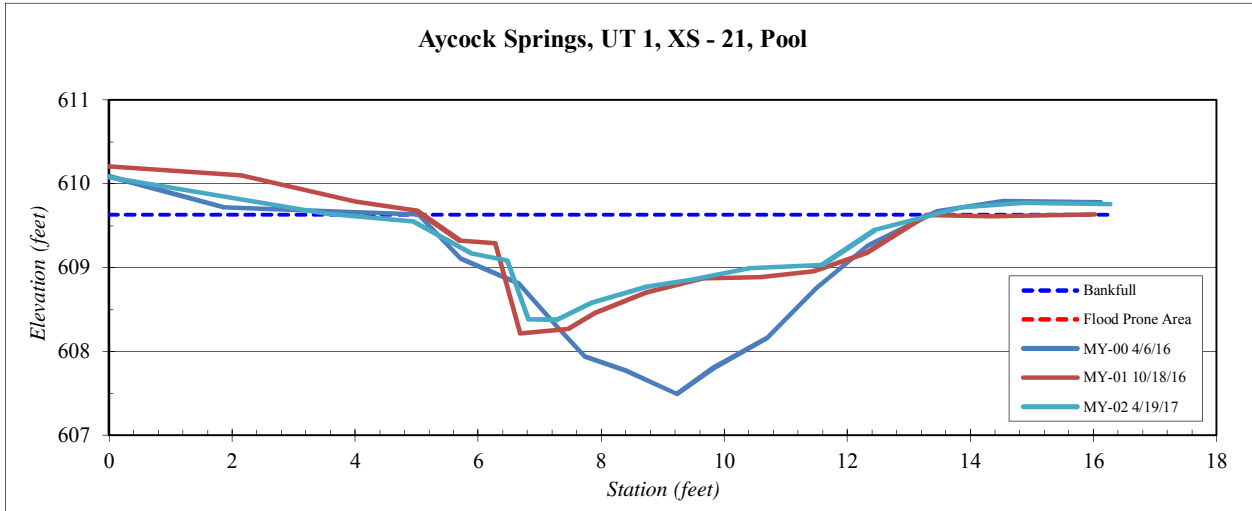
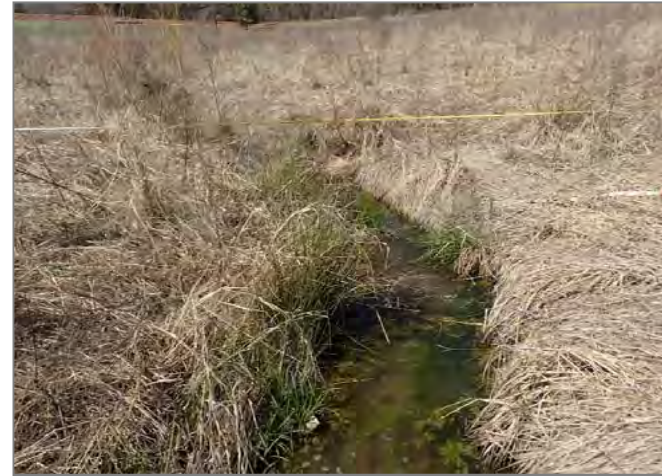
Site	Aycock Springs
Watershed:	Cape Fear, 0303002
XS ID	UT 1, XS - 21, Pool
Feature	Pool
Date:	4/19/2017
Field Crew:	Perkinson, Keith

Note: Point bar development appears stable after years 1 and 2 monitoring.

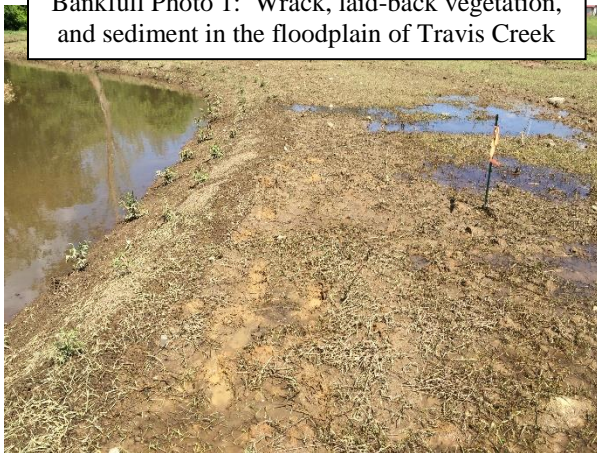
Bankfull Photo 1: Wrack, laid-back vegetation, and sediment in the floodplain of Travis Creek

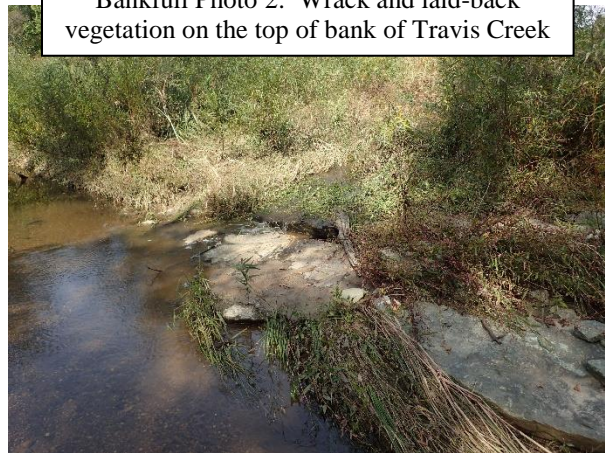
Bankfull Photo 2: Wrack and laid-back vegetation on the top of bank of Travis Creek

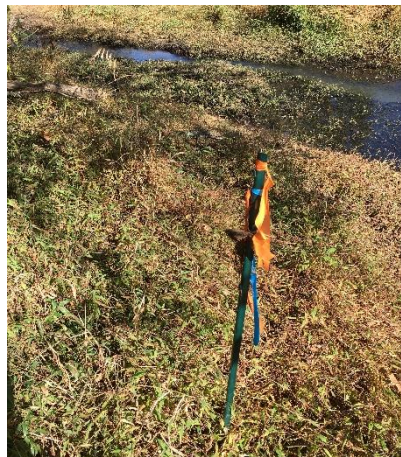
Bankfull Photo 3: Wrack and laid-back vegetation around a cross-section marker in the floodplain of Travis Creek

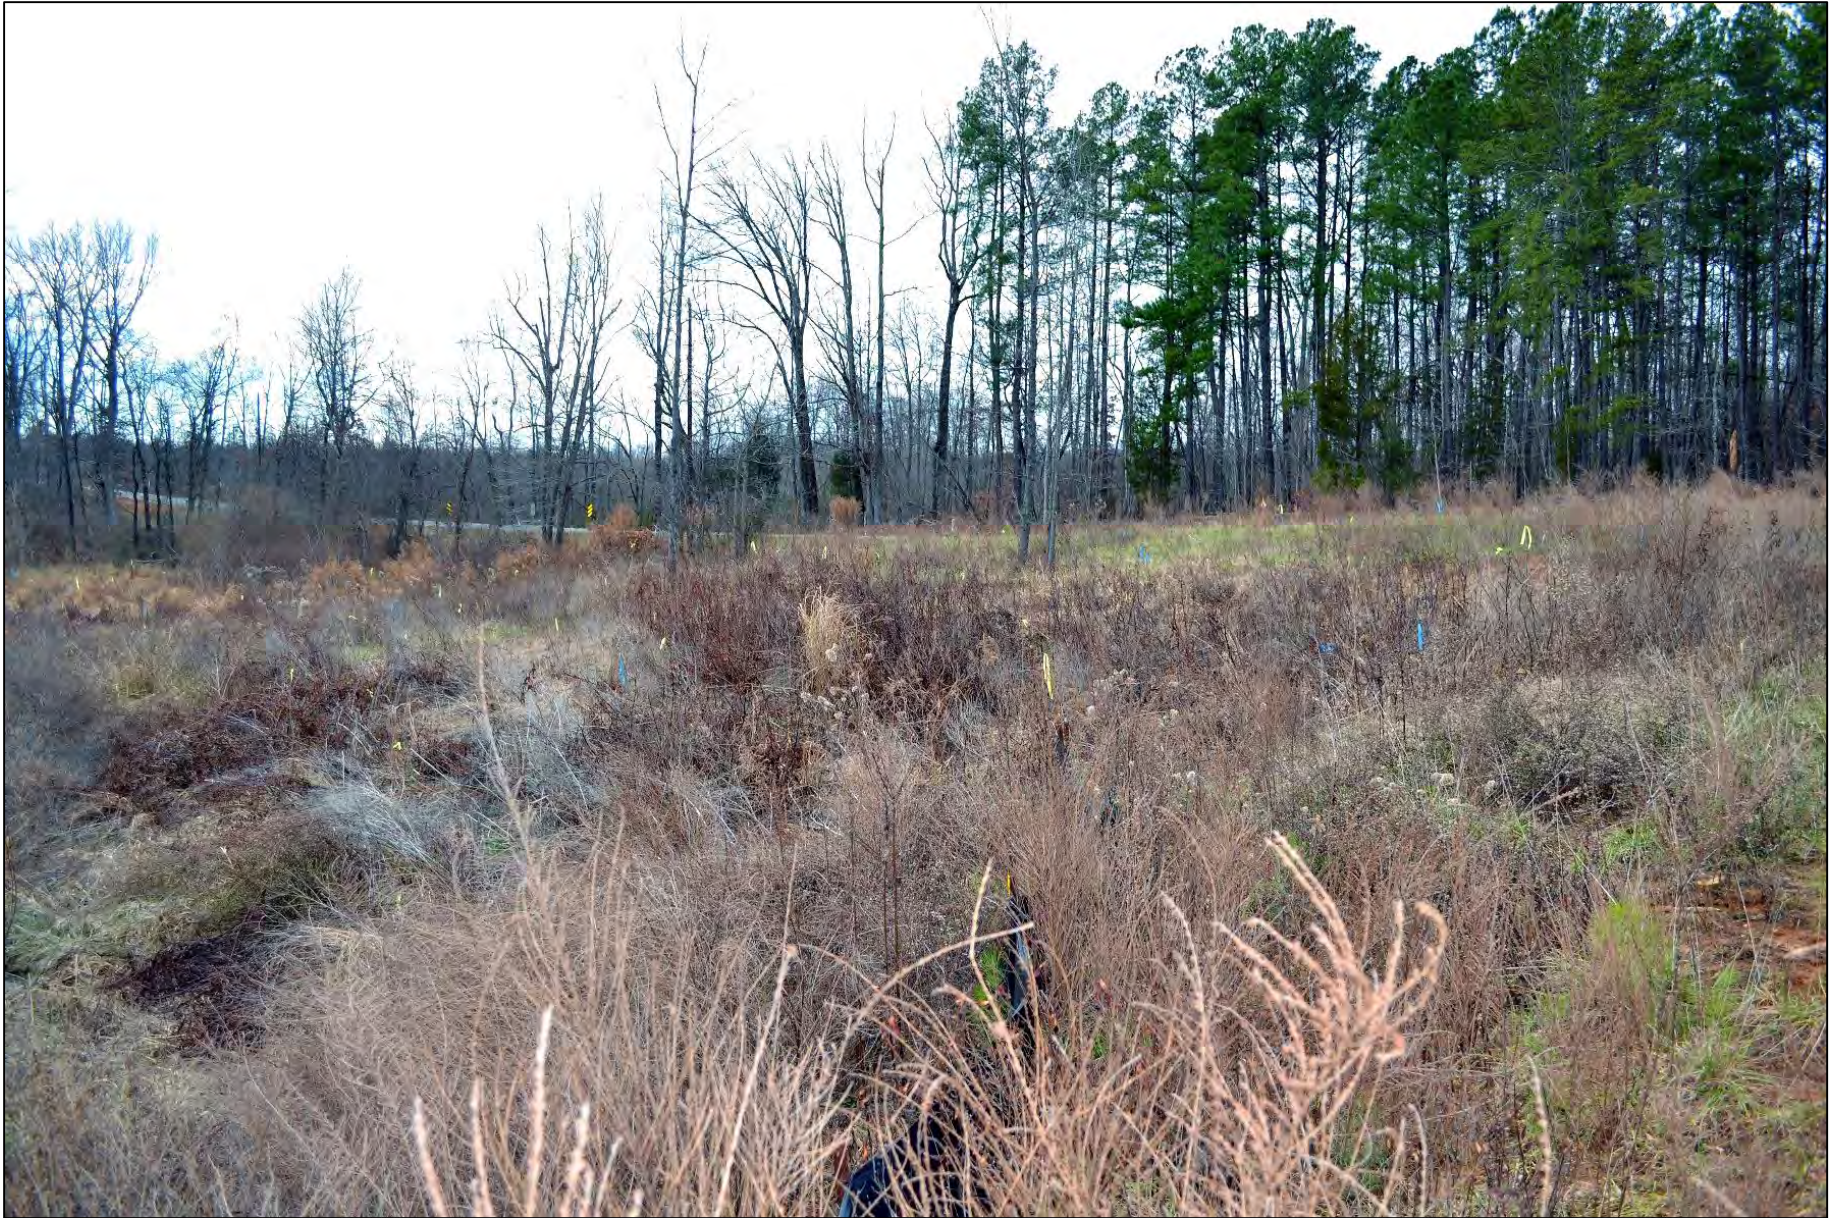
Map of Replant Areas- green dots indicate approximate location of where photos were taken.
