YEAR 3 (2018) MONITORING REPORT
AYCOCK SPRINGS
STREAM AND WETLAND MITIGATION SITE
ALAMANCE COUNTY, NORTH CAROLINA
DMS PROJECT NO. 96312
FULL DELIVERY CONTRACT NO. 5791

CAPE FEAR RIVER BASIN
CATALOGING UNIT 03030002

Data Collection – May-October 2018

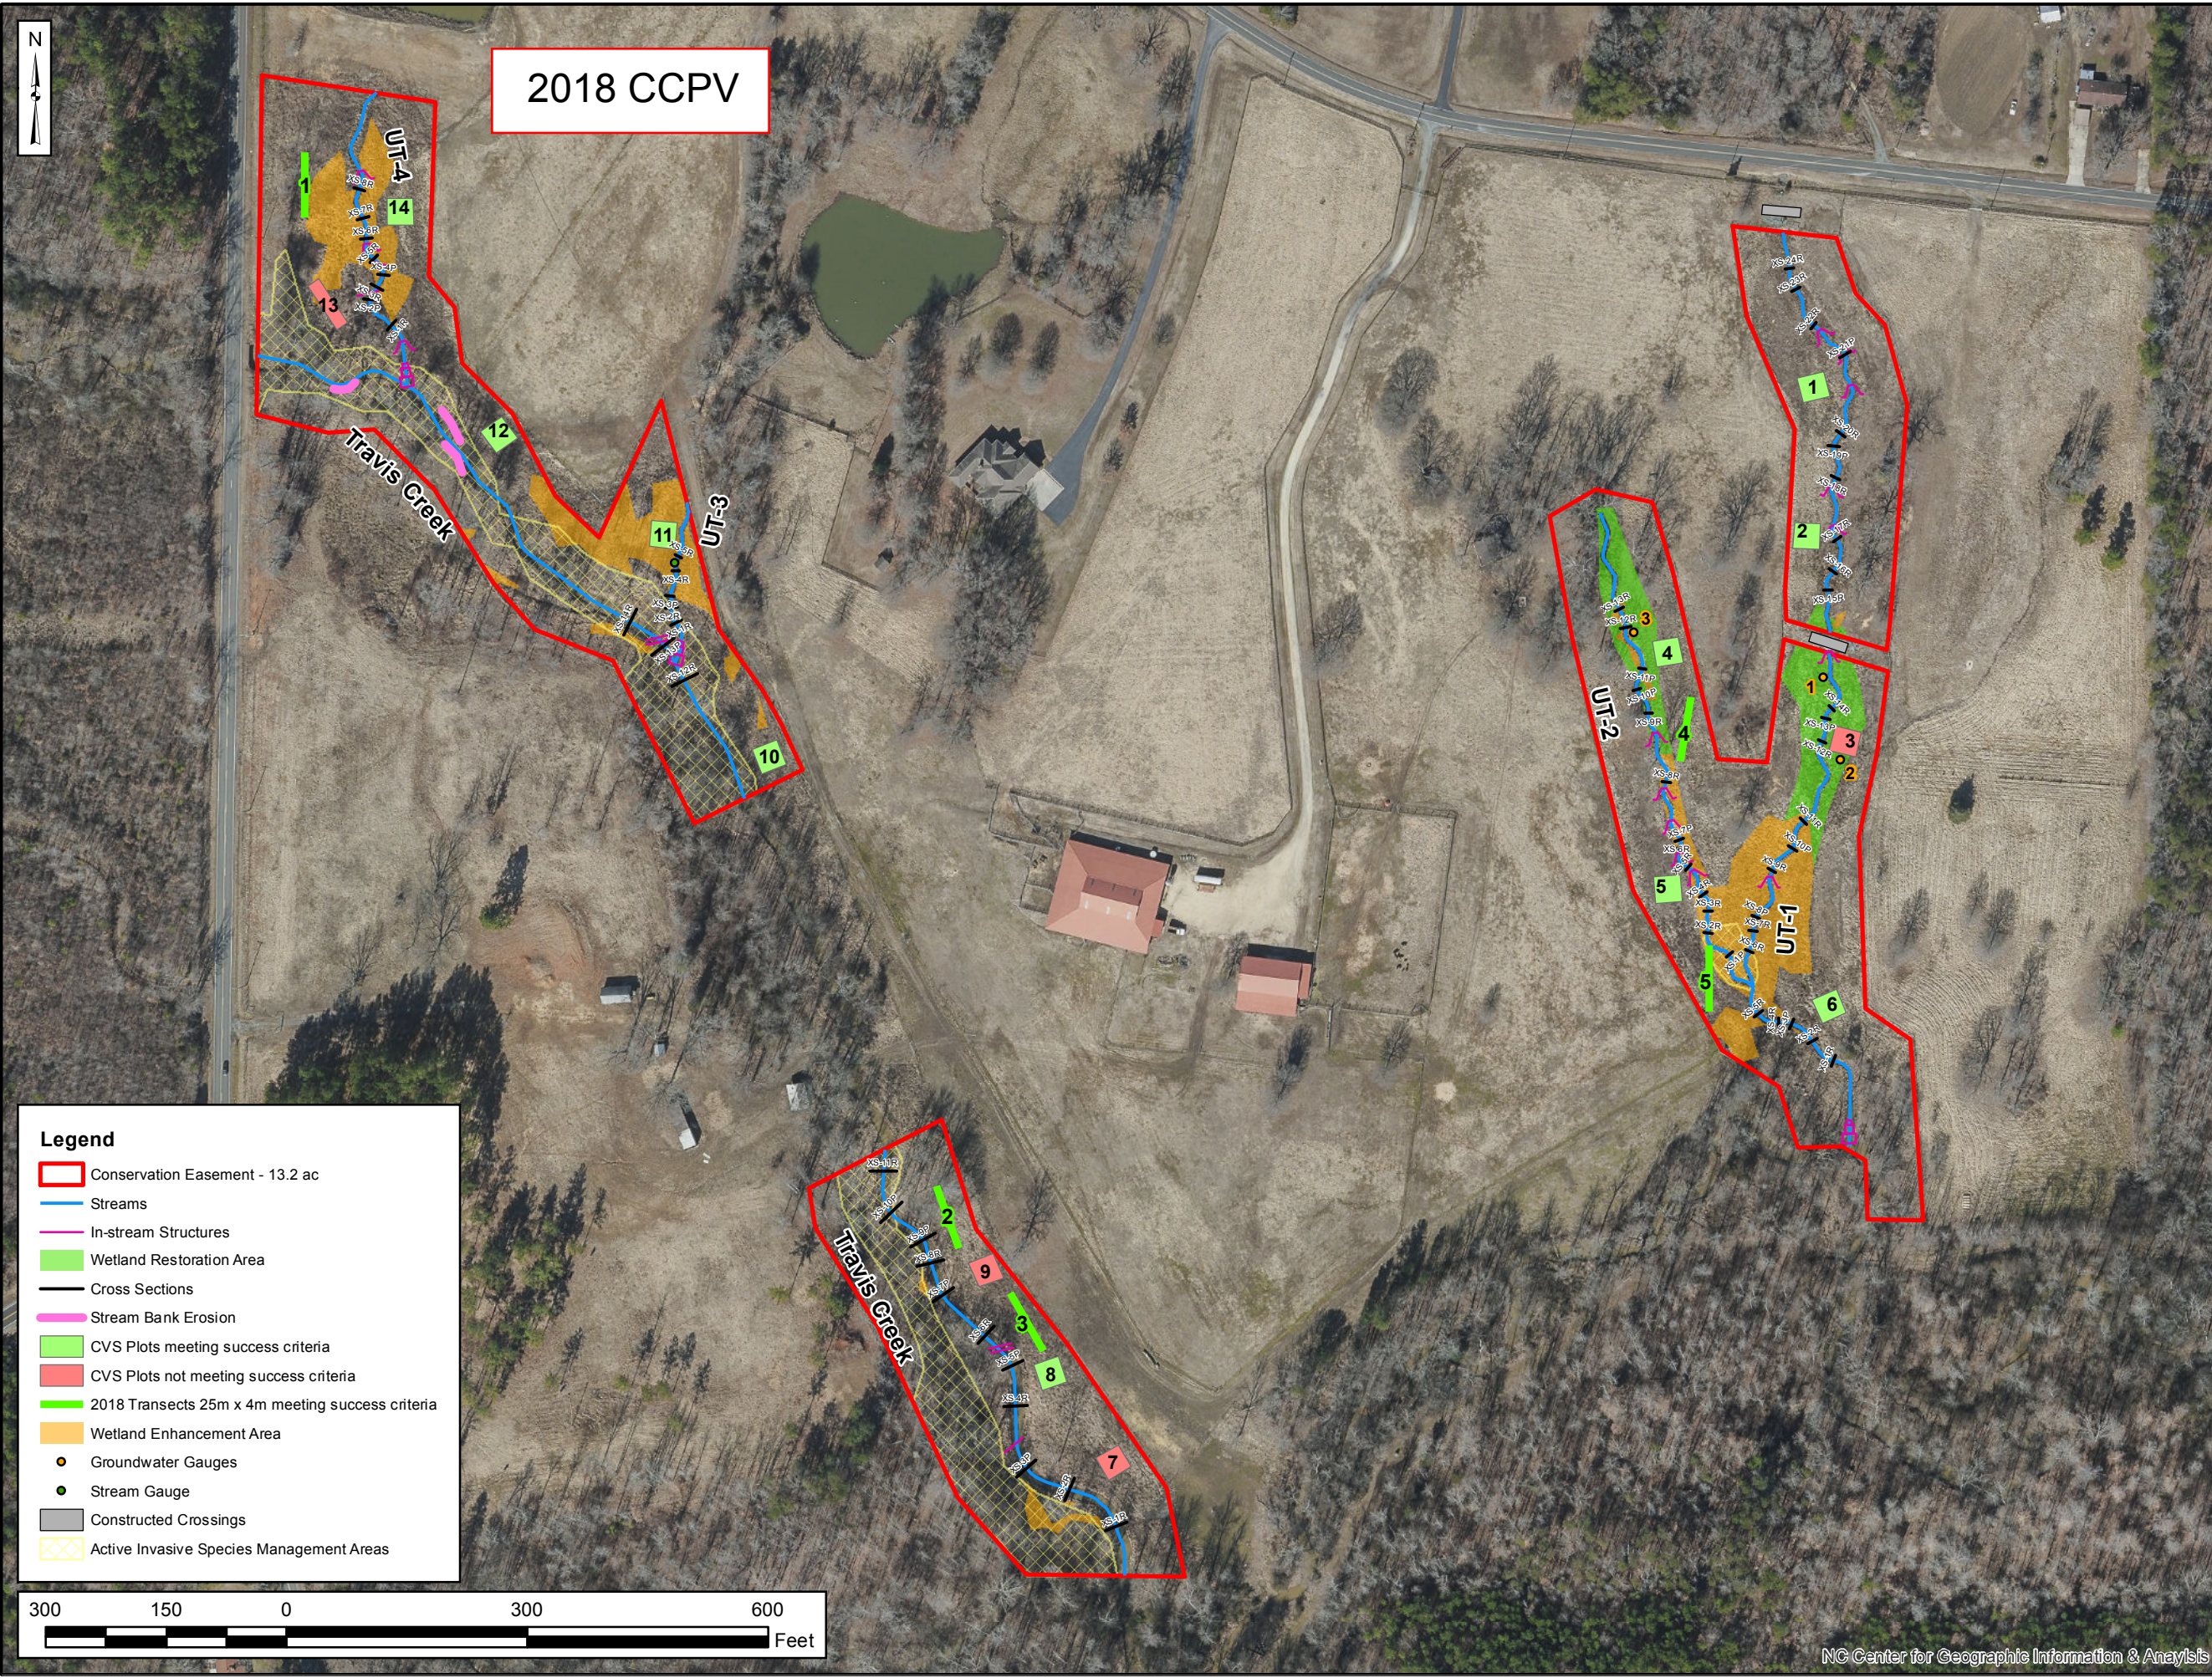
2018 CCPV

Across the site, all in-stream structures are intact and functioning as designed. No stream areas of concern were identified during Year 3 (2018) monitoring; however, three small areas of bank erosion were observed in the Enhancement (Level II) reach of Travis Creek. The pre-construction condition of Travis Creek included some stream bank erosion, and with the large amount of rainfall the Site received during Year 3 (2018), some of this erosion became more apparent. These areas will continue to be monitored for any significant change, but the erosion is not expected to cause any major stream stability problems. Additionally, several monitoring cross-sections (Travis XS-1, Travis XS-2, Travis XS-4, UT1 XS-2, UT2 XS-5, and UT2 XS-8) are showing Bank Height Ratios of <1. The bank height ratios were calculated based on fixing the cross-sectional area from last year's data, in accordance with the 2018 NCDMS "Standard Measurement of the BHR Monitoring Parameter" guidance. Each of these cross-sections exhibited a small amount of aggradation during Year 3 (2018). It is expected that this aggradation is the product of natural sediment transport and will not cause any long-term stream issues. Tables for annual quantitative assessments are included in Appendix D.

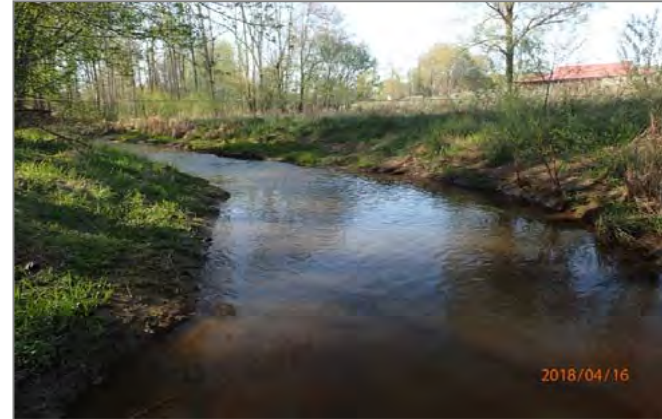
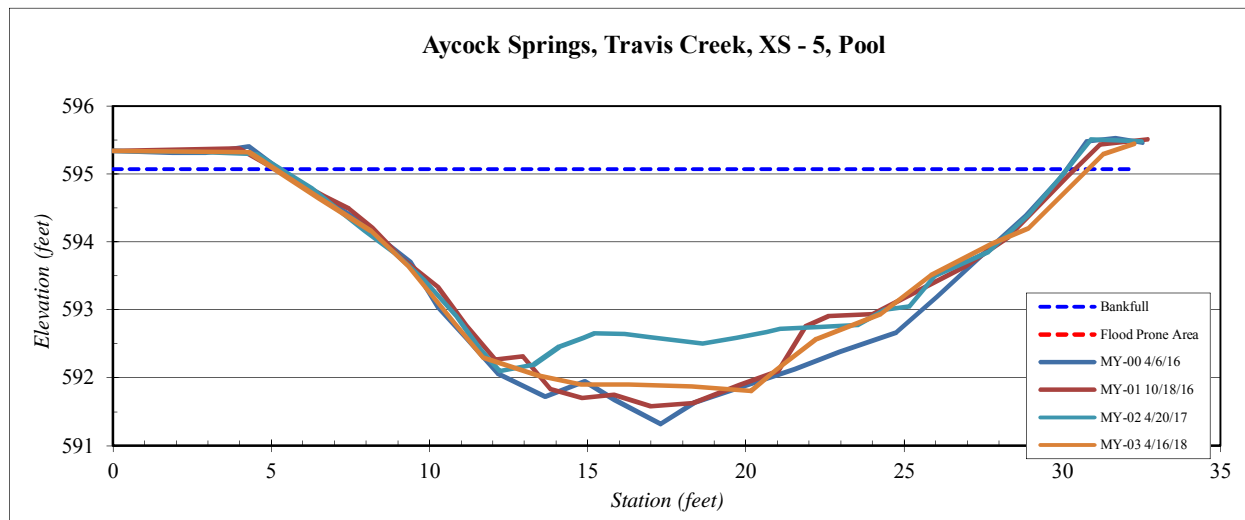
Site	Aycock Springs
Watershed:	Cape Fear, 0303002
XS ID	Travis Creek, XS - 5, Pool
Feature	Pool
Date:	4/16/2018
Field Crew:	Perkinson, Butler

Note: Sediment Deposition in pool appears natural and is not expected to lead to instability.

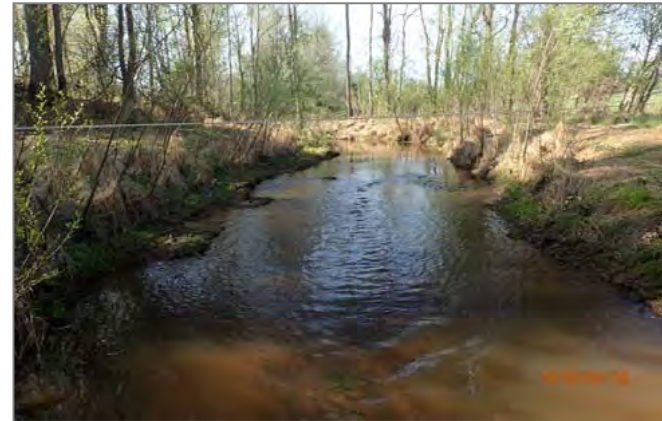
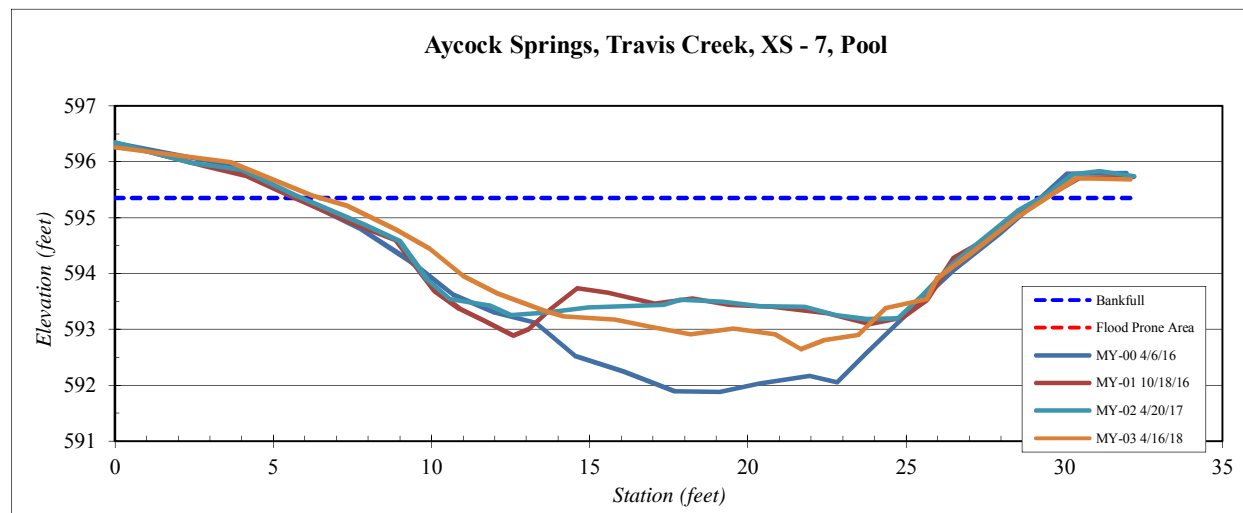
Site	Aycock Springs
Watershed:	Cape Fear, 0303002
XS ID	Travis Creek, XS - 7, Pool
Feature	Pool
Date:	4/16/2018
Field Crew:	Perkinson, Butler

Note: Sediment Deposition in pool appears natural and is not expected to lead to instability.

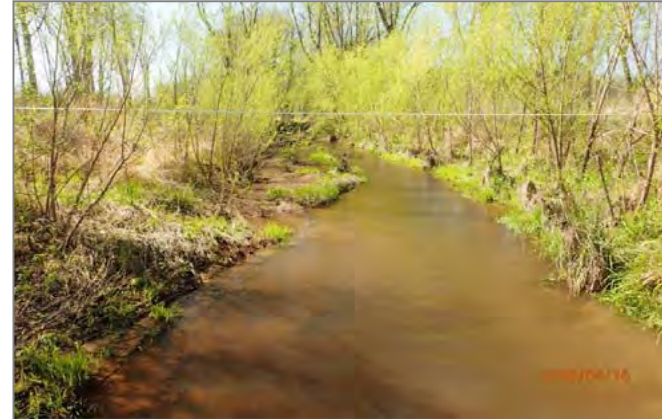
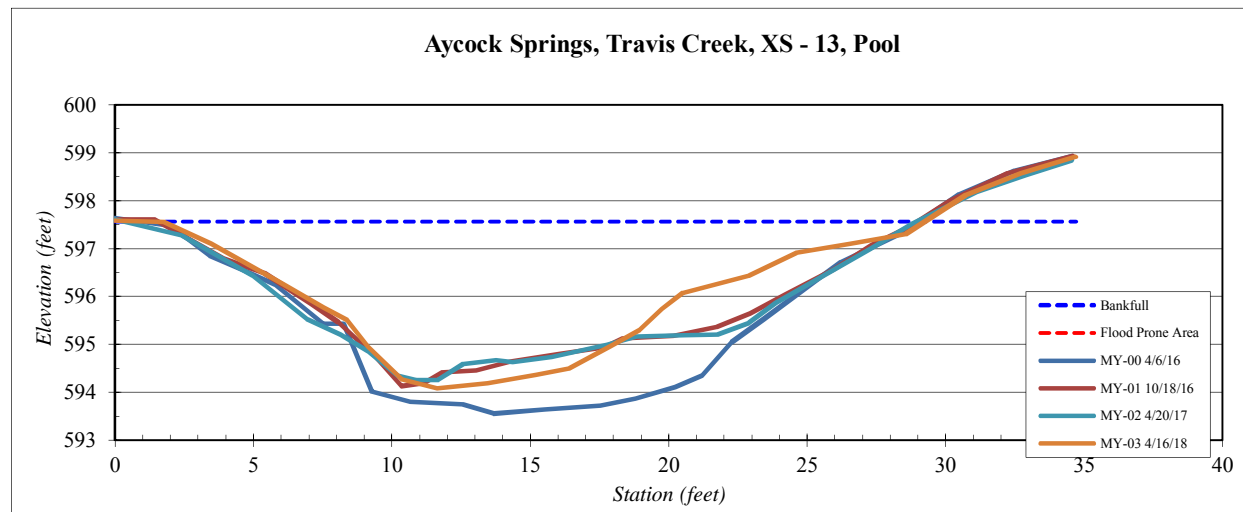
Site	Aycock Springs
Watershed:	Cape Fear, 0303002
XS ID	Travis Creek, XS - 13, Pool
Feature	Pool
Date:	4/16/2018
Field Crew:	Perkinson, Butler

Note: Sediment Deposition in pool appears natural and is not expected to lead to instability.

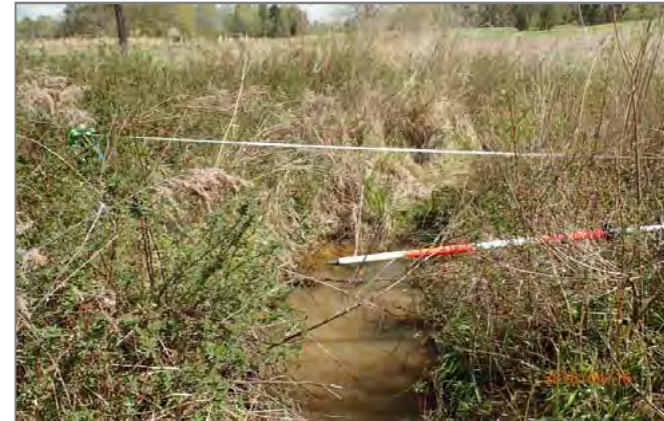
Site	Aycock Springs
Watershed:	Cape Fear, 0303002
XS ID	UT 1, XS - 8, Pool
Feature	Pool
Date:	4/16/2018
Field Crew:	Perkinson, Butler

Note: Cross Sections 8 and 9 (UT 1) are located in the vicinity of a bed material repair. Additional bed material was added by hand in this reach.

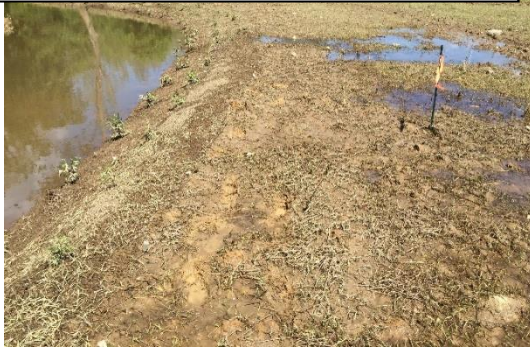
Bankfull Photo 1: Wrack, laid-back vegetation, and sediment in the floodplain of Travis Creek

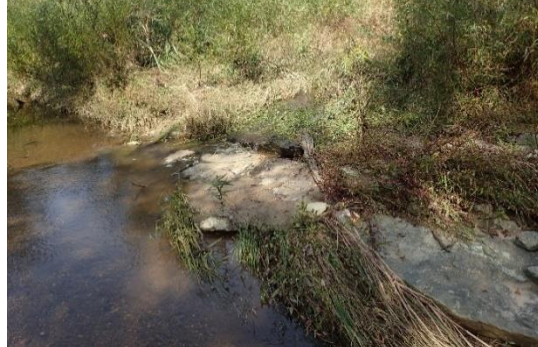
Bankfull Photo 2: Wrack and laid-back vegetation on the top of bank of Travis Creek

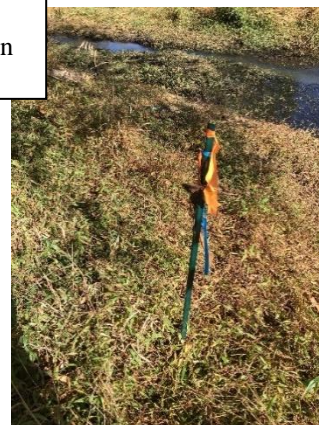
Bankfull Photo 3: Wrack and laid-back vegetation around a cross-section marker in the floodplain of Travis Creek

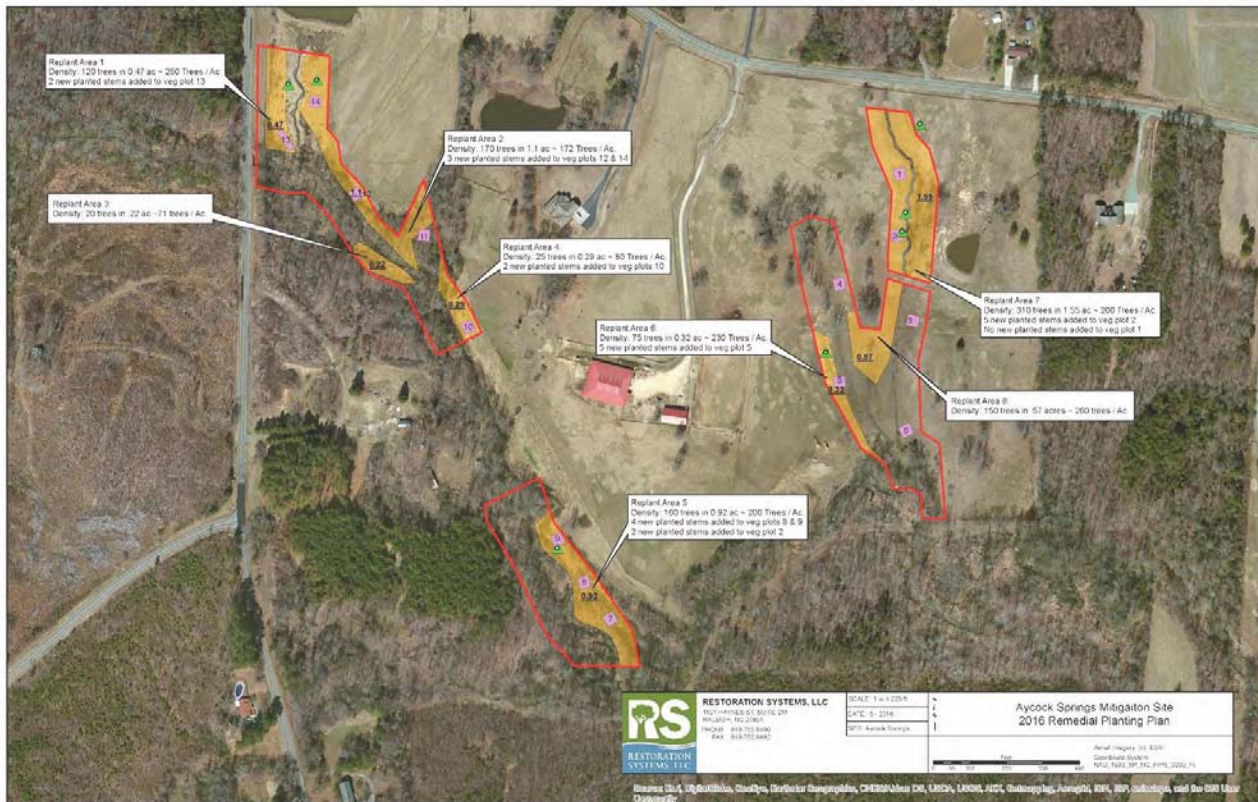
Map of Replant Areas- green dots indicate approximate location of where photos were taken.

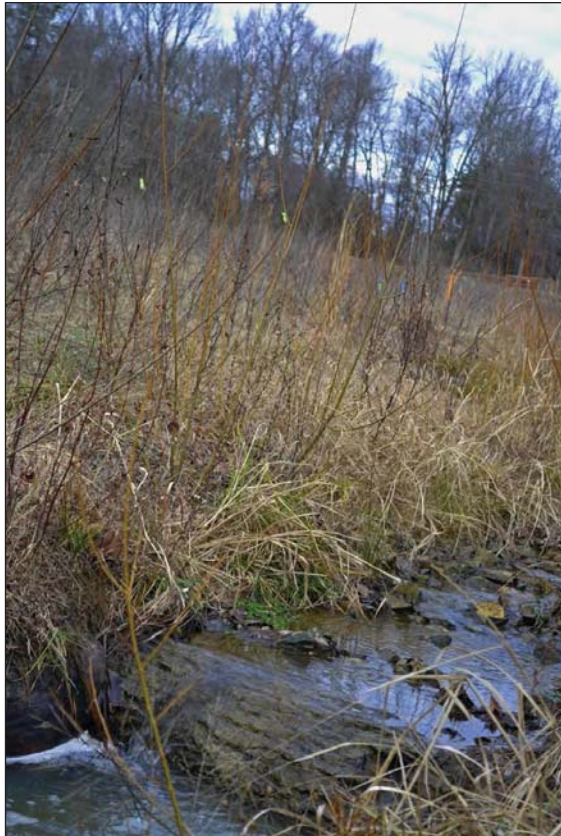
Photo 6 / 7: Live stake establishment on bank in Replant area 6
