YEAR 4 (2019) MONITORING REPORT
AYCOCK SPRINGS
STREAM AND WETLAND MITIGATION SITE

ALAMANCE COUNTY, NORTH CAROLINA
DMS PROJECT No. 96312
FULL DELIVERY CONTRACT No. 5791
NCDWR PROJECT No. 20140335
USACE ACTION ID No. SAW-2014-01711

Data Collection – May-November 2019

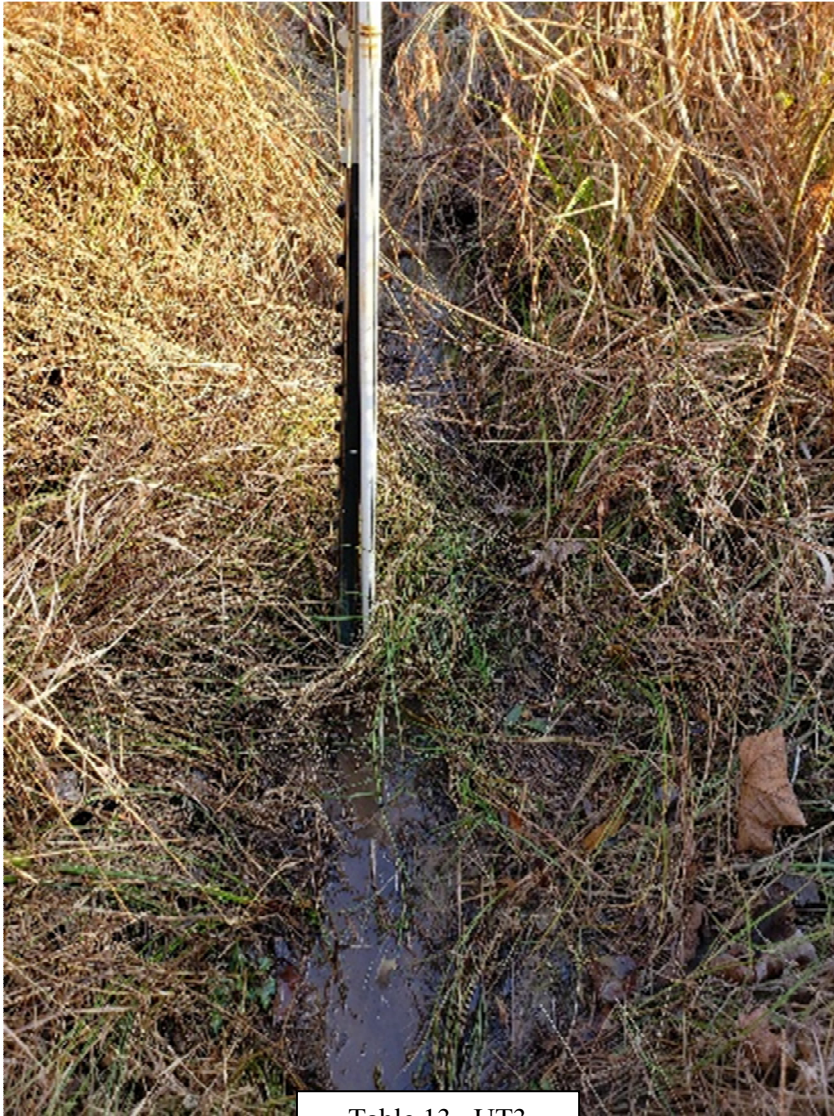
Table 13. UT3
Channel Evidence
UT-3 11-21-2019

UT3 Channel Evidence	Year 1 (2016)	Year 2 (2017)	Year 3 (2018)	Year 4 (2019)
Max consecutive days channel flow	37	110	276	145
Presence of litter and debris (wracking)	Yes	Yes	Yes	Yes
Leaf litter disturbed or washed away	Yes	Yes	Yes	Yes
Matted, bent, or absence of vegetation (herbaceous or otherwise)	Yes	Yes	Yes	Yes
Sediment deposition and/or scour indicating sediment transport	Yes	Yes	Yes	Yes
Water staining due to continual presence of water	Yes	Yes	Yes	Yes
Formation of channel bed and banks	Yes	Yes	Yes	Yes
Sediment sorting within the primary path of flow	Yes	Yes	Yes	Yes
Sediment shelving or a natural line impressed on the banks	Yes	Yes	Yes	Yes
Change in plant community (absence or destruction of terrestrial vegetation and/or transition to species adapted for flow or inundation for a long duration, including hydrophytes)	Yes	Yes	Yes	Yes
Development of channel pattern (meander bends and/or channel braiding) at natural topographic breaks, woody debris piles, or plant root systems	Yes	Yes	Yes	Yes

Exposure of woody plant roots within the primary path of flow	No	No	No	No
Other:
