YEAR 5 (2020) MONITORING REPORT
AYCOCK SPRINGS
STREAM AND WETLAND MITIGATION SITE
ALAMANCE COUNTY, NORTH CAROLINA
DMS PROJECT No. 96312
FULL DELIVERY CONTRACT No. 5791
NCDWR PROJECT No. 20140335
USACE ACTION ID No. SAW-2014-01711

CAPE FEAR RIVER BASIN
CATALOGING UNIT 03030002

Aycock Springs Year 5, 2020 Monitoring Summary

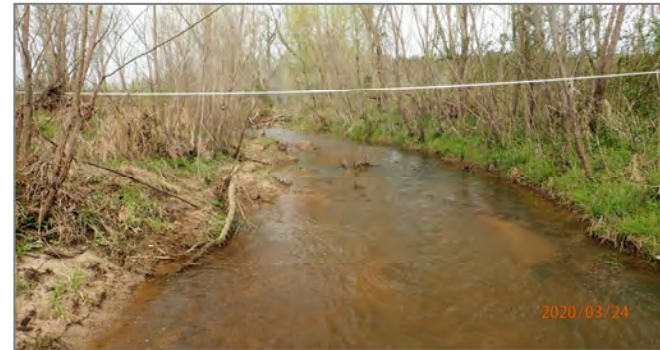
Site	Aycock Springs
Watershed:	Cape Fear, 0303002
XS ID	Travis Creek, XS - 13, Pool
Feature	Pool
Date:	3/24/2020
Field Crew:	Perkinson, Keith

Note: Sediment Deposition in pool appears natural and is not expected to lead to instability.

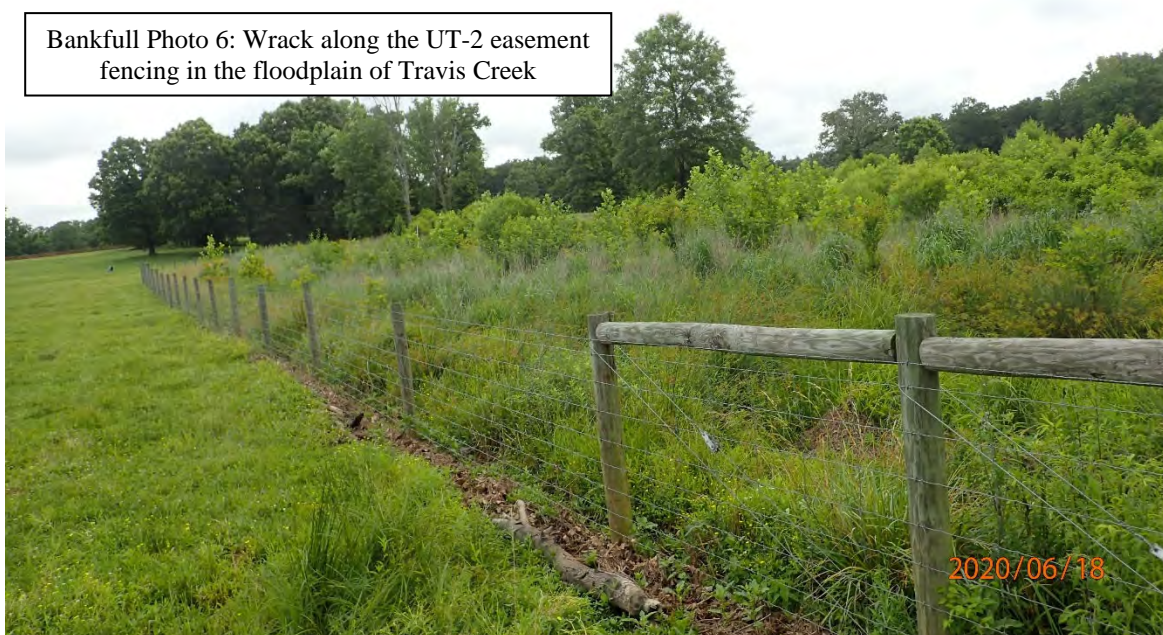
Bankfull Photo 6: Wrack along the UT-2 easement fencing in the floodplain of Travis Creek

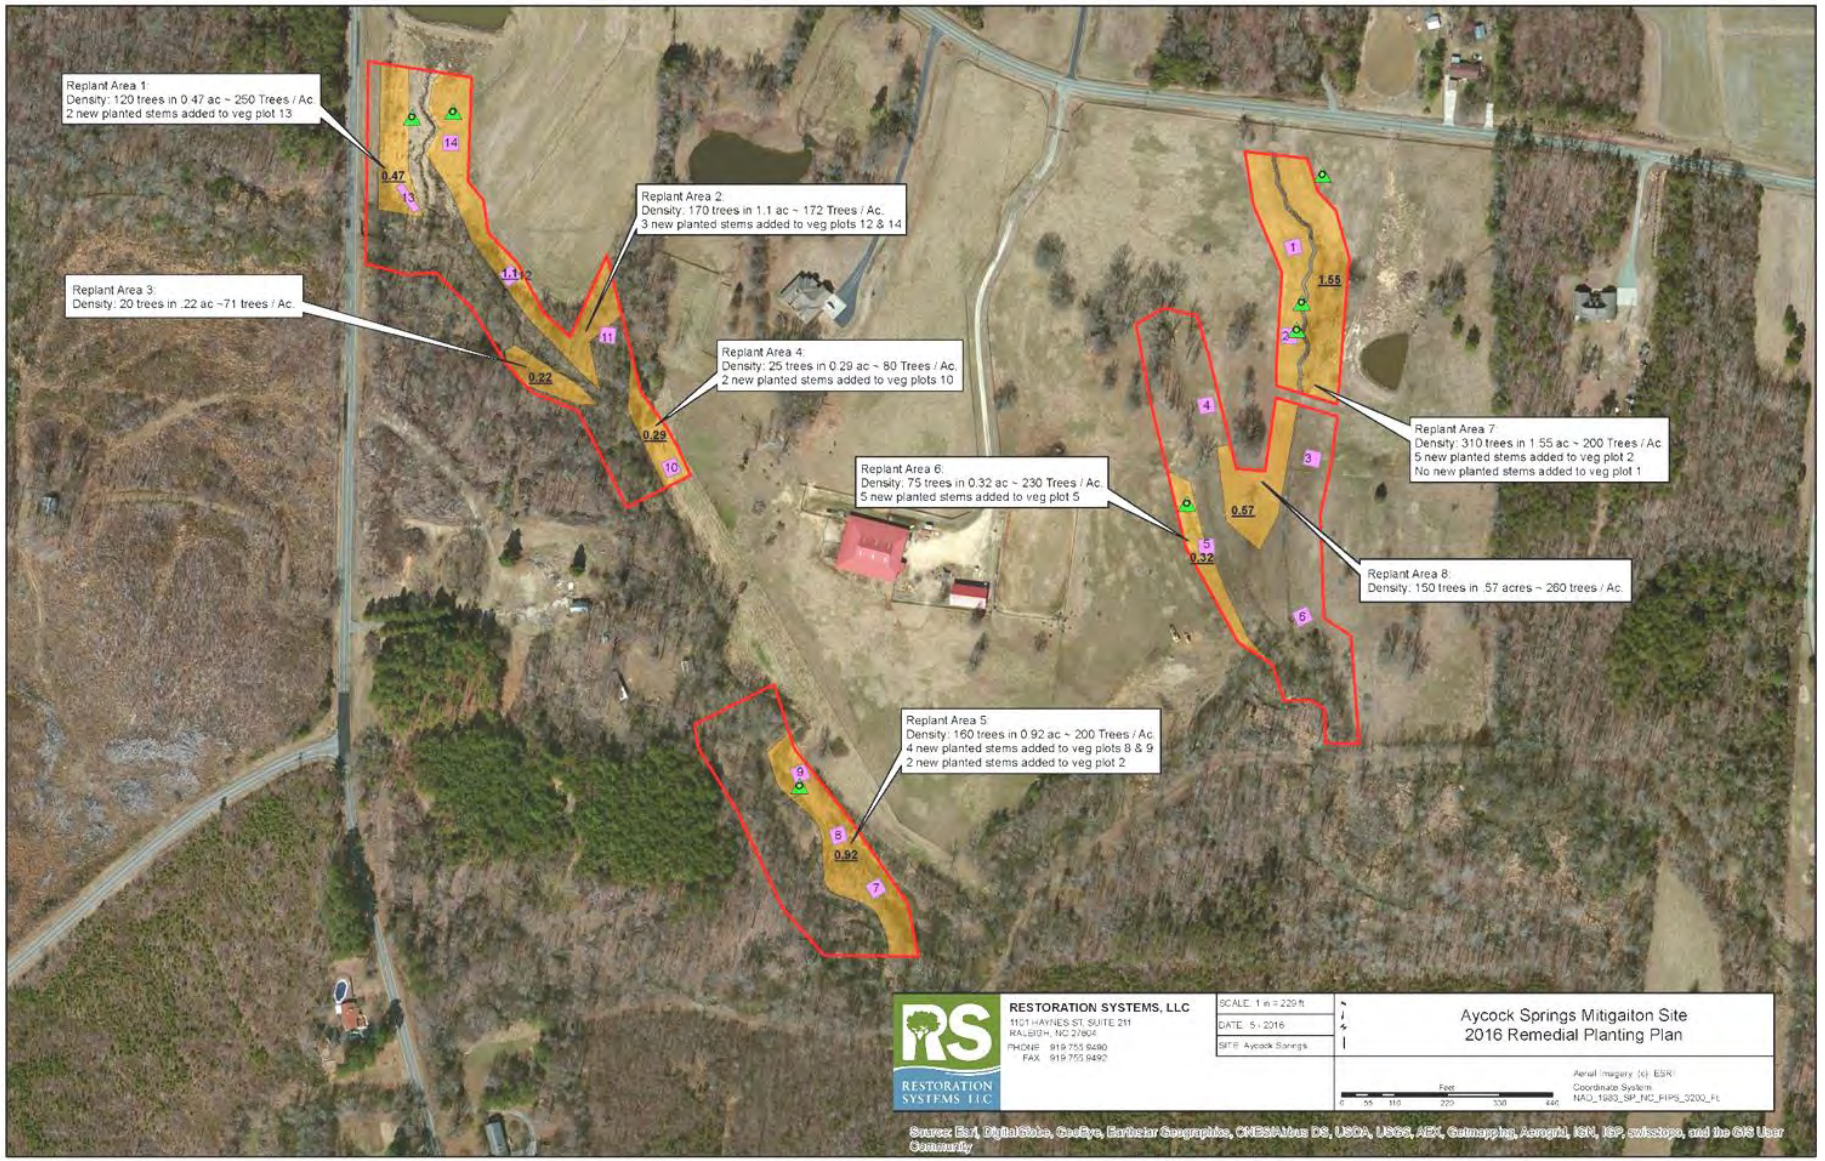
Map of Replant Areas- green dots indicate approximate location of where photos were taken.

Aycock Springs– Remedial Action Plan - Vegetation Update
