**YEAR 7 (2022) MONITORING REPORT**  
**AYCOCK SPRINGS**  
**STREAM AND WETLAND MITIGATION SITE**

ALAMANCE COUNTY, NORTH CAROLINA  
DMS PROJECT No. 96312  
FULL DELIVERY CONTRACT No. 5791  
NCDWR PROJECT No. 20140335  
USACE ACTION ID No. SAW-2014-01711

**Data Collection – January-October 2022**

**February 2023**

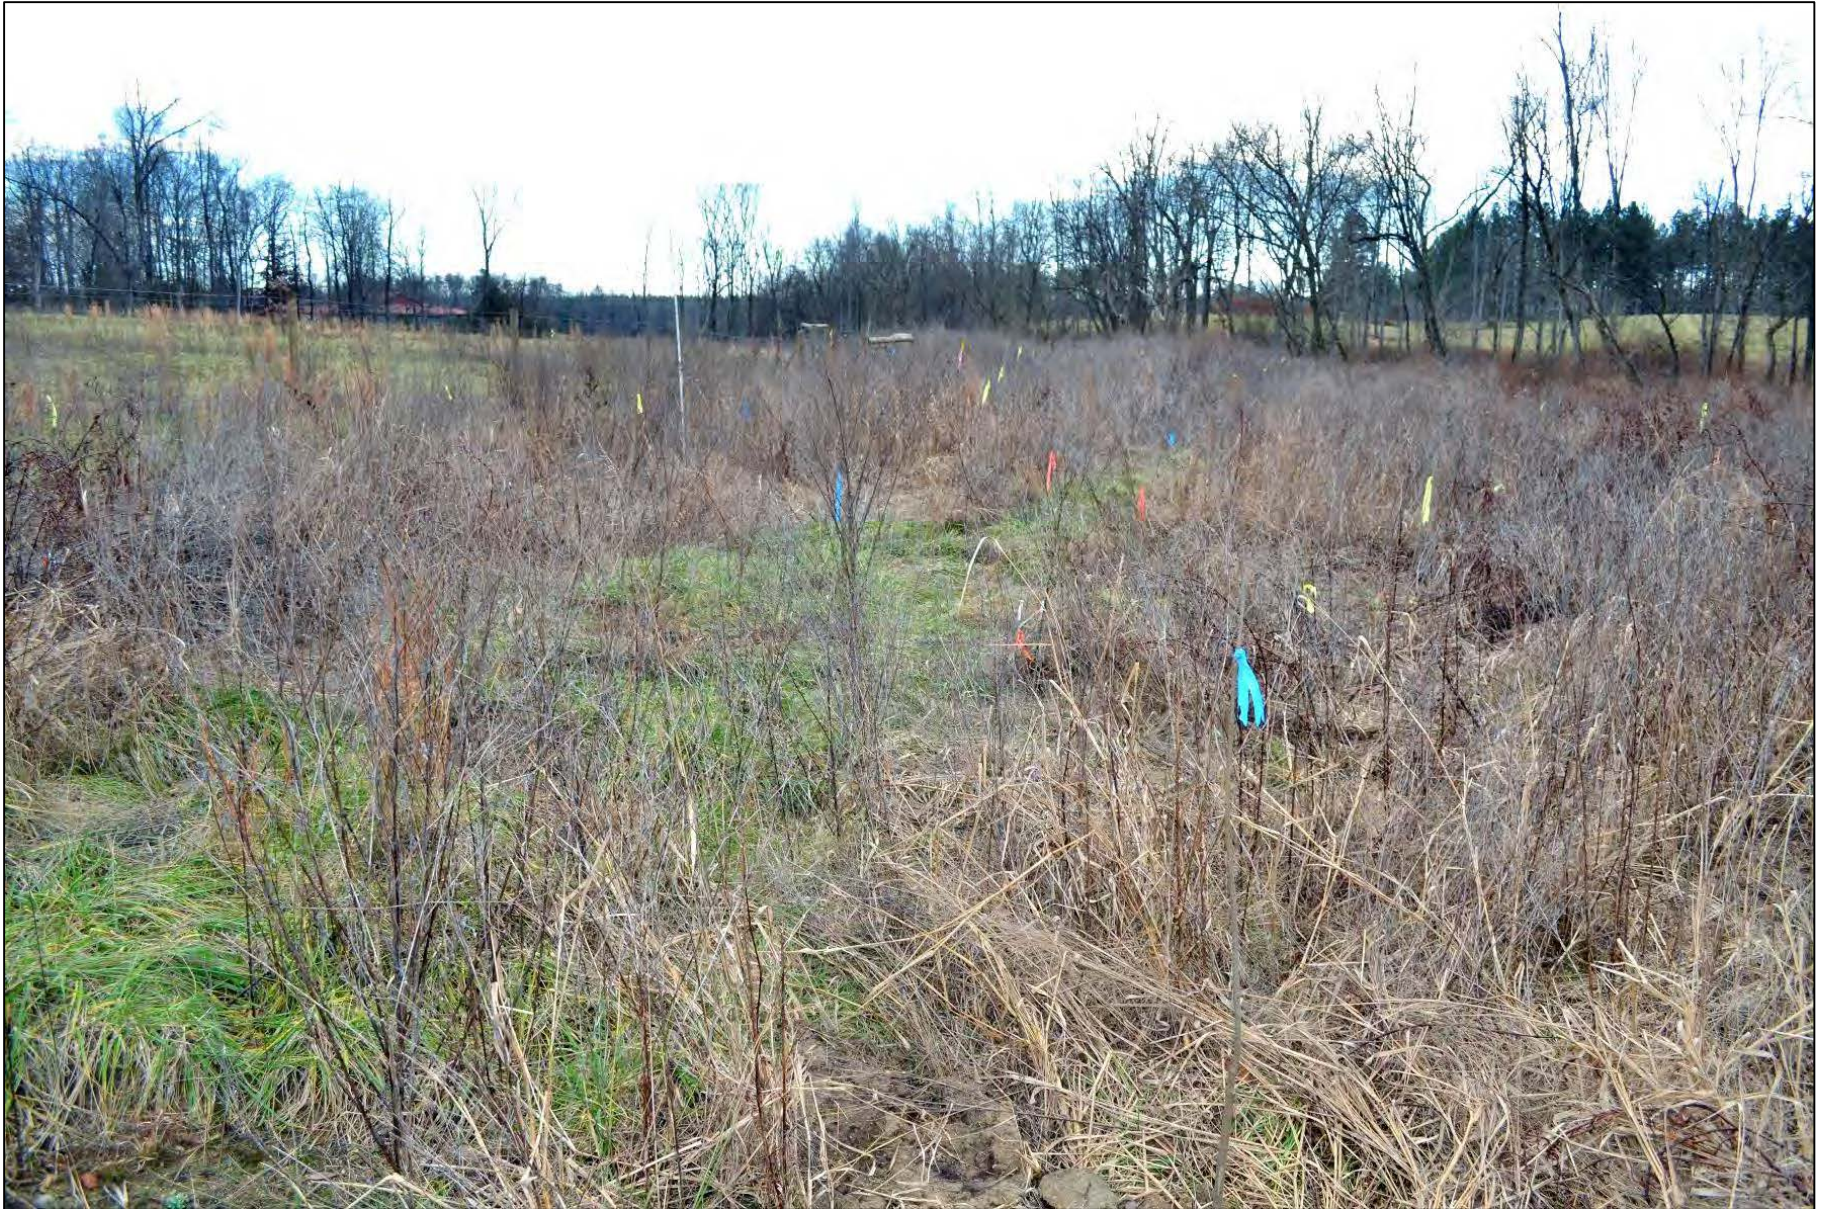
Photo 1: Looking SW. along Replant Area -1

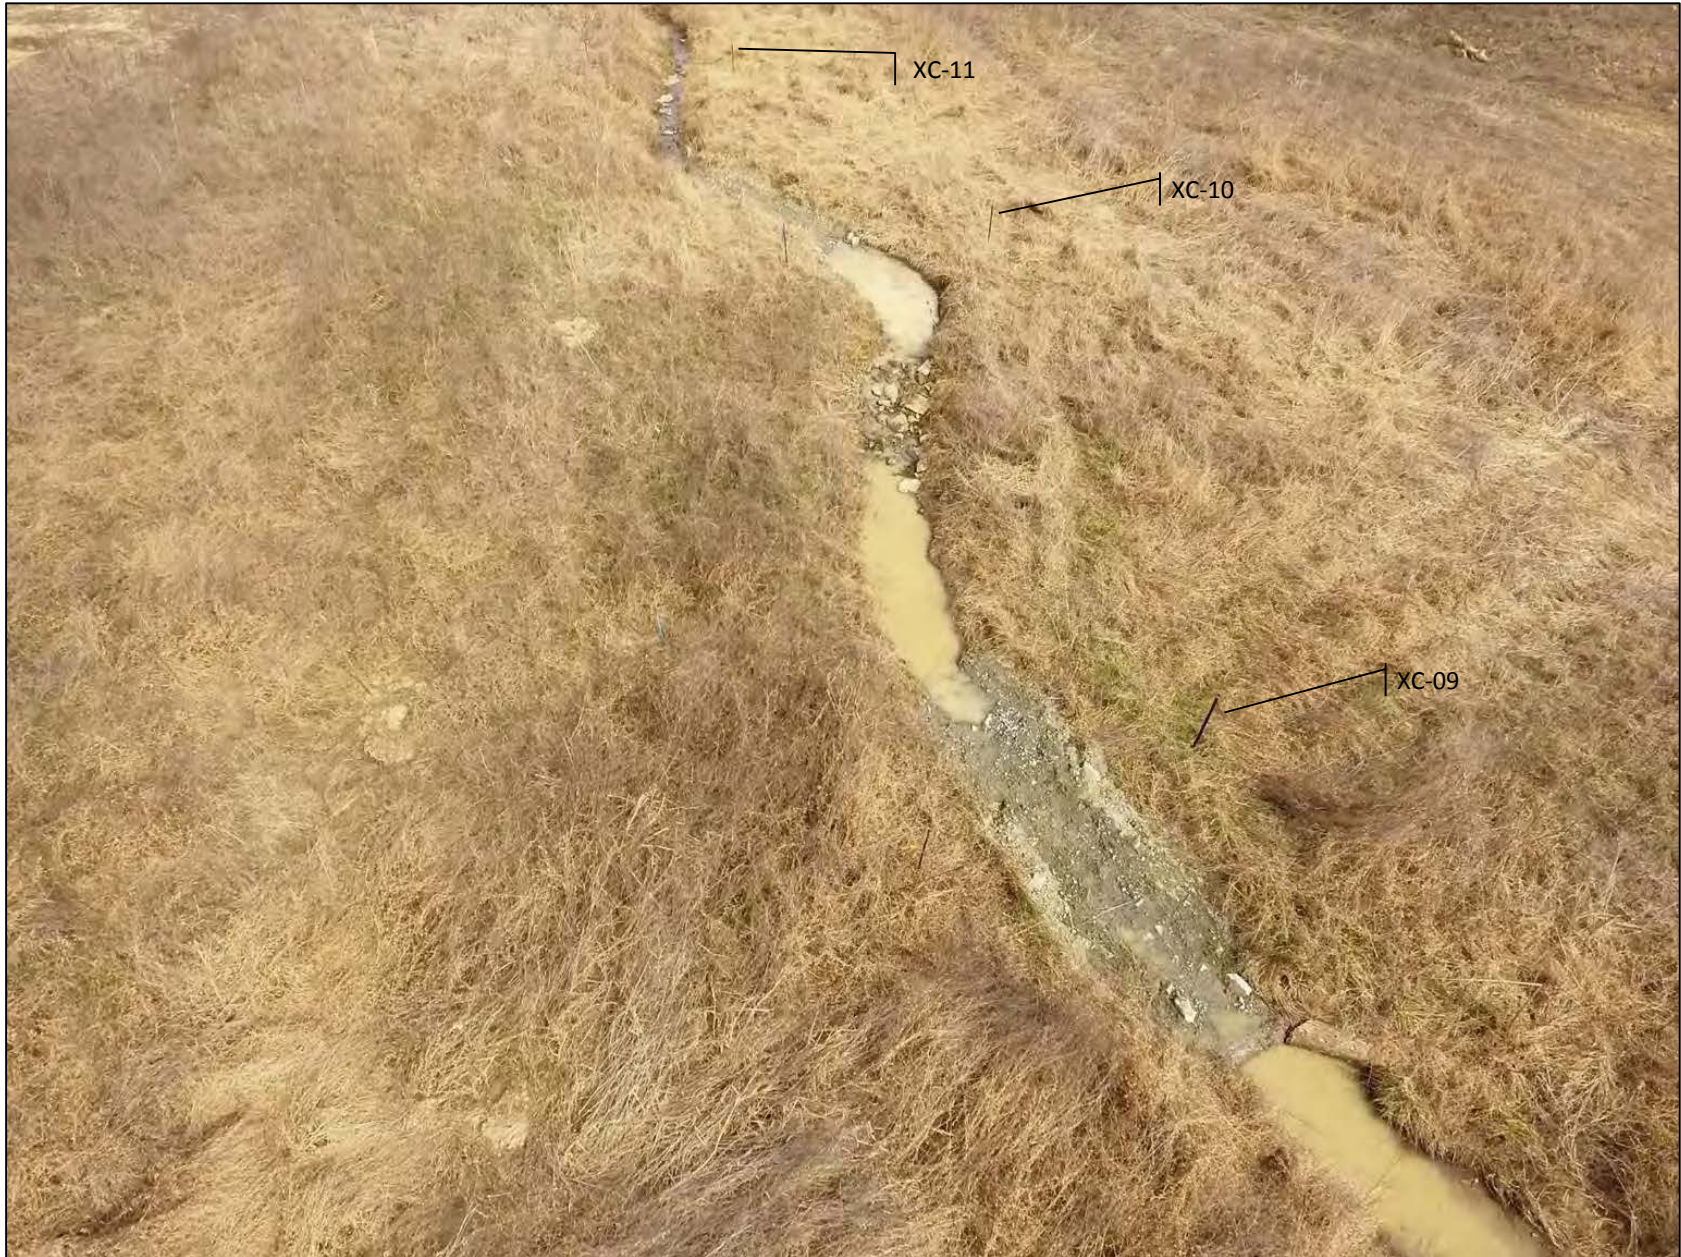
Photo 4: Substrate replaced, upstream riffle of XC 10 (pool)

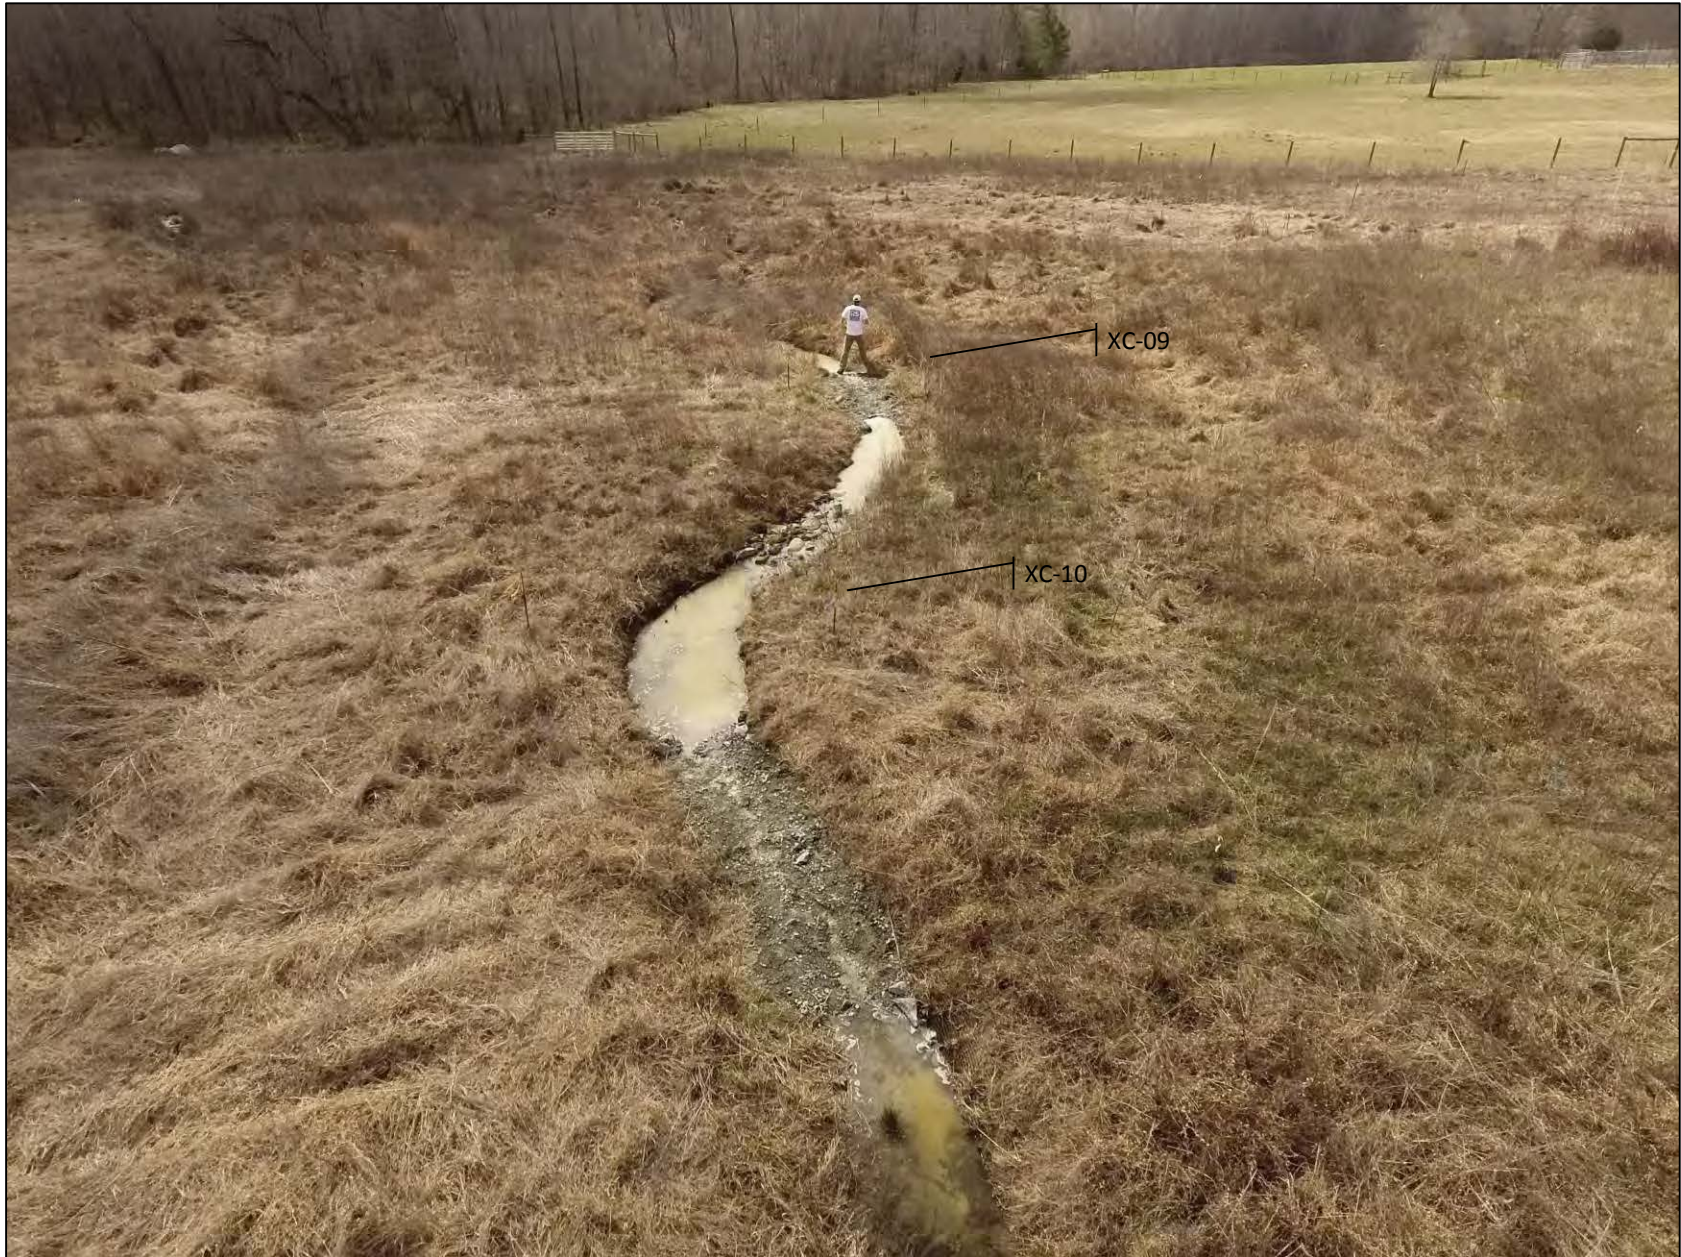
Photo 5: post replacement overview

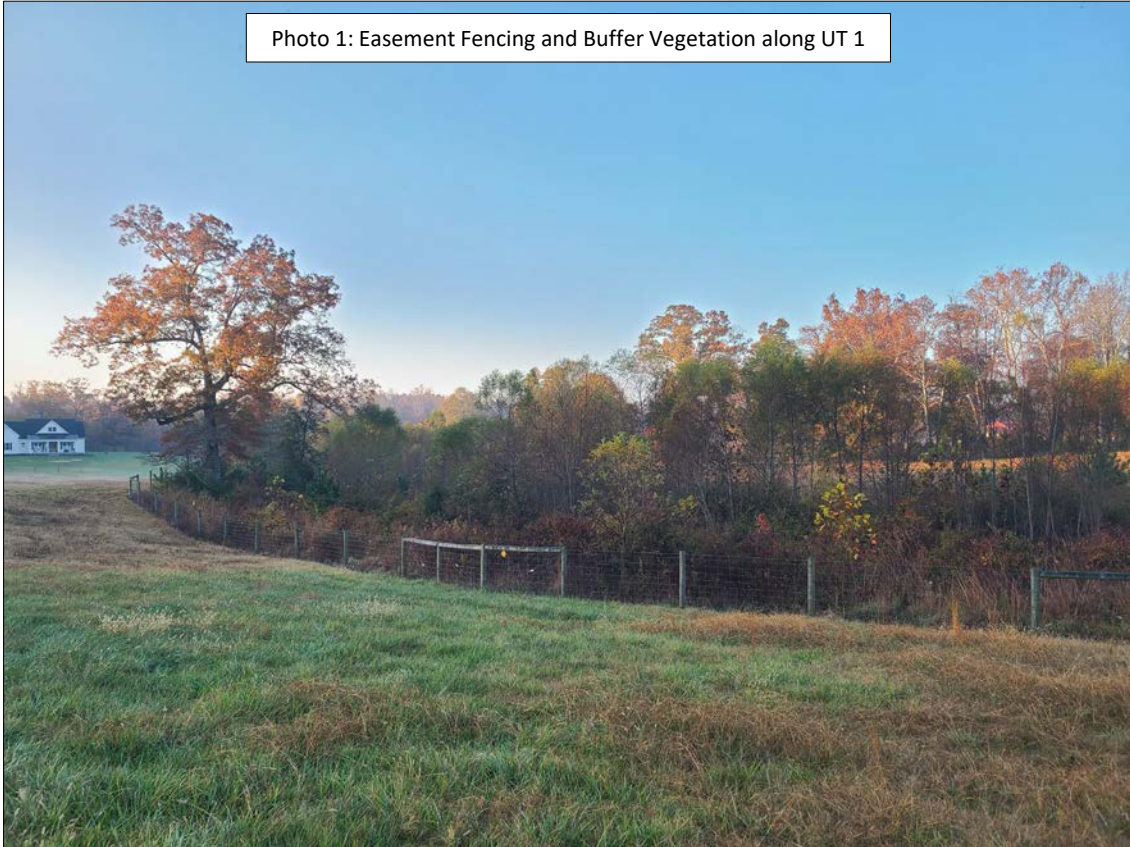
Photo 1: Easement Fencing and Buffer Vegetation along UT 1
